UNDERWATER BRIDGE INSPECTION REPORT

STRUCTURE NO. 66546

CANNON RIVER

SEPTEMBER 13, 2012

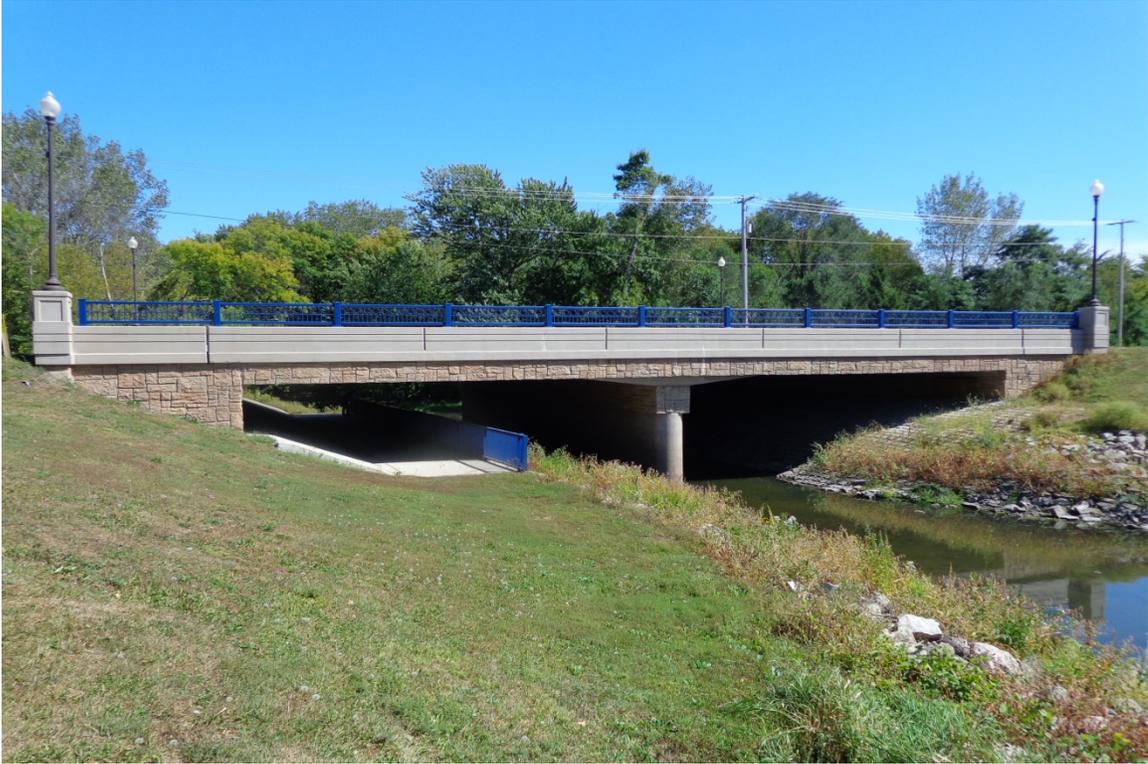
Photograph 1. Overall View of the Structure, Looking Southeast.

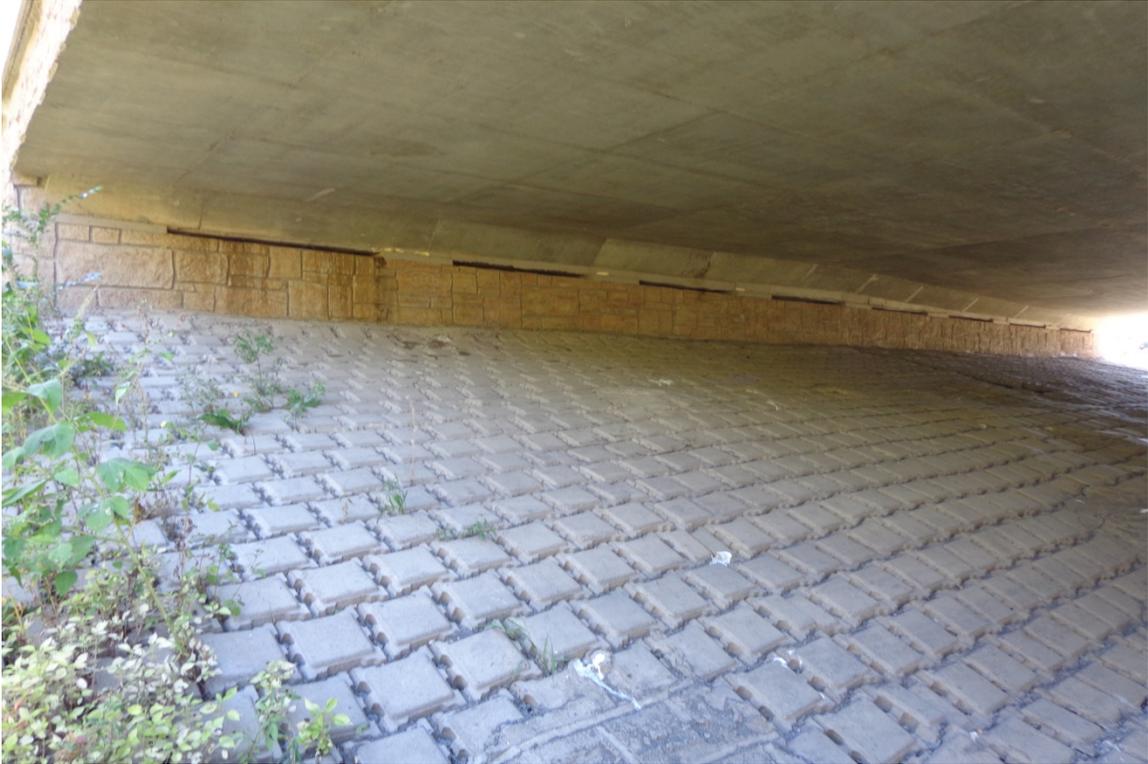
Photograph 2. View of South Abutment, Looking Southwest.

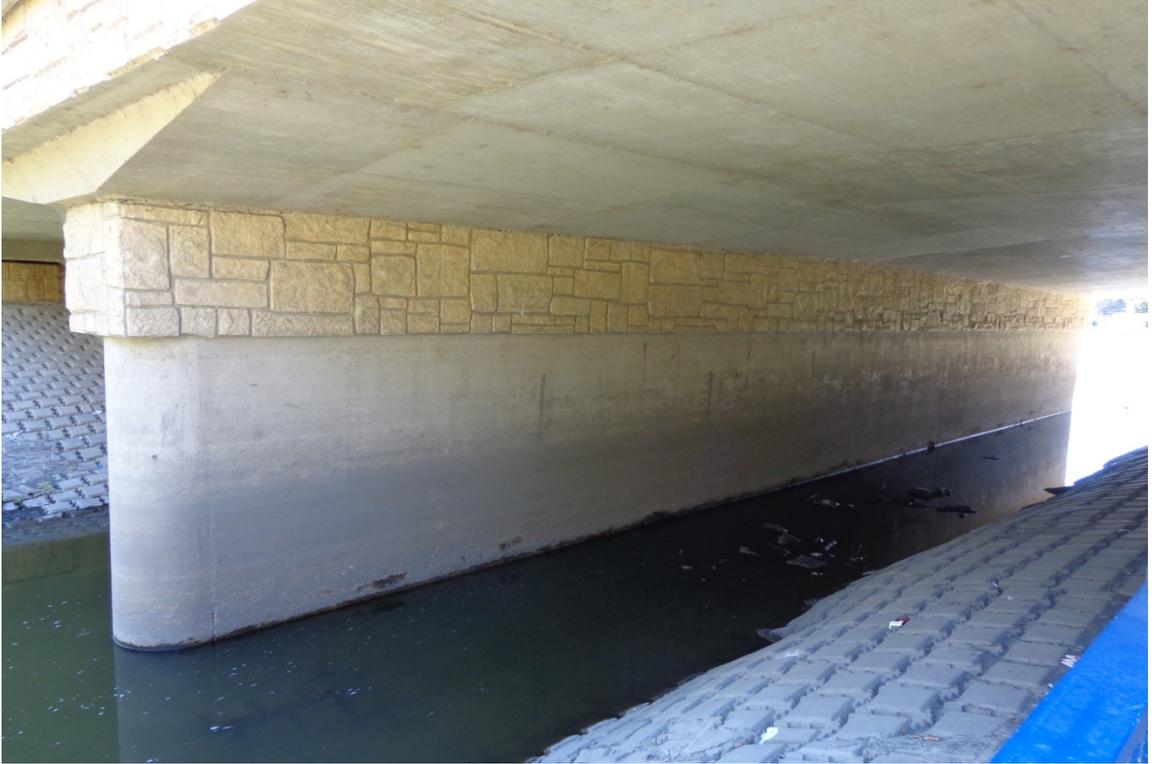
Photograph 3. View of Pier 1, Looking Southwest.

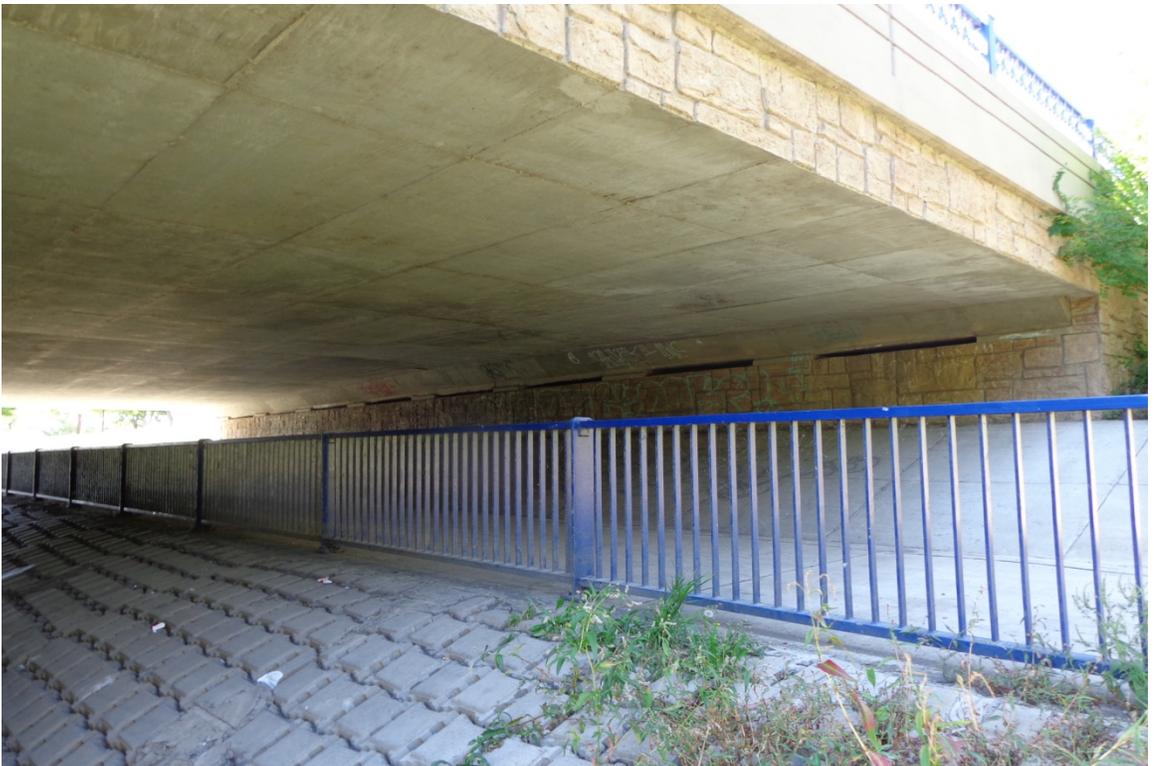
Photograph 4. View of North Abutment, Looking Northwest.

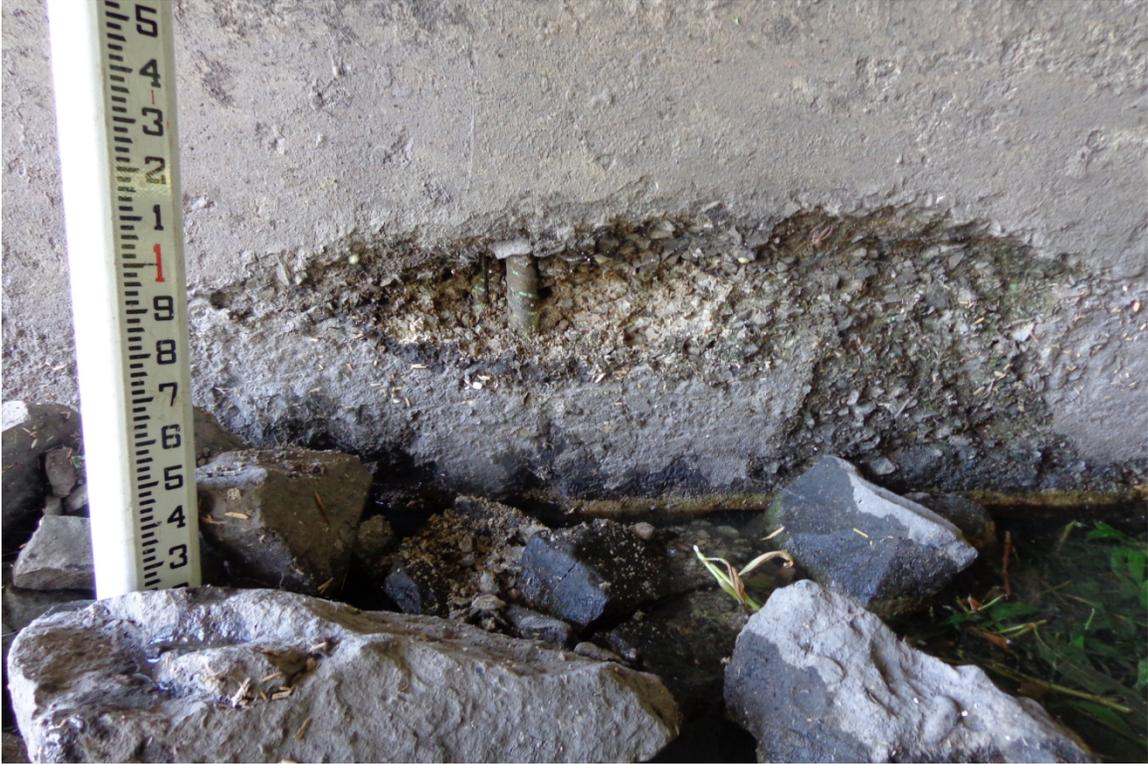
The substructure unit inspected at Bridge No. 66546, Pier 1, was found to be generally in satisfactory to fair condition with no defects of structural significance observed. The concrete was typically soft and easily erodible with up to 3 inches of penetration over 50 percent of the pier face from channel bottom to 1 foot above the waterline. Random locations exhibited exposed coated reinforcing steel with no surface corrosion present. The north and south embankment slopes were lined with an articulated concrete mat and the channel bottom material at the pier consisted of randomly displaced paving stones with sand infill.

Photograph 5. View of Typical Spalled Concrete along the South Face of Pier 1, Looking North.

- (A) Monitor concrete deterioration at Pier 1 and if the deficiencies continue to progress and the exposed reinforcing steel starts to corrode, repairs may become warranted at that time.

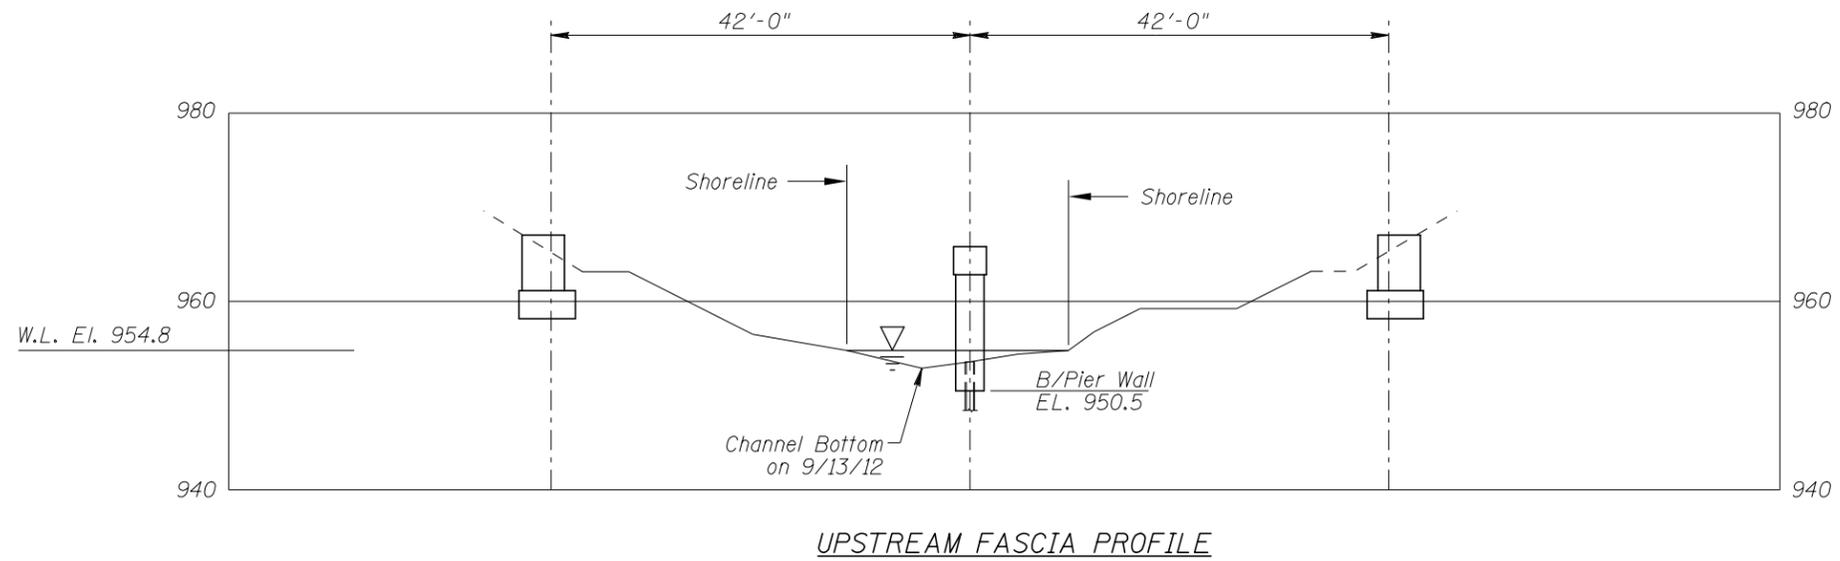
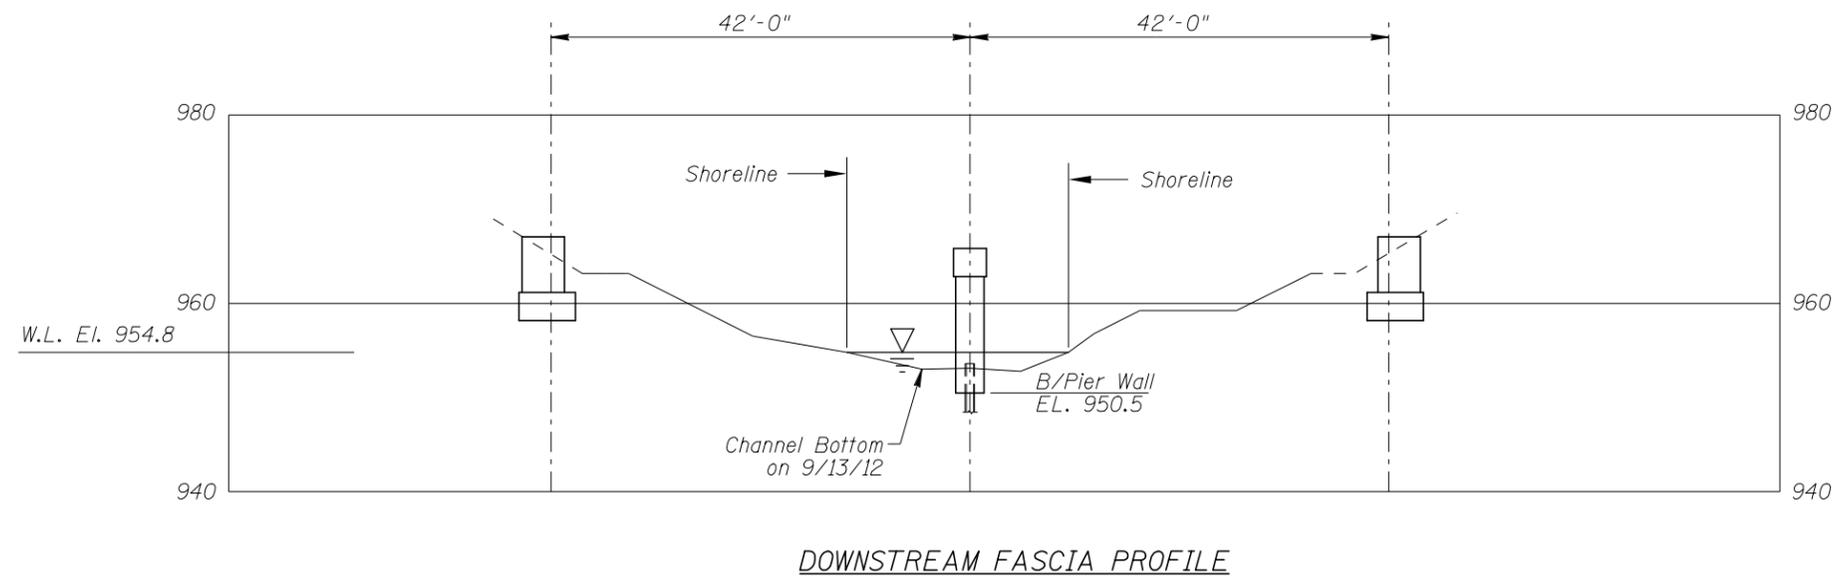
- ① The north and south slope embankments were lined with articulated concrete mat from top of slope to 1 foot below waterline and from 10 feet upstream to 10 feet downstream of the bridge fascias.
- ② Approximately 50 percent of the concrete surface of the pier wall exhibited soft and easily erodible concrete with up to 3 inches of penetration from channel bottom to 1 foot above waterline and exposed coated reinforcing steel was present.
- ③ The channel bottom consisted of randomly displaced paving stones with sandy infill.
