UNDERWATER BRIDGE INSPECTION REPORT

STRUCTURE NO. 66548
C.S.A.H. 29
OVER THE
CANNON RIVER
DISTRICT 6 - RICE COUNTY

SEPTEMBER 13, 2012
PREPARED FOR THE
MINNESOTA DEPARTMENT OF TRANSPORTATION
BY
COLLINS ENGINEERS, INC.
JOB NO. 7423

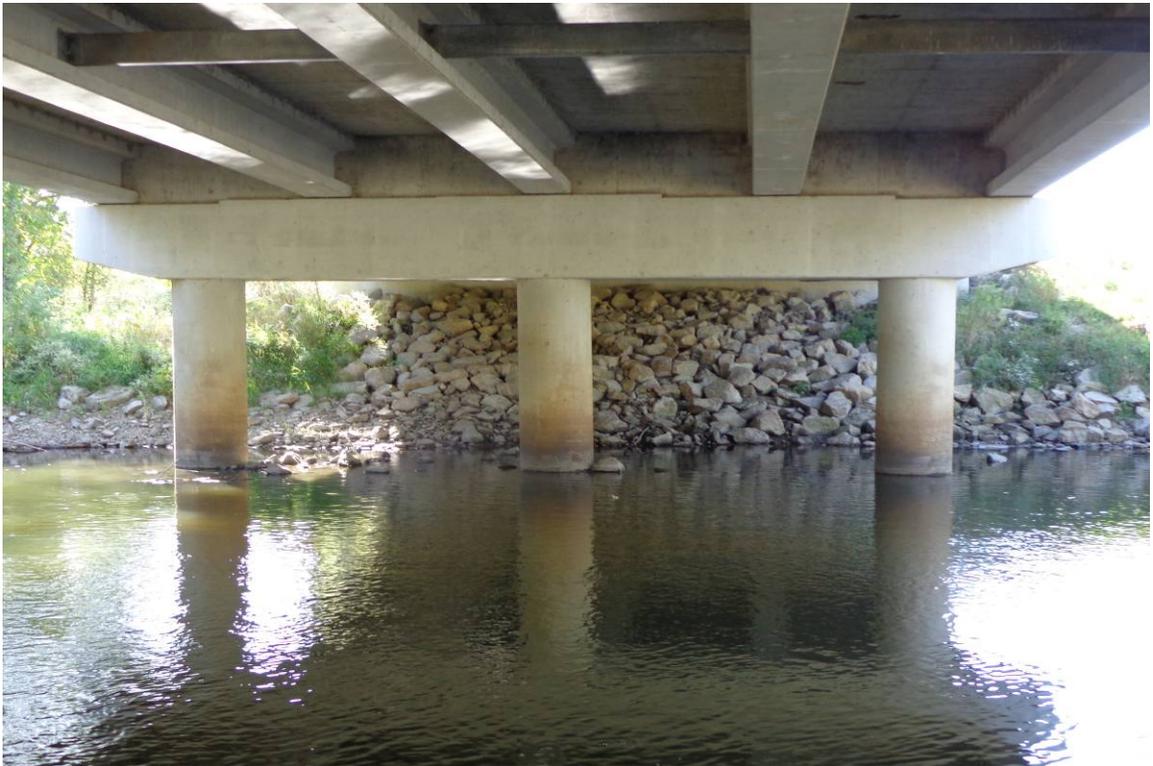
- (B) The concrete of the columns was in smooth and sound condition.

Photograph 2. View of Pier 1, Looking West.

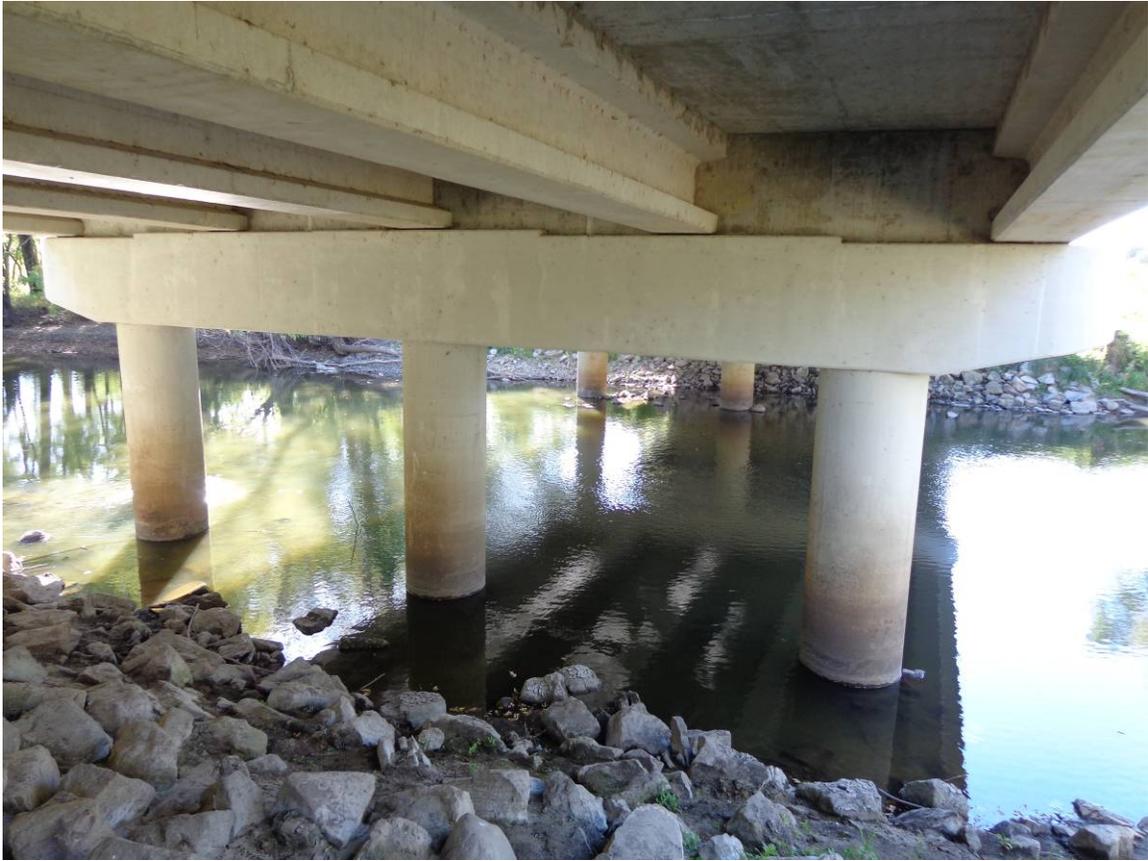
Photograph 3. View of Pier 2, Looking West.

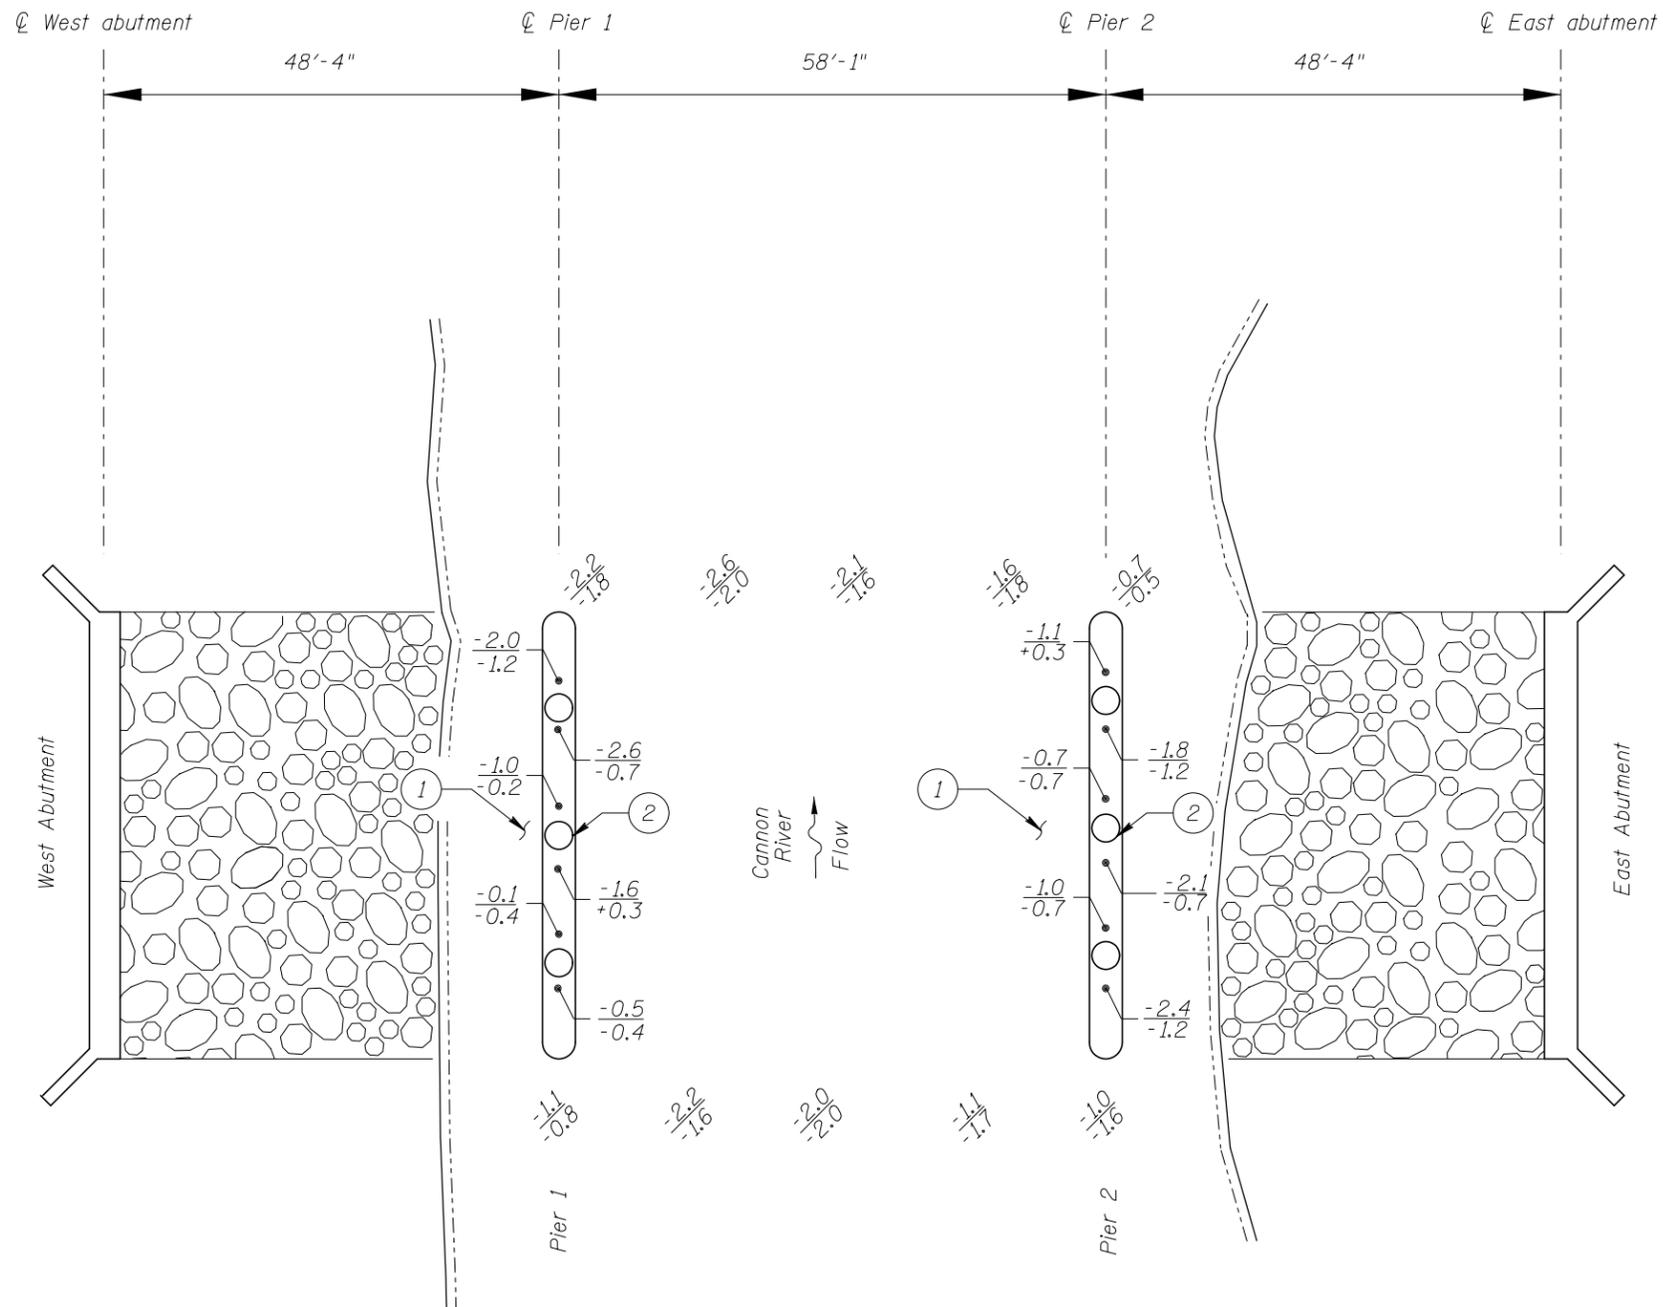
SOUNDING PLAN

- ① The channel bottom consisted of rock and gravel with soft silt infilling with minimal probe rod penetration.
- ② Concrete of the columns was in smooth and sound condition.

- (A) Reinspect the submerged substructure units at the normal maximum recommended (NBIS) interval of sixty (60) months.
