UNDERWATER BRIDGE INSPECTION REPORT

STRUCTURE NO. 89859

REDWOOD RIVER

OCTOBER 24, 2012

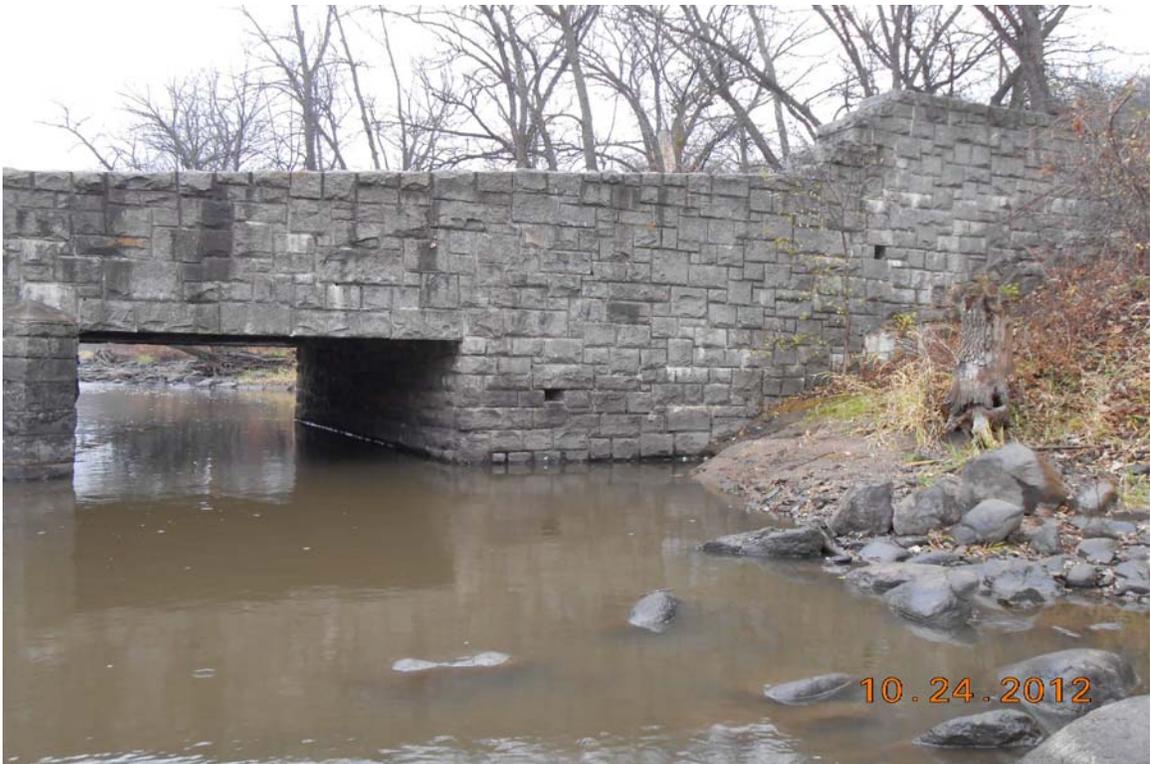
Photograph 2. View of South Abutment, Looking East.

- 8 Moderate accumulation of timber debris was observed along the South Abutment extending from the channel bottom to approximately 1 foot above the waterline.

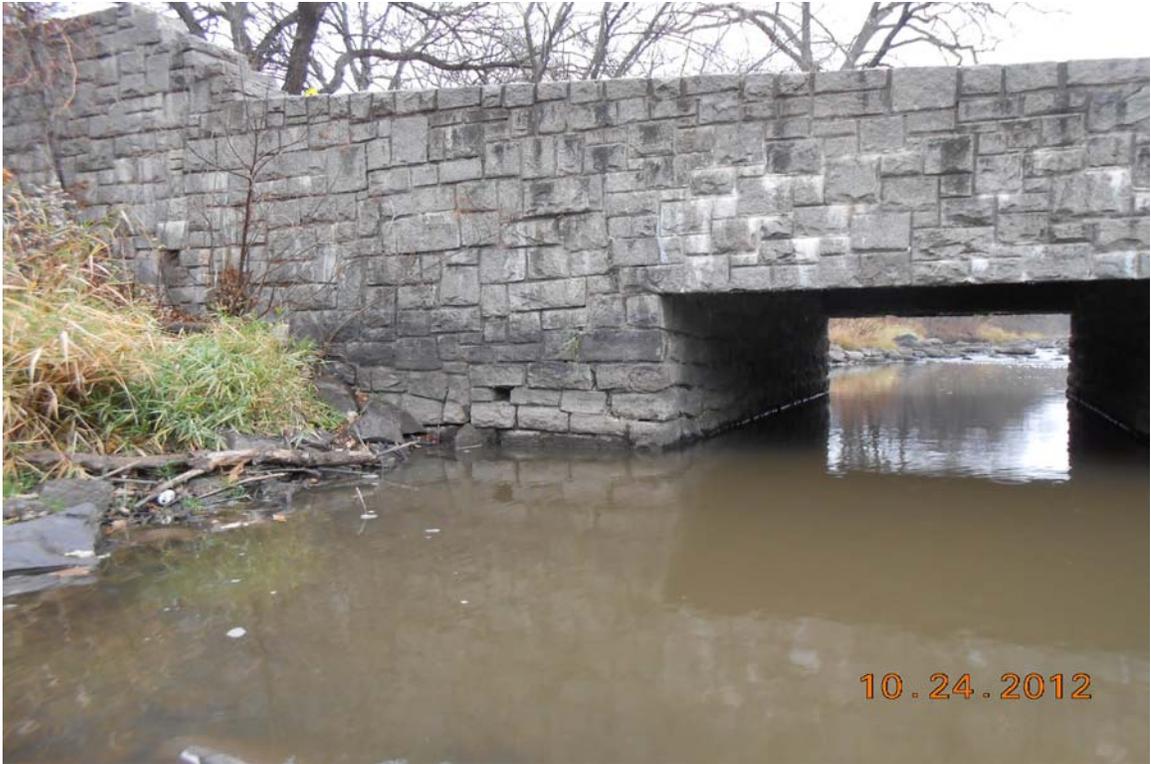
Photograph 3. View of North Abutment, Looking East.

- 1 Piers 2, 3, 6, and 8, as well as the North Abutment were encased in concrete from approximately 1.7 feet below the waterline to the channel bottom.

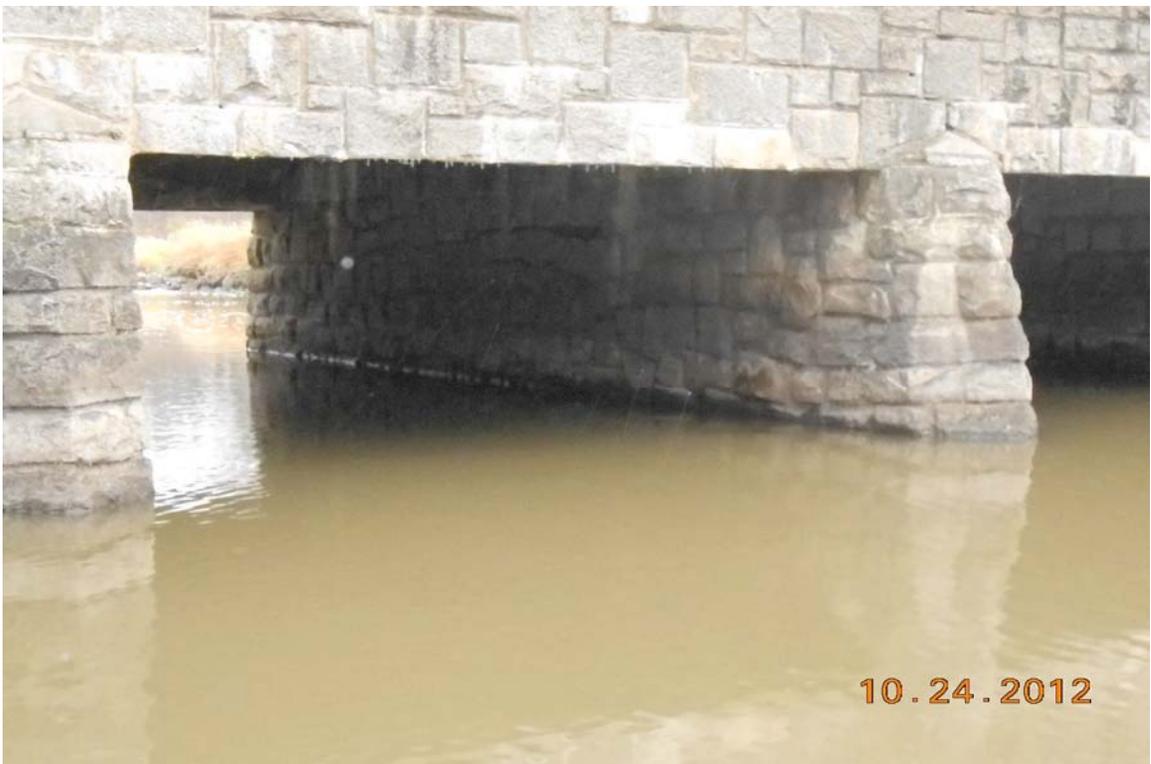
Photograph 4. View of Pier 8, Typical Pier Condition, Looking Southeast.

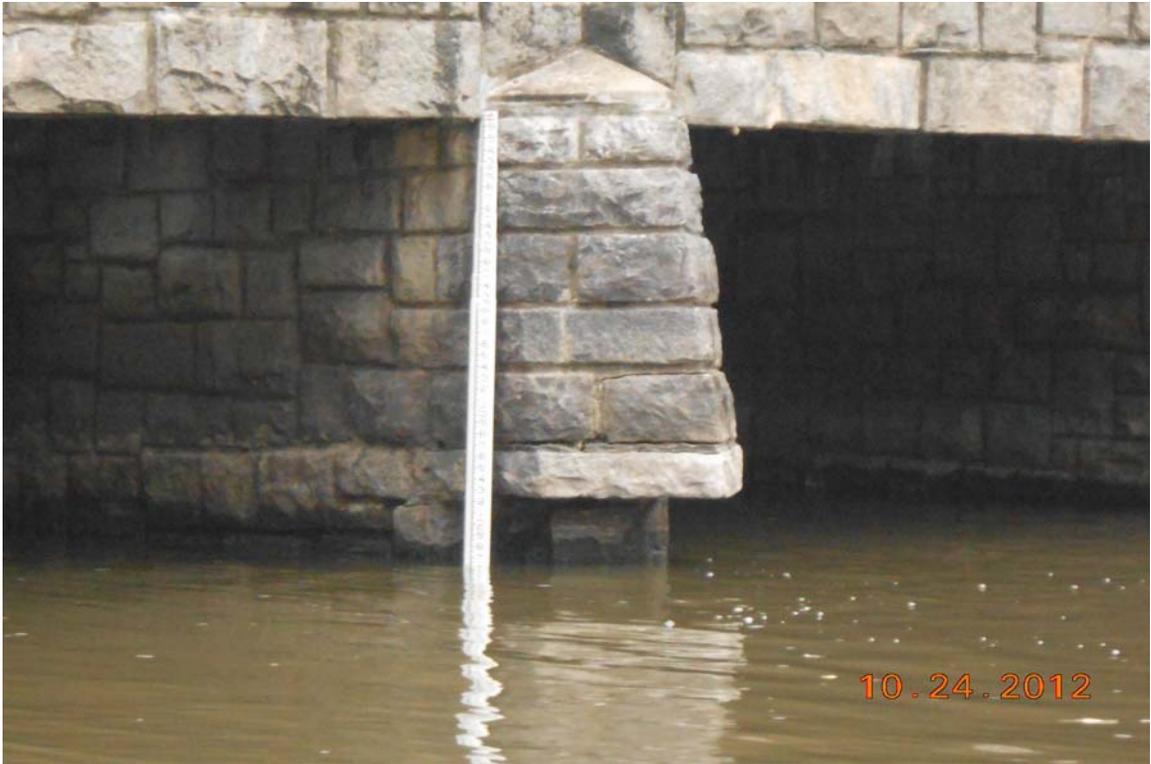
Photograph 5. View of Pier 6 Downstream Nose with Missing Stones, Looking Southeast.

- 5 One masonry stone was missing near the downstream nose of Pier 6 at 1 foot below the waterline.
- 6 Area of undercutting / void was observed at the streambed near the upstream nose of Pier 7. The cavity measured 2 feet wide by 6 inches high with up to 2 feet of horizontal penetration.

- (B) Additionally, the numerous areas of masonry loss of section and missing stone blocks should be repaired/replaced in order to avoid further, more detrimental deterioration of the affected substructure units.

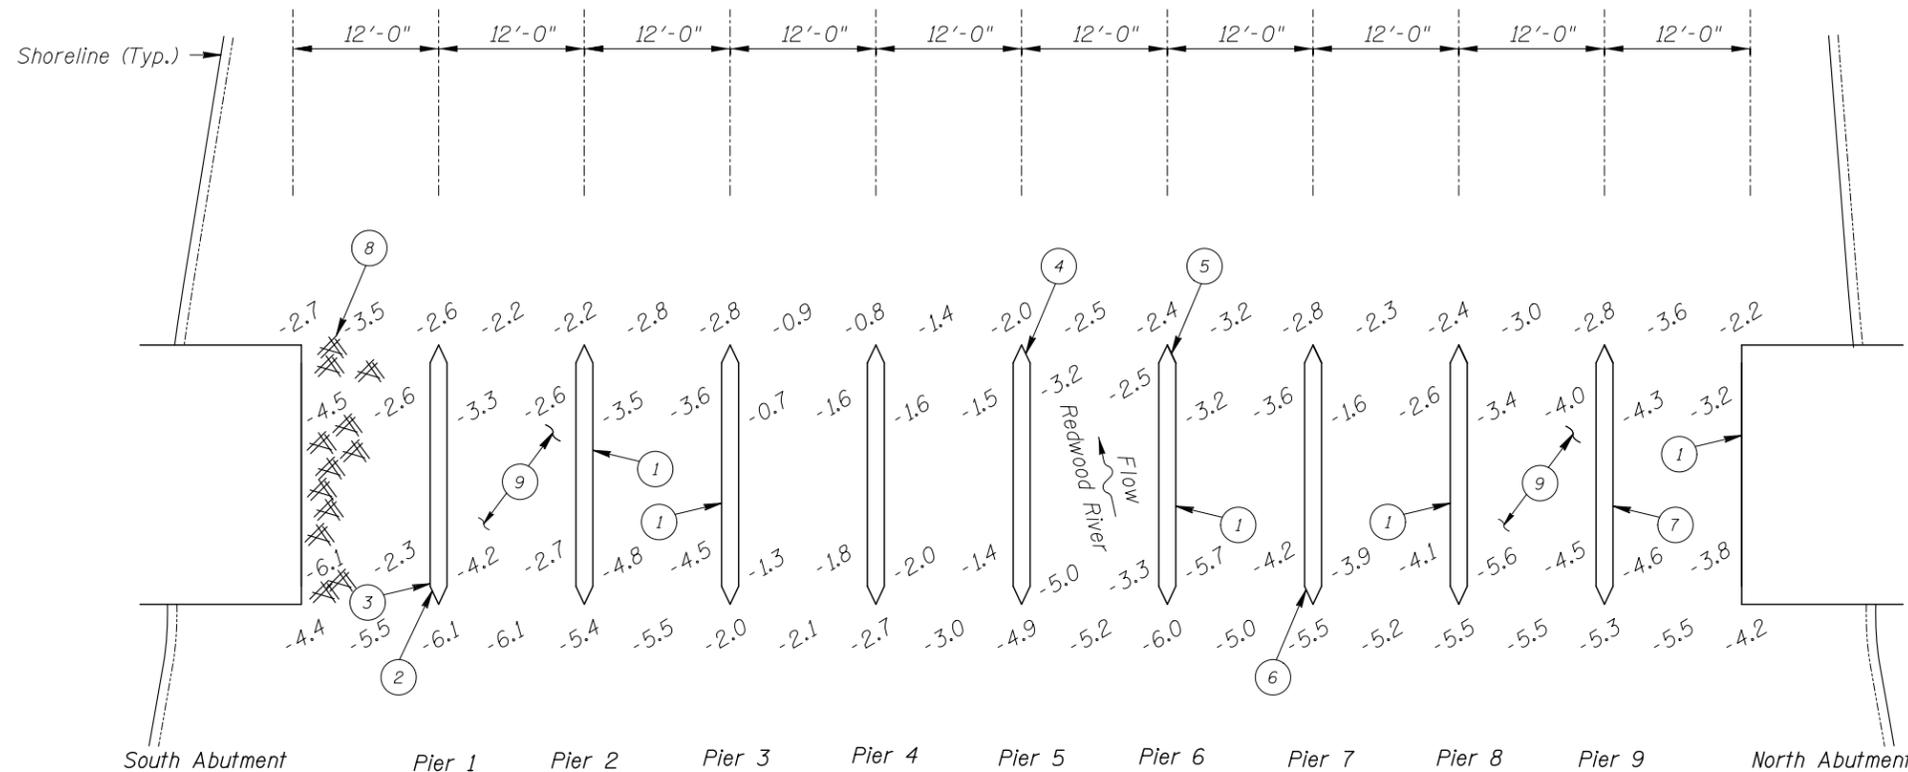
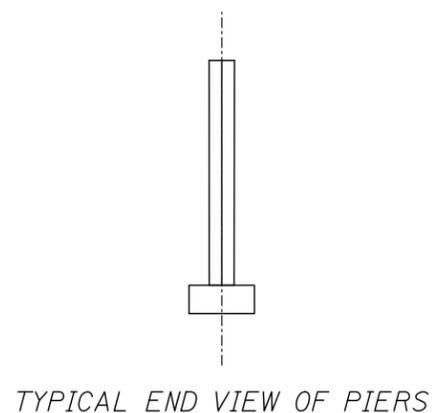
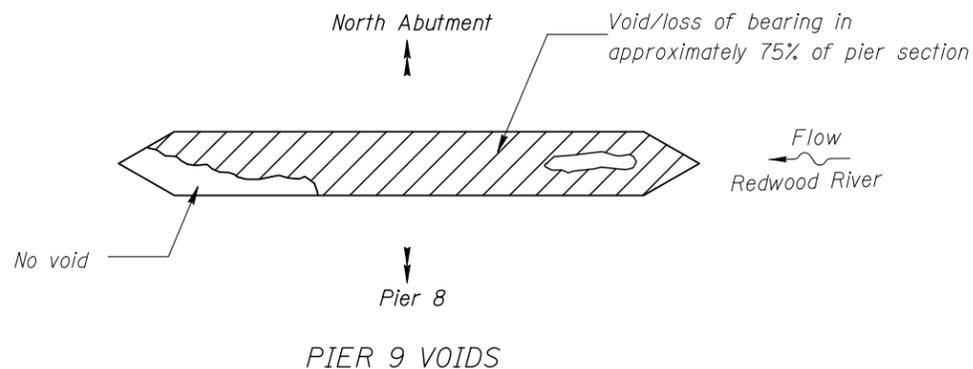
INSPECTION AND SOUNDING PLAN

- 2 Area of undercutting / void due to possible loss of masonry section and/or erosion of rock channel bottom was observed at the upstream nose of Pier 1 located near the streambed. The cavity measured 4 feet long by 3 inches high with up to 6 inches of horizontal penetration.

- 3 Loss of masonry stones was observed across the upstream nose of Pier 1 located near the waterline and measuring approximately 2.8 feet high.
- 4 One masonry stone was missing at the downstream nose of Pier 5 at 1 foot above the waterline.

- 7 Extensive loss of masonry stones and/or erosion of the river bottom was observed along the length of Pier 9 measuring up to 8 inches high and often exhibiting full pier width penetration. The total loss of bearing at the pier due to the above mentioned loss of section was estimated to be approximately 75 percent of the total pier cross sectional area. Above the voided area the pier masonry was intact with no displaced stone blocks and no significant loss or cracking of joint mortar.

- 9 The channel bottom material around Piers 1 through 9 typically consisted of rock and large cobbles.

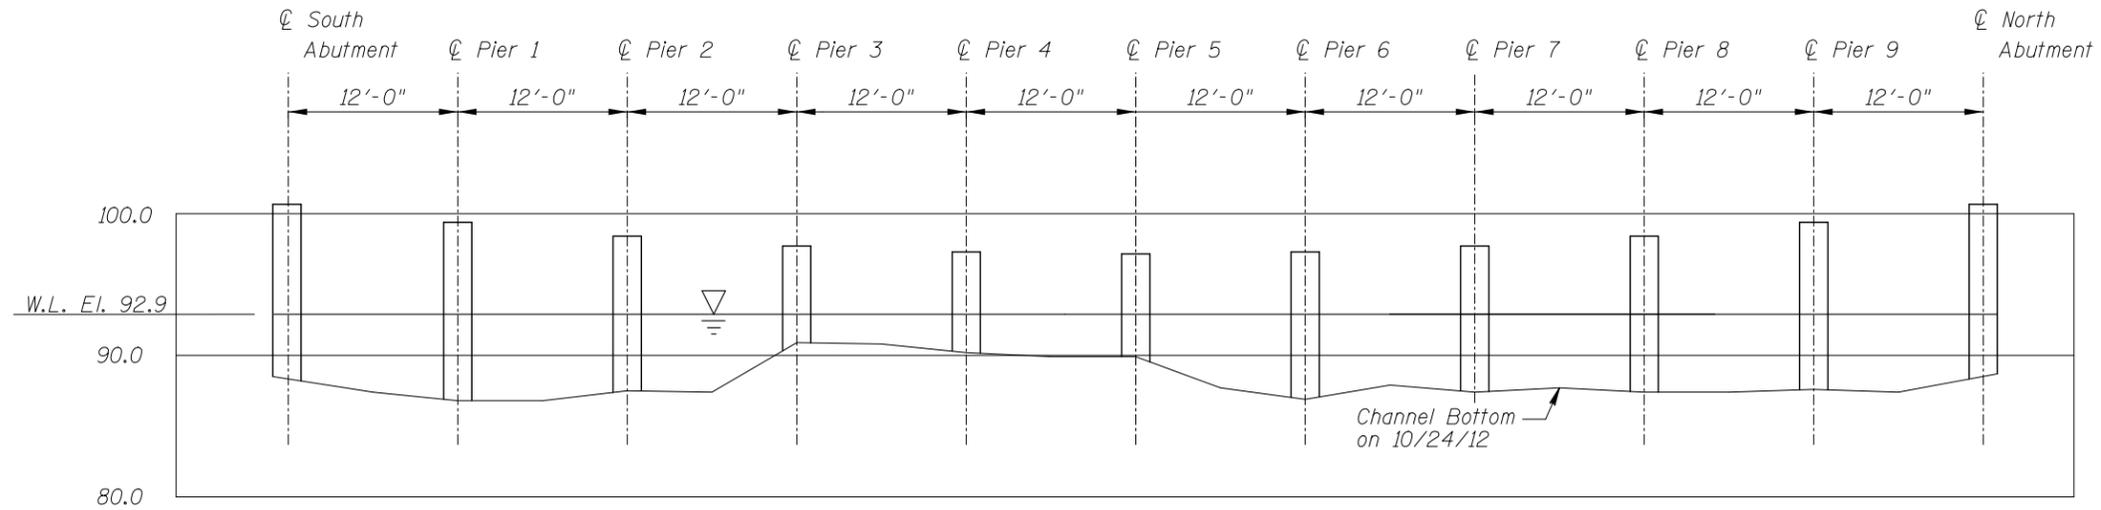
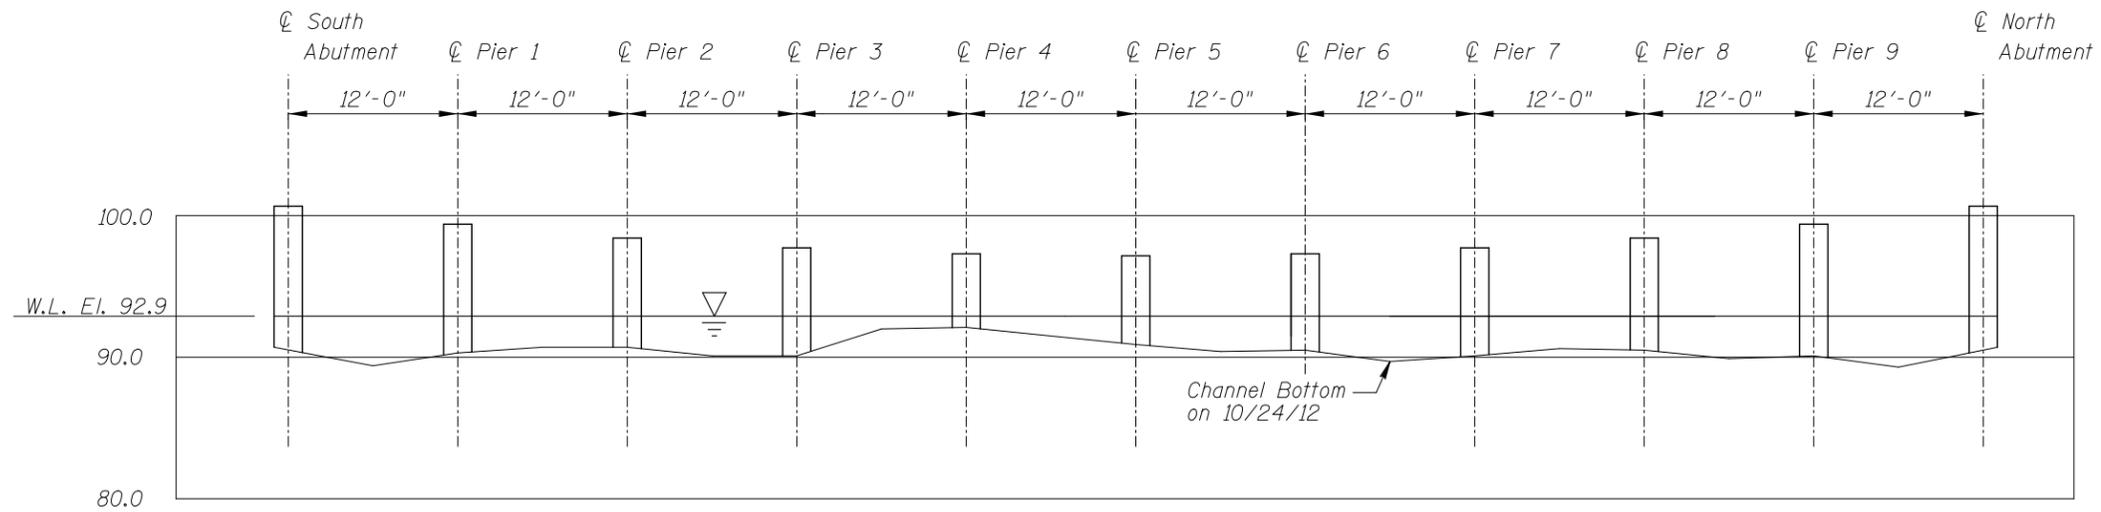
UPSTREAM FASCIA PROFILE

DOWNSTREAM FASCIA PROFILE
