UNDERWATER BRIDGE INSPECTION REPORT

STRUCTURE NO. 93153

MIDDLE FORK WHITEWATER RIVER

COLLINS ENGINEERS, INC.

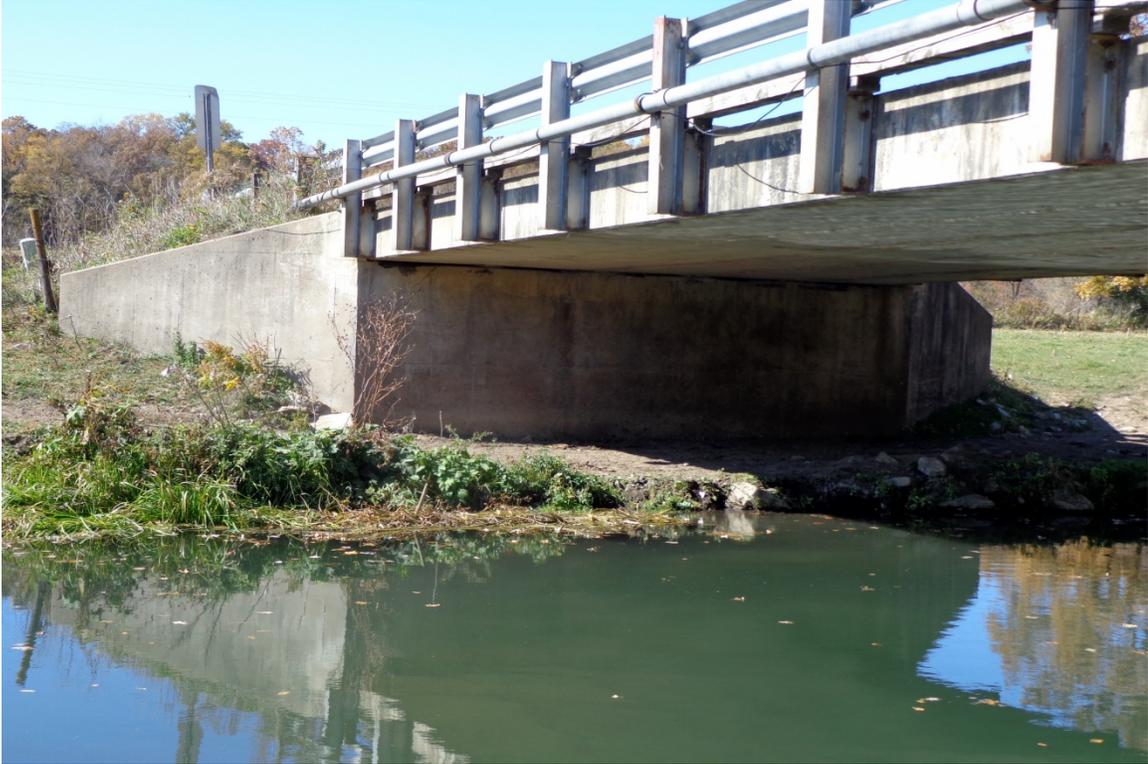
Photograph 2. View of the West Abutment, Looking Northwest.

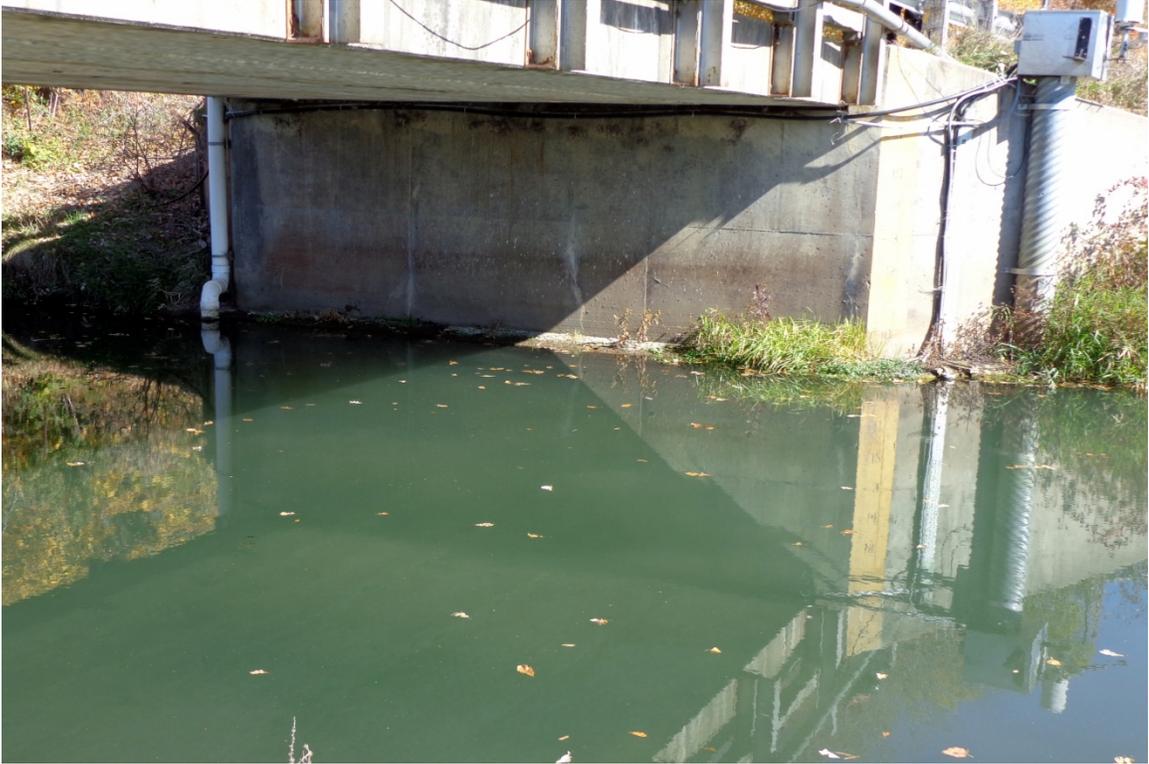
The substructure unit inspected at Bridge No. 93153, the East Abutment, was generally in fair condition, but with significant foundation undermining. The concrete footing was heavily weathered and was undermined a maximum of 3 feet vertically with 5 feet of horizontal penetration beneath the abutment foundation. The inspector observed three exposed steel H-piles under the abutment footing.

Photograph 3. View of the East Abutment, Looking East.

- (A) Based on the extent and severity of the undermining and evidence of loss of fill material behind the East Abutment, it is recommended that corrective action be taken to stabilize the channel bottom in the vicinity of the East Abutment and to prevent further scour/erosion.

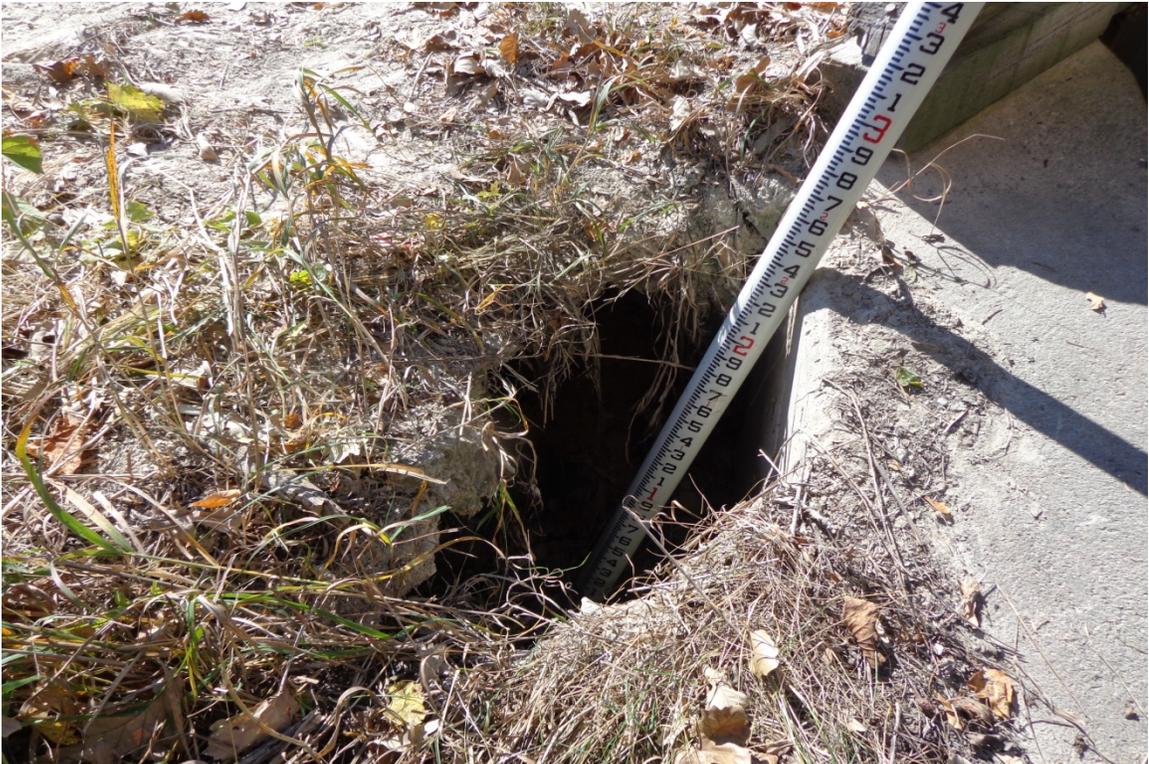
Photograph 4. View of Sink Hole at Northeast Wingwall, Looking North.

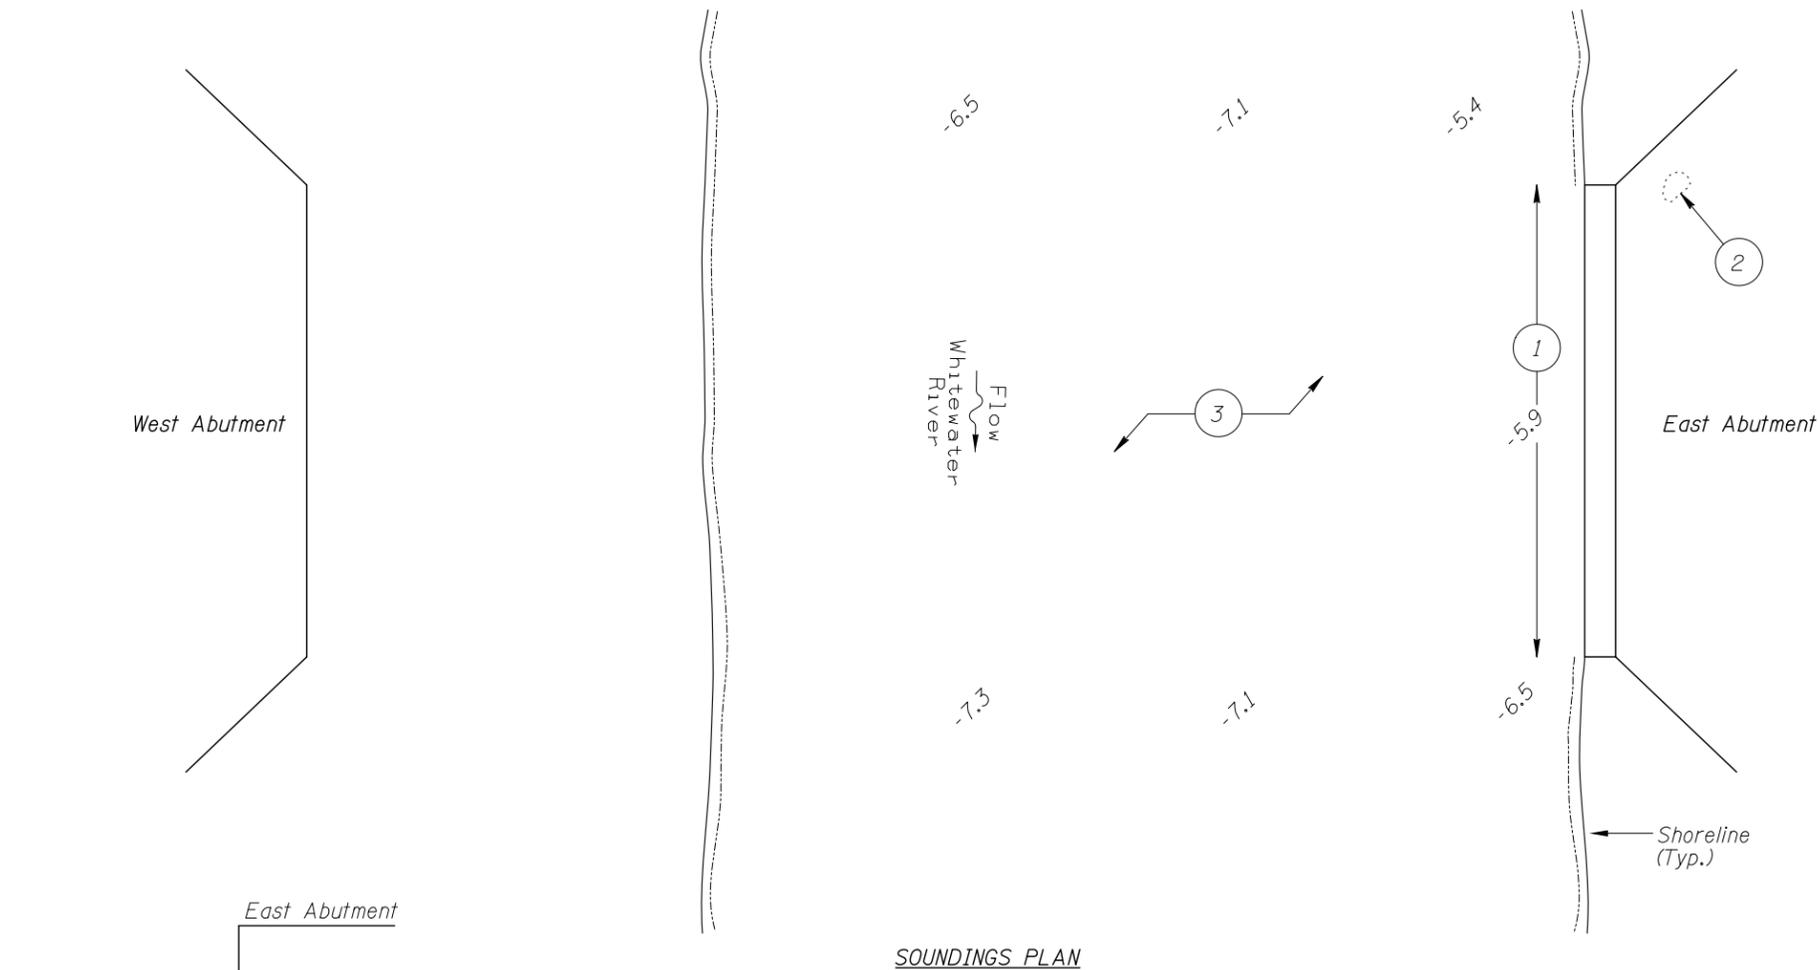
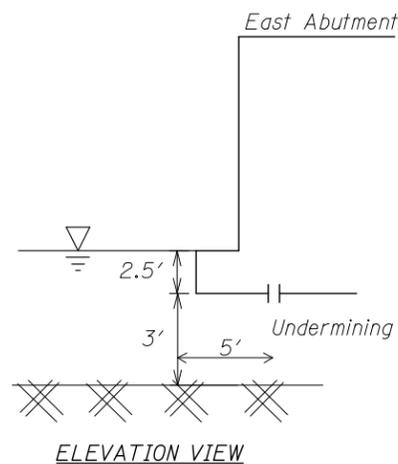
SOUNDINGS PLAN

- ① The East Abutment was undermined along its entire length with the undermining cavity measuring up to 3 feet vertically with 5 feet of horizontal penetration. Three steel H-piles were exposed within the cavity and appeared to be in good condition.
- ② Approximately 2 foot diameter by 2 foot deep area of loss of fill (erosion sink hole) was observed at the northeast corner of the back side of the East Abutment.
- ③ The channel bottom material consisted of silty sand with 6 inches of probe rod penetration and random scattered 6 to 12 inch diameter stone.
