UNDERWATER BRIDGE INSPECTION REPORT

STRUCTURE NO. 96271
PEDESTRIAN WALKWAY
OVER THE
CANNON RIVER
CITY OF NORTFIELD

MAY 23, 2012
PREPARED FOR THE
MINNESOTA DEPARTMENT OF TRANSPORTATION
BY
COLLINS ENGINEERS, INC.
JOB NO. 5221

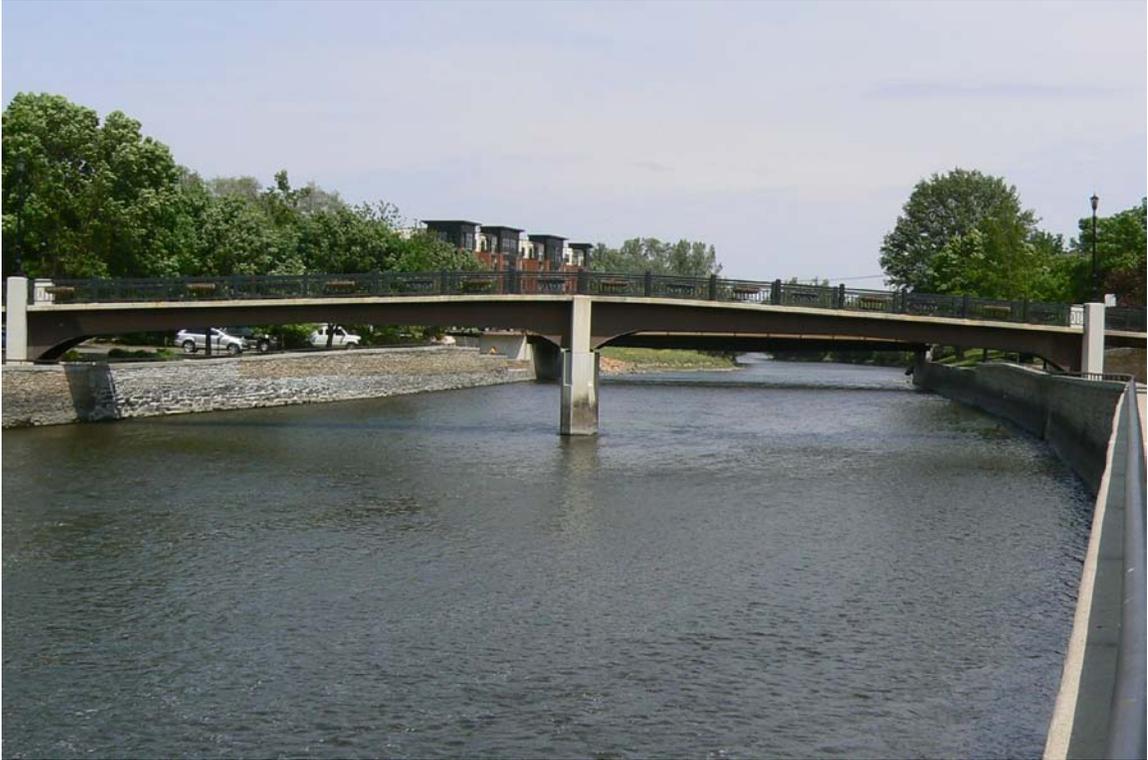
Photograph 1. Overall View of the Structure, Looking North.

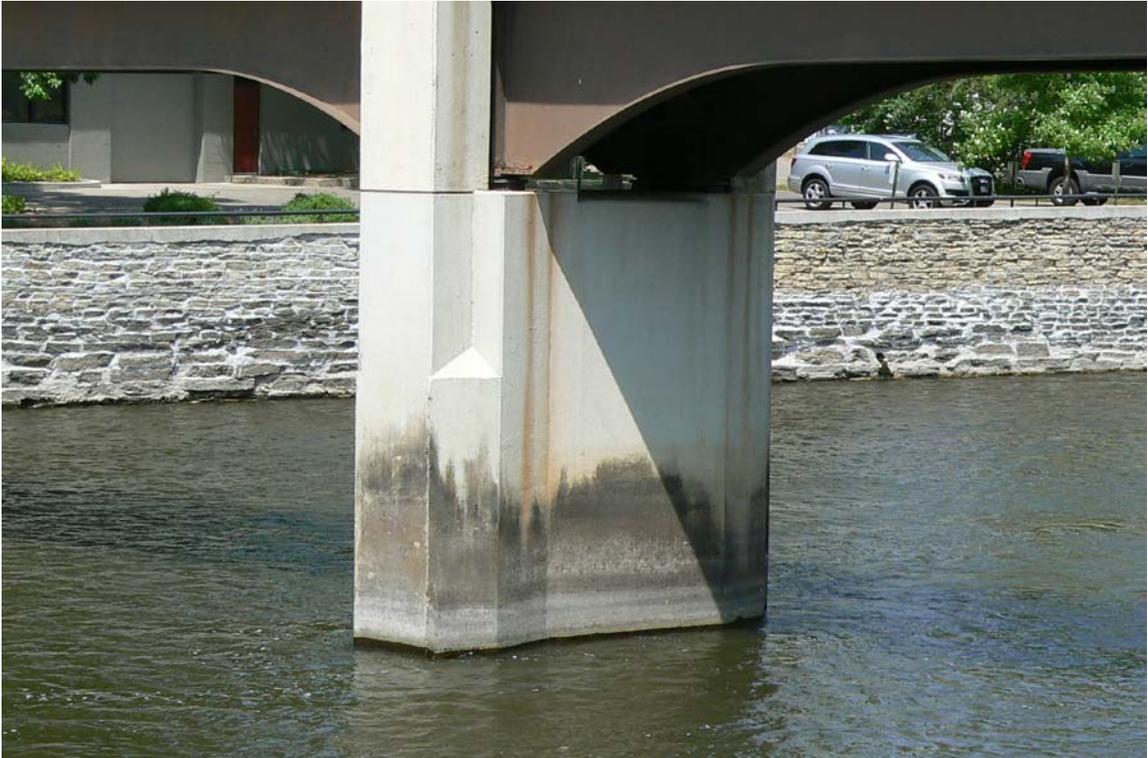
- (A) Concrete of the pier was smooth and sound with no notable defects.
- (B) Footing exposure, at approximately 2.1 feet below water, was observed around the entire pier with a maximum vertical exposure of 0.4 feet.
- (C) The channel bottom consisted of rock with no appreciable probe rod penetration possible.

Photograph 2. View of the Center Pier, Looking Northwest.

- (A) Monitor the footing exposure around the pier during future inspections.
- (B) Reinspect the submerged substructure units at the normal maximum recommended (NBIS) interval of sixty (60) months.

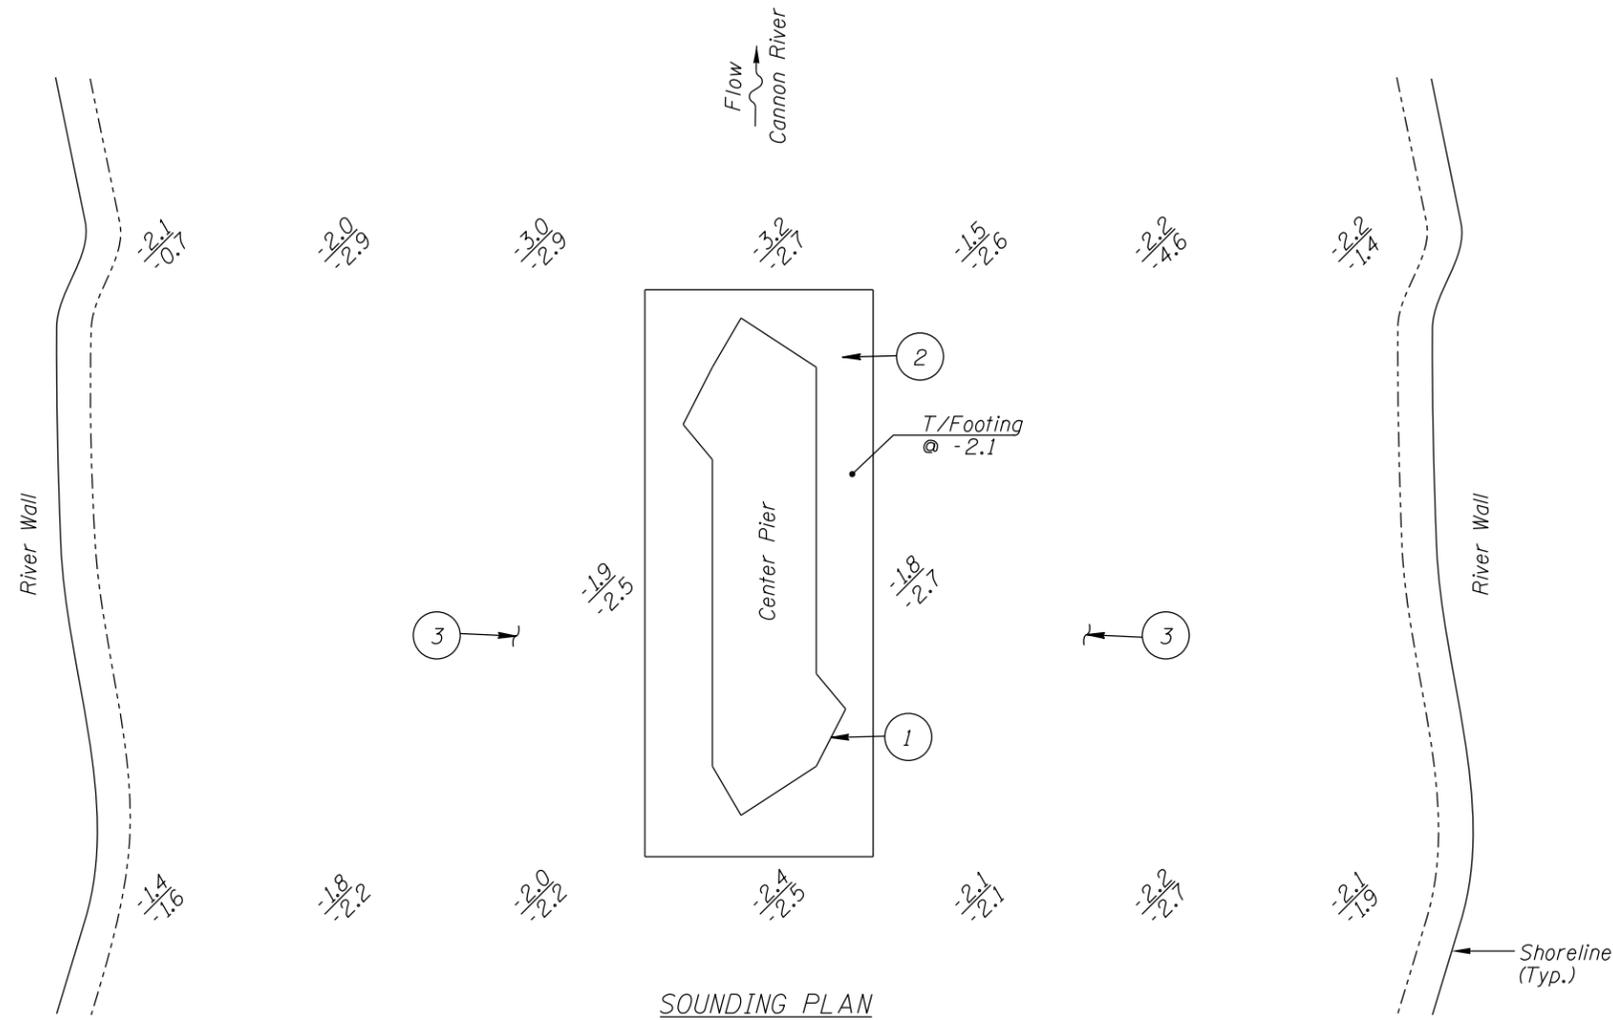
SOUNDING PLAN

- 1 Concrete was smooth and sound with no notable defects.
- 2 Footing exposure was observed at 2.1 feet below waterline around the entire pier with a maximum vertical exposure of 0.4 feet.
- 3 Channel bottom consisted of rock with no probe rod penetration.
