UNDERWATER BRIDGE INSPECTION REPORT

STRUCTURE NO. L0775

TWP NO. 386 (147<sup>th</sup> AVE)

NORTH BRANCH MIDDLE FORK OF THE ZUMBRO RIVER

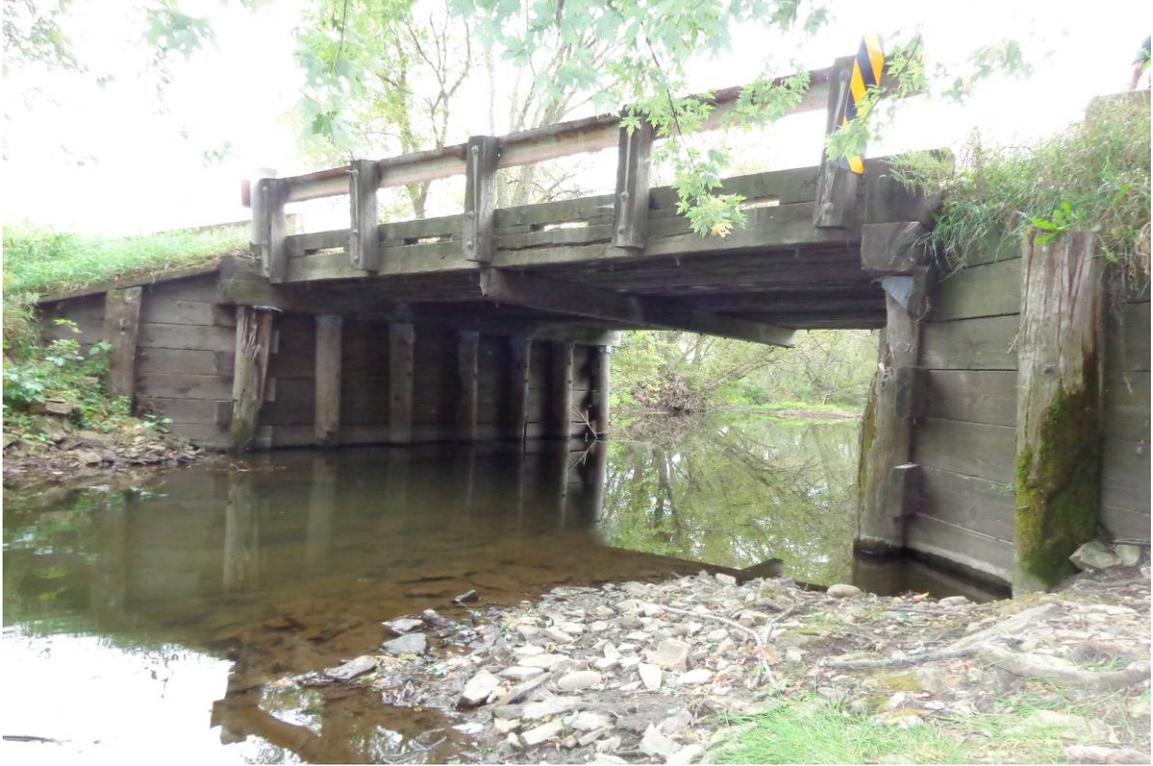
Photograph 1. Overall View of the Structure, Looking Northeast.

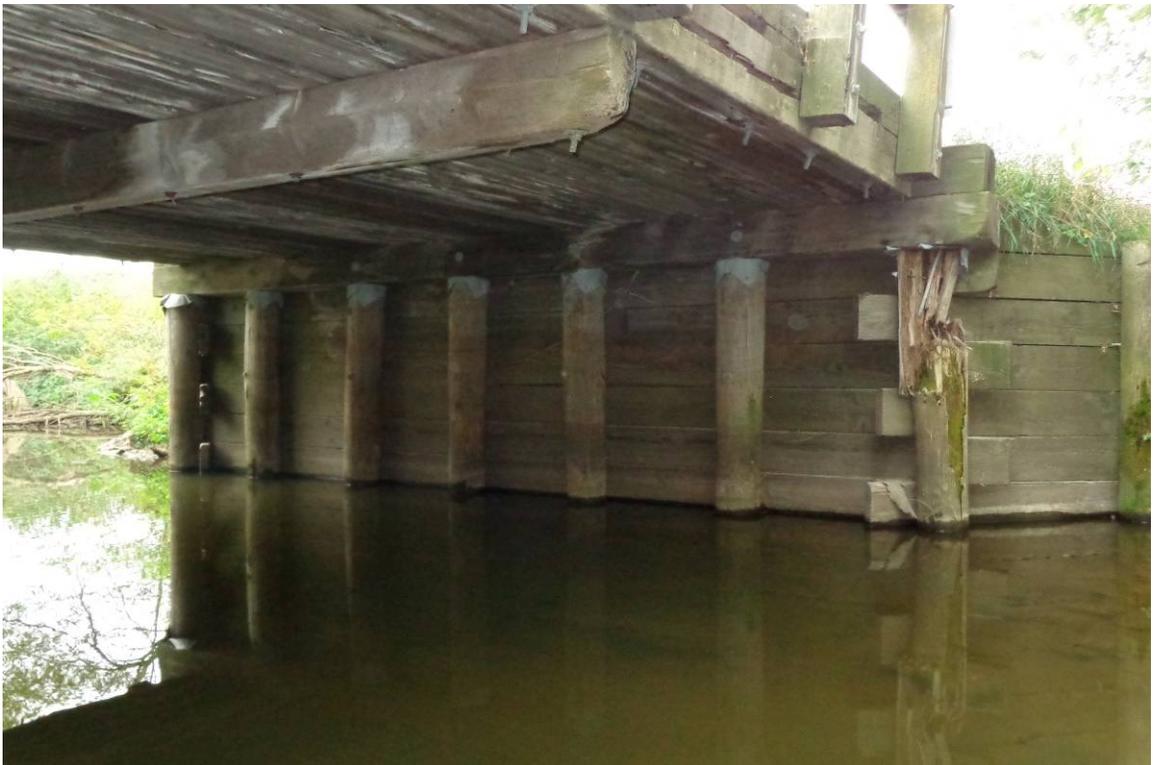
- (A) Pile 1 at the North Abutment and Pile 1 at the South Abutment have failed (severed).
- (B) All piles exhibited a soft outer shell with 3 inches of awl penetration and sounded hollow from the waterline up 2 feet.
- (C) Pile 6 at the South Abutment exhibited a soft outer shell with 3 inches of awl penetration and sounded hollow from the waterline up 4 feet.
- (D) The channel bottom material consisted of 1 foot diameter and smaller stone with 2 inches of silty infill.
- (E) The northeast wingwall had a 4 inch wide gap in the backwall planking located 6 inches above the waterline with loss of fill material occurring.

Photograph 2. View of South Abutment, Looking Southeast. Note the Failed Timber Pile.

- (A) Replace failed timber piles to restore the design bearing capacity of the substructure.
- (B) Reinspect the submerged substructure units at the normal maximum recommended (NBIS) interval of sixty (60) months.

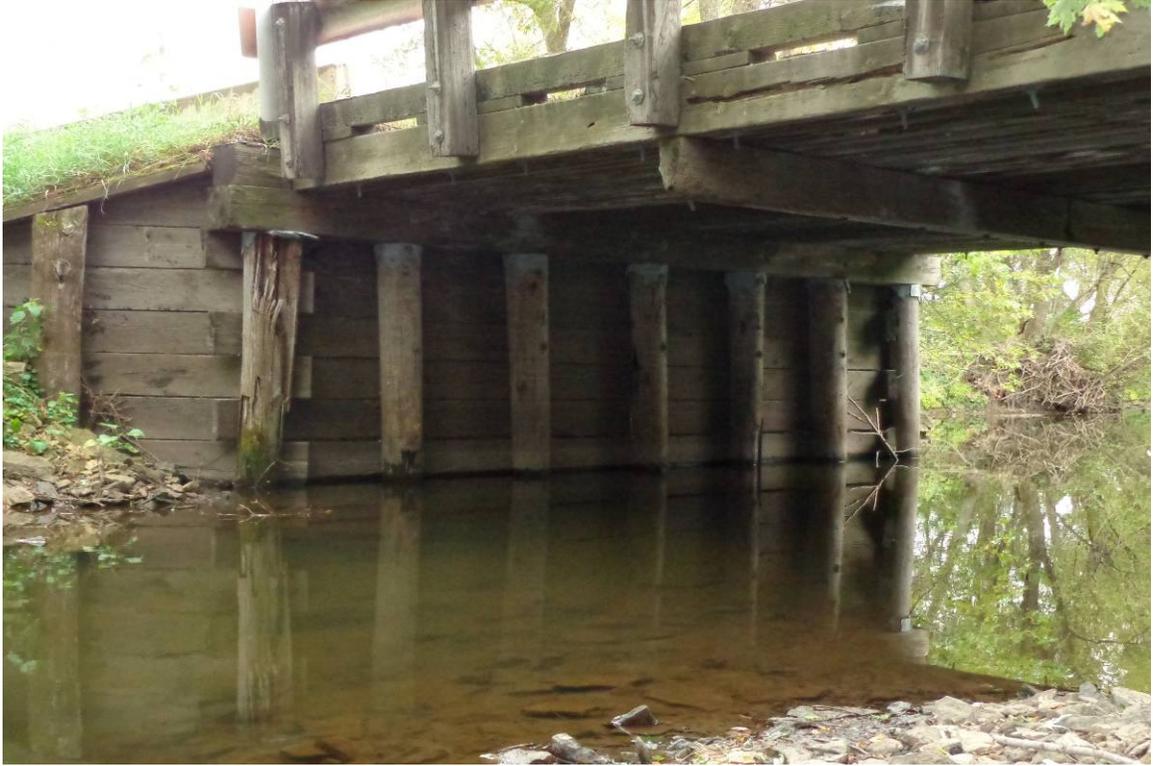
Photograph 3. View of North Abutment, Looking Northeast.

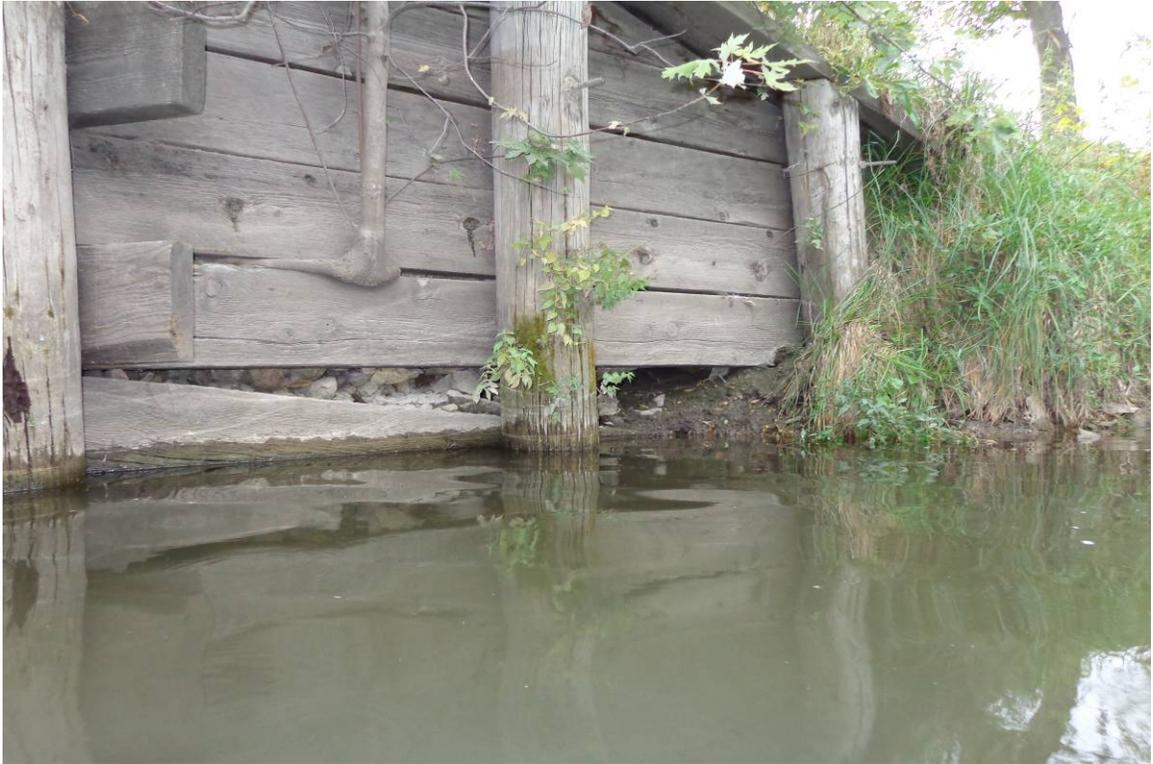
Photograph 4. View of gap in Northeast Wingwall, Looking Northwest.

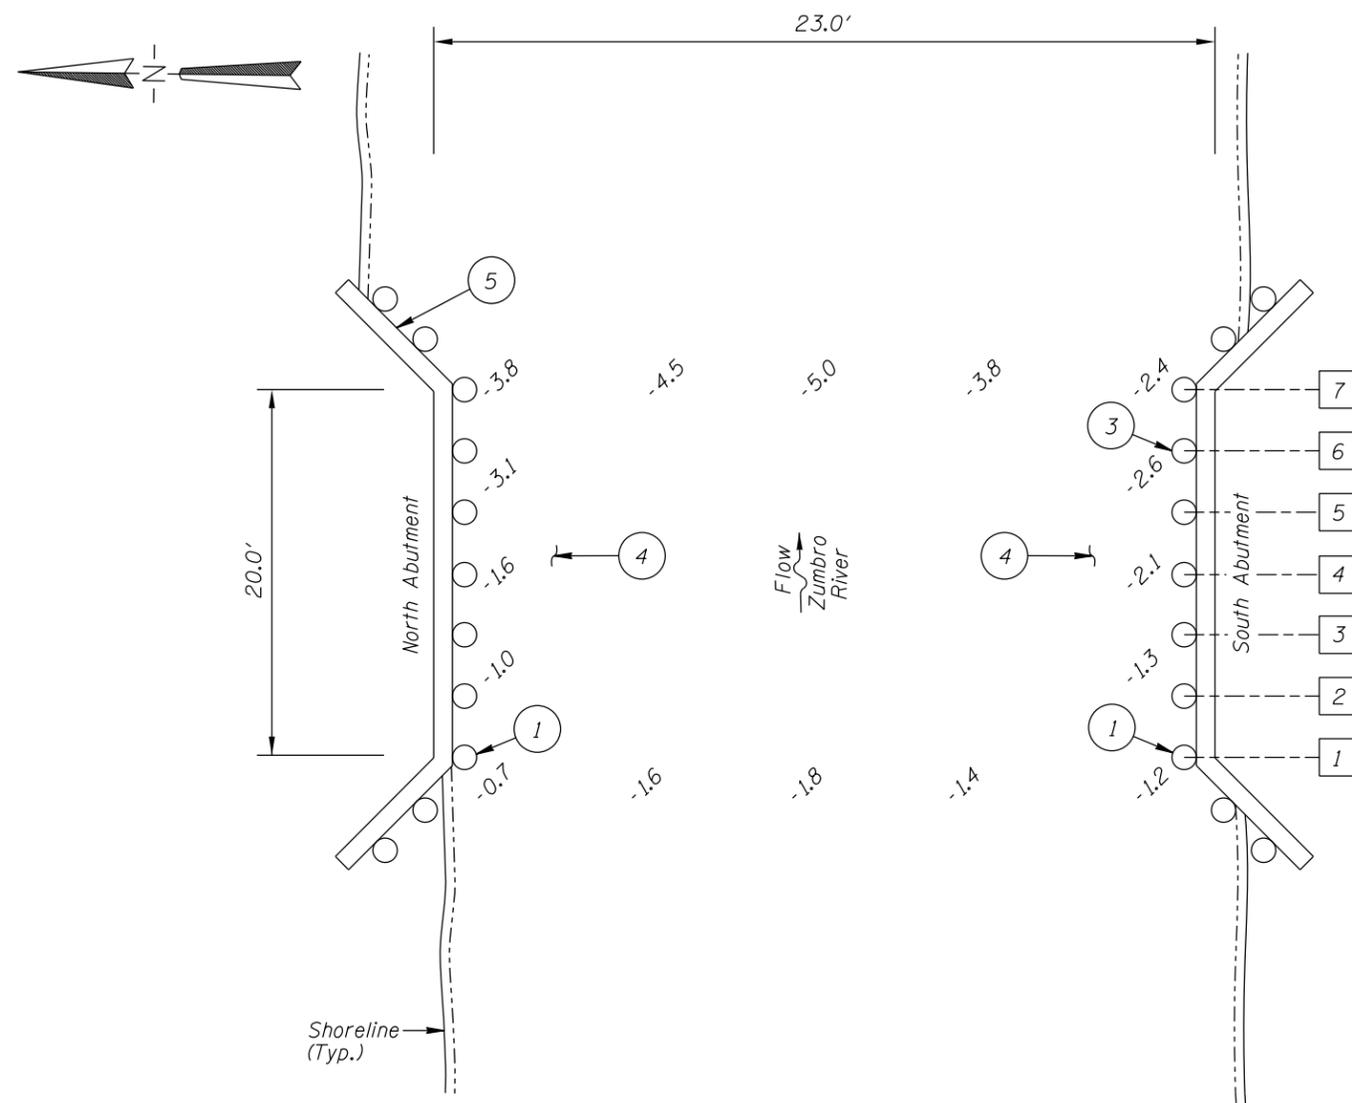
INSPECTION AND SOUNDING PLAN

- ① Pile 1 at the North Abutment and Pile 1 at the South Abutment have failed.
- ② All piles exhibited a soft outer shell with 3 inches of awl penetration and sounded hollow from the waterline up 2 feet.
- ③ Pile 6 at the South Abutment exhibited a soft outer shell with 3 inches of awl penetration and sounded hollow from the waterline up 4 feet.
- ④ The channel bottom material consisted of 1 foot diameter and smaller stone with 2 inches of silt infilling.
- ⑤ The northeast wingwall had a 4 inch wide gap along the backwall planking located 6 inches above the waterline with loss of fill material evident.
