UNDERWATER BRIDGE INSPECTION REPORT

STRUCTURE NO. L3907

352nd STREET

MAY 24, 2012

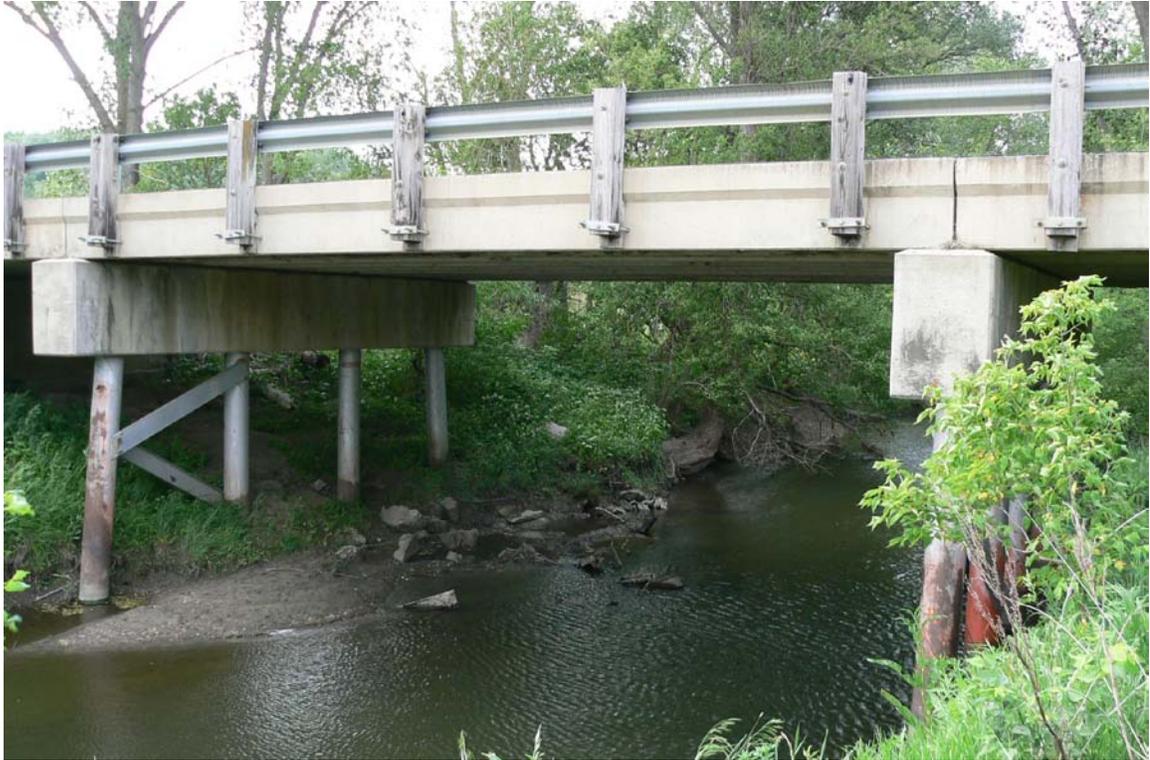
Photograph 1. Overall View of Structure, Looking Northwest

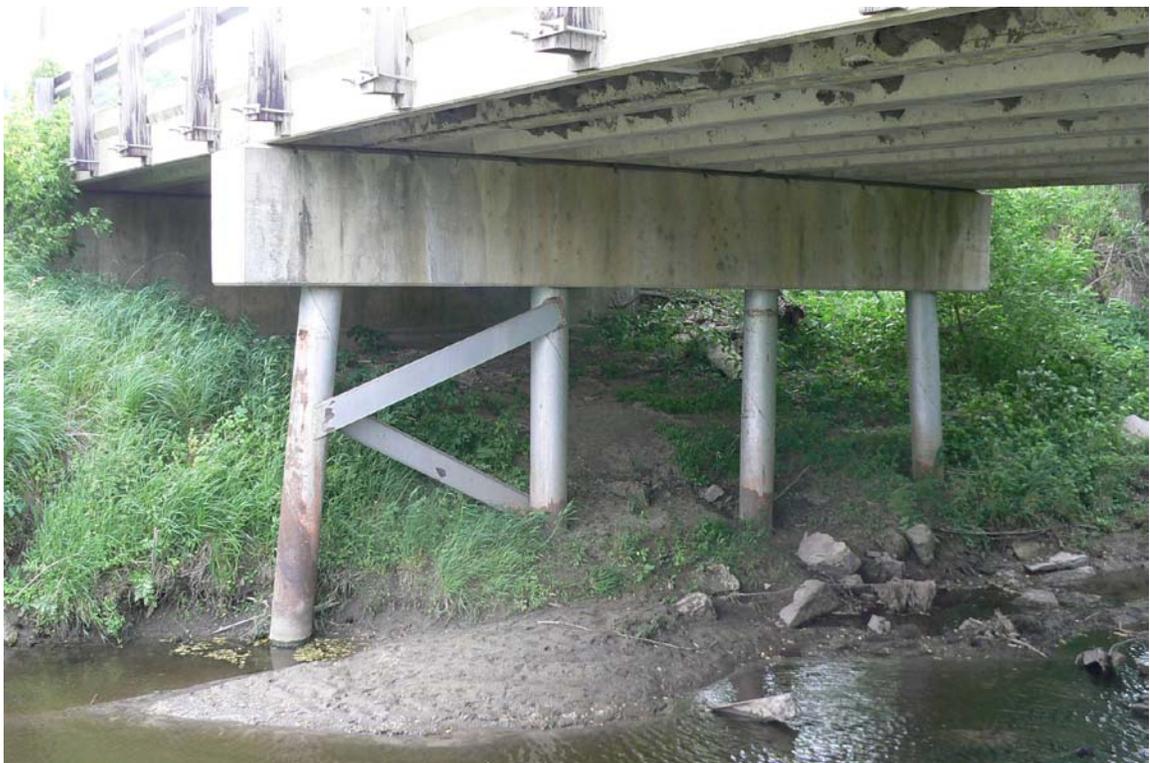
Photograph 2. View of Bent 1, Looking Northwest.

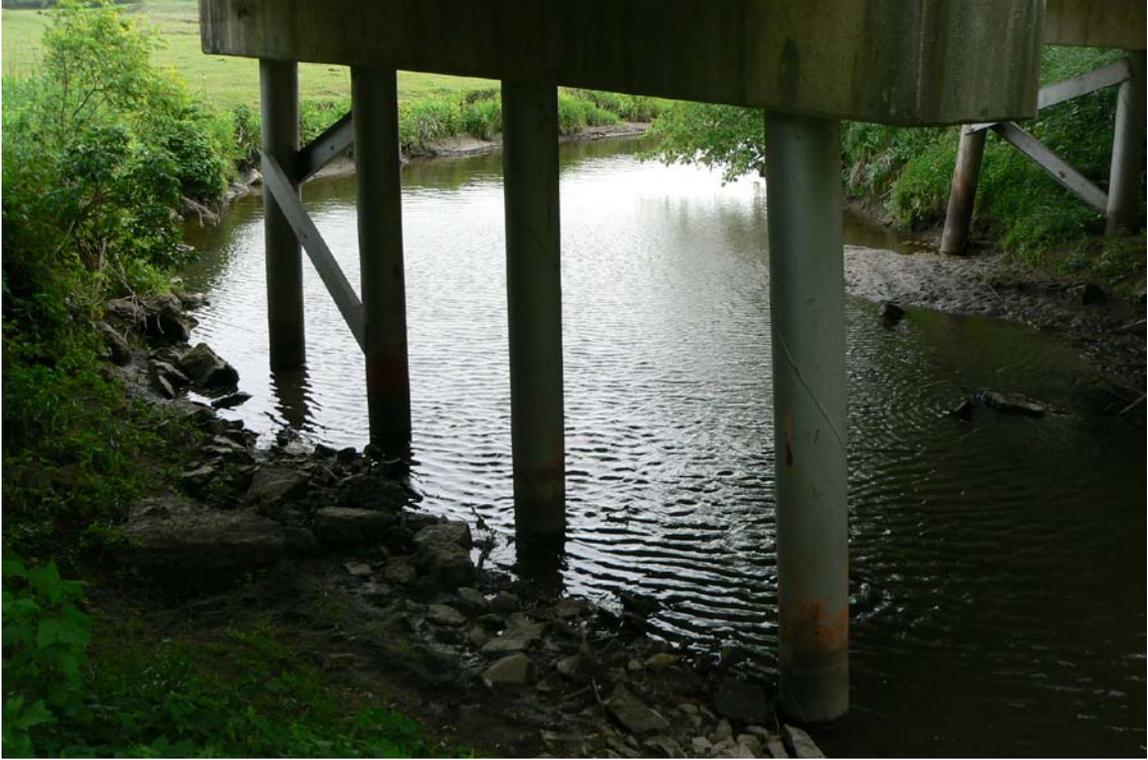
The substructure unit inspected at Bridge No. L3907, Bent 2, was found to be in good condition. Coating loss was observed on all piles extending from the channel bottom to 1 foot above the water line. The channel bottom appeared to be stable with no evidence of significant scour.

Photograph 3. View of Bent 2, Looking Southwest.

- (A) Reinspect the submerged substructure at the normal maximum recommended (NBIS) interval of sixty (60) months.

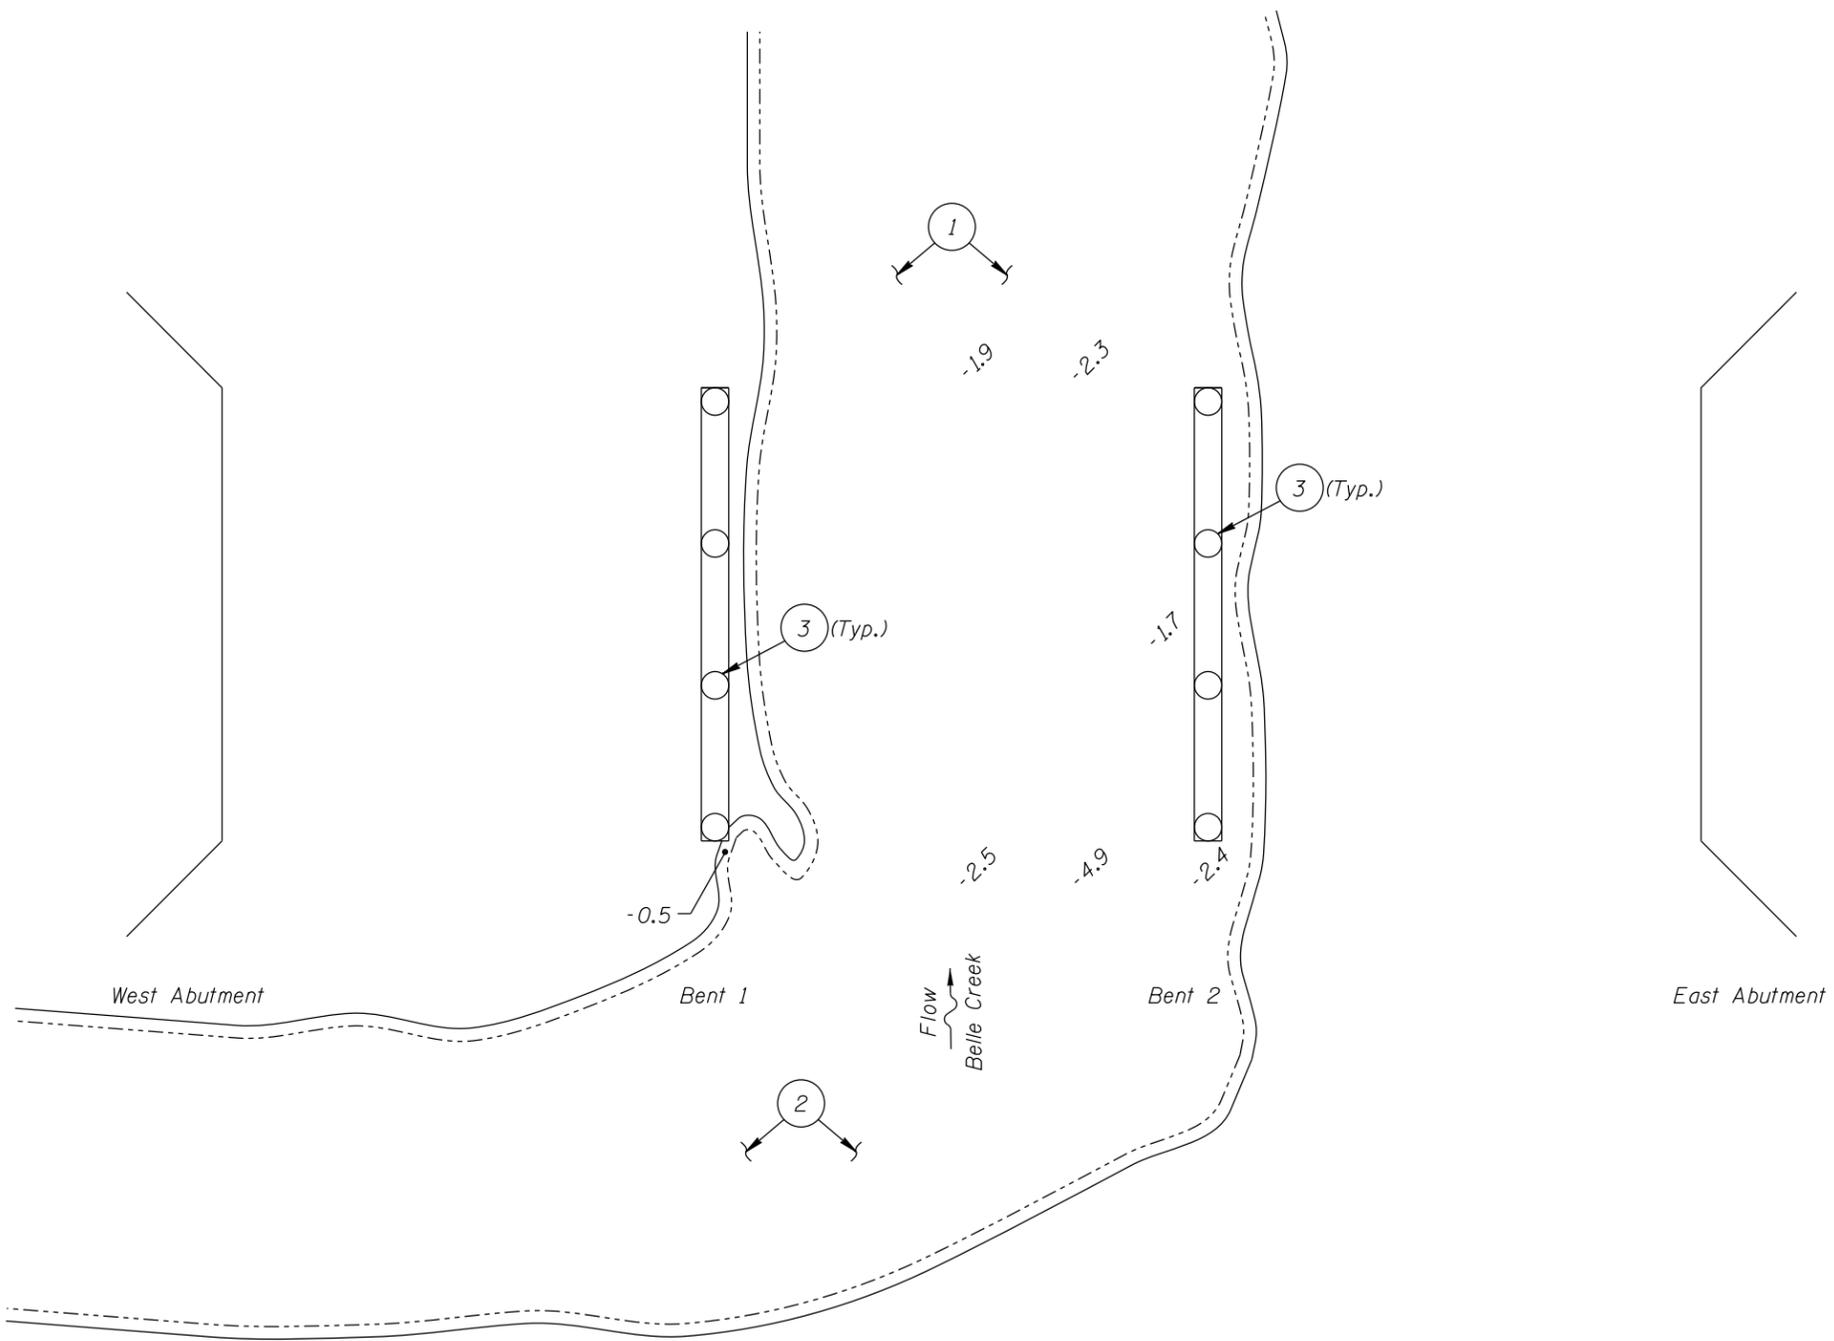
SOUNDING PLAN

- (A) The channel bottom material at the downstream half of Bent 2 consisted of sand, gravel and construction debris.
- (B) The channel bottom material at the upstream half of Bent 2 consisted of silty clay with a probe rod penetration of up to 1.5 feet.
- (C) All piles exhibited coating loss, typically extending from the channel bottom to 1 foot above the water line.

- INSPECTION NOTES:
- ① Channel bottom material consisted of sand and gravel with construction debris.
 - ② Channel bottom material consisted of silty clay with up to 1.5-feet of probe rod penetration.
 - ③ Steel piles were generally sound, with loss of coating extending 1 foot above the waterline to the channel bottom.
