UNDERWATER BRIDGE INSPECTION REPORT

STRUCTURE NO. L4665
TWP 48
OVER THE
SOUTH FORK ROOT RIVER
FILLMORE COUNTY

OCTOBER 4, 2012
PREPARED FOR THE
MINNESOTA DEPARTMENT OF TRANSPORTATION
BY
COLLINS ENGINEERS, INC.
JOB NO. 7423

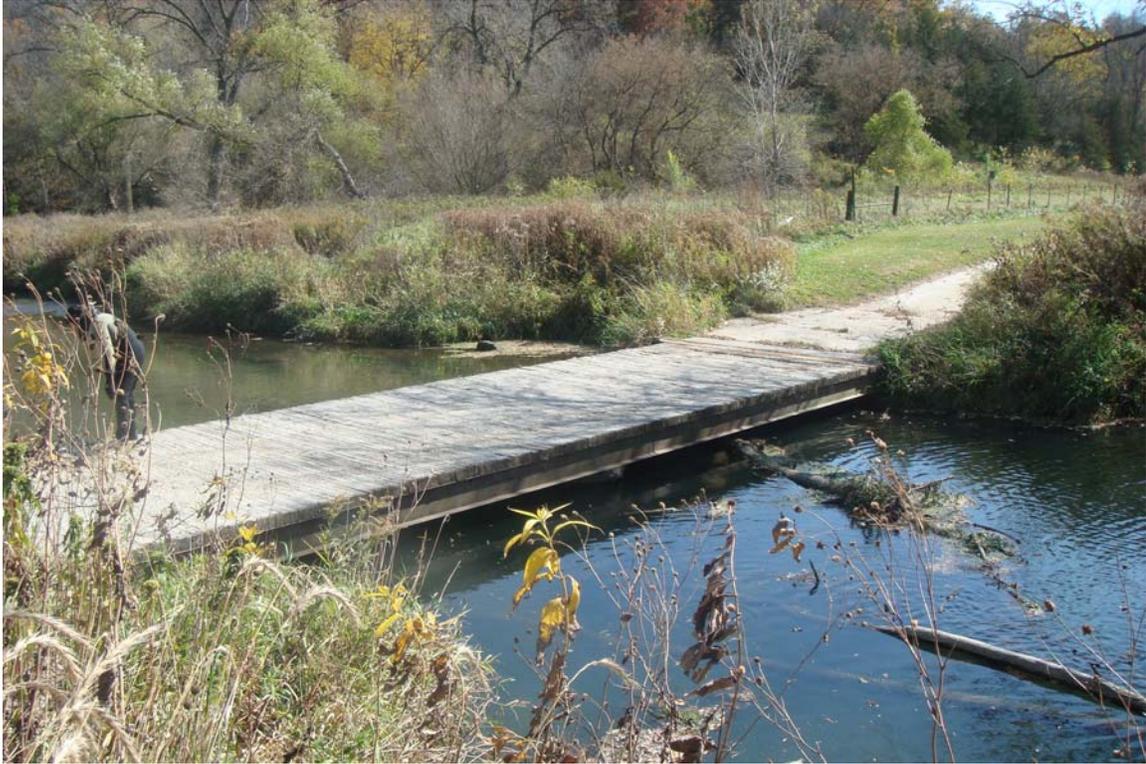
Photograph 1. Overall View of the Structure, Looking Southeast.

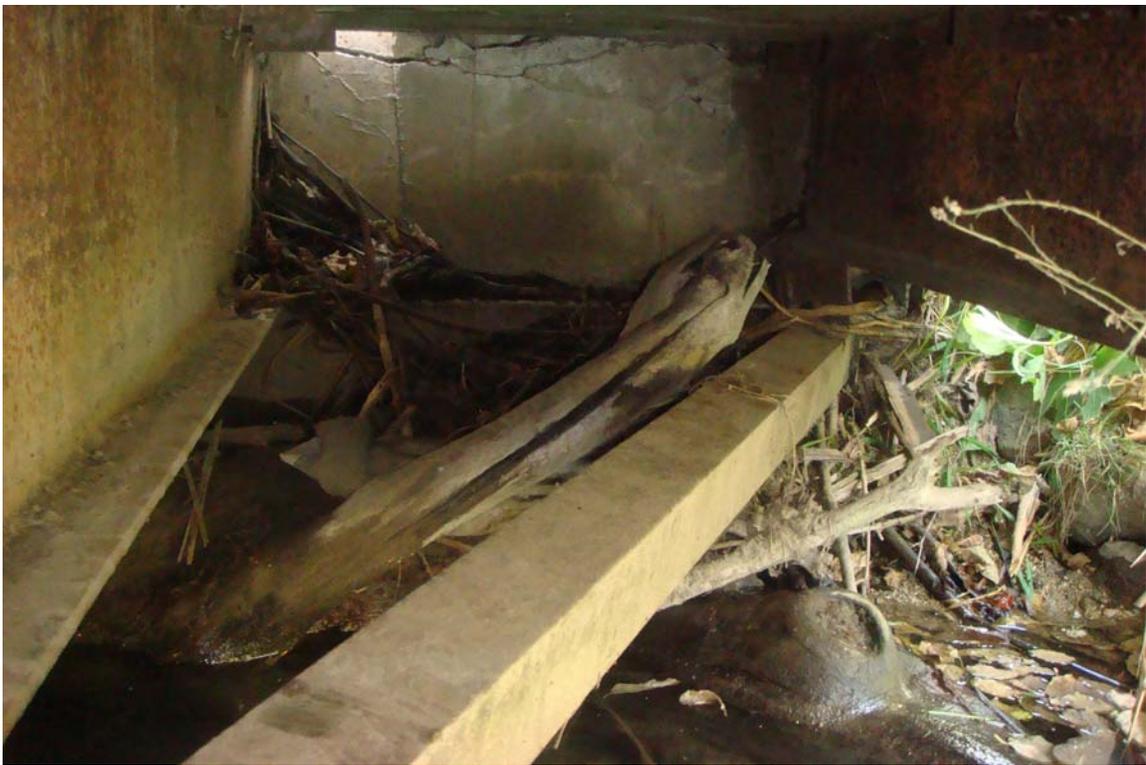
- (A) A heavy accumulation of timber debris was observed under the bridge span at the upstream fascia of the bridge, and about 10 to 15 feet upstream of the bridge and each abutment. The accumulations typically consisted of 1 foot diameter and smaller logs and branches extending from the channel bottom to 1 foot above the waterline. Although not as heavy, there is moderate accumulations of the debris directly along both abutments.
- (B) The concrete of both the abutments was rough, with scaling that had 1 inch maximum penetration.
- (C) The steel beams of the superstructure (minimal free headroom between the beams and waterline) showed light surface and nodular corrosion with no detectable loss of section.

Photograph 2. View of the North Abutment between Beams 4 and 5, Looking North. Note heavy timber debris accumulation.

- 7 A moderate accumulation of 1 foot diameter and smaller timber debris was observed extending from the channel bottom to 1 foot above the waterline at Beams 4 and 5 along the North Abutment.

Remove the heavy accumulation of timber debris, which is significantly restricting the channel at the bridge and has the potential to exert considerable lateral load on the bridge superstructure.

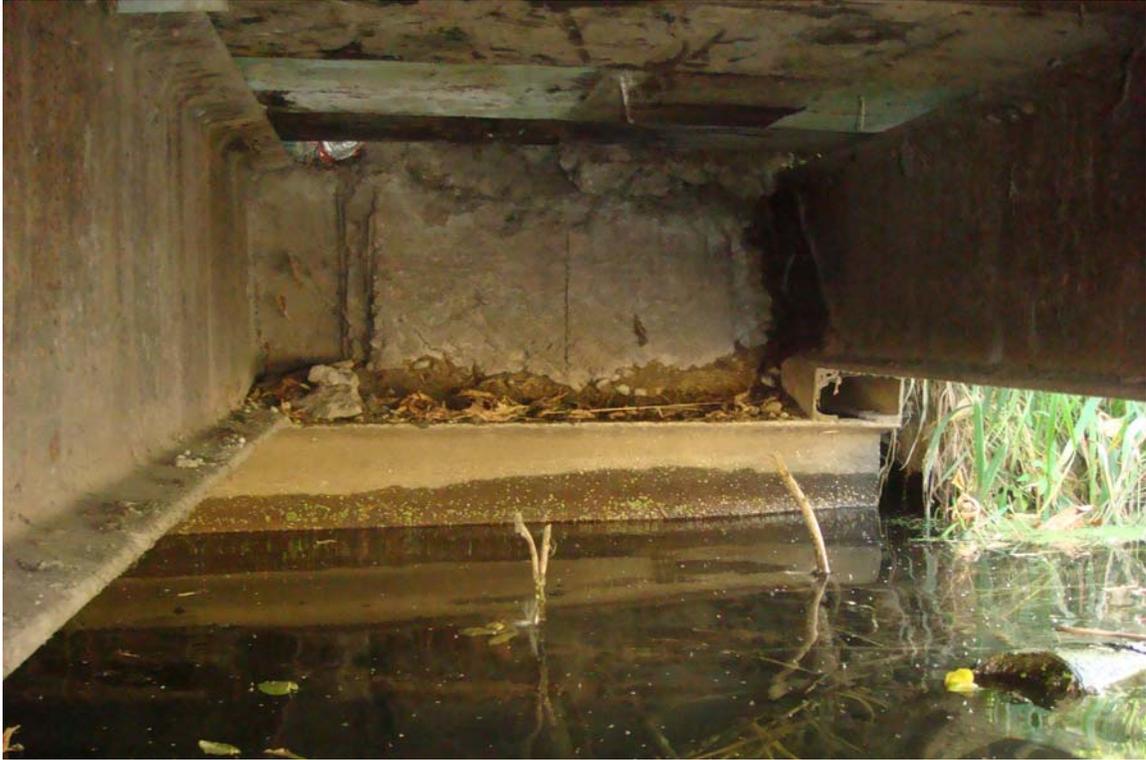
Photograph 3. View of the South Abutment between Beams 1 and 2, Looking South.

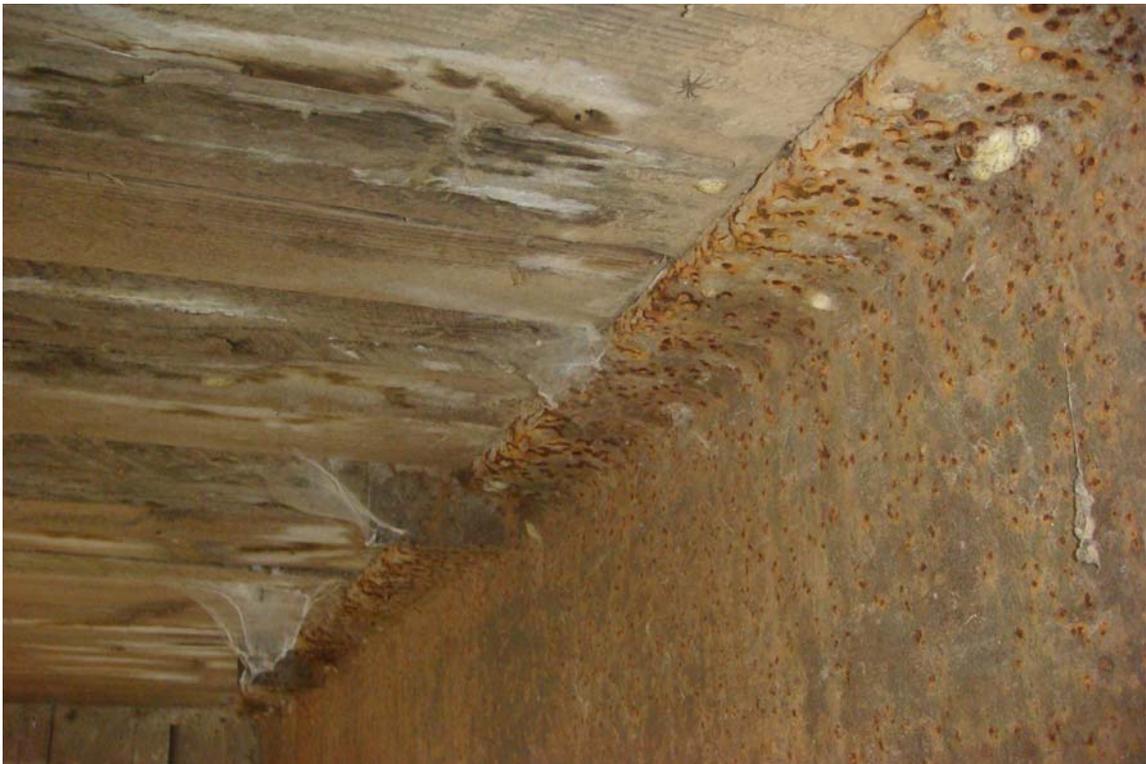
Photograph 4. View of the Typical Steel Beam Condition, Looking Northeast. Note the Surface and Nodular Corrosion.

- 3 Concrete was rough and scaling was present with approximately 1 inch of maximum penetration.
- 4 The steel beams showed light surface and nodular corrosion with no notable section loss.

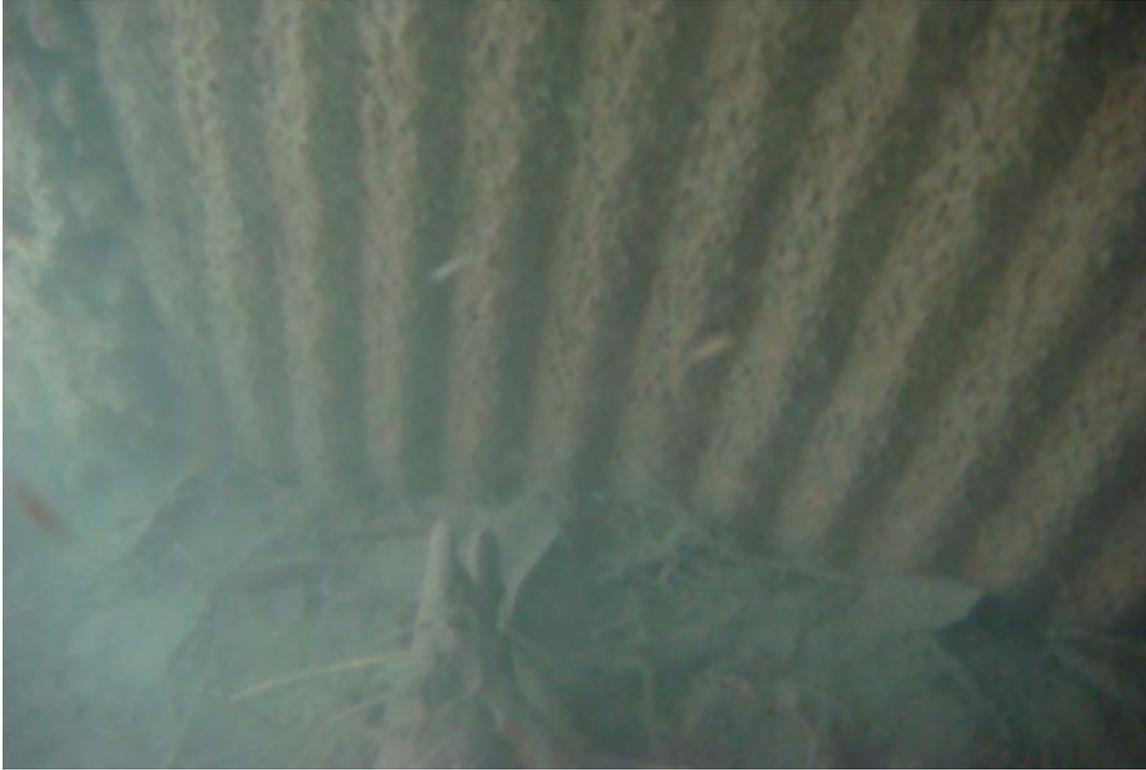
Photograph 5. View of the Corrugated Face of the South Abutment Underwater between Beams 4 and 5, Looking South.

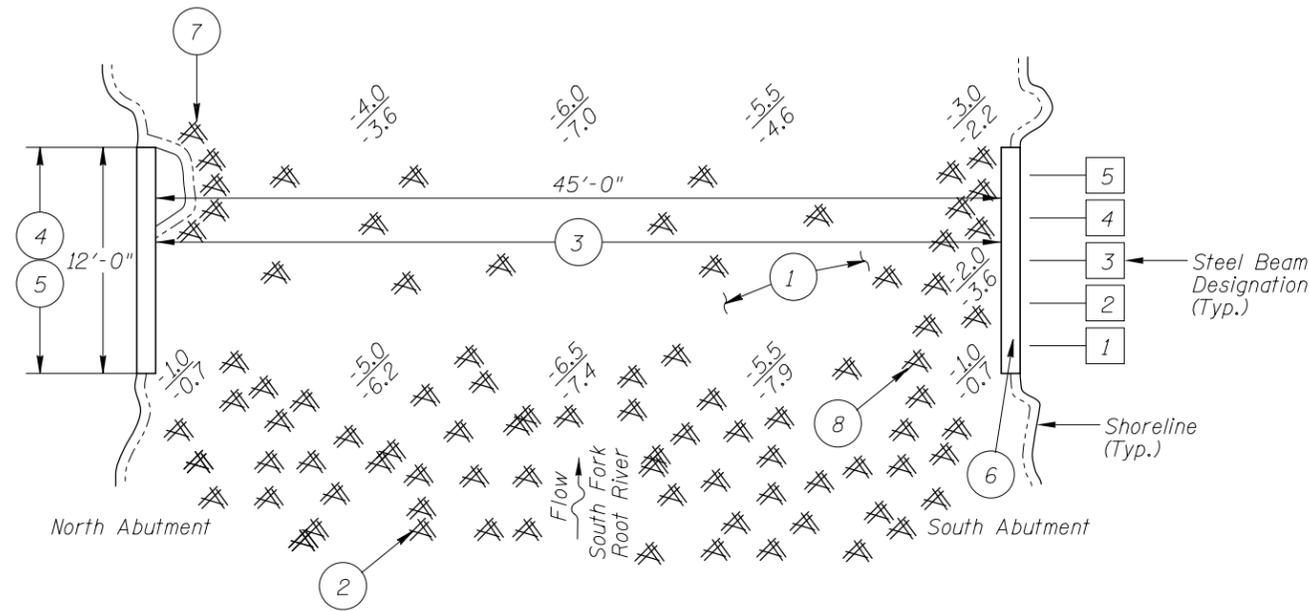
- 1 Channel bottom consisted of soft organics and silt with up to 2 feet of probe rod penetration and some scattered 2 feet diameter and smaller rocks.

- 2 A heavy accumulation of timber debris was observed under the bridge span, at the upstream fascia of the bridge, and extended approximately 10 to 15 feet upstream of the bridge. The timber debris consisted of 1 foot diameter and smaller logs and branches and extended from the channel to 1 foot above the waterline.

- 5 The underside of deck exhibited random cracking in isolated deck plank members.
- 6 At the west end of the South Abutment, between Beams 1 and 2 and half the way to Beam 3, there was a cavity in the abutment backwall just below the steel beam seat channel. Overall, cavity due to apparent section loss was 5 feet long horizontally and a maximum of 6 inches high vertically with a maximum penetration back into the wall of approximately 2 feet. In this area, the seat channel appears to be sagging down somewhat with a corresponding drop to the southwest corner of the bridge deck.

- 8 A moderate accumulation of 6 inch diameter and smaller timber debris was observed extending from the channel bottom to the waterline all along the South Abutment.
