UNDERWATER BRIDGE INSPECTION REPORT

STRUCTURE NO. L4675

WEISEL CREEK

MINNESOTA DEPARTMENT OF TRANSPORTATION  
UNDERWATER BRIDGE INSPECTION

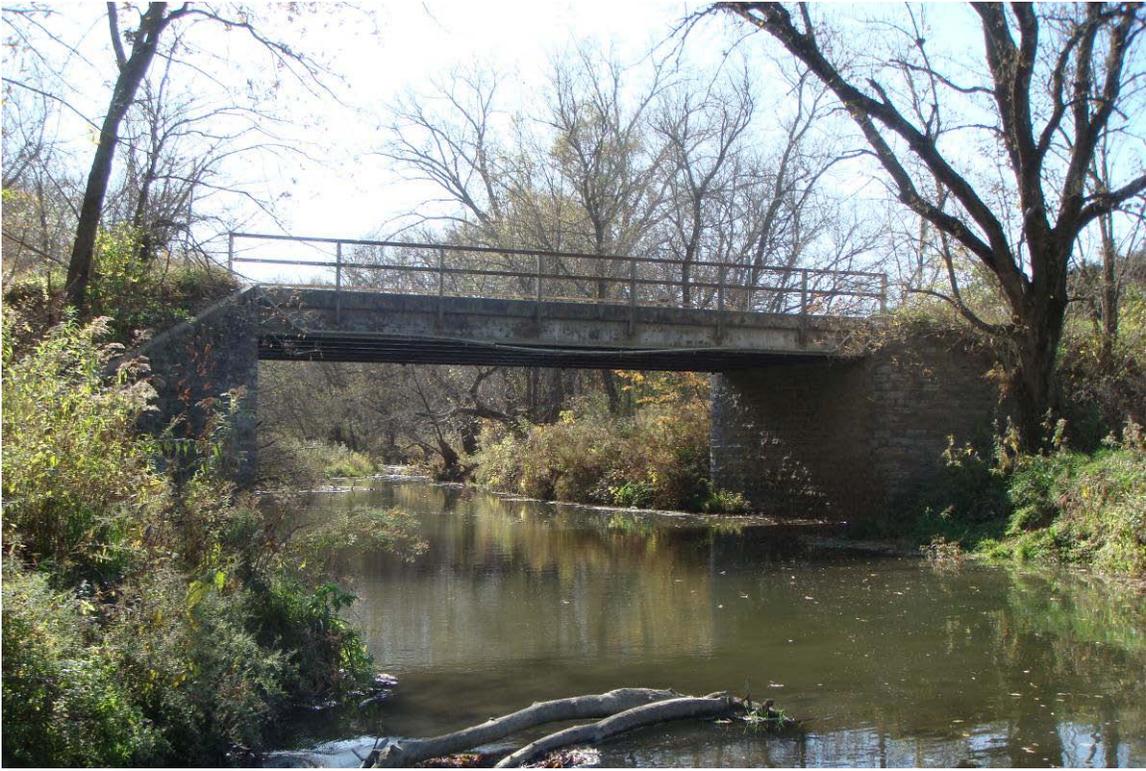
Photograph 1. Overall View of the Structure, Looking Southwest.

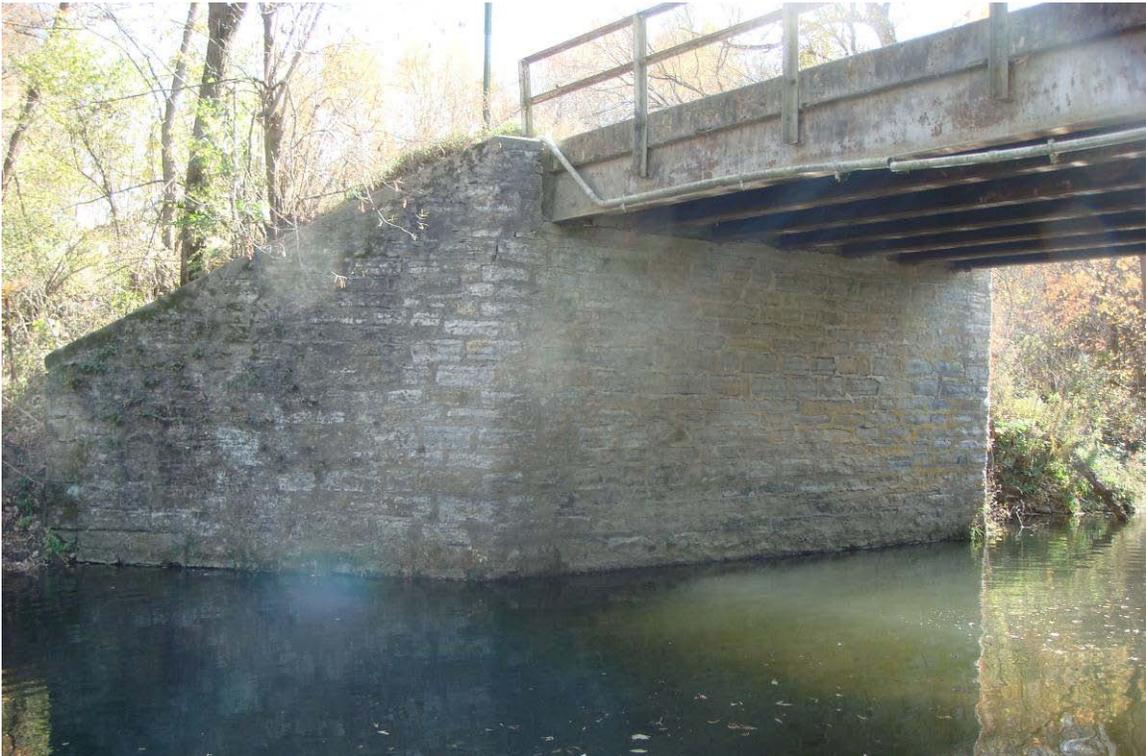
Photograph 2. View of East Abutment, Looking Southeast.

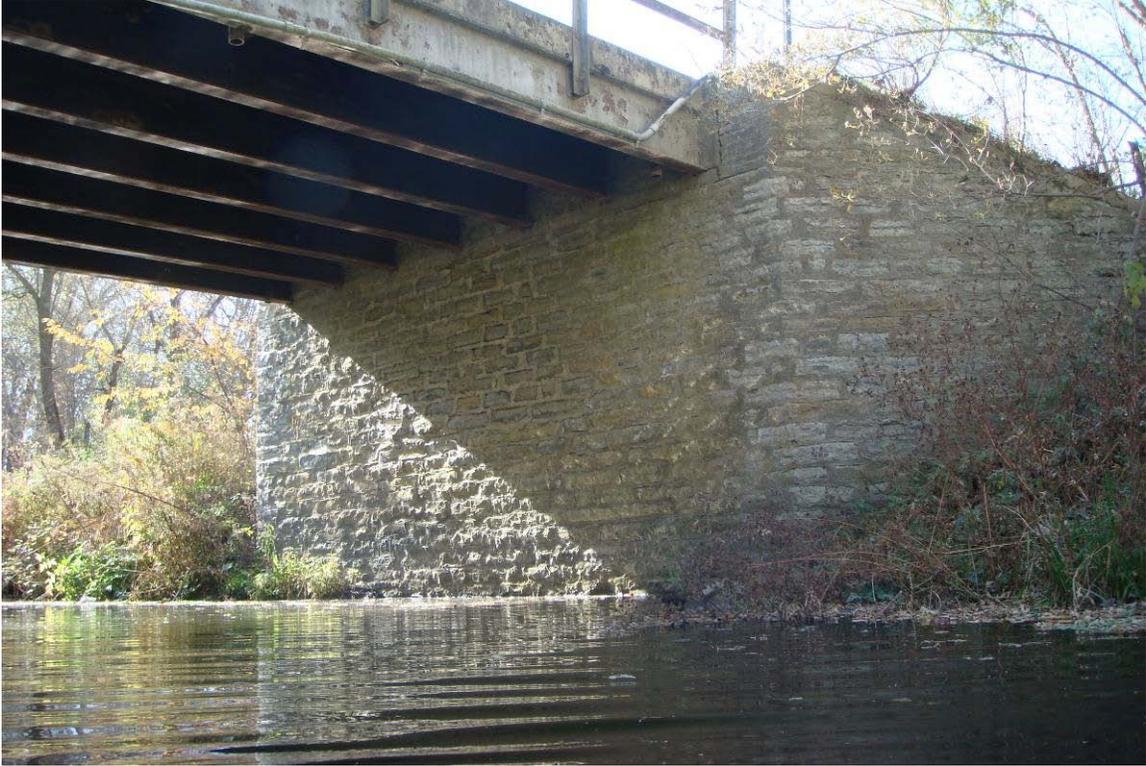
Photograph 3. View of West Abutment, Looking Southwest.

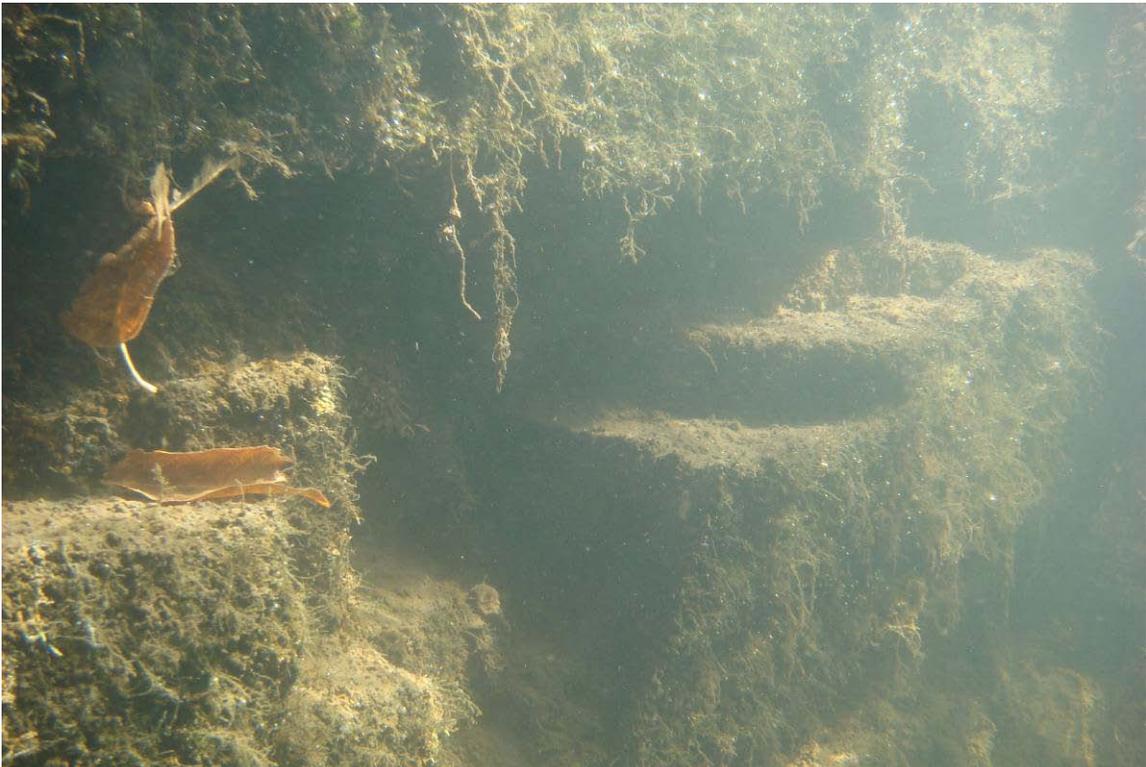
- (A) The abutments were in satisfactory condition with moderate deterioration of the masonry and a loss of joint mortar from the waterline to 2 feet below the waterline with typical penetrations of 4 inches and maximum penetrations of 12 inches.
- (B) A minor scour depression, 1 foot deep with a radius of 4 feet, was observed at the upstream corner of the East Abutment. The bottom of the depression was lined with riprap.
- (C) A 1.5 feet wide ledge (possible footing) was exposed along the entire breastwall of the abutment with up to 3 feet of vertical face exposure. There was no undermining below the ledge detected.
- (D) A moderate accumulation of debris consisting of 1 foot diameter and smaller branches, a corrugated metal pipe and metal wire mesh was observed along the East Abutment extending from the channel bottom to the waterline.

Photograph 4. View of Typical Mortar Loss and Masonry Condition Around Waterline, Looking East.

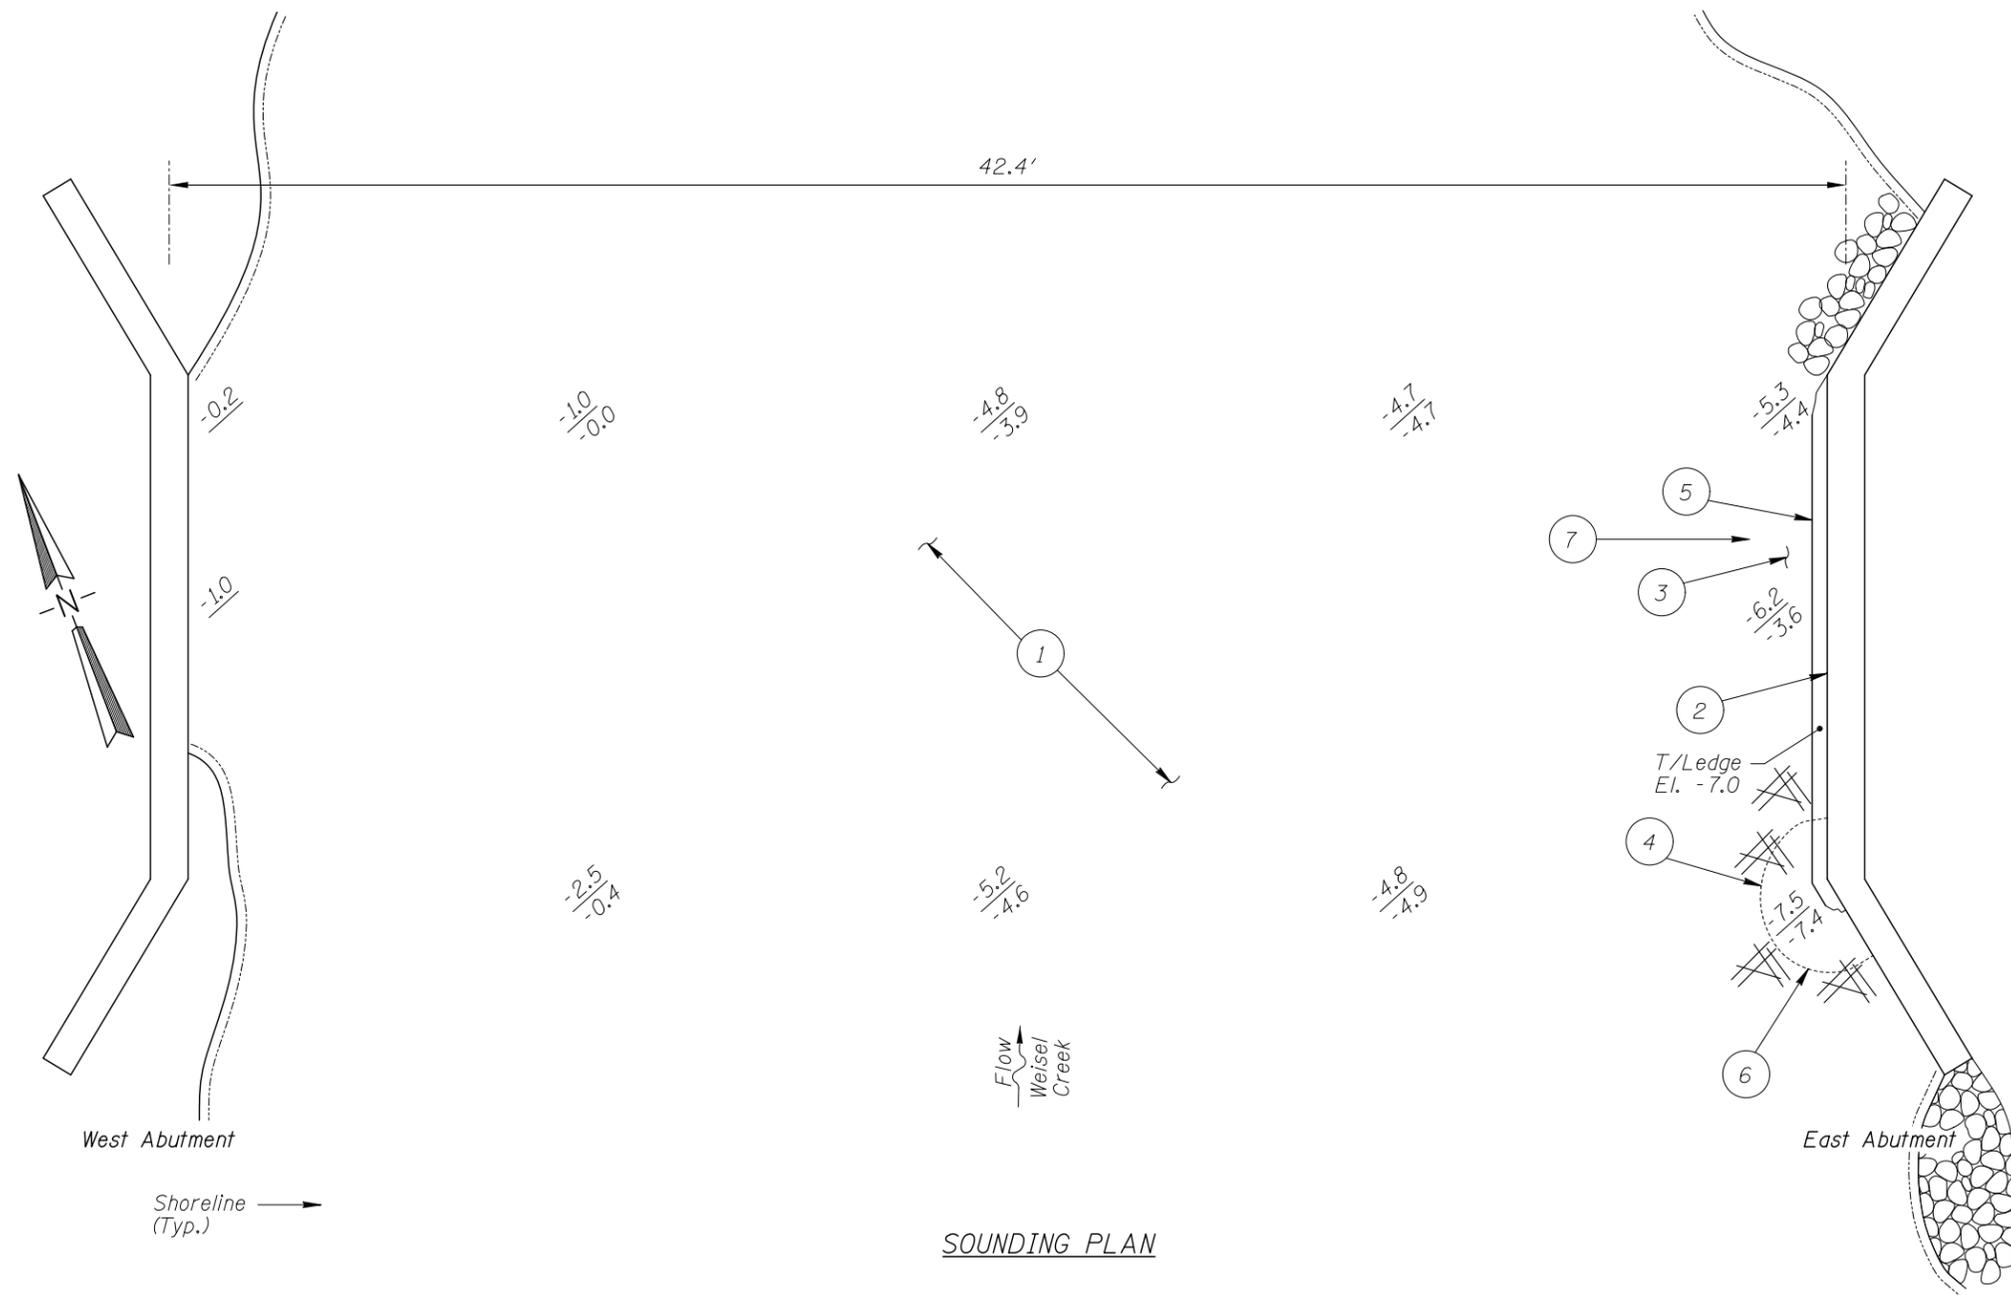
SOUNDING PLAN

- ① The channel bottom material consisted of a soft silt material allowing 2 feet of maximum probe rod penetration.
- ② The mortar in the joints was deteriorated along the abutment wall from the waterline to 2 feet below the waterline with 4 inch typical penetrations, and 12 inch maximum penetrations near the waterline.

- ③ Riprap was observed along the entire face of the abutment, extending 3 feet into the channel.
- ④ A minor scour depression was observed, 1.5 foot deep with a radius of 4 feet. Riprap lined the bottom of the depression.

- ⑤ A 1.5-foot-wide ledge (possible footing) was exposed along the breastwall with up to 3 feet of vertical exposure and with no undermining detected.
- ⑥ Moderate accumulation of timber debris consisting of 1 foot diameter and smaller branches and a section of corrugated metal pipe was observed at the upstream fascia of the East Abutment.

- ⑦ Metal wire mesh debris was observed on the downstream half of the East Abutment.

- (A) Since insufficient bridge foundation information was available, monitor the East Abutment for any further ledge (possible footing) exposure and/or undermining during future inspections.
