UNDERWATER BRIDGE INSPECTION REPORT

STRUCTURE NO. L4870

ROOT RIVER

MINNESOTA DEPARTMENT OF TRANSPORTATION  
UNDERWATER BRIDGE INSPECTION

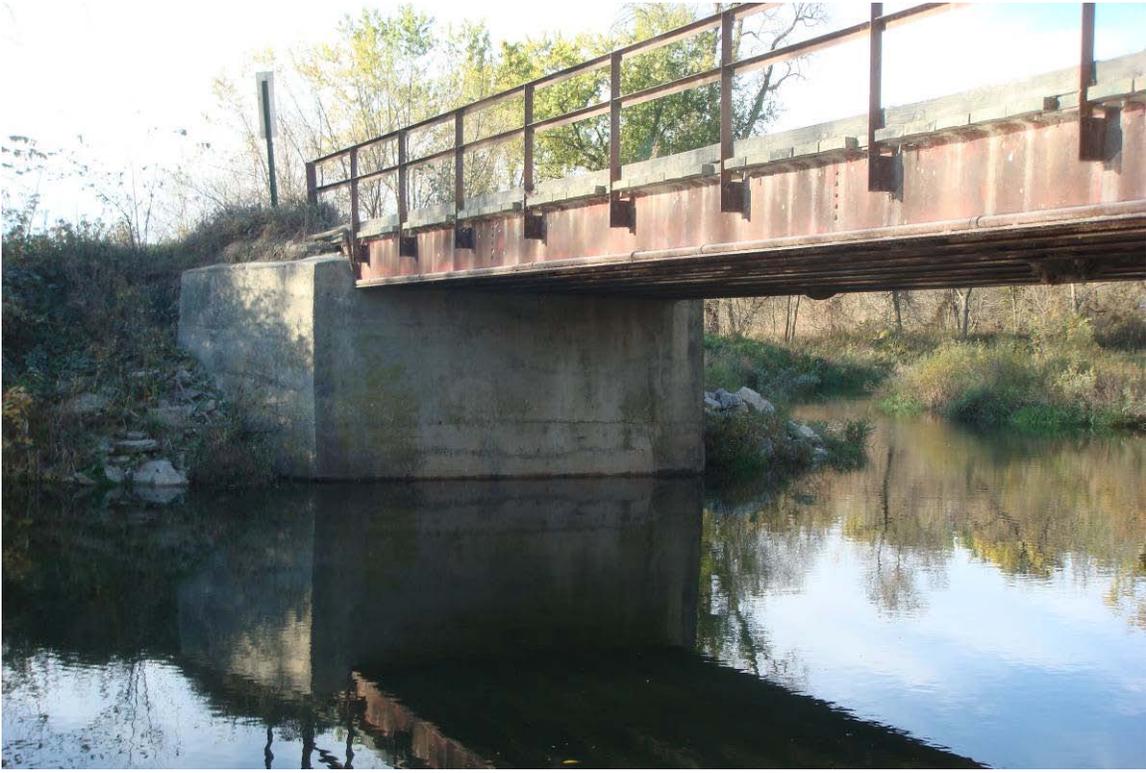
- (A) The South Abutment footing was undermined between the upstream corner and 12 feet downstream, exposing the underlying masonry wall (original construction) which was found to be in good condition. The undermining cavity was up to 1.5 feet high with approximately 1.5 feet of horizontal penetration.
- (B) An area of poor consolidation was observed on the east corner of the South Abutment from 1.5 feet below to 6 inches above the waterline with 5 inches of maximum penetration. A formed steel angle was exposed due to an area of section loss, up to 1 foot wide and 4 inches deep, on the west corner of the South Abutment that extended from 3 feet above to 2 feet below the waterline.
- (C) Random areas of section loss were observed on the submerged portion of the North Abutment with typical penetrations of 12 inches with no exposed reinforcing steel.

Photograph 2. View of South Abutment, Looking Southwest.

Monitor the height of exposure and condition of the masonry wall exposed below the concrete facing at the South Abutment, and if deterioration continues, further concrete encasement may be required.

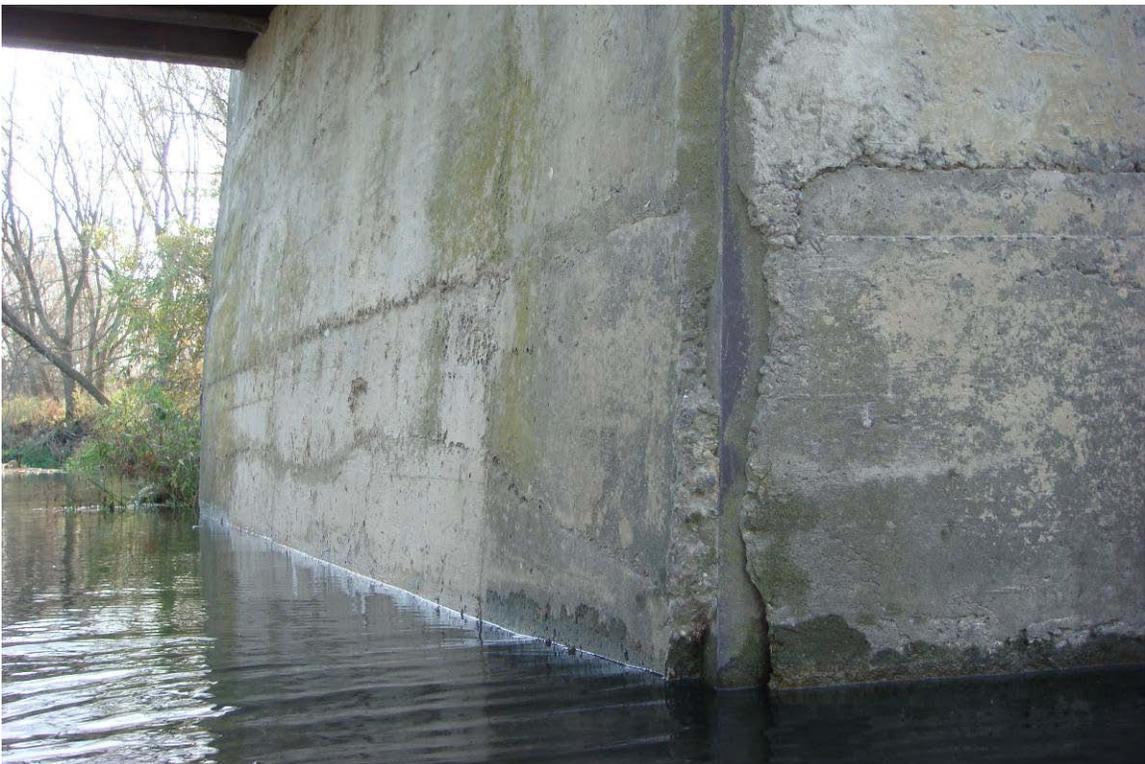
Photograph 4. View of the Exposed Steel Angle and Area of Concrete Section Loss at the South Abutment Upstream Corner, Looking Southeast.

- 7 A formed steel angle was exposed due to an area of section loss, up to 1 foot wide and 4 inches deep, on the west corner of the South Abutment which extended from 3 feet above to 2 feet below the waterline.

- (A) Although not structurally detrimental at this time, the areas of concrete section loss on the South Abutment should be repaired using a concrete mix which provides a high durability and low permeability, to prevent further deterioration of the concrete.
- (B) Monitor the height of exposure and condition of the masonry wall exposed below the concrete facing at the South Abutment, and if deterioration continues, further concrete encasement may be required.
- (C) Reinspect the submerged substructure units at the normal maximum recommended (NBIS) interval of sixty (60) months.

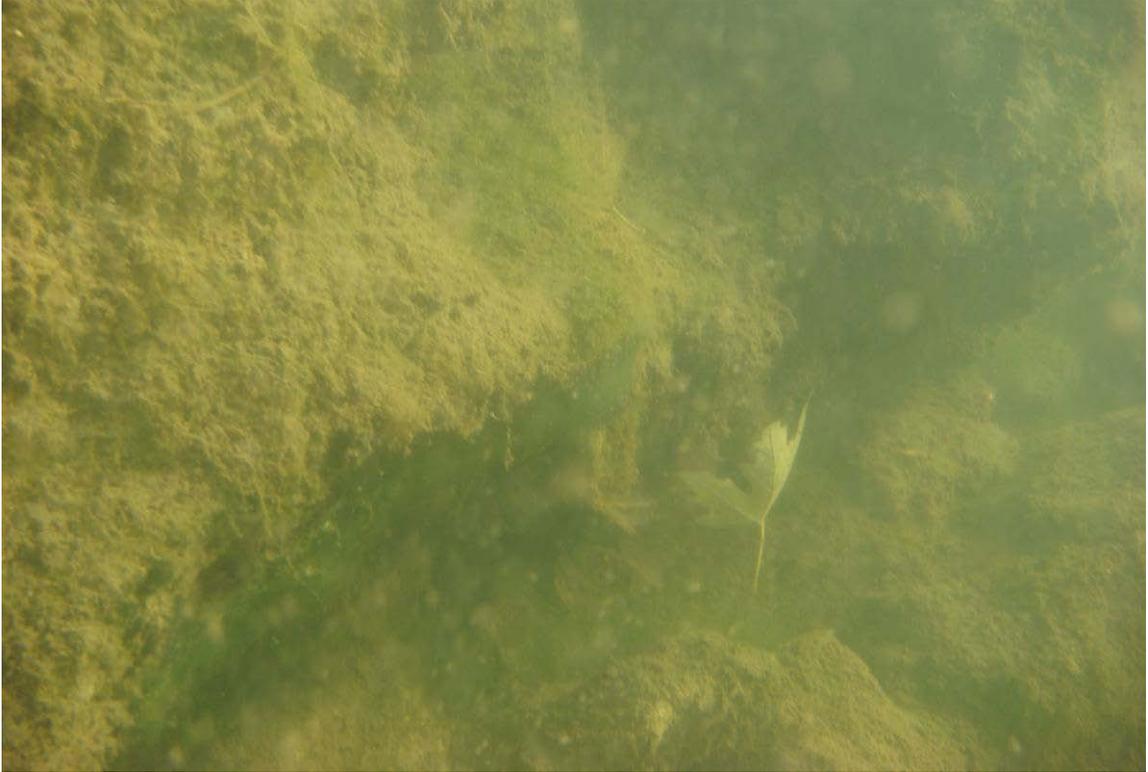
Photograph 5. View of Irregular Concrete Underwater along the North Abutment, Looking North.

- 5 A concrete ledge was located at 2.3 feet below the waterline at the South Abutment and 1.8 feet below the waterline at the North Abutment. The concrete was irregular with up to 6 inch deep irregularities.

- 6 Random areas of section loss were observed on the submerged portion of the North Abutment with average penetrations of 12 inches and no exposed reinforcing steel detected.

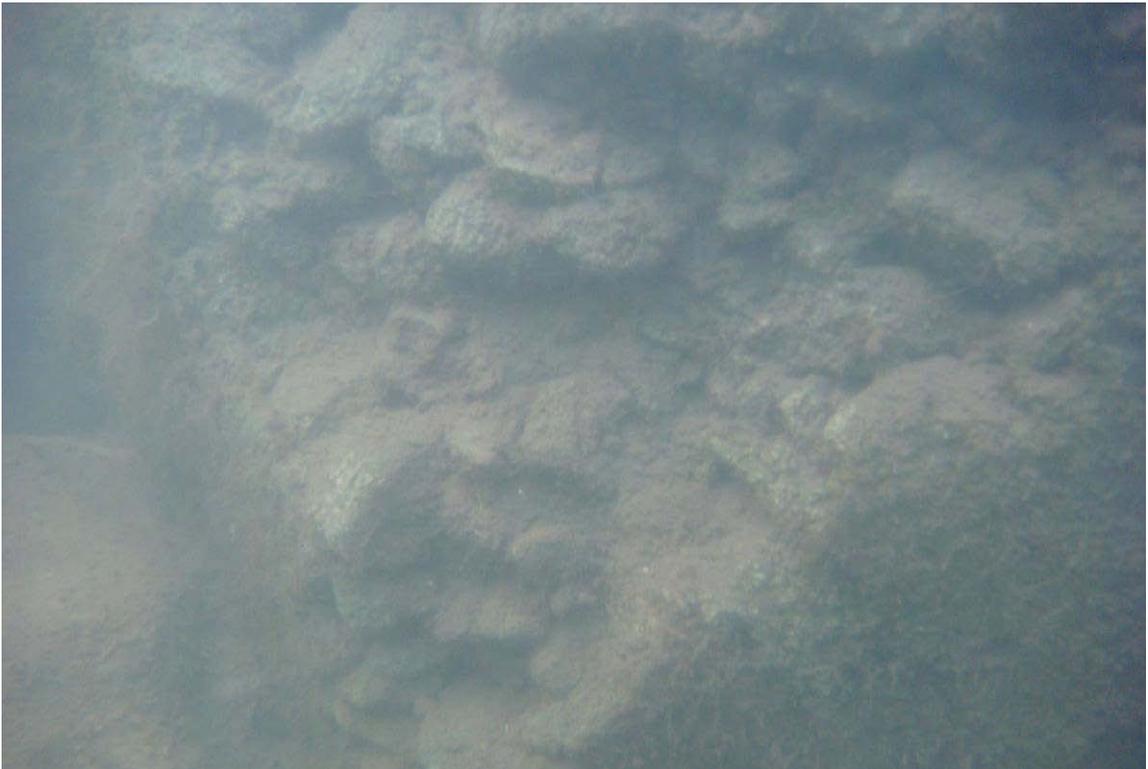
Photograph 6. View of Irregular Concrete Underwater along the South Abutment, Looking South.

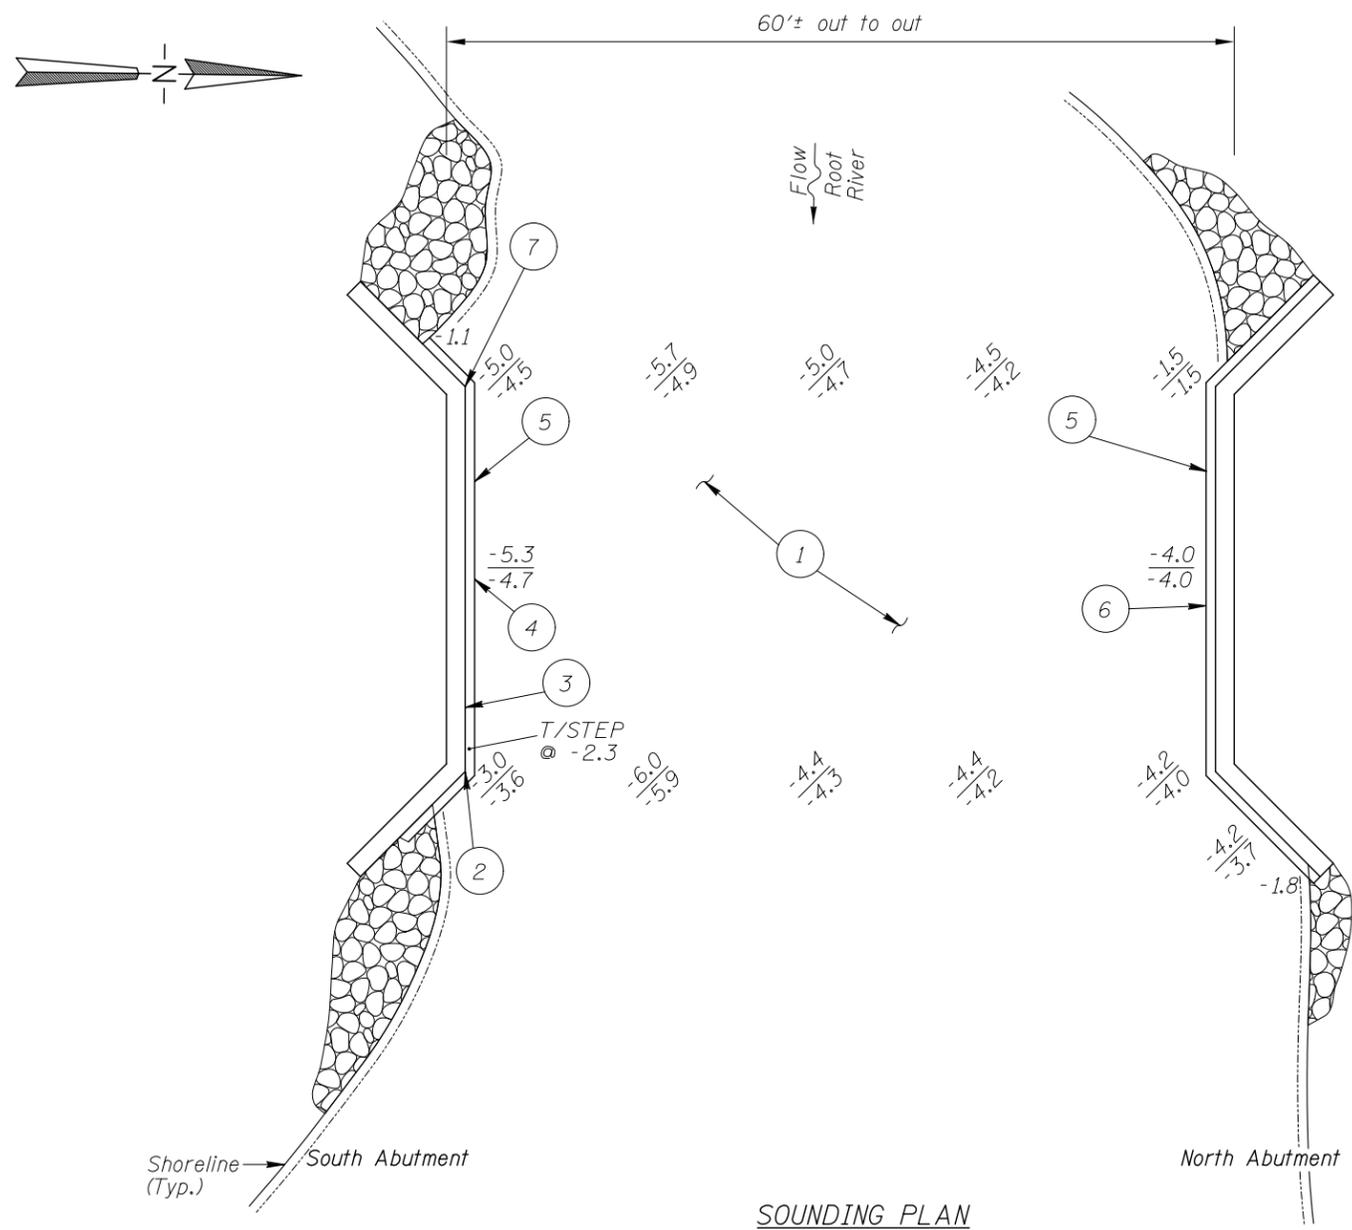
SOUNDING PLAN

- 1 The channel bottom consisted of riprap with no probe rod penetration. Along the face of the South Abutment there was up to 6 inches of infill.
- 2 An area of poor consolidation was observed on the east corner of the South Abutment from 1.5 feet below to 6 inches above the waterline with 5 inches of maximum penetration.

- 3 A 6 inch band of poorly consolidated concrete was observed at the waterline extending from the downstream 1/4 point to the east wingwall.
- 4 The upstream half (from 12 feet downstream of the upstream corner to the upstream corner) of the South Abutment concrete wall facing exhibited undermining that was 1.5 feet high with up to 1.5 feet of penetration, which exposed the underlying masonry (original construction). Random areas of section loss were observed on the submerged portion of the South Abutment facing with average penetrations of 6 inches exposing heavily corroded vertical reinforcing steel near the center of the abutment.
