UNDERWATER BRIDGE INSPECTION REPORT

STRUCTURE NO. L5948

110<sup>TH</sup> AVE (TWNS 366)

DECEMBER 16, 2012

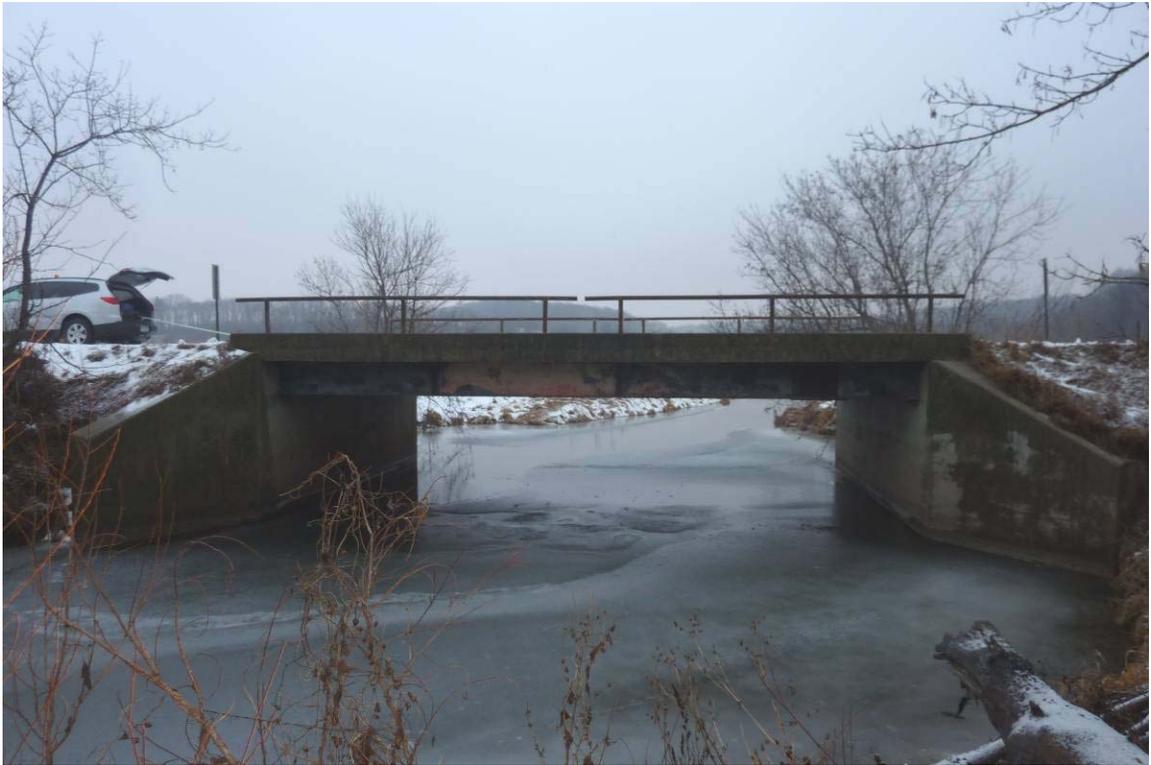
Photograph 1. Overall View of the East Fascia, Looking West.

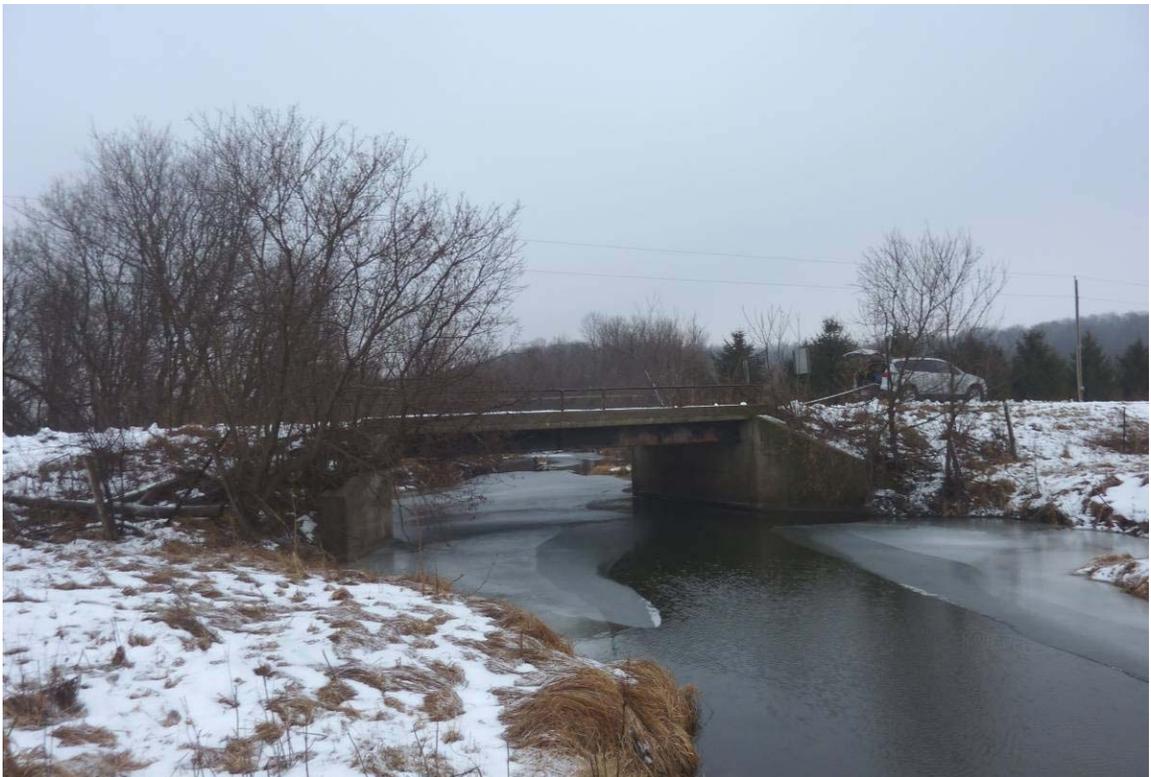
Photograph 2. Overall View of the West Fascia, Looking East.

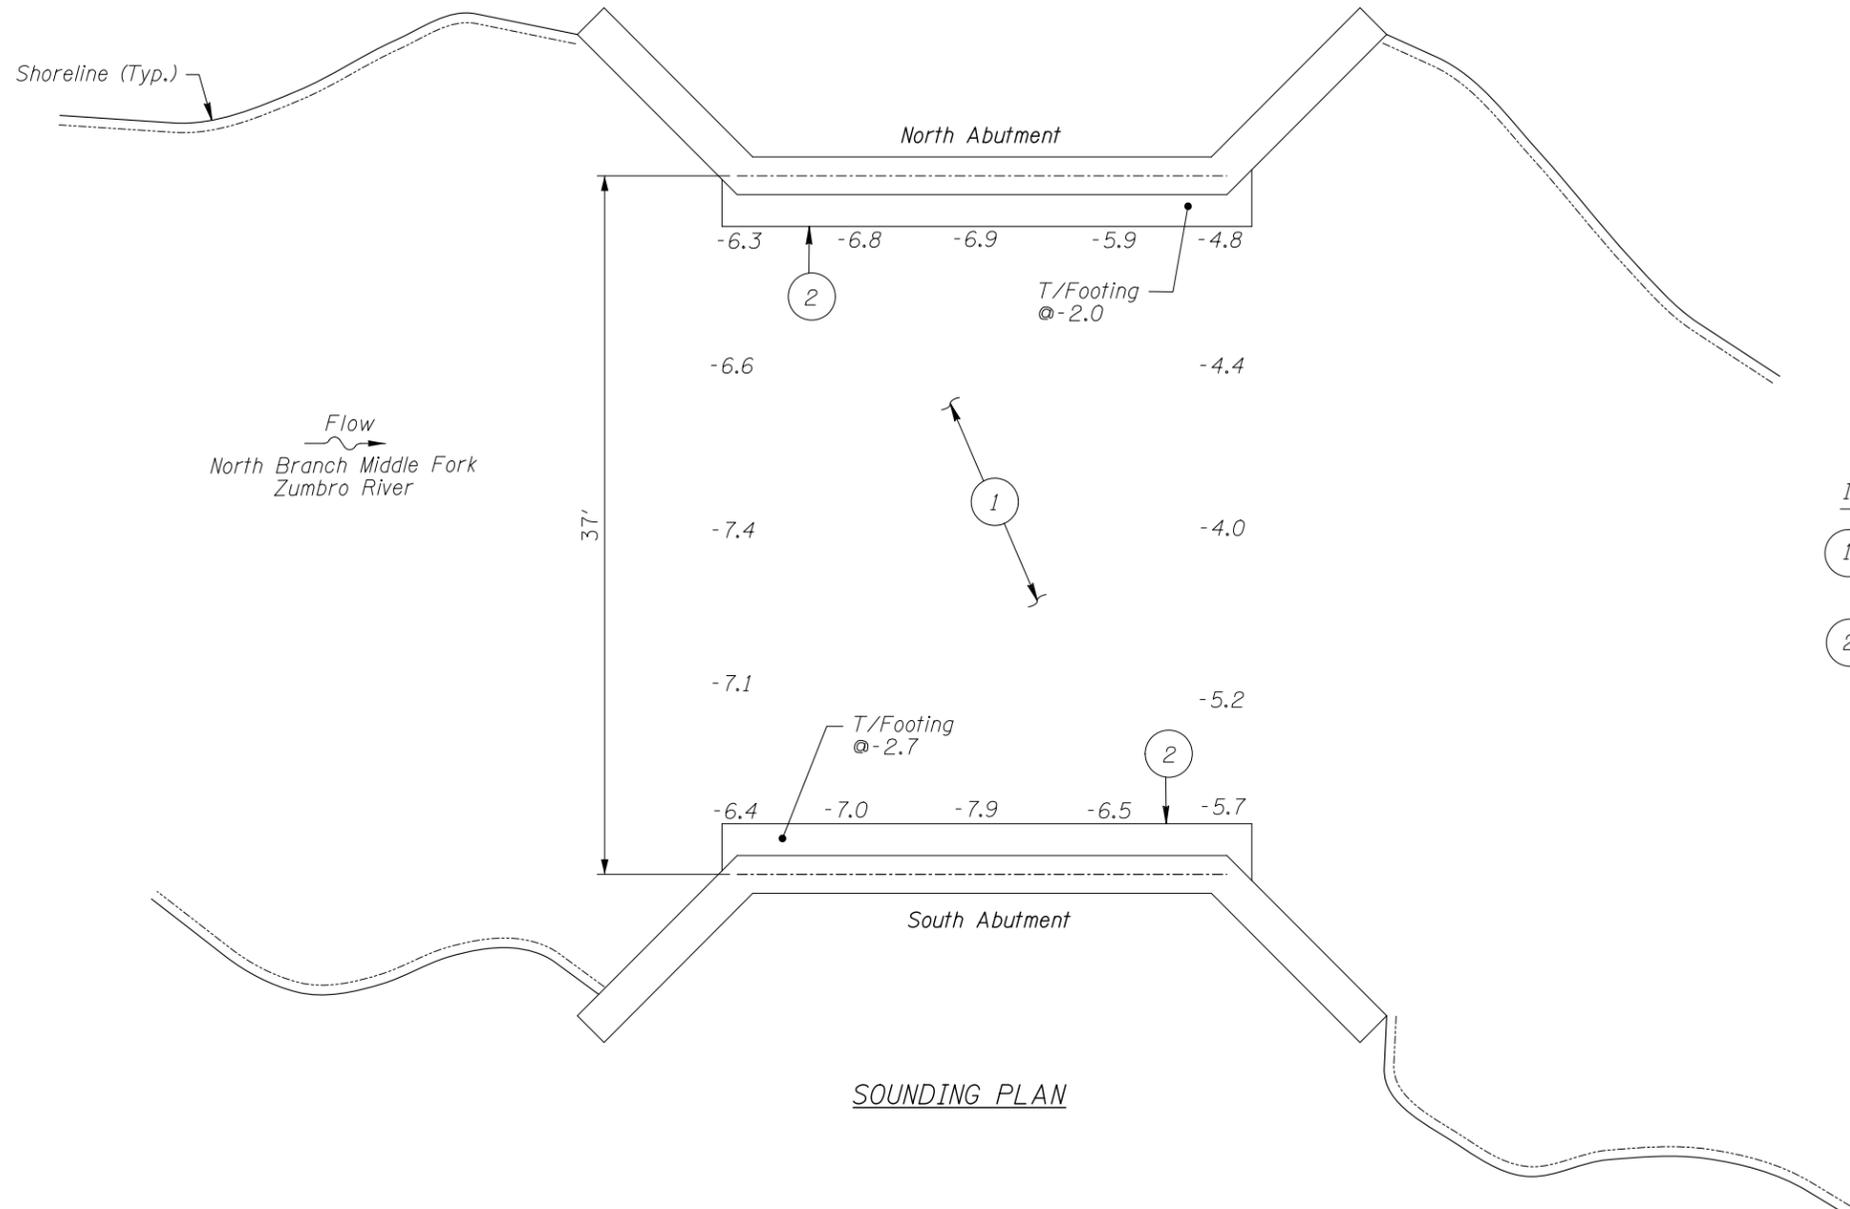
SOUNDING PLAN

- INSPECTION NOTES:
- ① The channel bottom material consisted of silt allowing up to 6 inches of probe rod penetration.
  - ② The footing was exposed along the North and South Abutments with up to 5 feet of maximum vertical face exposure.

- (A) Consideration should be given to placement of scour countermeasures along the exposed footing of both abutments in order to prevent further exposure and/or possible foundation undermining. Until the countermeasures are installed, the foundation exposure should be closely monitored during future underwater inspection and during or after events of high water and increased flow.
