UNDERWATER BRIDGE INSPECTION REPORT

STRUCTURE NO. L8547

NORTH BRANCH MIDDLE FORK OF THE ZUMBRO RIVER

COLLINS ENGINEERS, INC.

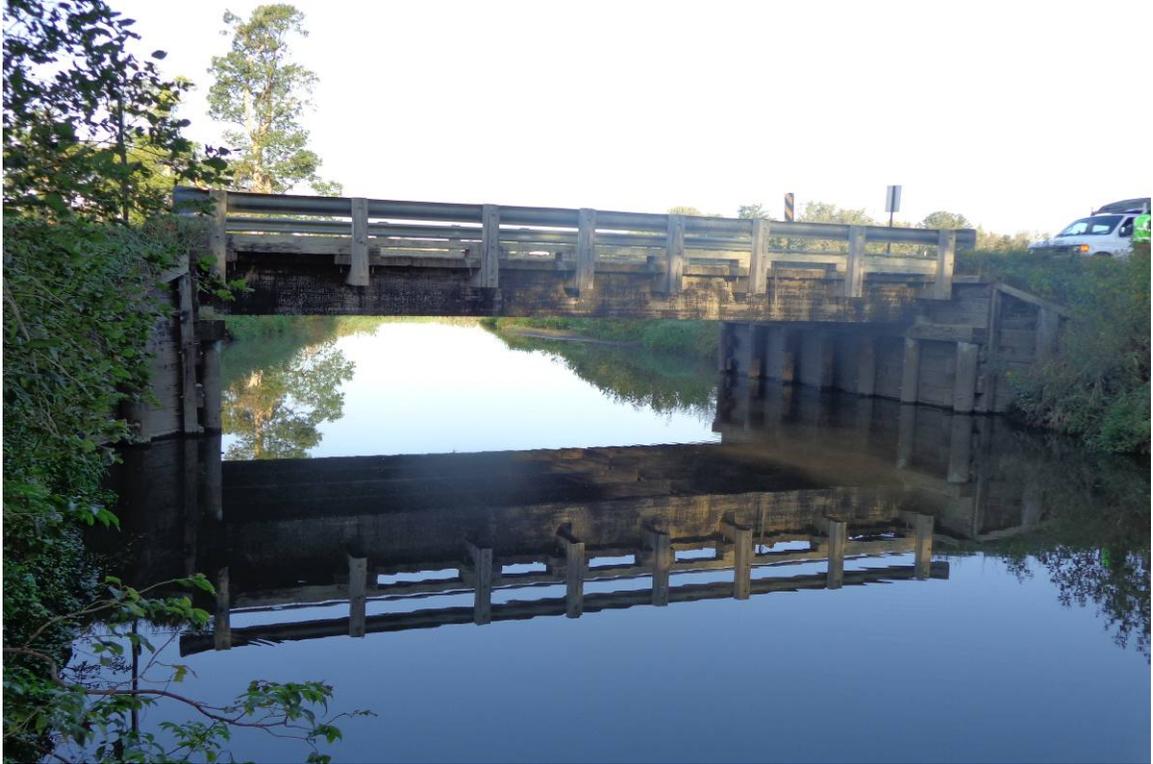
Photograph 1. Overall View of the Structure, Looking Northwest.

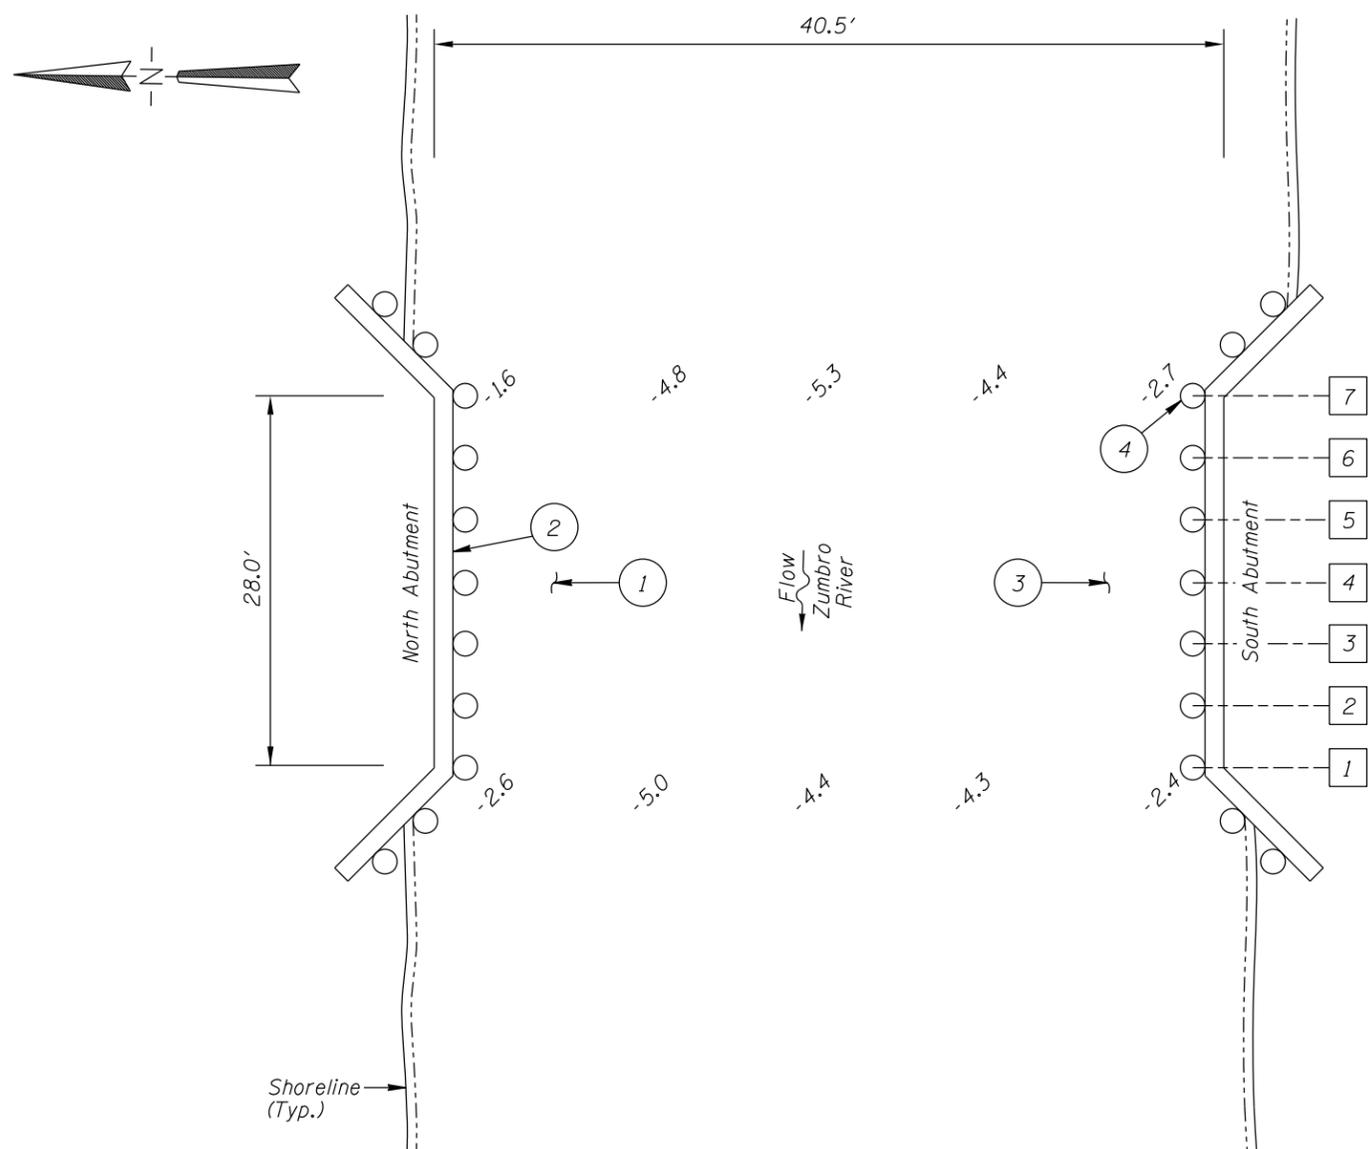
| INSPECTION AND SOUNDING PLAN | | |

- ① The channel bottom at the North Abutment consisted of soft silt with 2 feet of probe rod penetration.
- ② A 1/2 inch wide gap was observed in the deck planking of the North Abutment with apparent loss of backfill material present.
- ③ The channel bottom at the South Abutment consisted of 6 inch diameter stone with silty sand infilling.
- ④ Pile 7 at the South Abutment exhibited delamination of the outer 1 inch of shell and sounded hollow from 1 foot above to 1 foot below the waterline.
