UNDERWATER BRIDGE INSPECTION REPORT

STRUCTURE NO. 08520

MINNESOTA RIVER

DISTRICT 7 - BROWN COUNTY, CITY OF NEW ULM

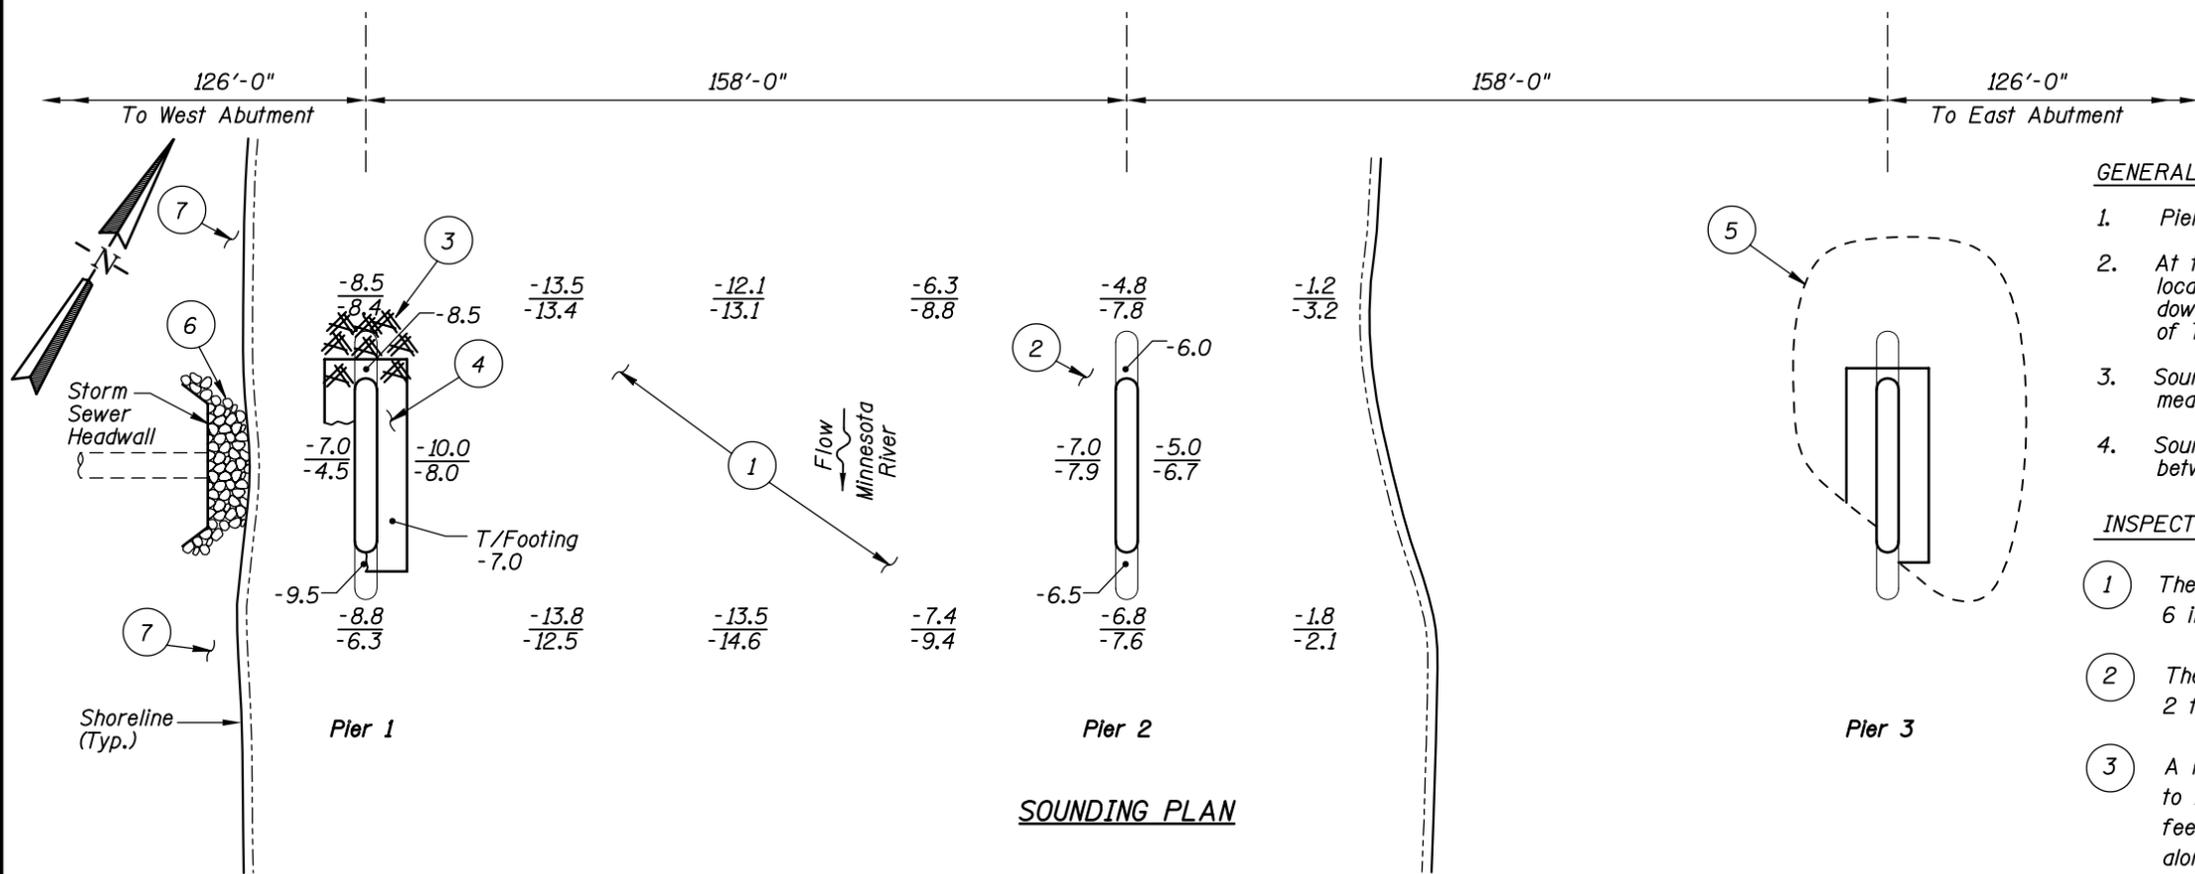
- 1 The channel bottom consisted of firm gravel and riprap, typically 6 inches in diameter, with up to 2 inches of probe rod penetration.
- 2 The channel bottom around Pier 2 consisted of soft silt with up to 2 feet of probe rod penetration.

- 3 A moderate accumulation of timber debris, which included pieces up to 10 inches in diameter, was observed from the channel bottom to 2 feet above the channel bottom at the upstream nose and extending along both faces of Pier 1 to the upstream quarter points.

- 4 The top of the footing was exposed at Pier 1 from the upstream quarter point on the west face, around the upstream nose, and along the entire east face with up to 3 feet of vertical face exposure along the east face.

- 5 The top of the footing was exposed at Pier 3 around the majority of the pier with up to 2 feet of vertical face exposure due to a dry scour depression.

- 6 The storm sewer headwall was well protected with riprap up to 3 feet in diameter.
- 7 Vertical bank erosion was observed upstream and downstream of the structure along the west embankment.

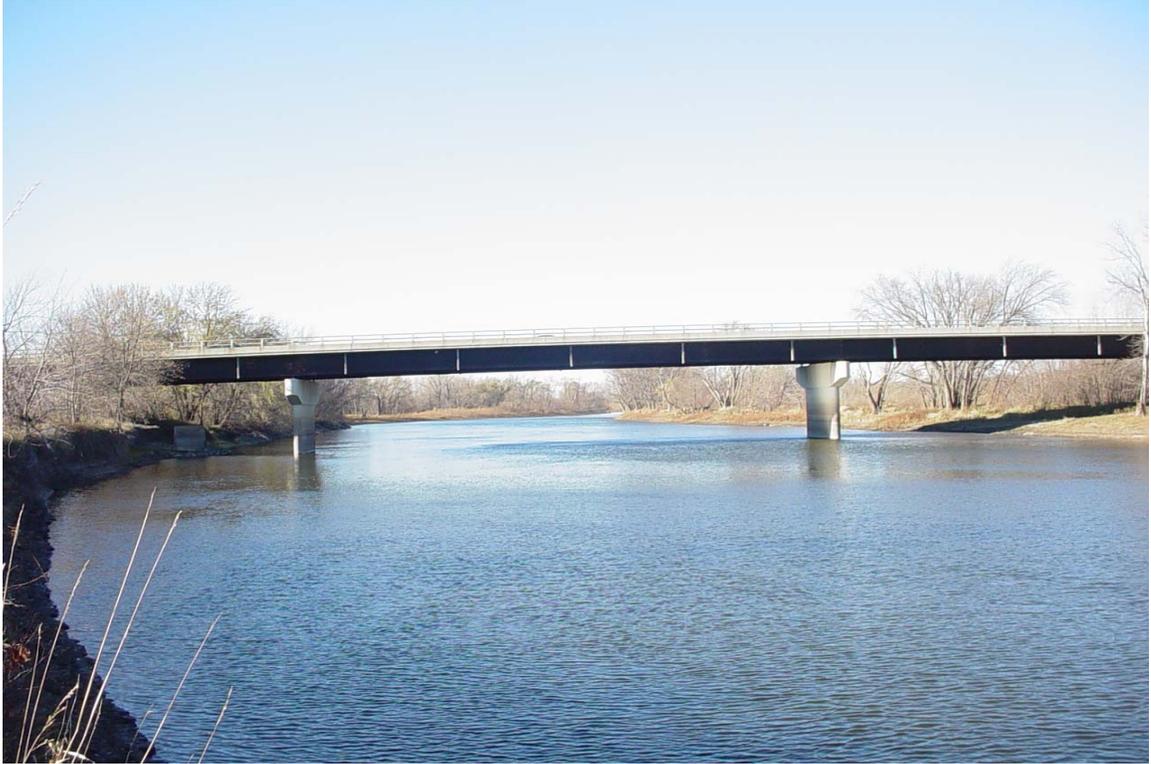
Photograph 1. Overall View of the Structure, Looking Northwest.

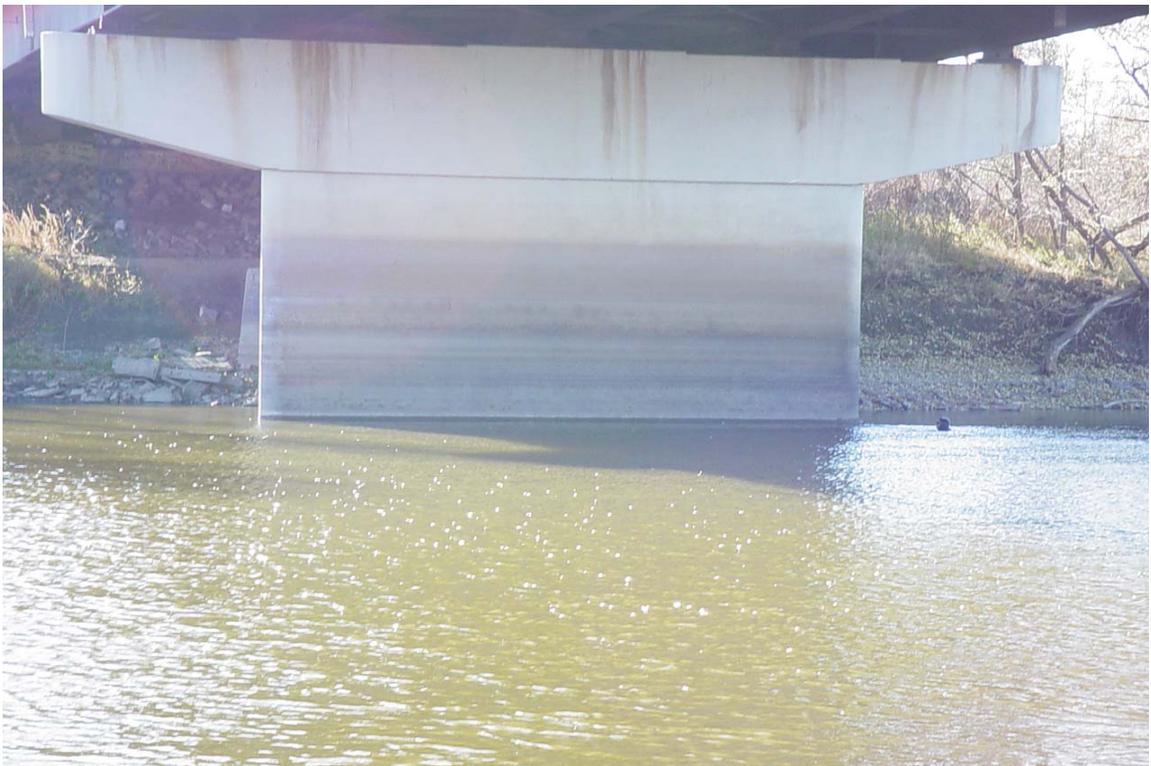
- (A) A moderate accumulation of timber debris, which included pieces up to 10 inches in diameter, was observed from the channel bottom to 2 feet above the channel bottom at the upstream nose and extending along both faces of Pier 1 to the upstream quarter points.
- (B) The top of the footing was exposed at Pier 1 from the upstream quarter point on the west face, around the upstream nose, and along the entire east face with up to 3 feet of vertical face exposure along the east face.
- (C) Pier 3 was not underwater, but exhibited footing exposure around the entire pier with up to 2 feet of vertical face exposure due to a dry scour depression.

Photograph 2. View of Pier 1, Looking Southwest.

- (A) Monitor the timber debris at Pier 1, and if found to be increasing in the future, removal operations may become warranted.

- (B) Because the bridge has been evaluated to be scour critical, monitor the footing exposure during high flows and also during future inspections, and if found to be increasing, countermeasures may be warranted.
- (C) Reinspect the submerged substructure units at the normal maximum recommended (NBIS) interval of five (5) years, unless a period of high flow creates the need for a sooner inspection.

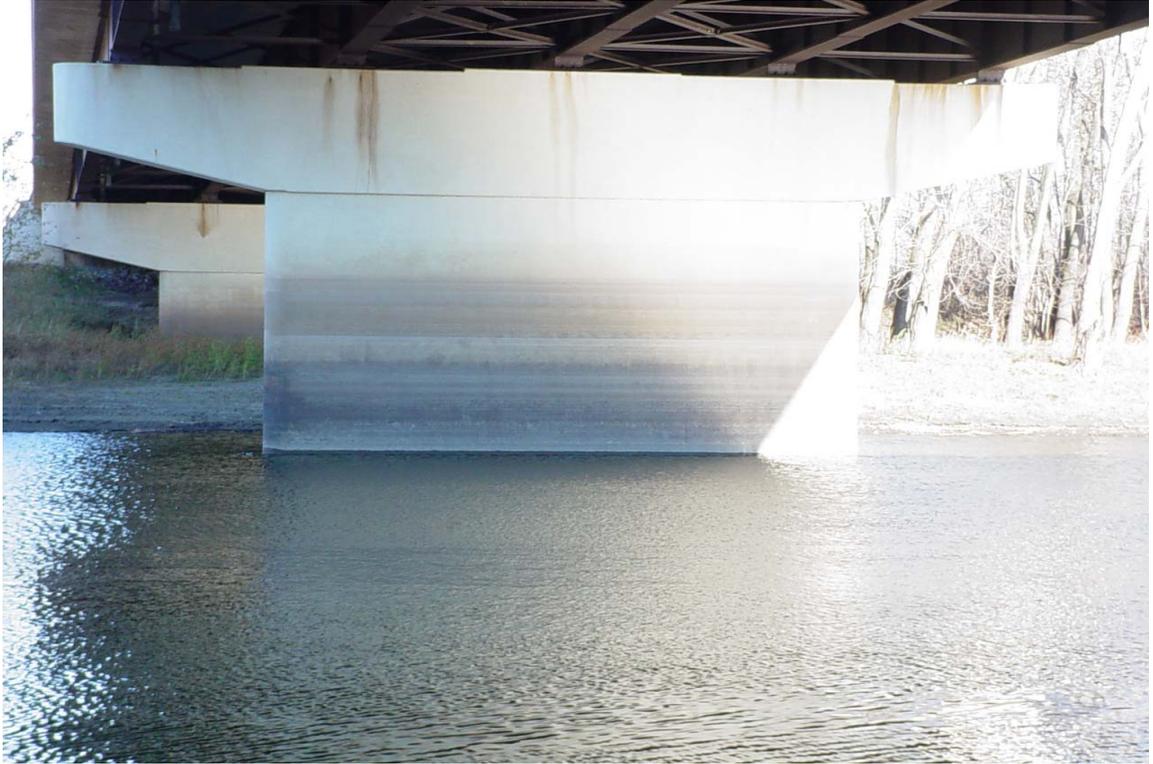
Photograph 3. View of Pier 2, Looking East.

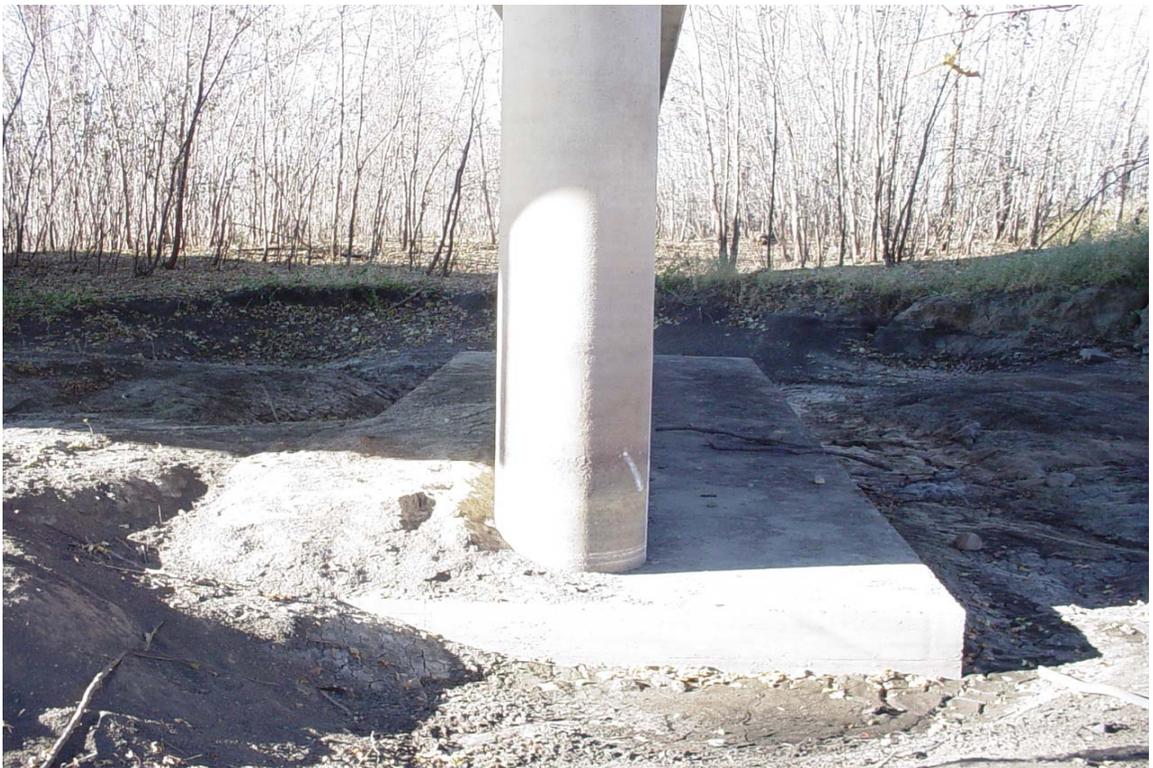
Photograph 4. View of Pier 3, Looking Northwest.
