UNDERWATER BRIDGE INSPECTION REPORT

STRUCTURE NO. 7208

BLUE EARTH RIVER

MINNESOTA DEPARTMENT OF TRANSPORTATION
UNDERWATER BRIDGE INSPECTION

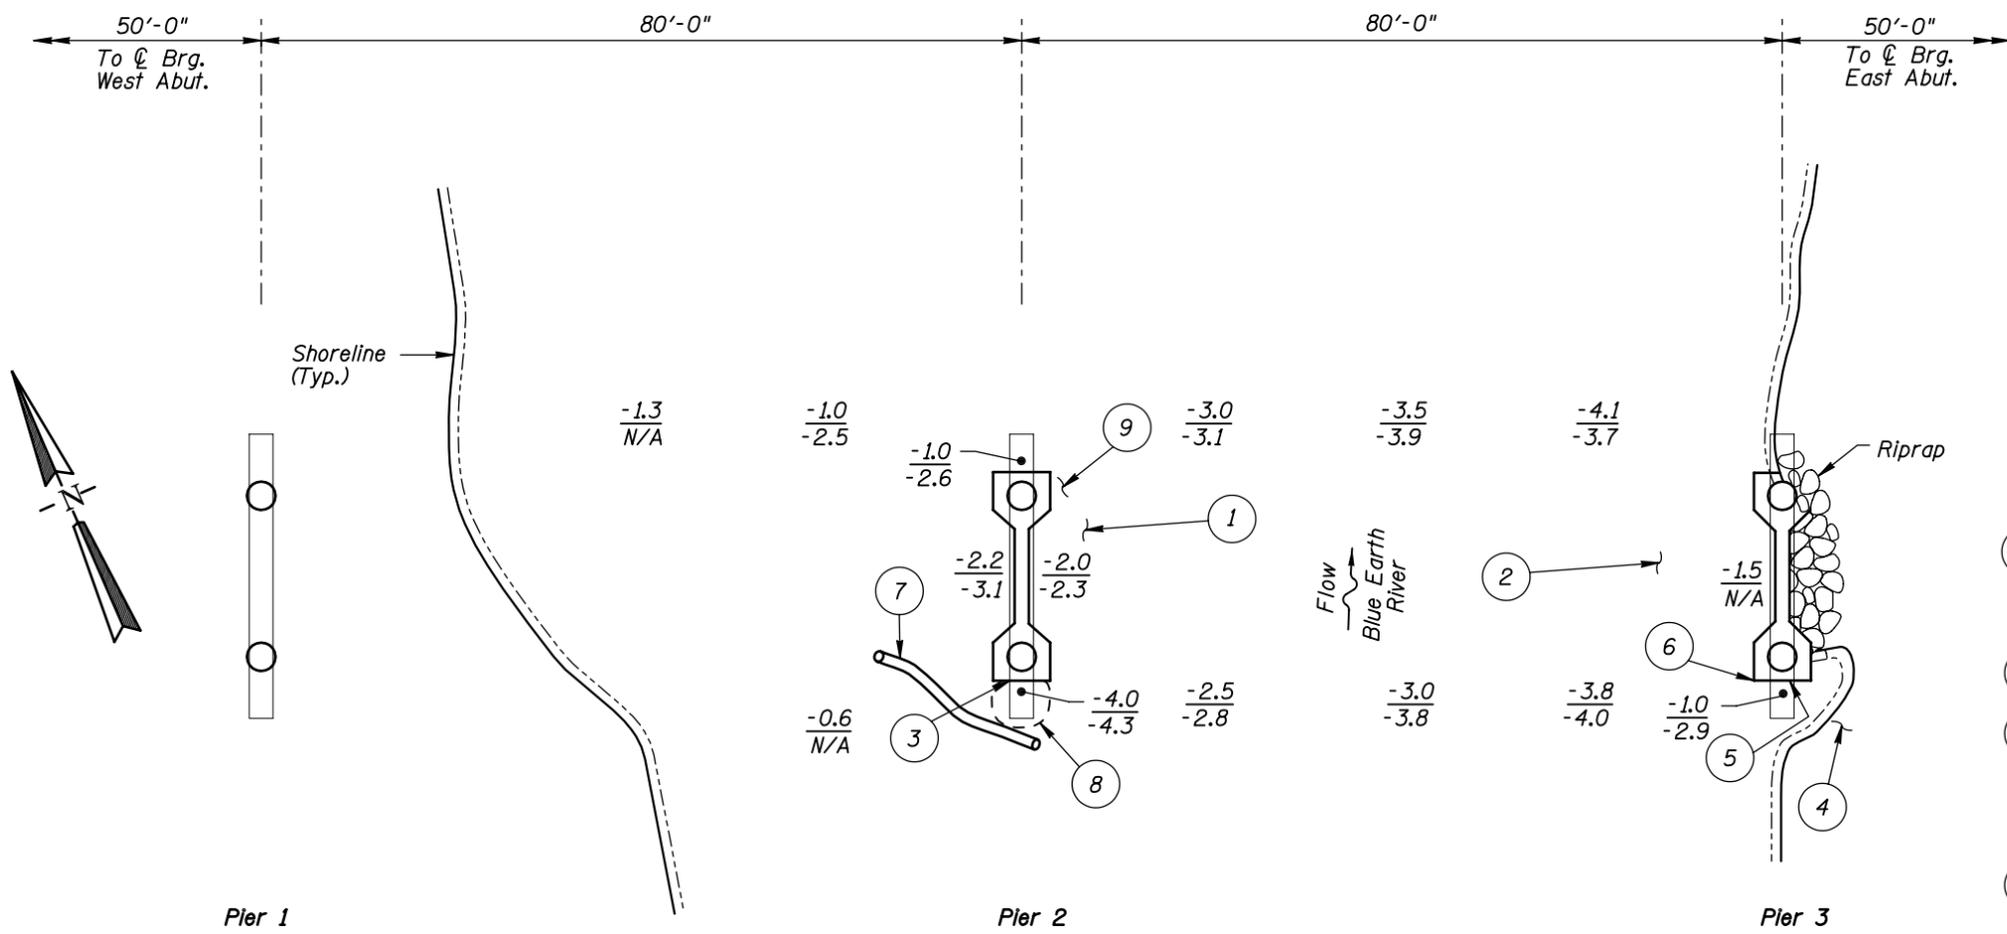
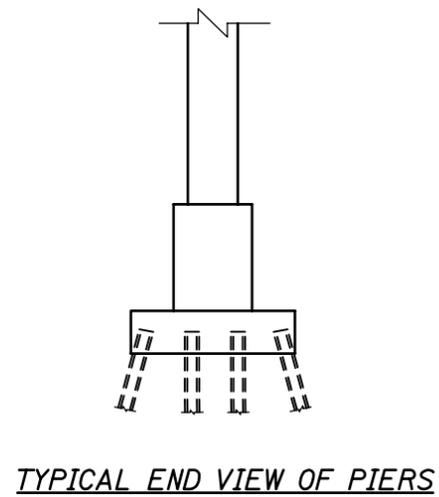
SOUNDING PLAN

- INSPECTION NOTES:**
1. The channel bottom at Pier 2 consisted of silty sand on the west side and riprap, up to 2 foot in diameter, along the east side and upstream nose.

2. The channel bottom consisted of silty clay.
 3. An area of section loss, 1.5 foot high and extending the entire width of Pier 2 was observed at the top corner of the webwall at the upstream end with a maximum penetration of 6 inches and exposed reinforcing.

4. Moderate erosion of the embankment was observed at the upstream end of Pier 3.
 5. A hairline crack was observed at the upstream end of Pier 3 extending from the top of the webwall to the channel bottom.

6. An area of section loss, 7 inches high and 12 inches long, was observed at the top corner of the webwall at the upstream end of Pier 3 with 1 inch of penetration.

7. A log, 8 inches in diameter and 30 feet long, was observed at the upstream end of Pier 2.
 8. A scour depression, 2 feet deep and 7 feet in radius, was observed at the upstream end of Pier 2.

9. A piece of steel sheet piling was observed at the downstream end of Pier 2 extending from the channel bottom to 1 foot above the waterline.

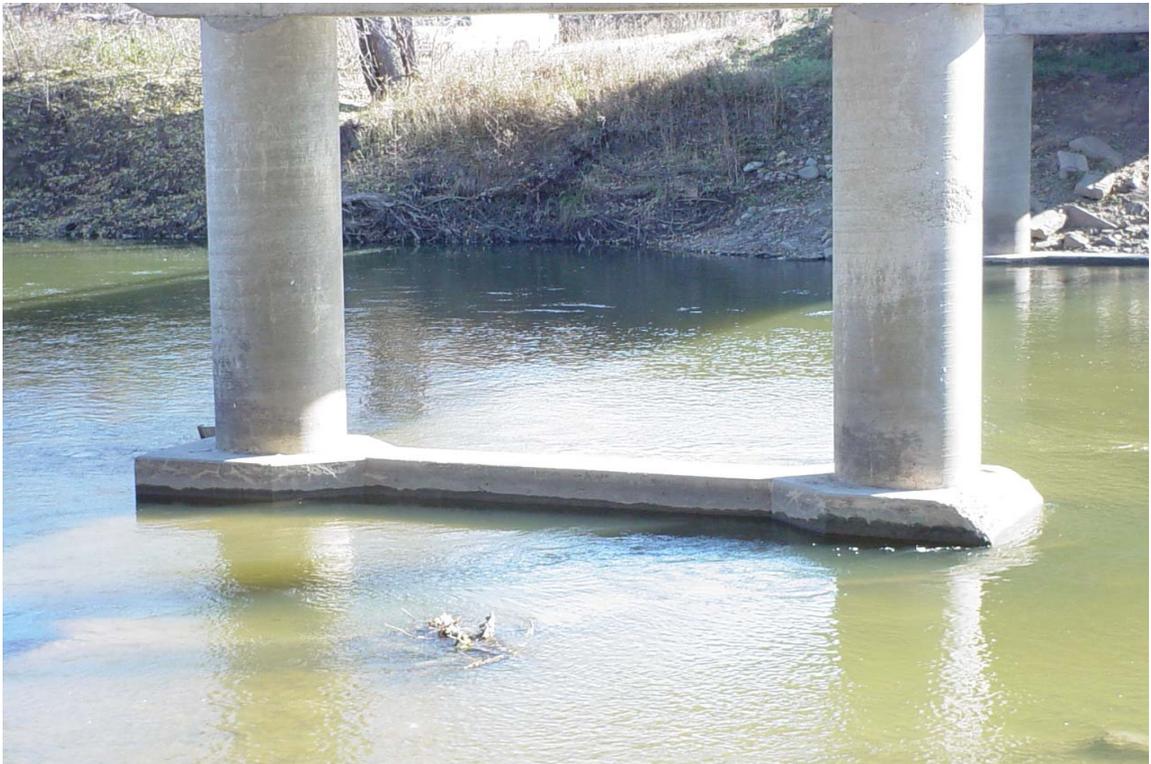
Photograph 2. View of Pier 2, Looking East.

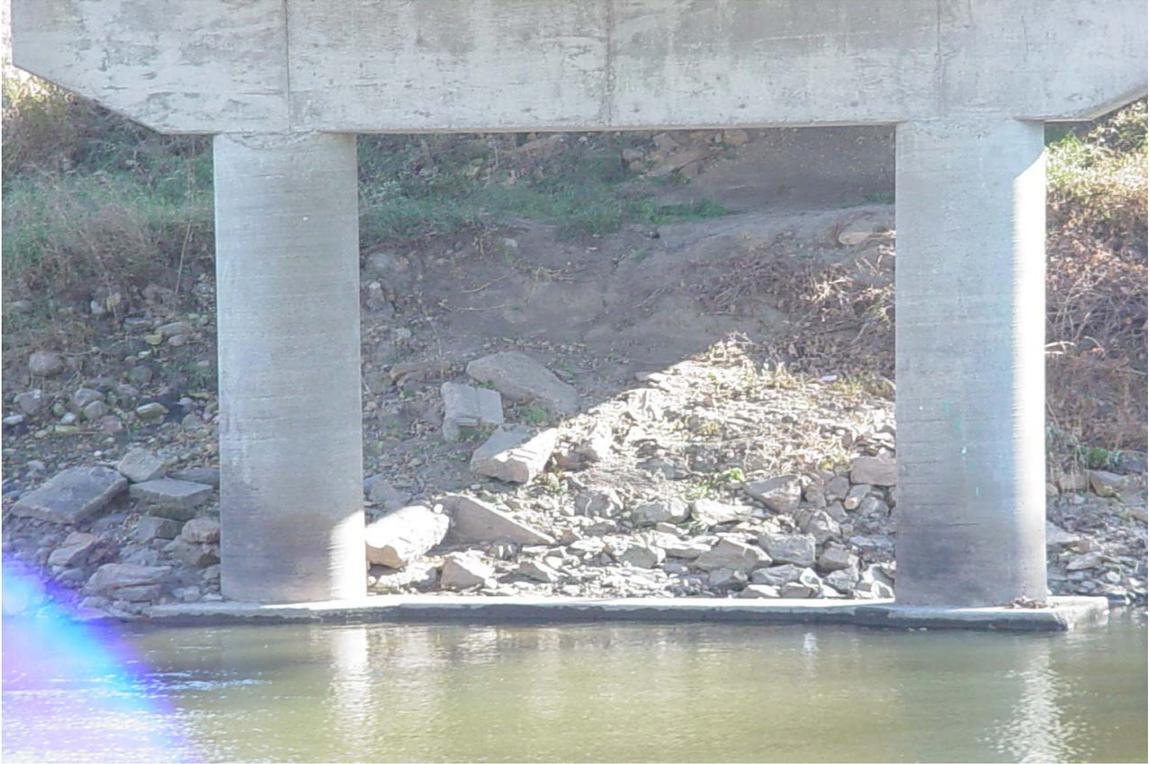
Photograph 3. View of Pier 3, Looking East.

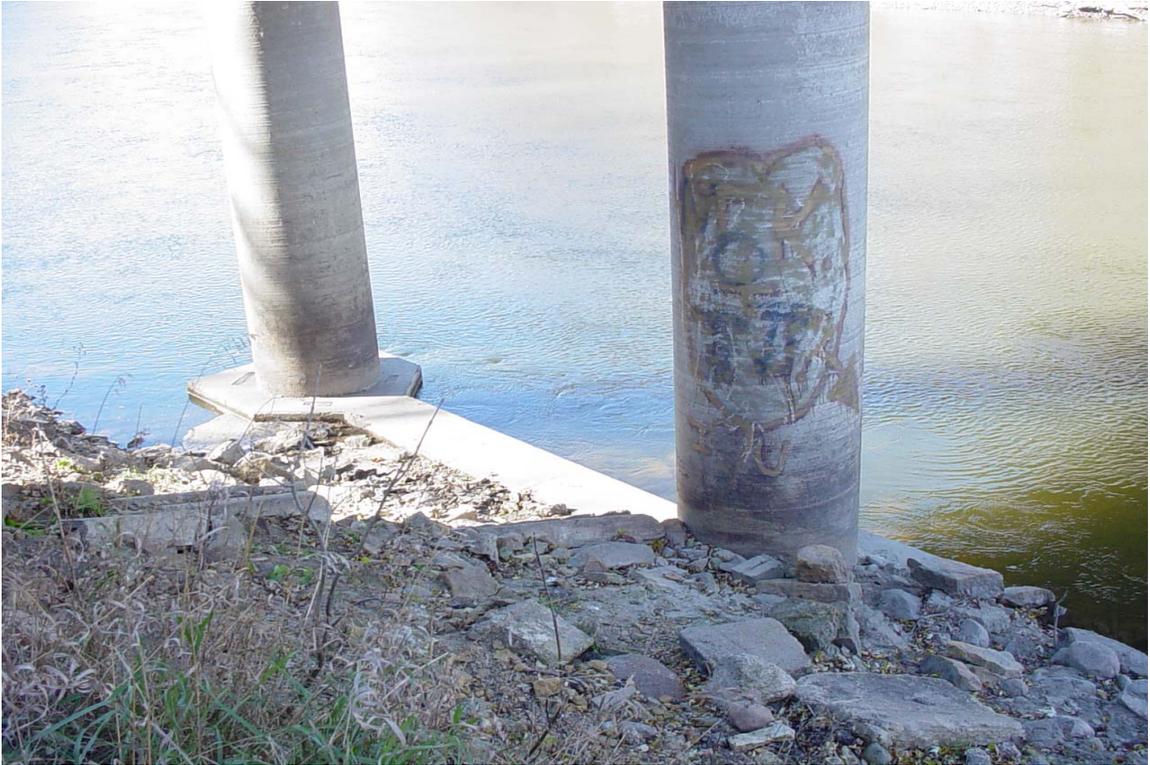
Photograph 4. View of Pier 3, Looking West.
