UNDERWATER BRIDGE INSPECTION REPORT

STRUCTURE NO. 07542

CSAH NO. 9

BLUE EARTH RIVER

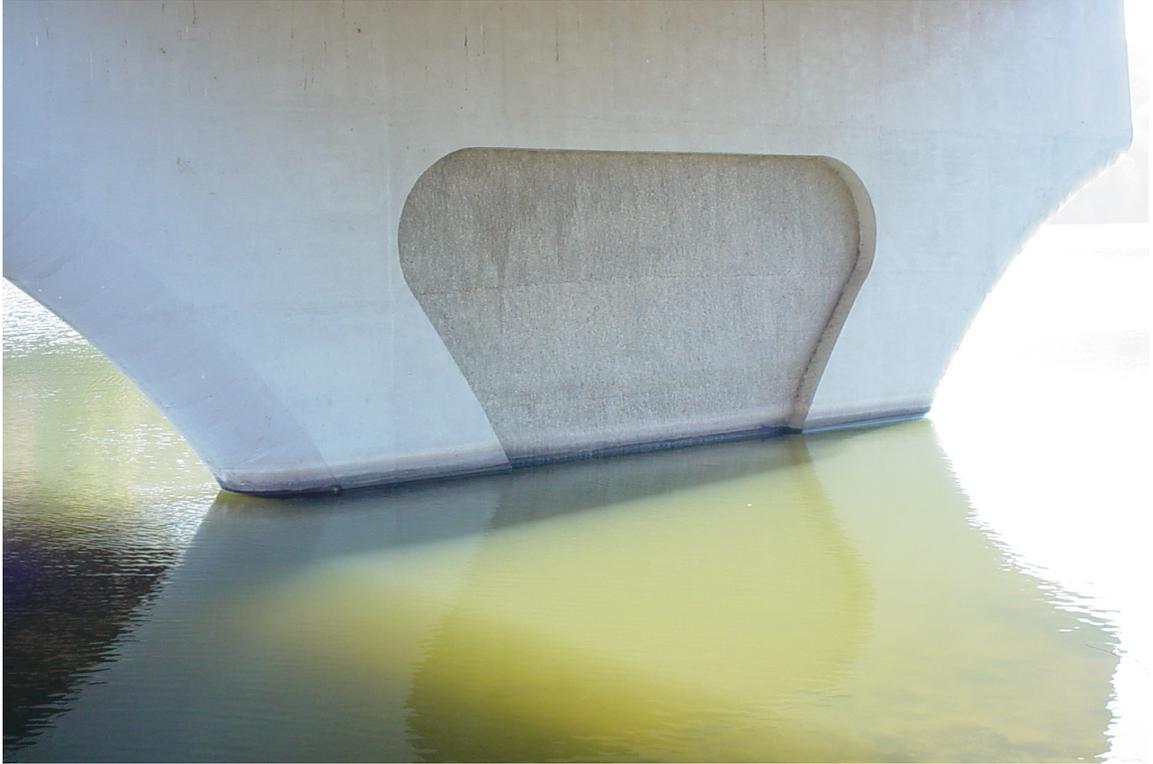
Photograph 1. View of Pier 1, Looking Southeast.

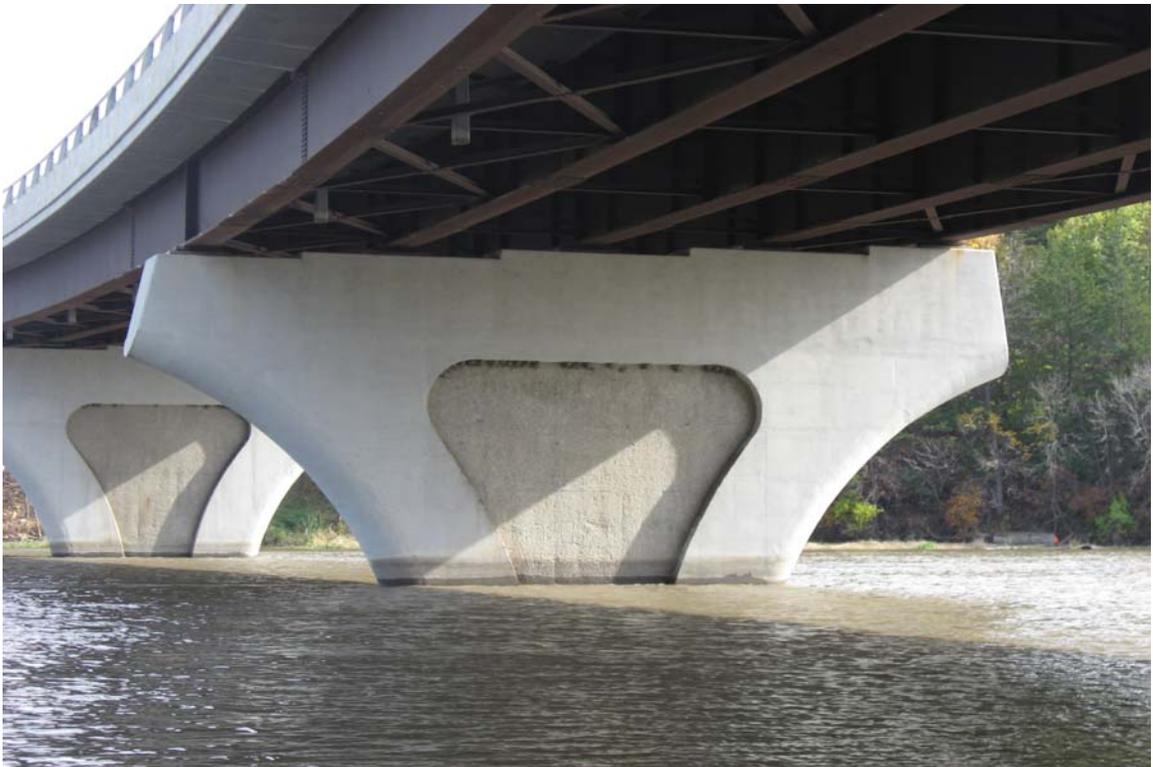
- (A) Areas of minor poor consolidation and/or section loss were observed in and around the waterline at random locations on all of the piers, typically with up to 1 inch of penetration.
- (B) Timber debris consisting of logs and branches was observed at Pier 2 extending from the upstream nose to the midpoint on both side faces extending from the channel bottom up 4 feet.

Photograph 2. View of Pier 2, Looking Southeast.

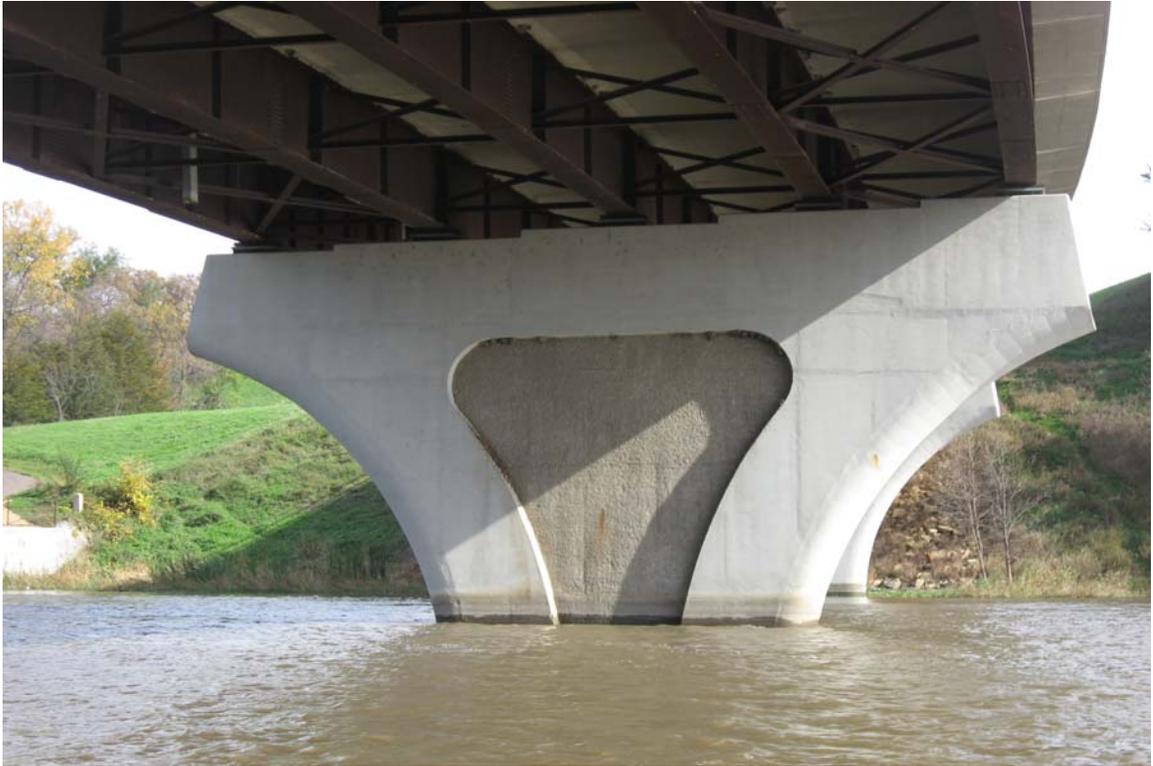
Photograph 3. View of Pier 3, Looking Southeast.

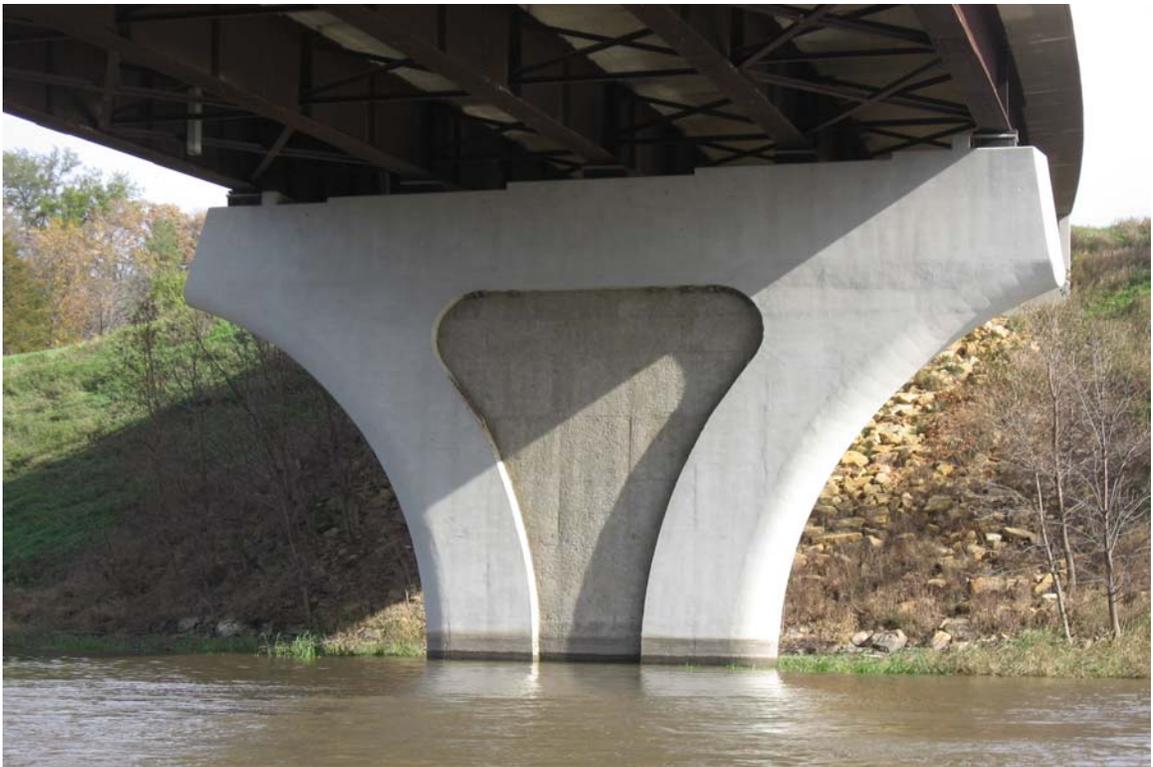
Photograph 4. View of Pier 4, Looking Northwest.

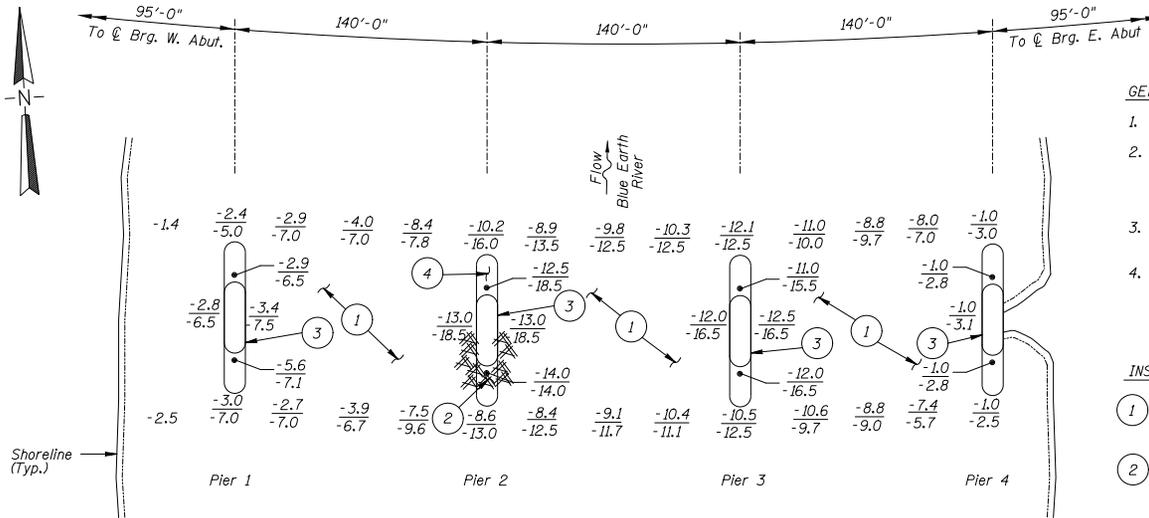
INSPECTION AND SOUNDING PLAN

- The channel bottom material consisted of soft silt with up to 2 feet of probe rod penetration.
- A moderate accumulation of timber debris, consisting of logs and branches, was observed at Pier 2 and extended from the upstream nose to the midpoint on each face of the pier and from the channel bottom up 4 feet.
- Areas of minor poor consolidation and/or section loss were observed in and around the waterline at random locations on all of the piers, typically with up to 1 inch of penetration.
- The remains of the sheet pile cofferdam used during original construction were observed along the downstream nose of the pier.
