UNDERWATER BRIDGE INSPECTION REPORT

STRUCTURE NO. 07569
CSAH NO. 90
OVER THE
BLUE EARTH RIVER
DISTRICT 7 - BLUE EARTH COUNTY

PREPARED FOR THE
MINNESOTA DEPARTMENT OF TRANSPORTATION
BY
COLLINS ENGINEERS, INC.
JOB NO. 5221 (CEI 28A)

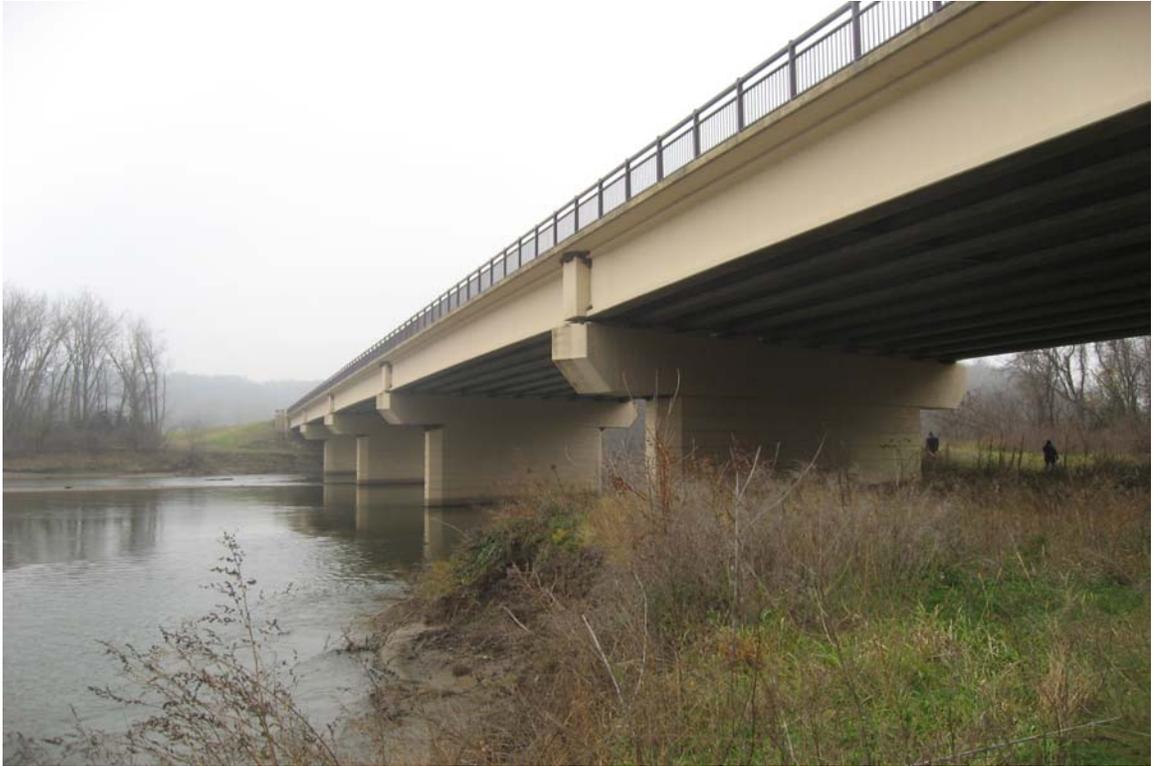
Photograph 1. Overall View of the Structure, Looking South.

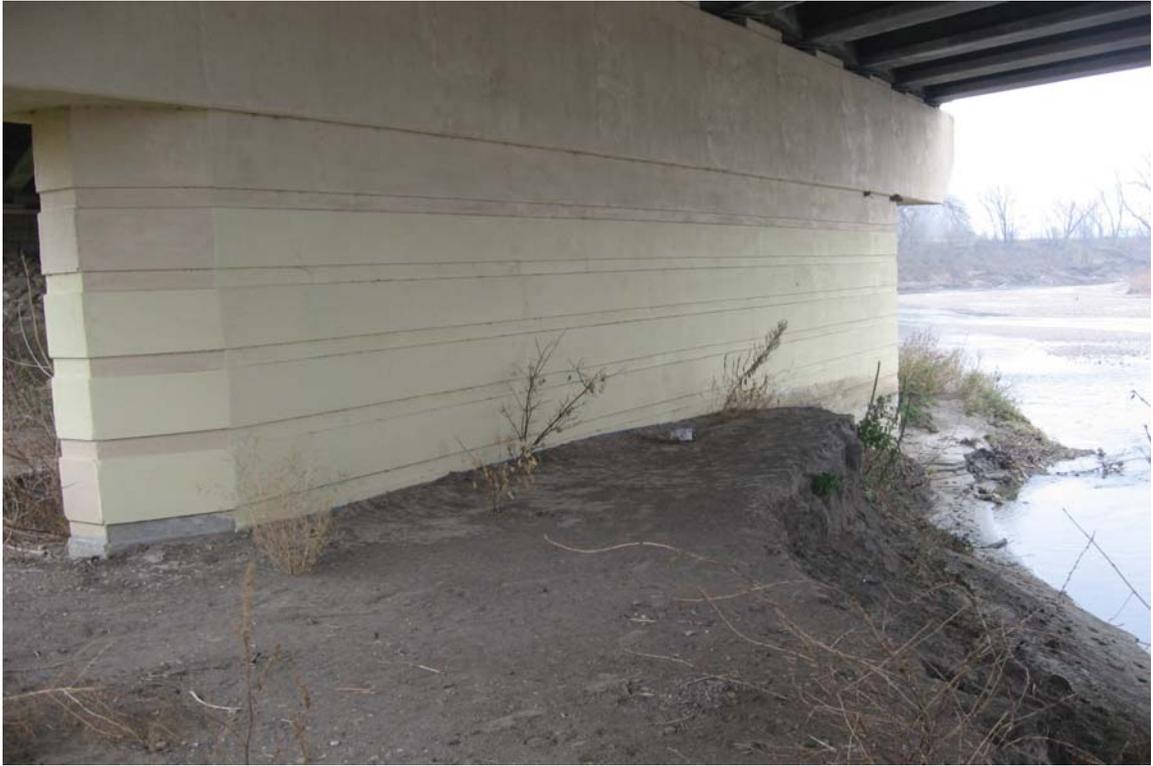
- (D) A light accumulation of timber debris was observed around the upstream nose and along the west face of Pier 2.
- (E) Both river banks exhibited steep vertical slopes due to erosion. The erosion along the northerly bank cuts past / through Pier 1.

Photograph 2. View of Pier 1, Looking North.

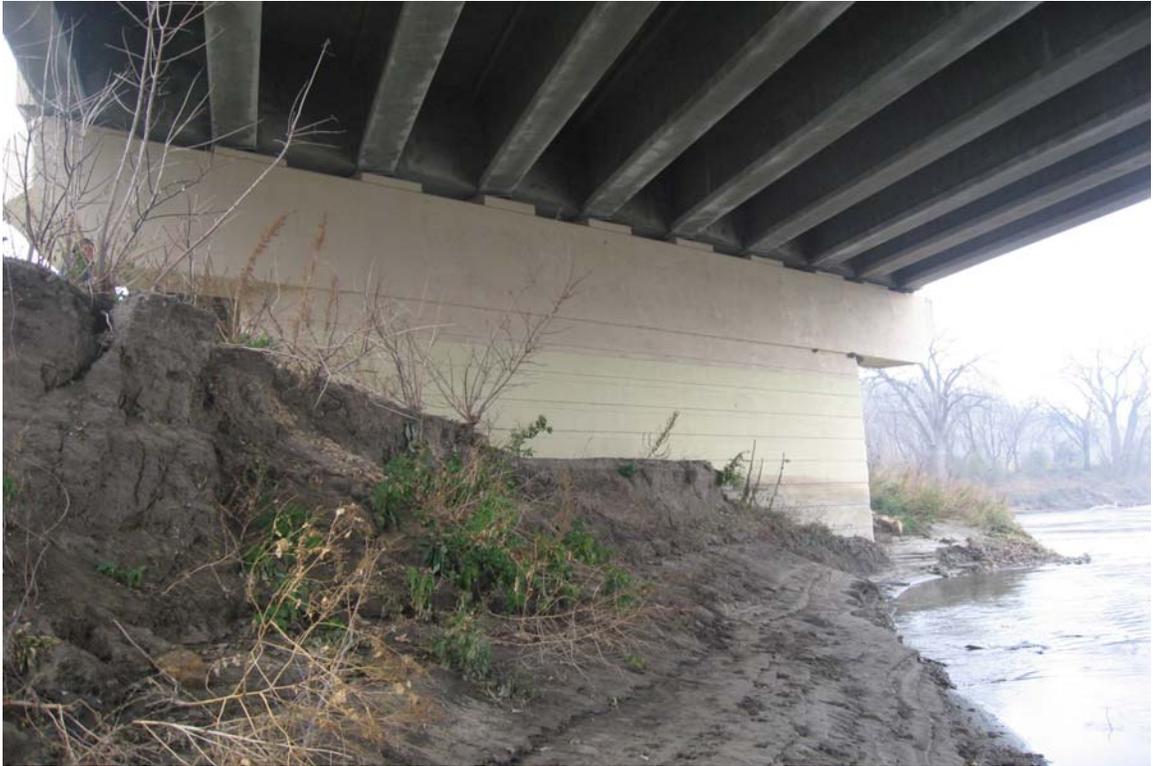
Photograph 3. View of Pier 1, Looking South.

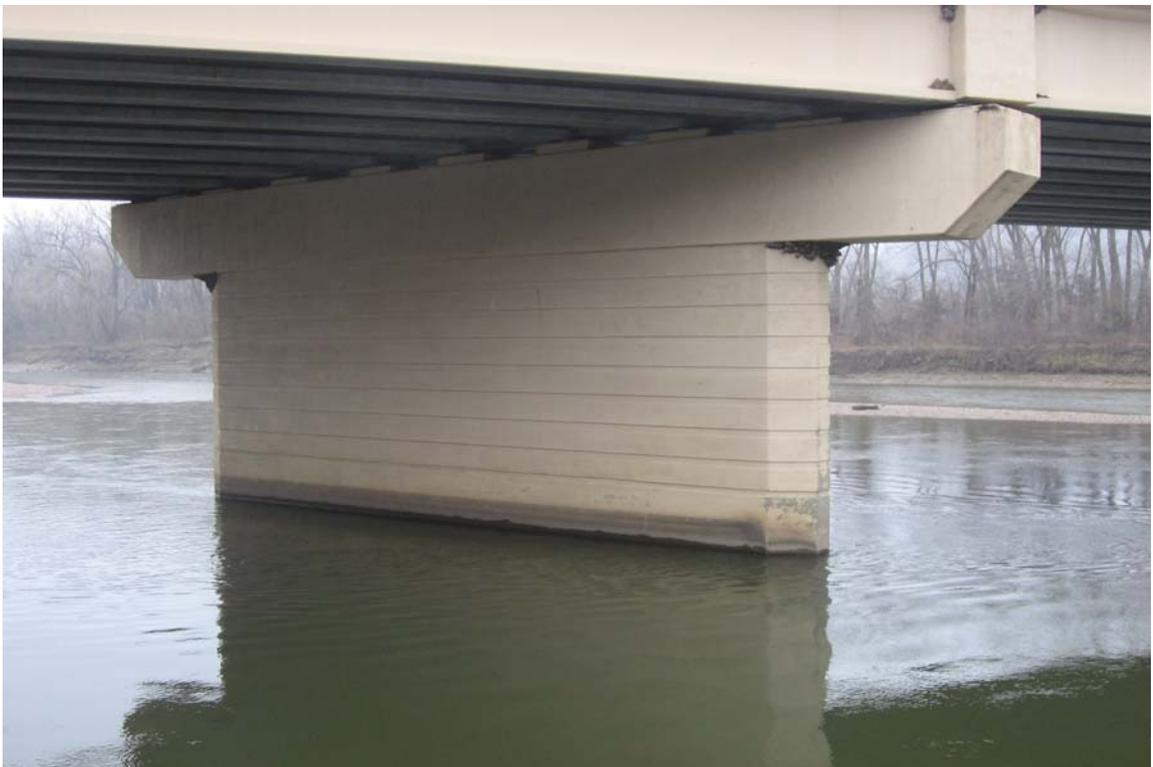
Photograph 4. View of Pier 2, Looking East.

- 3 Light accumulation of timber debris was observed around the upstream nose and along the west face of Pier 2.
- 4 Scour depression with a 7 foot radius and 2.5 feet of depth was observed around the upstream nose of Pier 2.

Monitor the accumulation of timber debris around the upstream nose of Piers 2 and 3, and if it progresses further, removal may be required so it does not adversely affect the piers or their surrounding channel bottom.

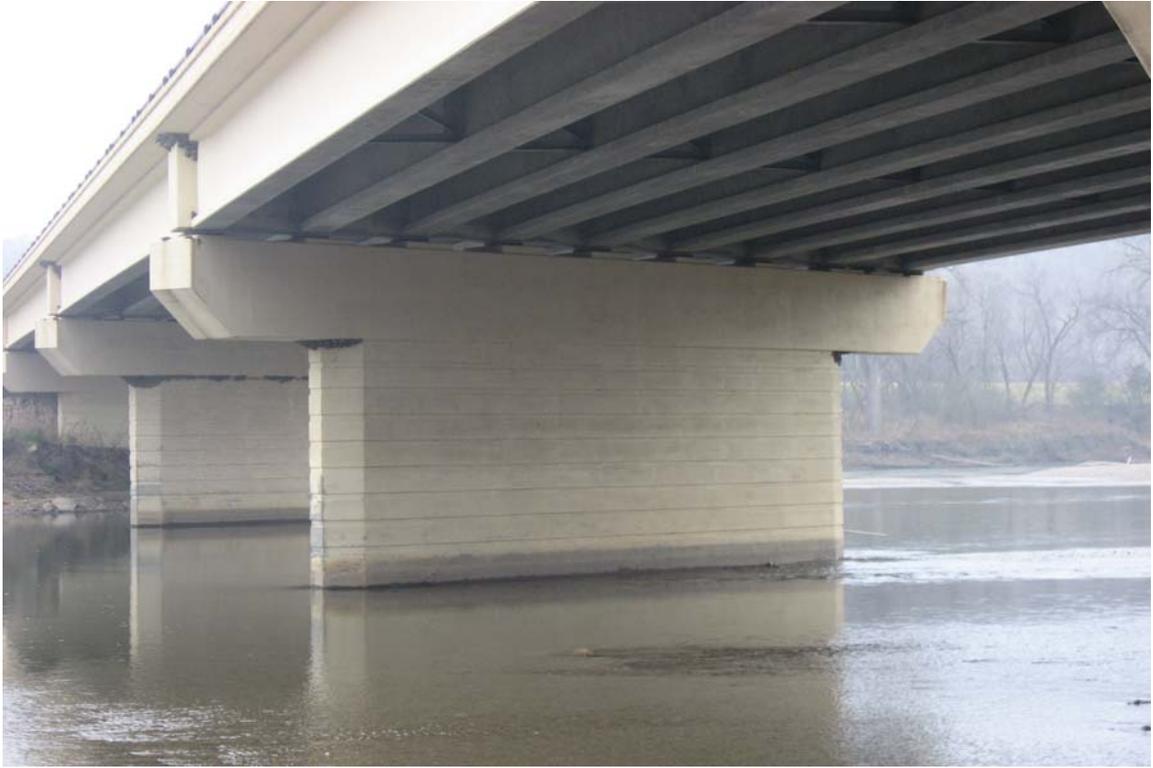
Photograph 5. View of Pier 3, Looking North.

- 2 A small amount of timber debris consisting of branches 2 inches and smaller was observed from the upstream end of Pier 3 to the quarter point on both sides from the channel bottom up 1 foot.

- 7 A 7 feet radius scour depression 2 feet deep was observed at the upstream end of Pier 3.
- 8 A 5 feet radius scour depression 2 feet deep was observed at the upstream end of Pier 4.

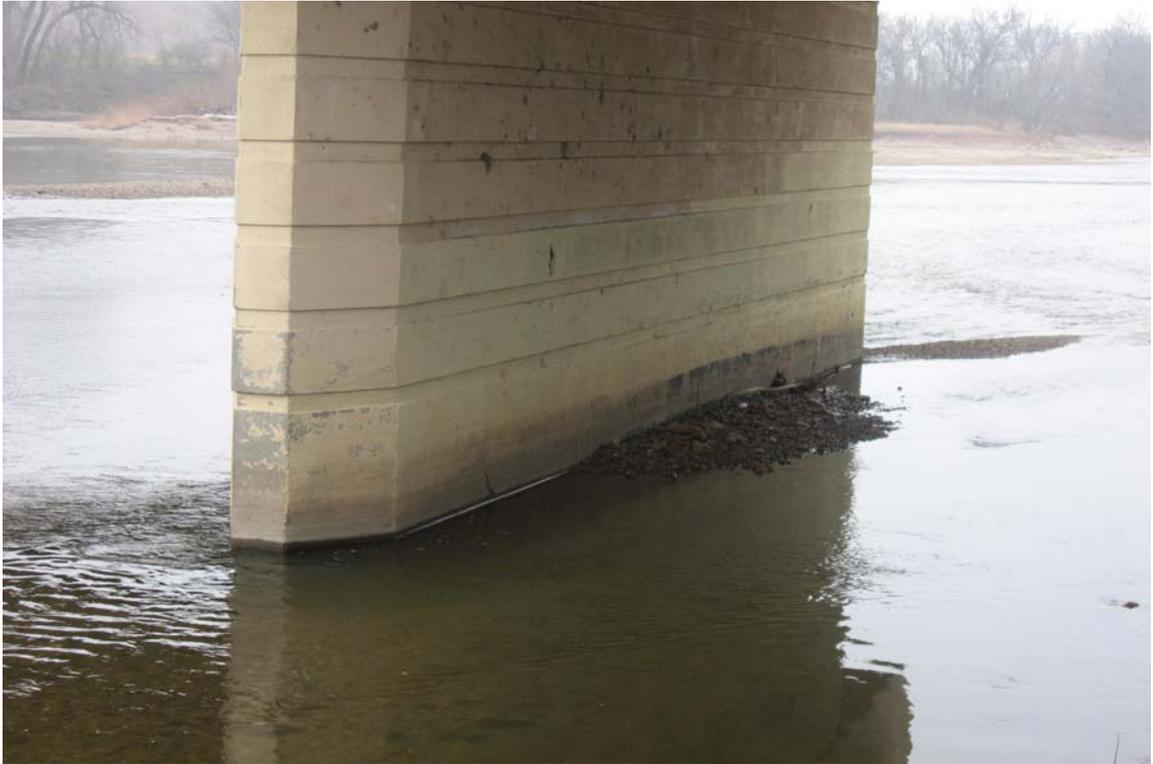
Photograph 6. View of Pier 4, Looking North.

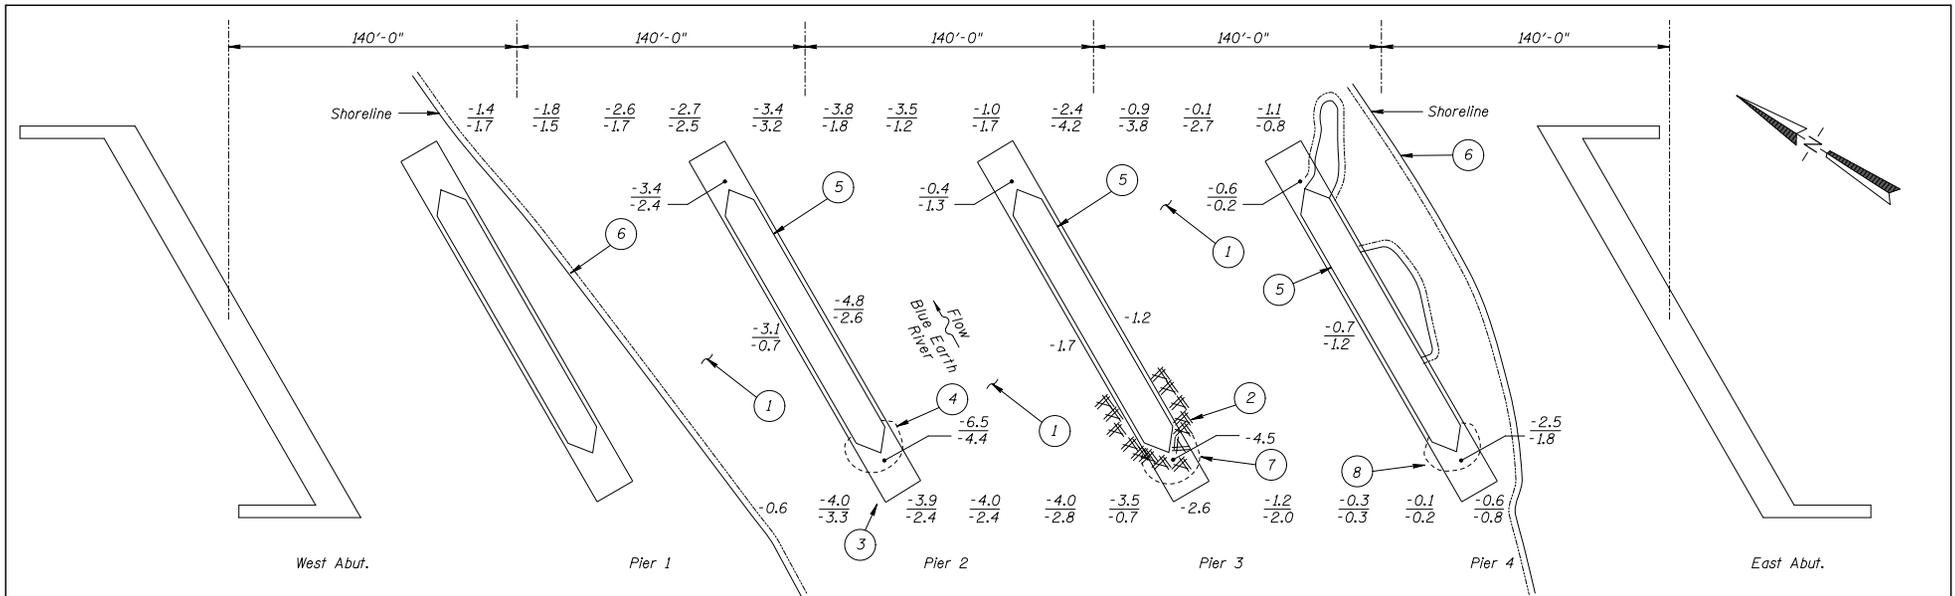
SOUNDING PLAN

- 1 The channel bottom material around the substructure units consisted of sand, gravel, and 2 to 4 feet diameter cobbles with up to 1 inch of probe rod penetration.

- 5 Overall the concrete of the piers was in good condition and only exhibited random vertical cracks.
- 6 Vertical bank erosion was observed all along the river bank.
