UNDERWATER BRIDGE INSPECTION REPORT

STRUCTURE NO. 8527

MINNESOTA RIVER

DISTRICT 7 - BROWN COUNTY

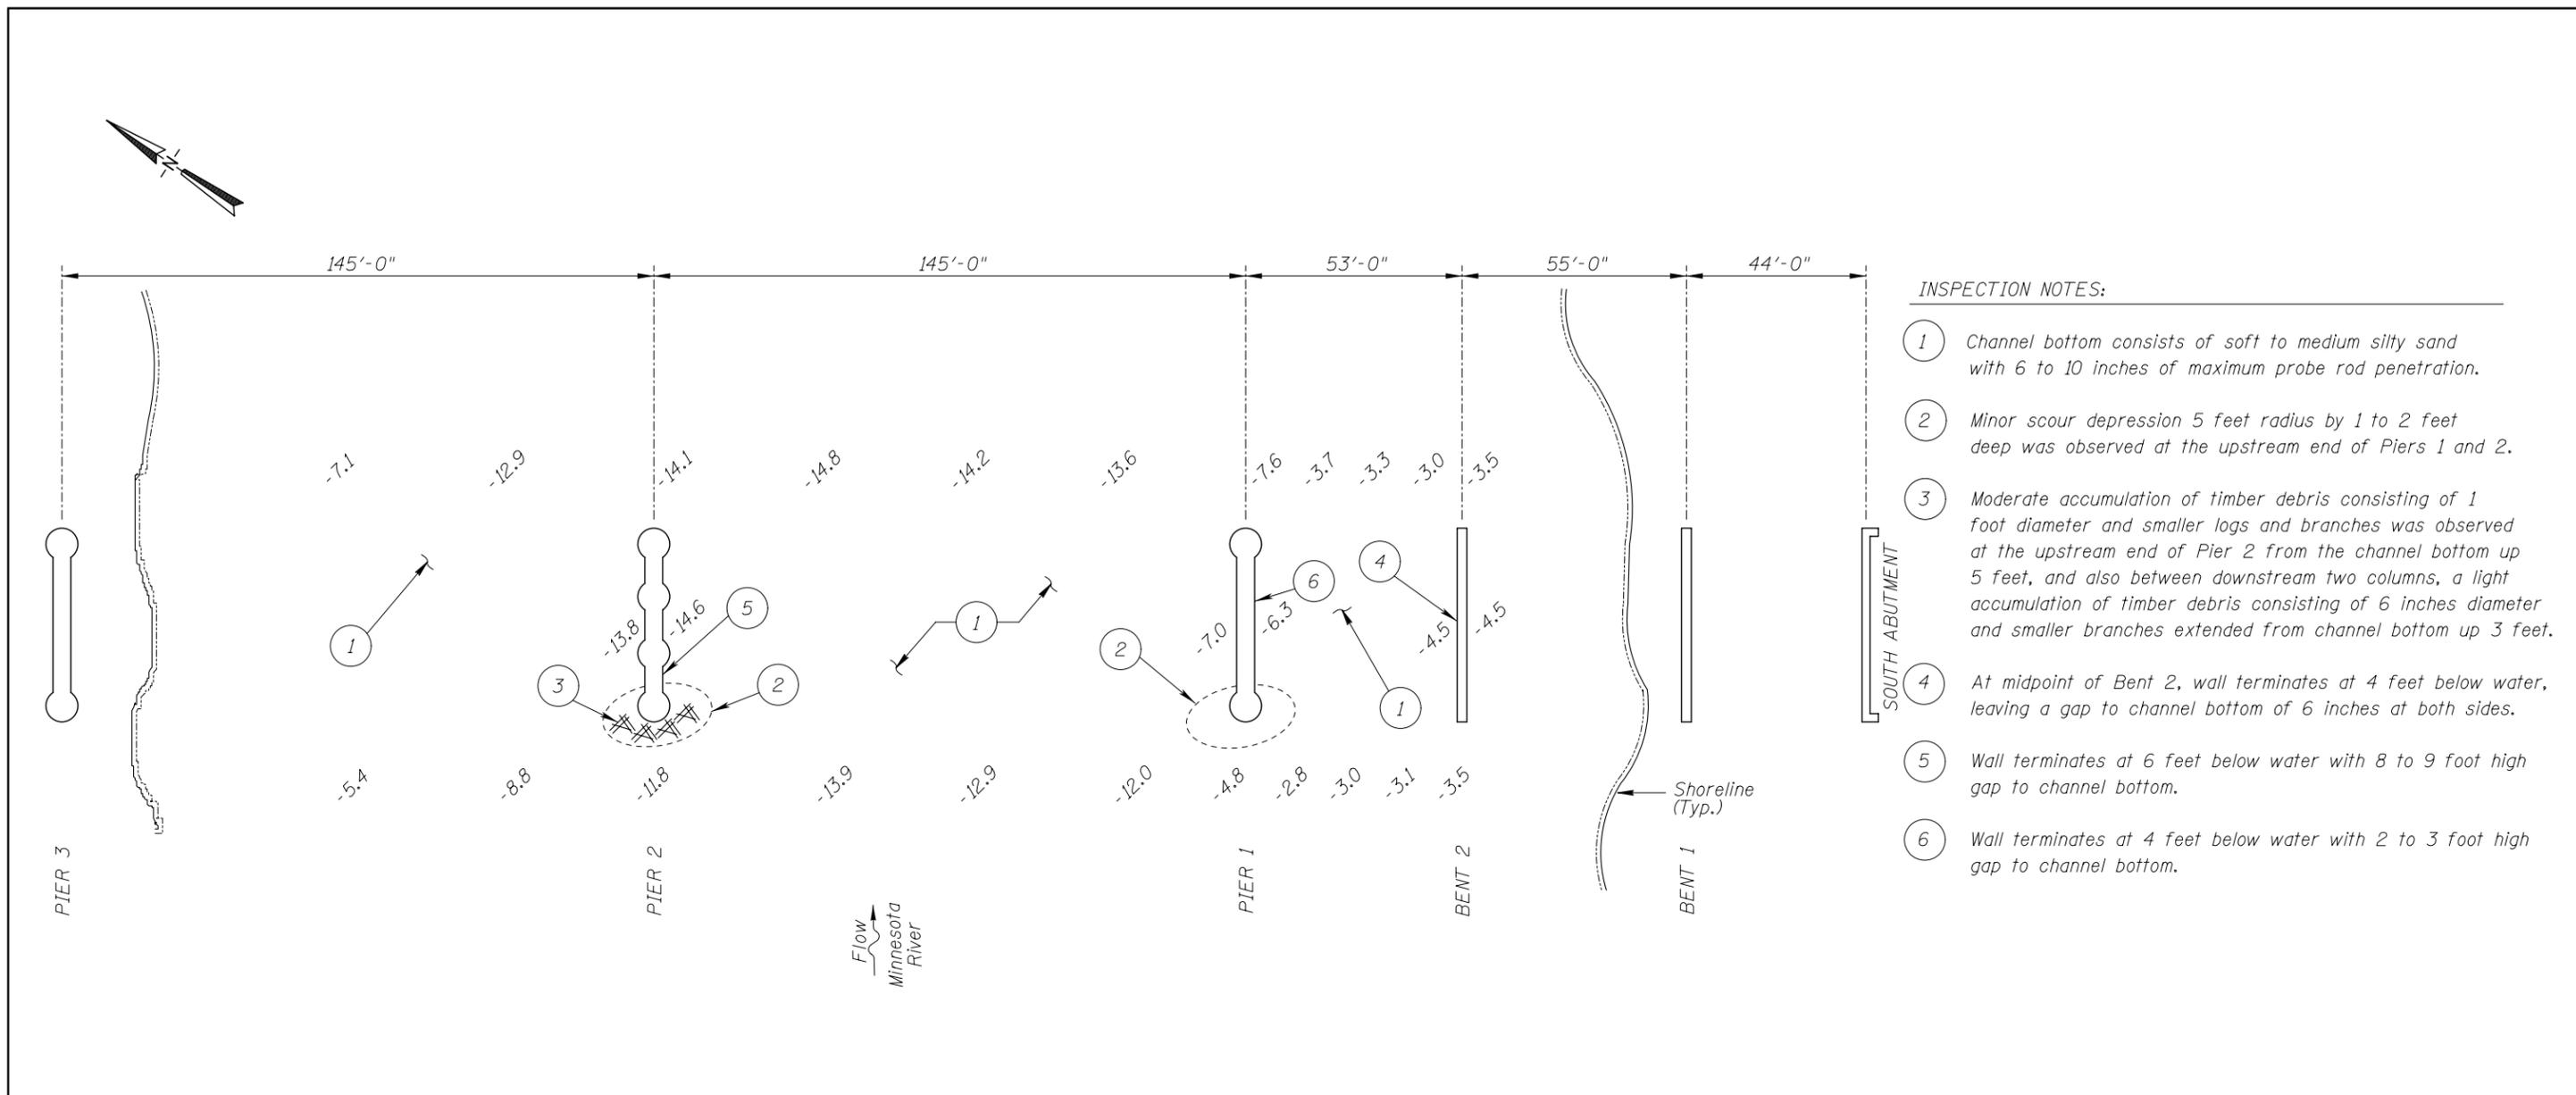
SOUNDING PLAN

- (A) The concrete surfaces the piers and bent were found to be smooth and sound with no significant structural defects observed.
- (B) A scour depression 5 feet in radius by 1 to 2 feet in depth was observed at the upstream end of Piers 1 and 2.
- (C) A moderate accumulation of timber debris consisting of logs and branches 1 foot in diameter and smaller was observed at the upstream end and between the downstream two columns of Pier 2 extending from the channel bottom up 5 feet.

- (A) Monitor the accumulations of timber debris around Pier 2, and if found to be progressing in the future, removal operations may be necessary at that time.
