UNDERWATER BRIDGE INSPECTION REPORT

STRUCTURE NO. 2110

CSAH NO. 8

MINNESOTA RIVER

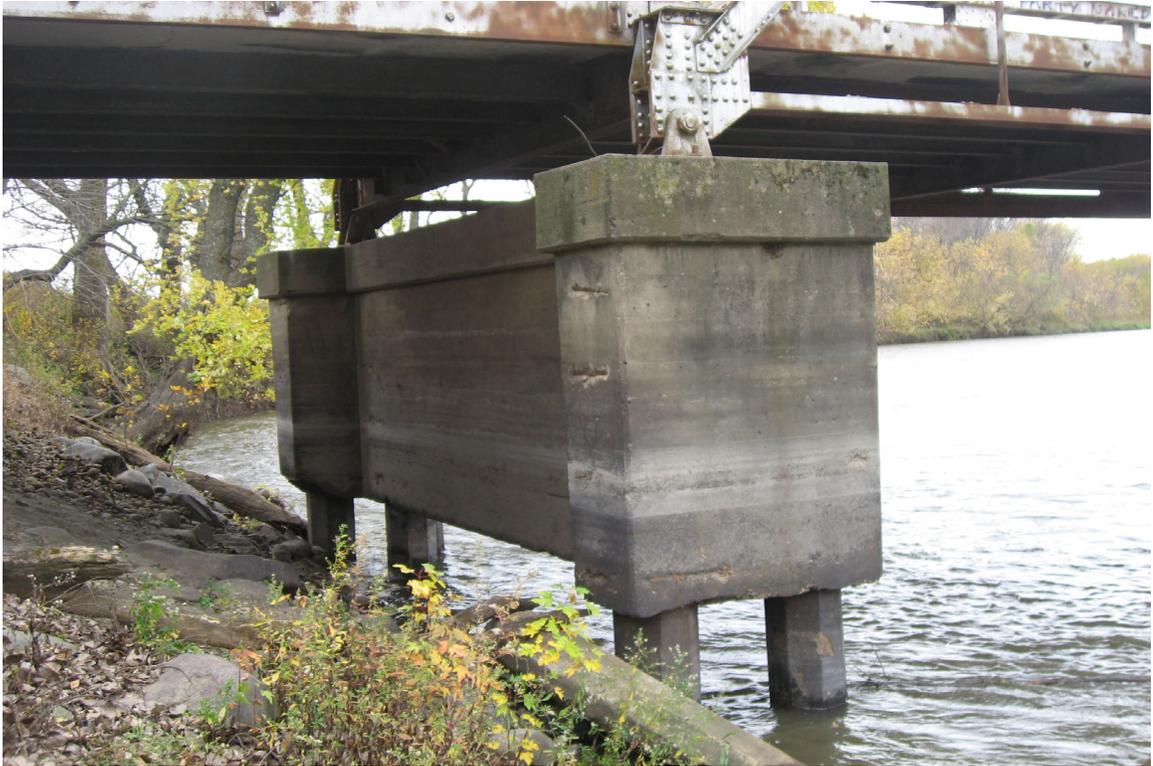
Photograph 1. View of Bent 2, Looking Northwest.

- 12 Highly eroded riverbank.
- 13 Scaling at all piles of Bent 4 starting 1 foot below the waterline to -3 feet, with 1/4 inch maximum penetration.
- 14 Scaling at all piles of Bent 2 starting 1 foot below to the channel bottom, with 1/2 inch maximum penetration.

Patch the spalls on the piles of Bents 2, 3, and 4 with epoxy grout.

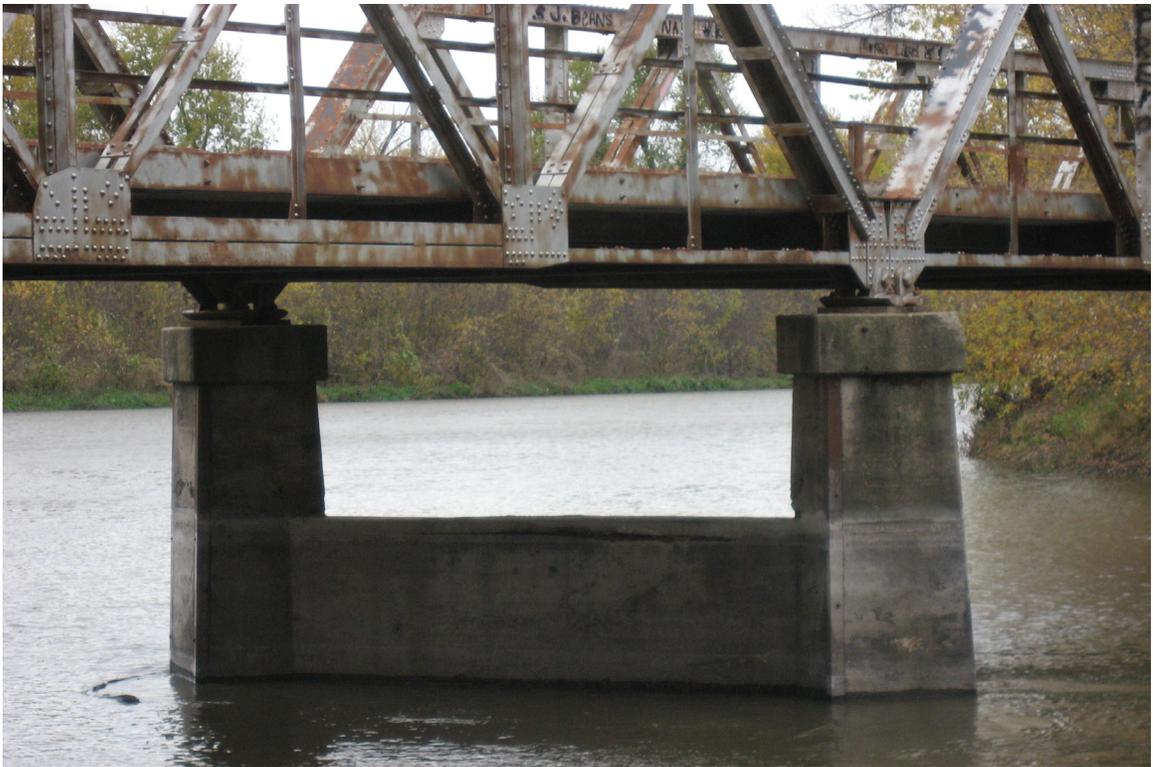
- (A) All of the piles of Bents 2, 3, and 4 exhibited widespread scaling with penetrations of up to 1 inch.
- (B) Pier 1 exhibited heavy scaling on each face of the upstream nose with 1 inch maximum penetration, and at the downstream end with penetrations that were 4 inches maximum depth.

- (C) The tops of both column footings of Pier 1 were exposed at 12.8 feet below water. Heavy to moderate deterioration was present from 12.8 feet to bedrock at 14.8 feet all around the footings. At the downstream column of Pier 1, the horizontal penetrations due to section loss were approximately 12 inches at the upstream corner and sides and 8 inches towards the downstream nose, and at the upstream column of Pier 1, the horizontal penetrations were approximately 2 feet at the upstream corner and sides.

Photograph 2. View of Pier 1, Looking Northwest.

Repair the footing of Pier 1 by forming a new enlarged encasement around existing footings keyed into river bed.

Patch heavy scaling on Pier 1 with formed, reinforced, anchored concrete designed for underwater applications.

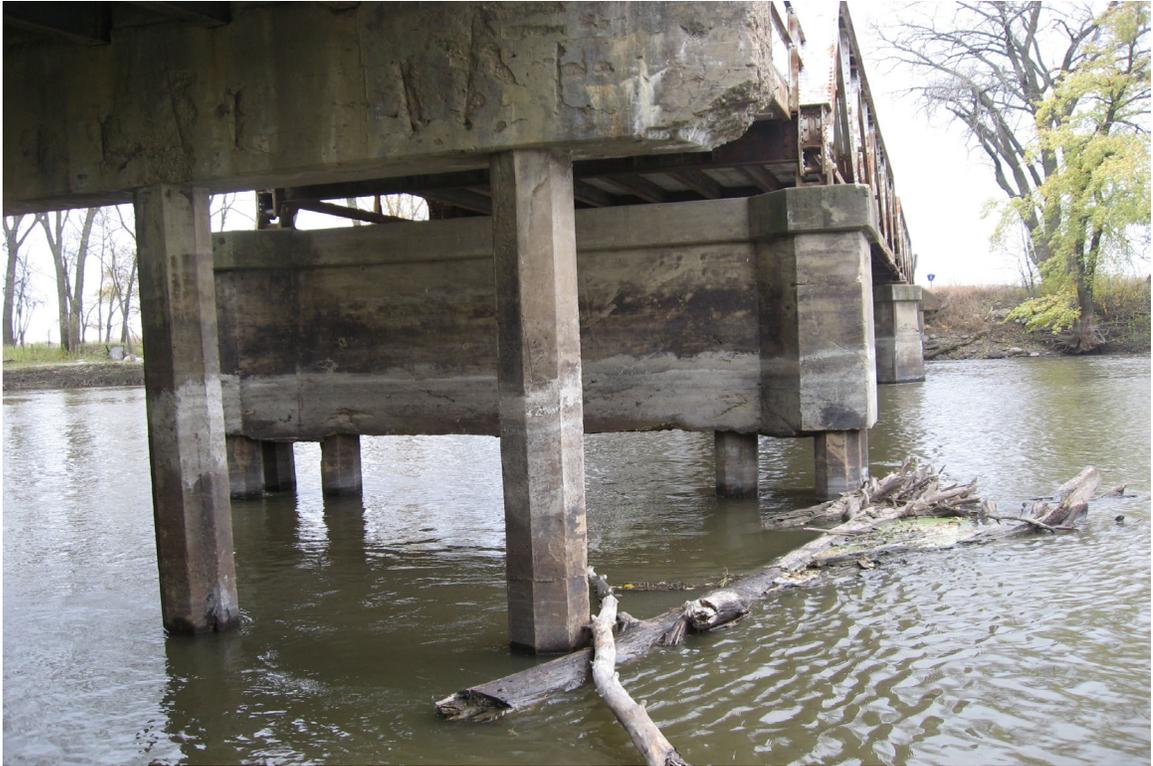
- (D) A heavy accumulation of timber debris consisting of logs and branches was observed at the upstream noses of Bents 3 and 4 extending from the channel bottom to 1 foot above the waterline.

Photograph 3. View of Bents 3 and 4, Looking Southeast.

- 8 Scaling at all piles of Bent 3 starting 1 foot below the waterline to -3 feet, with 1 inch maximum penetration.
- 9 Spall with impending spall on pile from pile cap down 5 feet, up to 1.5 foot wide with 1.5 inches maximum penetration and exposed reinforcing steel (corroded).

Remove the timber debris upstream of Bents 3 and 4 during routine maintenance.

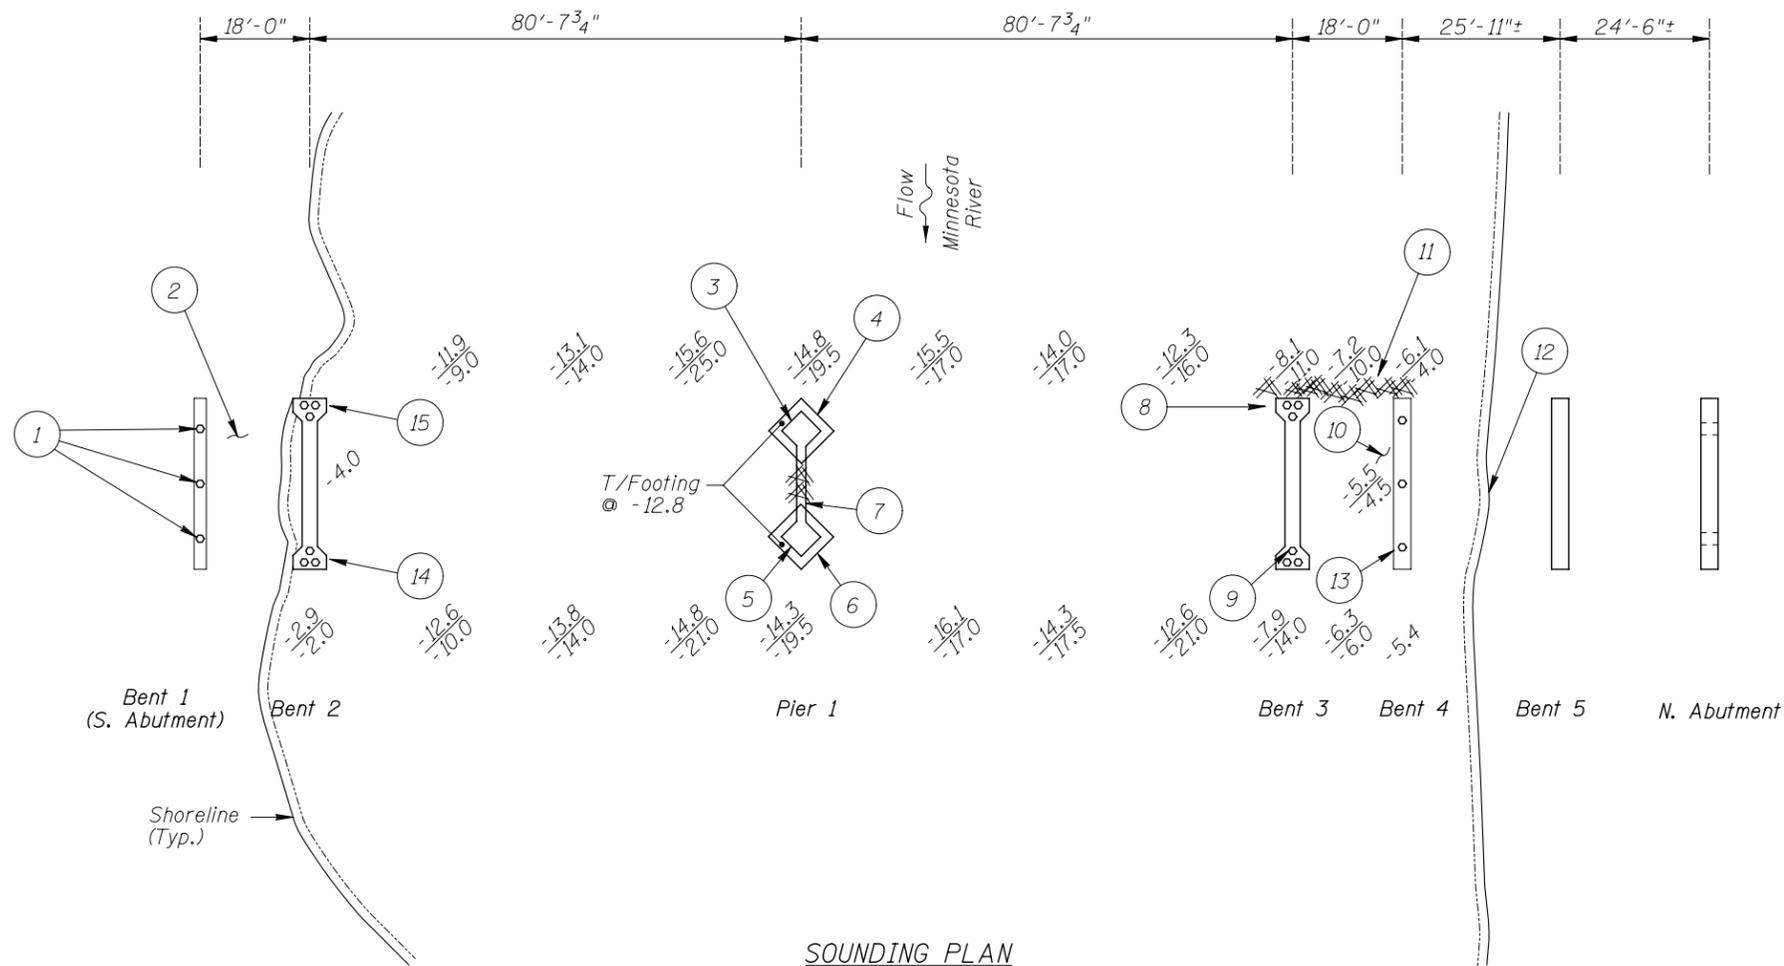
SOUNDING PLAN

- 1 Three octagonal concrete piles exposed a maximum of 4 feet below the pile cap of the abutment. A timber and concrete wall was exposed behind the piles.

- 2 Riprap, typically 1 foot to 2 foot in diameter, and soil bank sloped steeply to river channel.
- 3 Heavy scaling from -5 feet to -10 feet, 2.5 feet on each face of the upstream nose with 1 foot maximum penetration. Moderate scaling on all faces from -3 feet to -10 feet, 1/2 inch maximum penetration. Light scaling above -5 feet typically 1/8 inch penetration.

- 4 Top of footing located at -12.8 feet. Heavy deterioration was present from -12.8 feet to bedrock at -14.8 feet all the way around the footing with approximately 2 feet of horizontal penetration typical at the upstream corner and sides.

- 5 Moderate scaling on all faces from -7 feet to -10 feet with 3 inches to 4 inches maximum penetration. Light scaling above -7 feet typically 1/8 inch penetration.

- 6 Top of footing exposed at -12.8 feet. Heavy to moderate deterioration was present from -12.8 feet to bedrock at -14.8 feet all the way around the footing. Horizontal penetration was approximately 12 inches at upstream nose and sides and 8 inches towards the downstream nose.

- 7 The diaphragm wall extended 10 feet below water with light scaling of 1/8 inch typical penetration. Timber debris consisting of 6 inch to 8 inch diameter branches was present between the columns below the wall.

- 10 Channel bottom consisted of 4 inches of soft silt over firmer silt.
- 11 A heavy accumulation of timber debris consisting of logs and branches up to 2 feet in diameter was observed at the upstream noses of Bents 3 and 4, extending from the channel bottom to 1 foot above the waterline.

- 15 On the downstream face of the northern most pile of Bent 1 at the upstream end, pile exhibited section loss (1.5 inches) from under the pile cap to 1.5 feet above waterline with exposed and corroded reinforcement.
