UNDERWATER BRIDGE INSPECTION REPORT

STRUCTURE NO. 07024

173RD STREET

WATONWAN RIVER

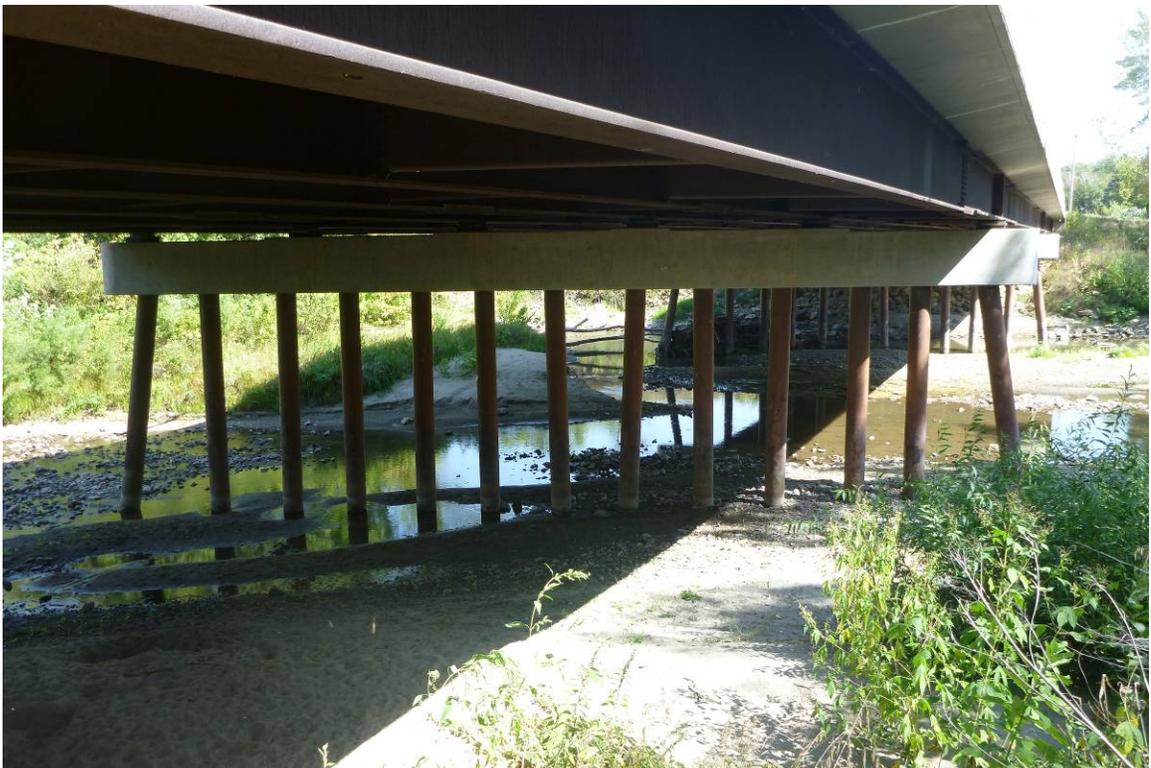
Photograph 2. View of Pier 1, Looking East.

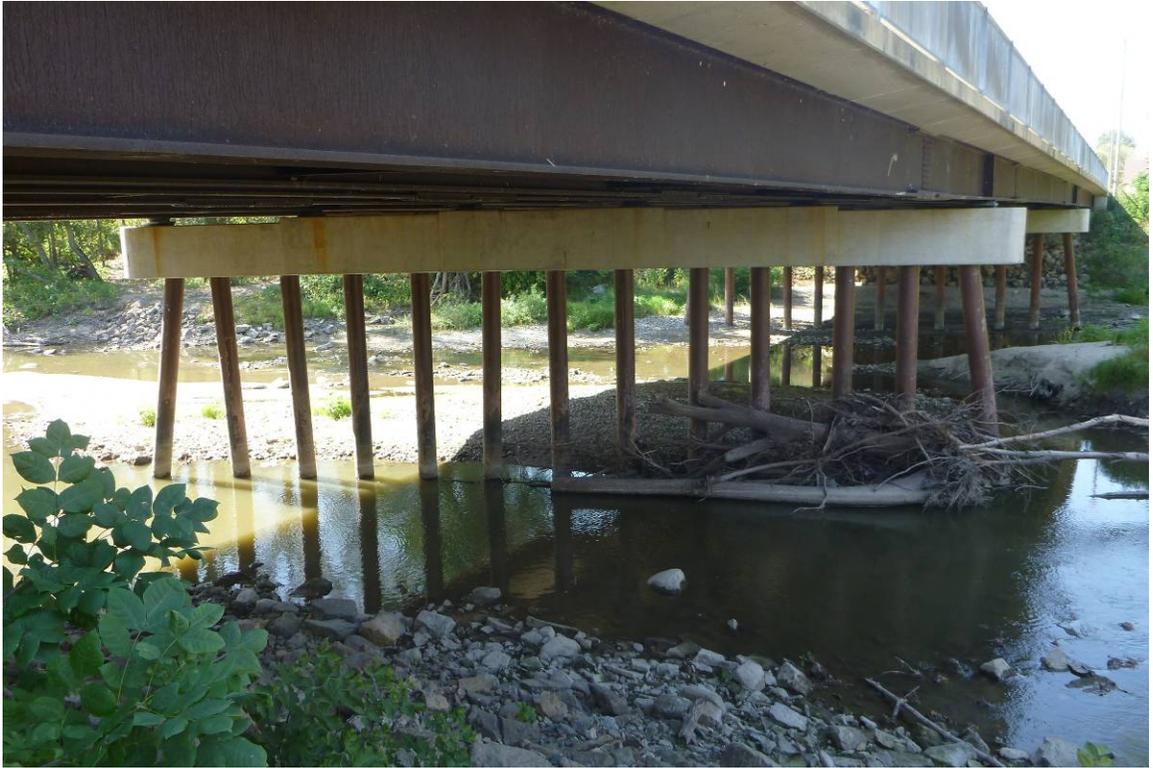
- (A) The channel bottom material consisted of sand, gravel, and cobbles allowing up to 2 inches of probe rod penetration.
- (B) Coating failure and light surface corrosion was observed from 5 feet above the waterline to the channel bottom.
- (C) A moderate accumulation of timber debris consisting of logs and branches up to 1.5 feet in diameter was observed along the east side of the upstream half of Pier 2. The accumulation extended 20 feet off the upstream pile of the pier, from 6 feet above the waterline to the channel bottom.

Photograph 3. View of Pier 2, Looking West.

- (B) Monitor timber accumulation at Pier 2 during future inspections.

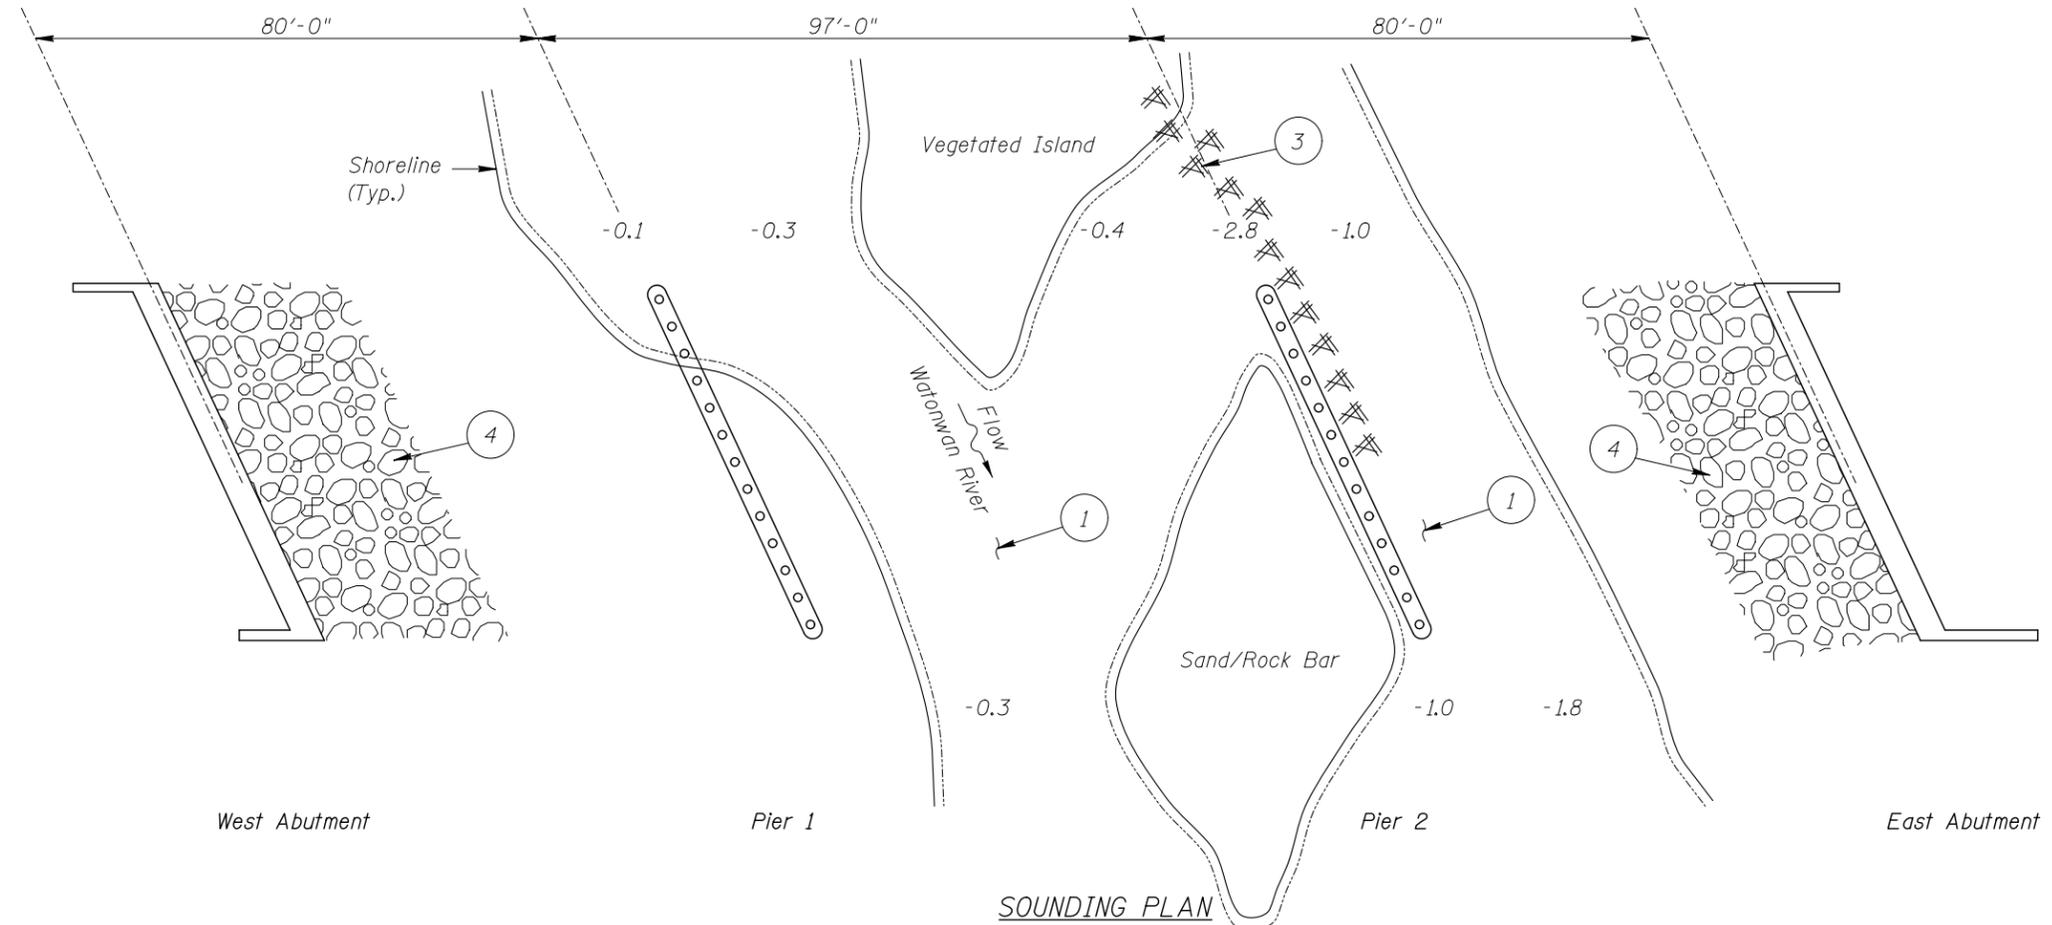
**INSPECTION AND SOUNDING PLAN**

1. The channel bottom material typically consisted of sand, gravel, and cobbles allowing up to 2 inches of probe rod penetration.
2. The steel pipe piles typically exhibited coating failure from the channel bottom to 5 feet above the waterline with light surface corrosion and no appreciable loss of section.
3. Moderate timber debris accumulation, consisting of up to 1.5 foot diameter trees and branches, was observed along the upstream half on the east side of pier 2 extending from the channel bottom to 6 feet above the waterline and up to 20 feet off the upstream pile of the pier.
4. The east and west abutments were well armored by up to 2 foot diameter riprap.
