UNDERWATER BRIDGE INSPECTION REPORT

STRUCTURE NO. 07514

BLUE EARTH RIVER

SEPTEMBER 11, 2012

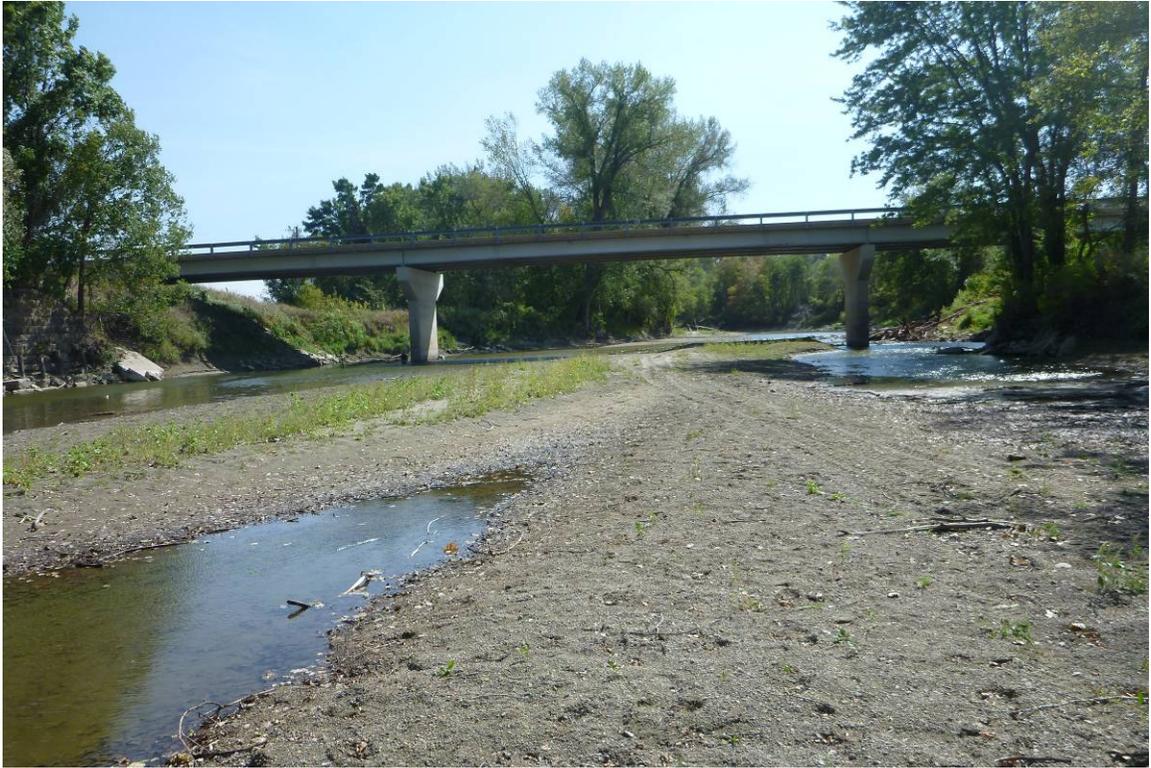
The substructure units inspected at Bridge No. 07514, Piers 1 and 2, were found to be in good condition with no structurally significant defects observed. A minor scour depression was observed at the upstream nose of Pier 2, as well as light accumulation of timber debris. The channel bottom around the substructure units appeared stable with no evidence of significant scour and no significant changes since the previous inspection.

Photograph 1. Overall View of Bridge, Looking South.

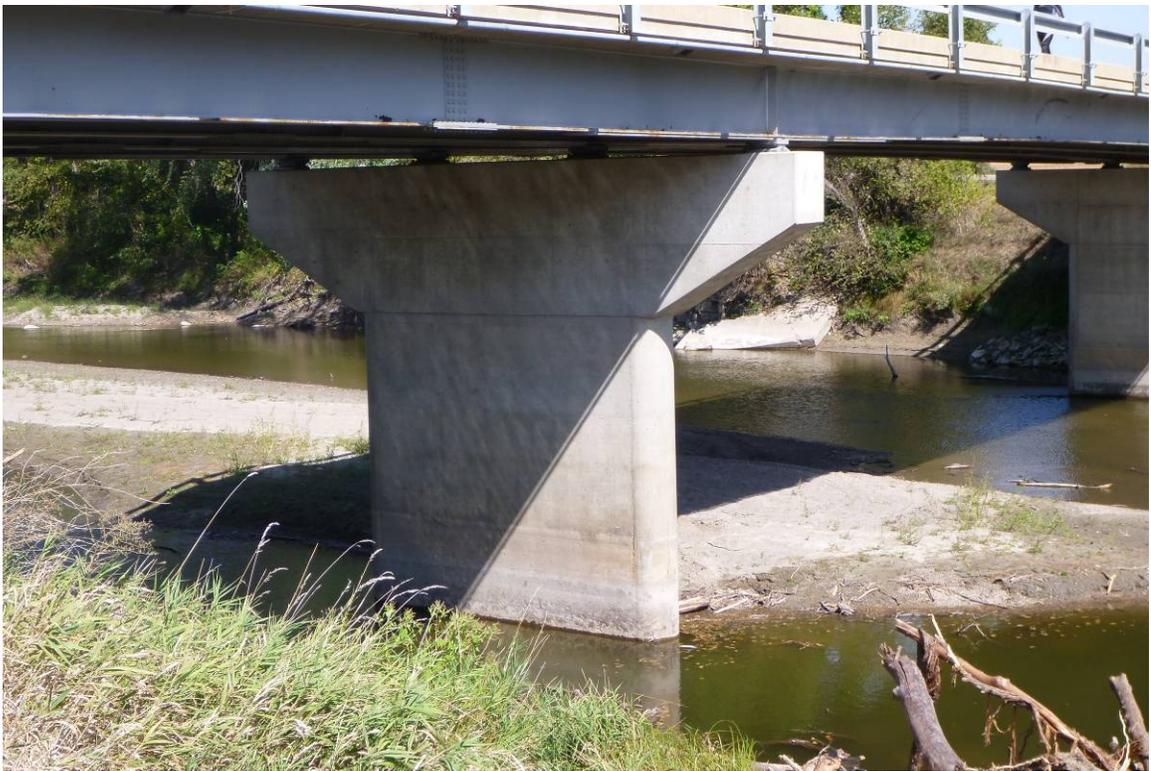
Photograph 2. View of Pier 1, Looking East.

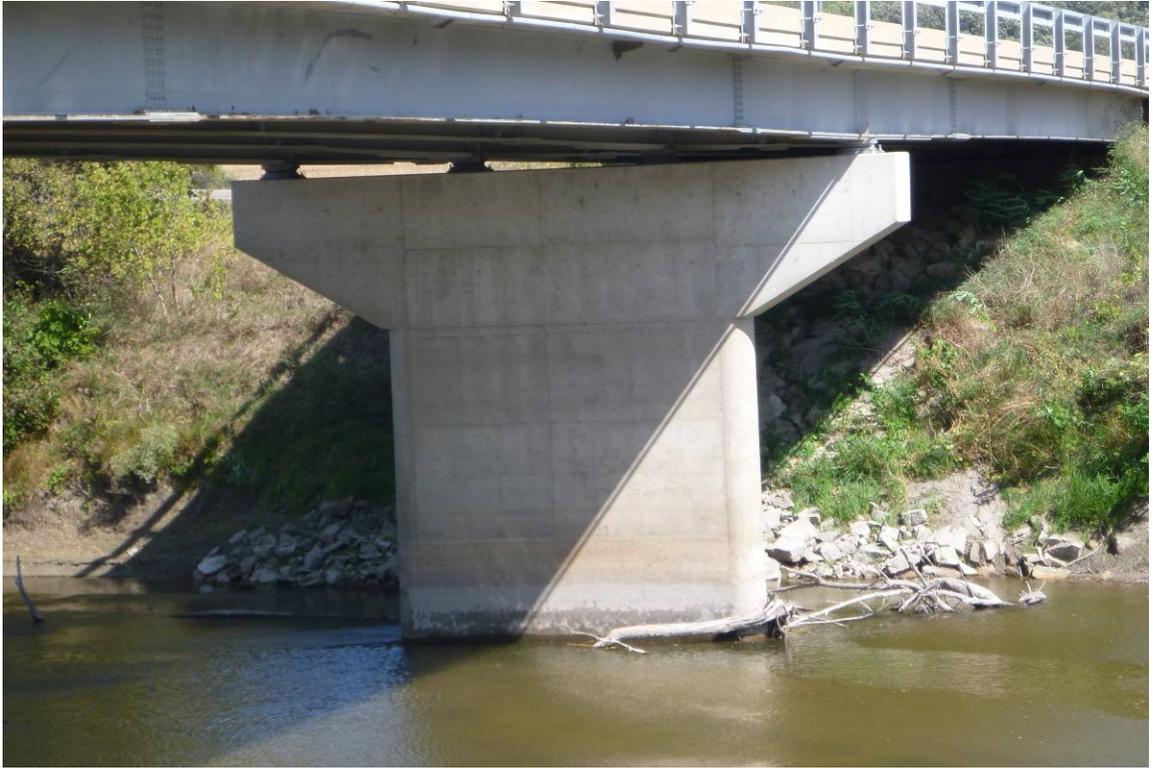
Photograph 3. View of Pier 2, Looking East.

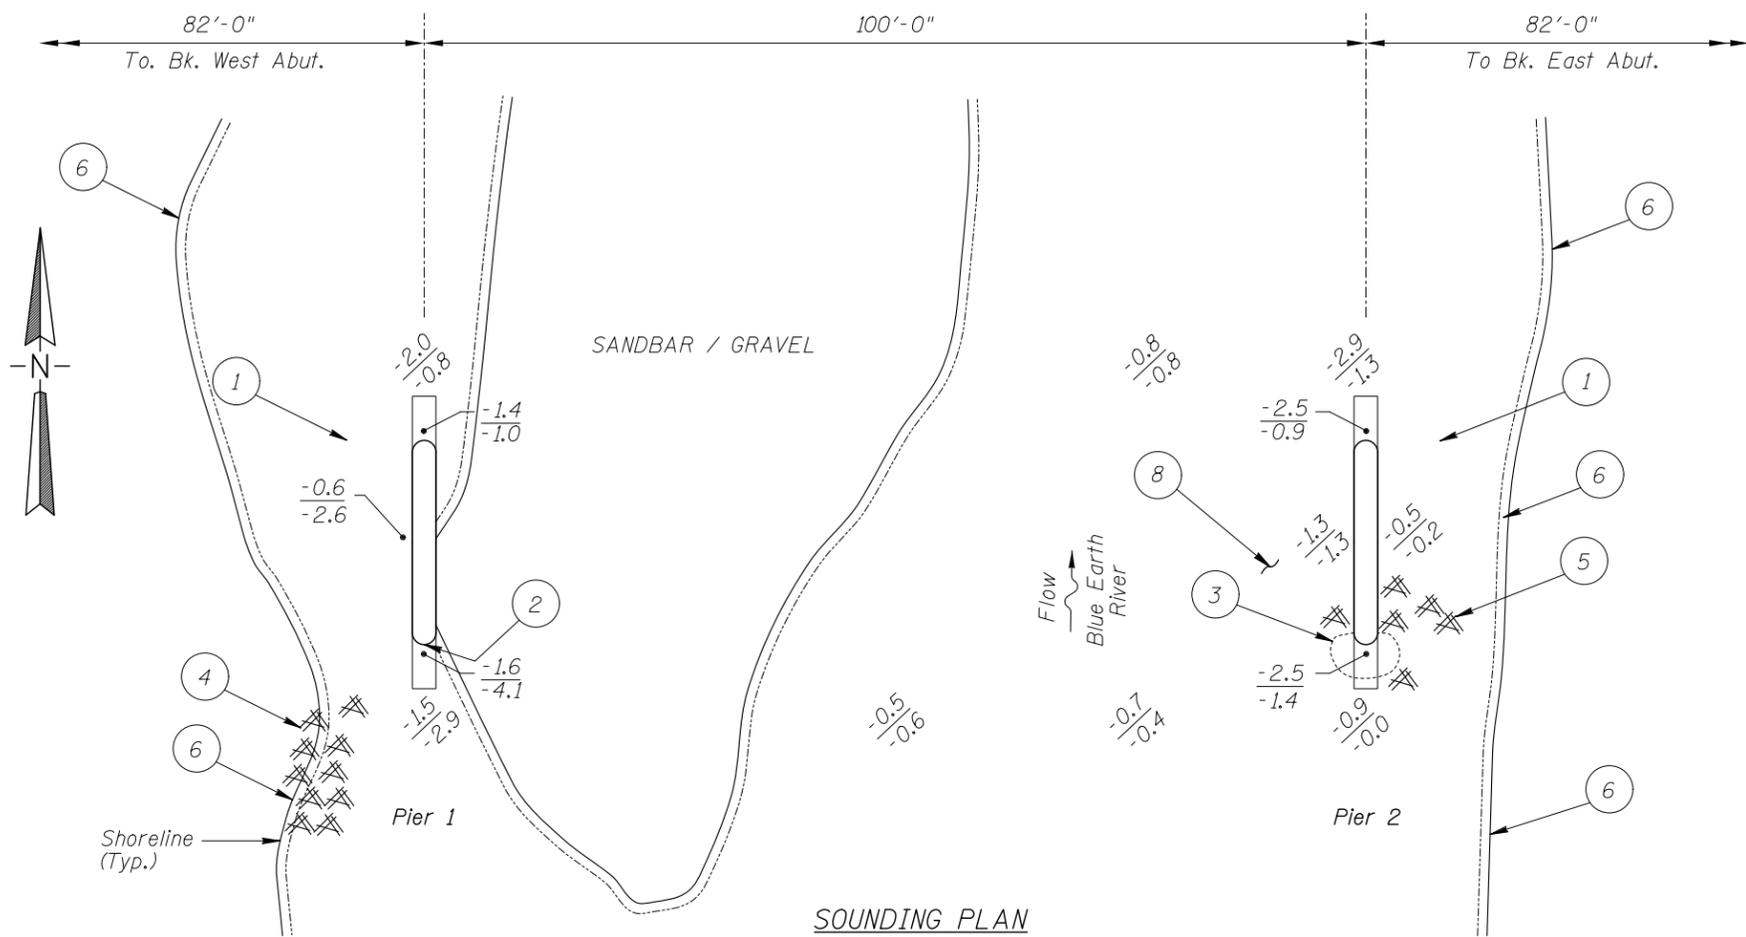
- ① The channel bottom consisted of soft silty sand with up to 8 inches of probe rod penetration.
- ② Minor areas of poor consolidation were observed in the concrete of Pier 1 at the upstream end.
- ③ A scour depression, 4 feet in radius and 1.5 feet deep, was observed at the upstream nose of Pier 2.
- ④ A moderate to heavy accumulation of timber debris, was observed along the west embankment upstream of the structure.
- ⑤ A light accumulation of timber debris, with pieces up to 6 inches in diameter, was observed at the upstream nose of Pier 2 and extended to the east embankment.
- ⑥ Minor vertical bank erosion was observed at the east embankment and upstream and downstream of the structure along both shorelines.
- ⑦ The concrete of the piers was smooth and sound.
- ⑧ The channel bottom consisted of gravel with 2 inches of probe rod penetration.

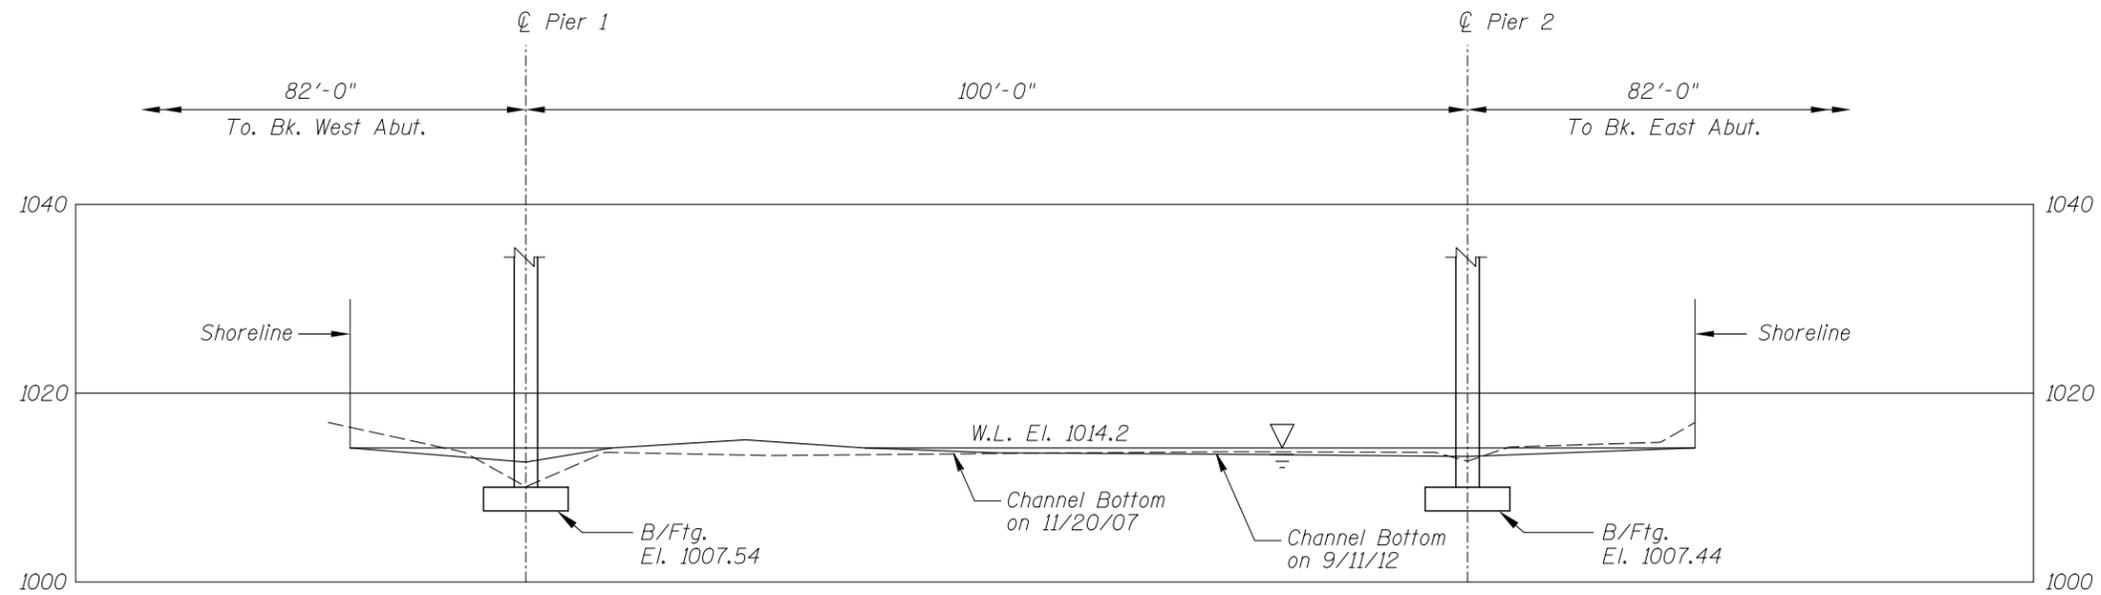
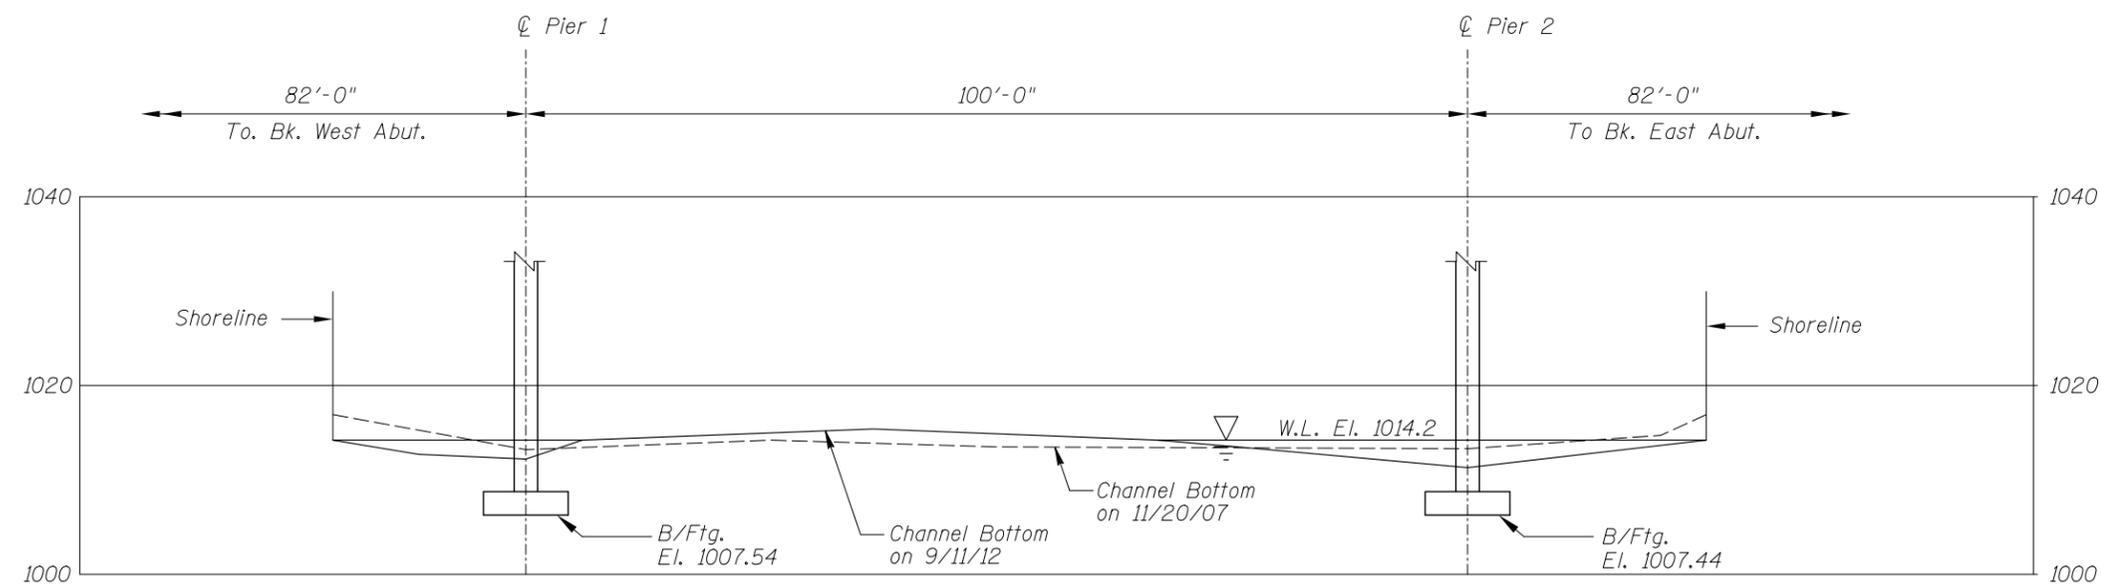
UPSTREAM FASCIA PROFILE

DOWNSTREAM FASCIA PROFILE
