UNDERWATER BRIDGE INSPECTION REPORT

STRUCTURE NO. 07532

CSAH NO. 20

WILLOW CREEK

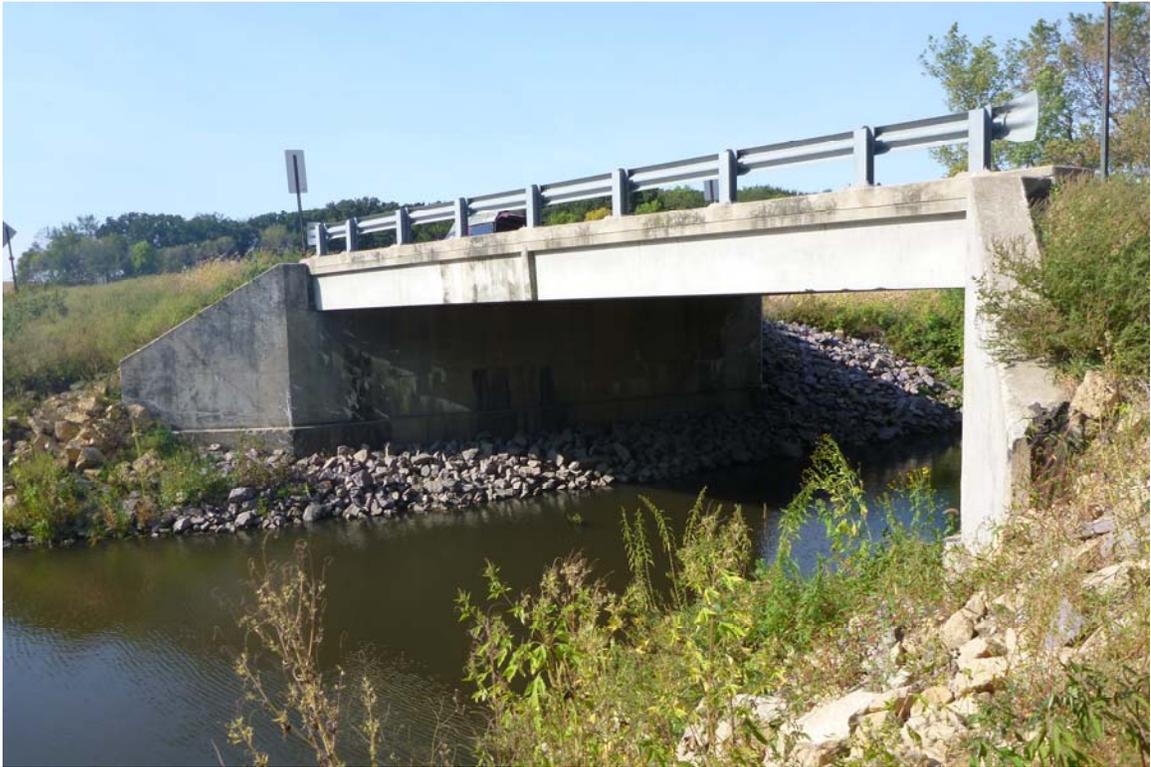
Photograph 1. Overall View of the Structure, Looking West.

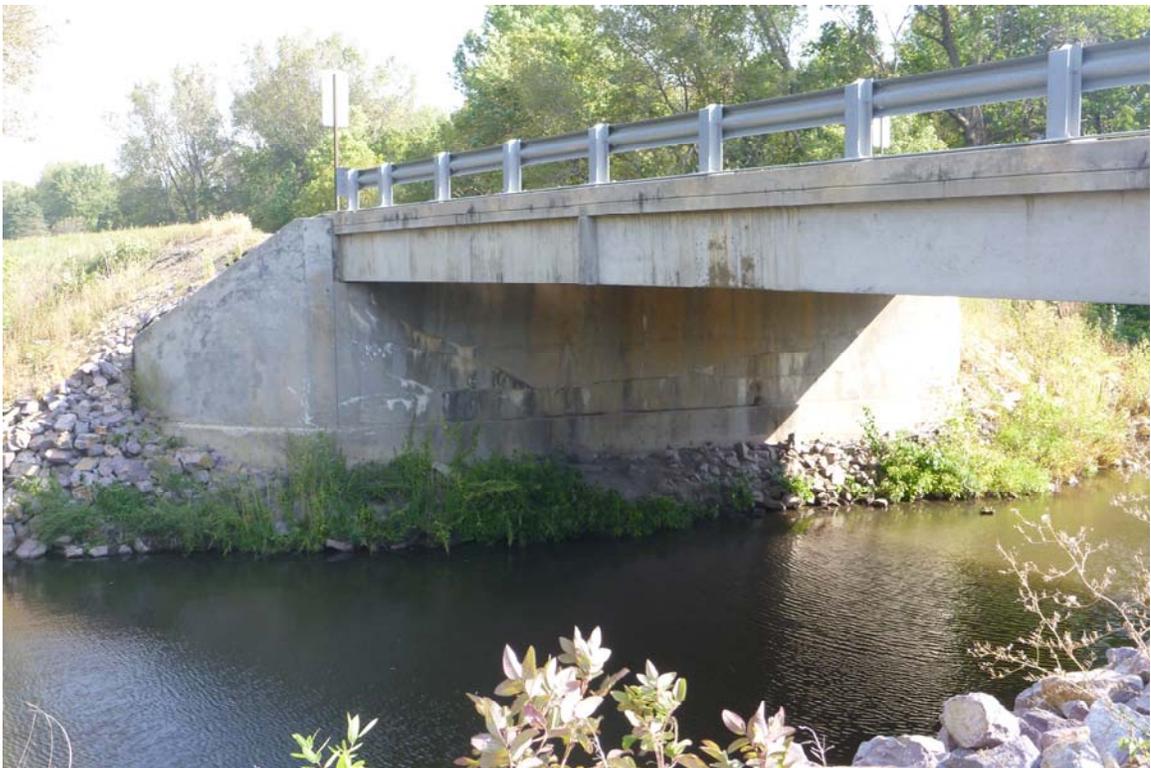
- (A) The channel bottom material consisted of gravel, cobbles, and 1 foot diameter riprap with no appreciable probe rod penetration.
- (B) The North and South Abutments were armored by 1 to 1.5 foot riprap.
- (C) Widespread hairline to 1/8 inch wide horizontal cracks with some exudation were observed on the concrete surfaces of both abutments from 5 feet to 10 feet above the waterline.

Photograph 2. View of North Abutment, Looking Northeast.

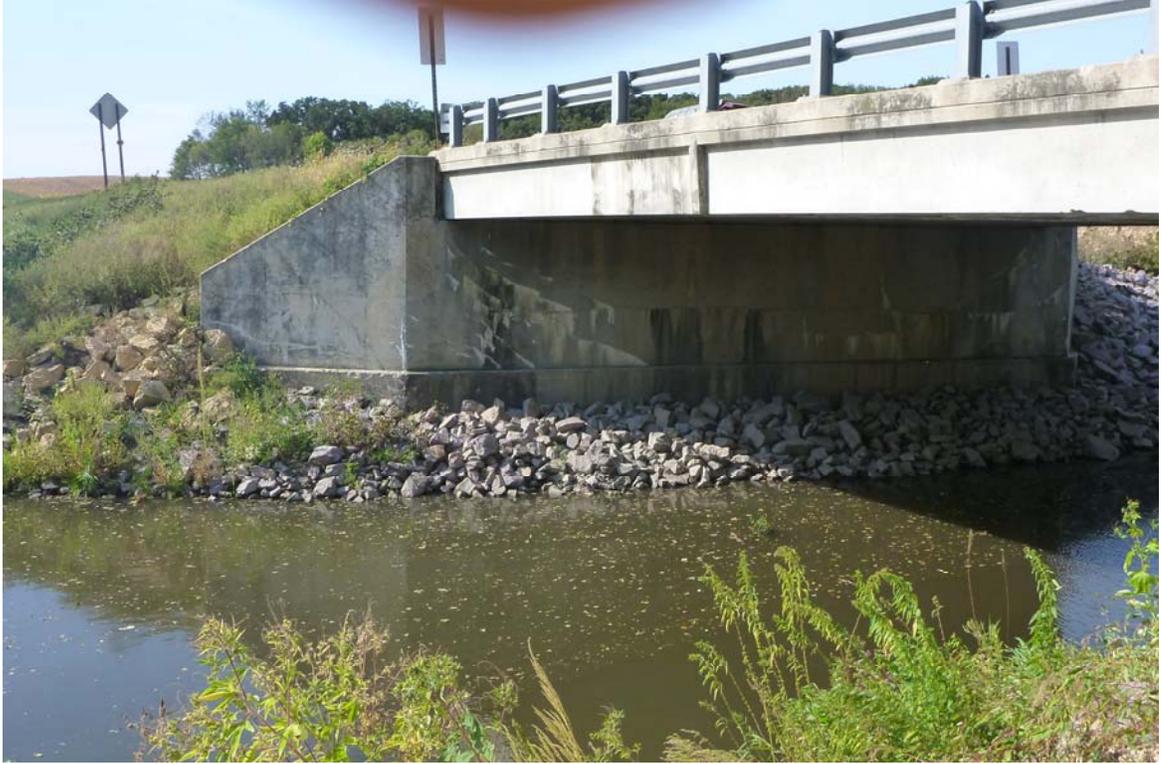
Photograph 3. View of South Abutment, Looking Southwest.

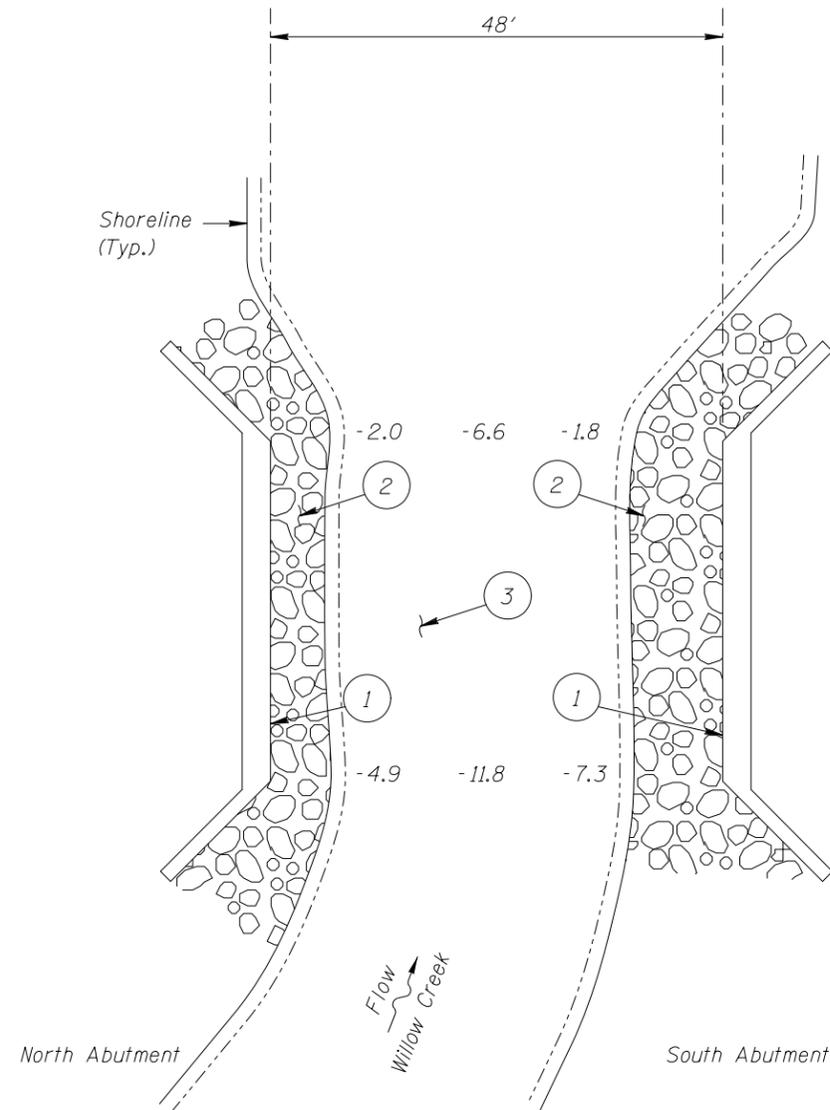
SOUNDING PLAN

- 1 Widespread hairline to 1/8 inch wide horizontal cracks with some exudation were observed on the concrete surfaces of both abutments from 5 feet to 10 feet above the waterline.
- 2 1 to 1.5 foot diameter riprap was armoring the North and South Abutments.
- 3 The channel bottom material typical consisted of firm gravel, cobbles and 1 foot diameter riprap allowing no appreciable probe rod penetration.
