UNDERWATER BRIDGE INSPECTION REPORT

STRUCTURE NO. 07542

BLUE EARTH RIVER

SEPTEMBER 11, 2012

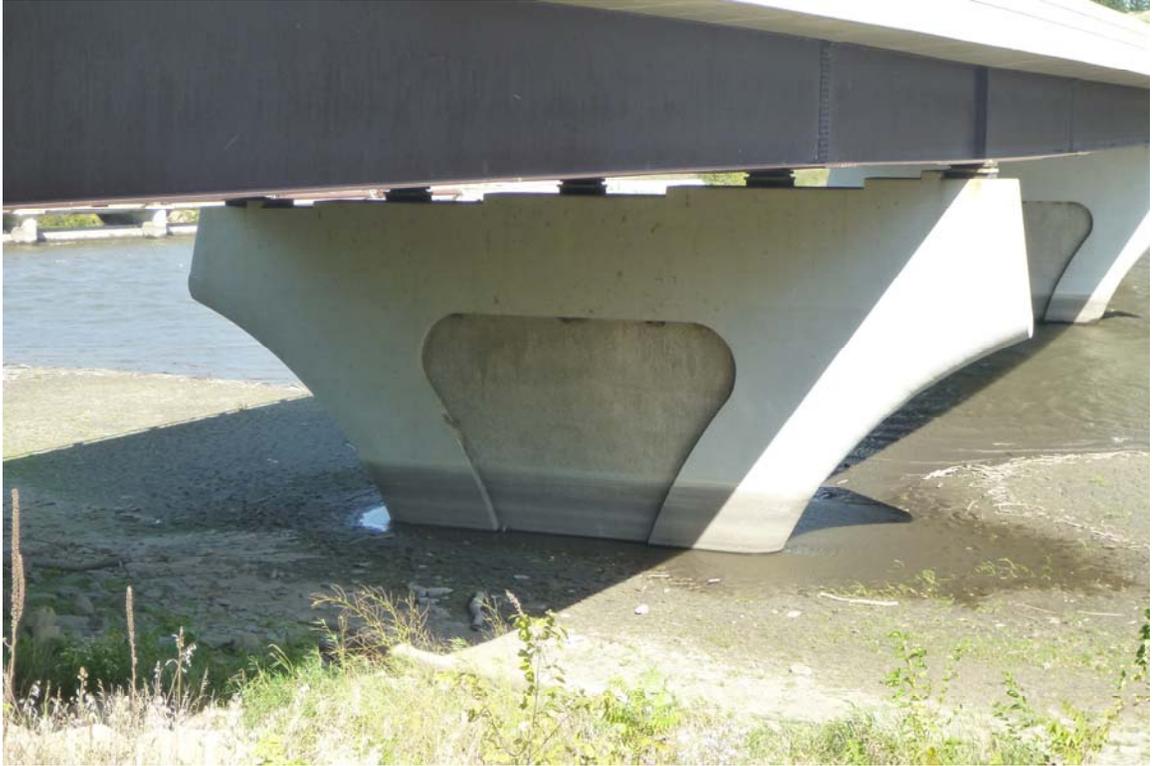
Photograph 1. View of Pier 1, Looking Northeast.

- (A) Areas of minor poor consolidation and/or section loss were observed 2 to 3 feet above the waterline at random locations on all of the piers, typically with up to 1 inch of penetration.
- (B) Timber debris consisting of logs and branches was observed at Pier 2 extending from the upstream nose to the midpoint on both faces extending from the channel bottom up 4 feet.

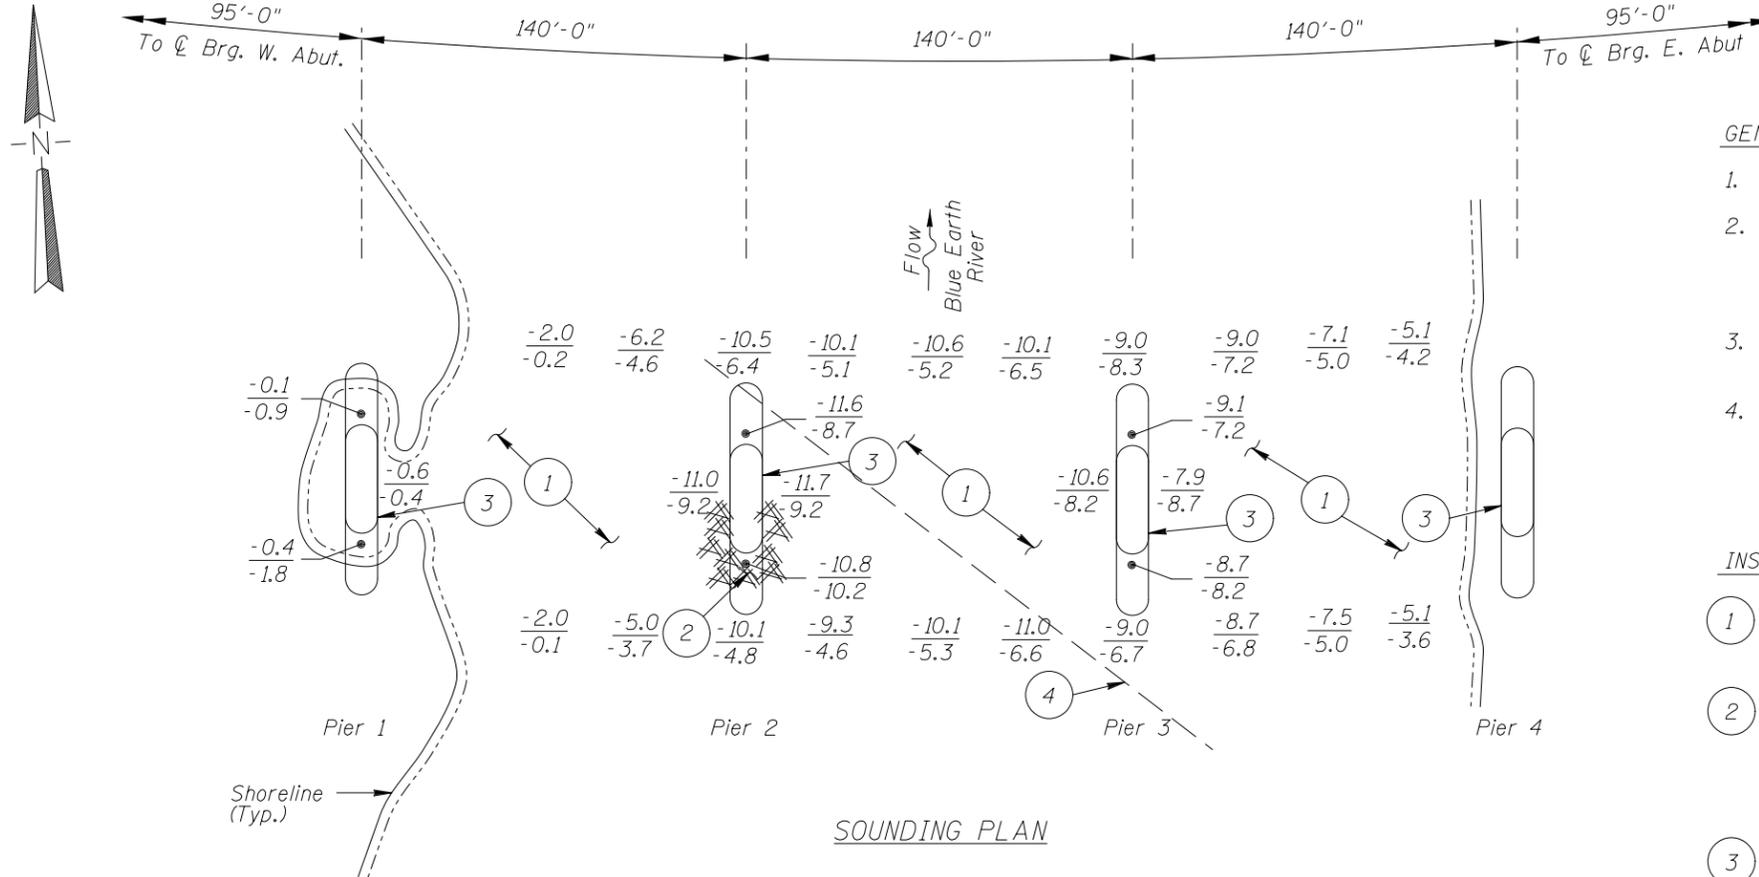
- 1 The channel bottom material consisted of soft silt with up to 2 feet of probe rod penetration.
- 2 A moderate accumulation of timber debris, consisting of logs and branches, was observed at Pier 2 and extended from the upstream nose to the midpoint on each face of the pier and from the channel bottom up 4 feet.
- 3 Areas of minor poor consolidation and/or section loss were observed 2 to 3 feet above the waterline at random locations on all of the piers, typically with up to 1 inch of penetration.
- 4 The remains of the sheet pile cofferdam used during original construction were observed 4.0 feet plus or minus below the waterline.
