UNDERWATER BRIDGE INSPECTION REPORT

STRUCTURE NO. 07569

BLUE EARTH RIVER

MINNESOTA DEPARTMENT OF TRANSPORTATION  
UNDERWATER BRIDGE INSPECTION

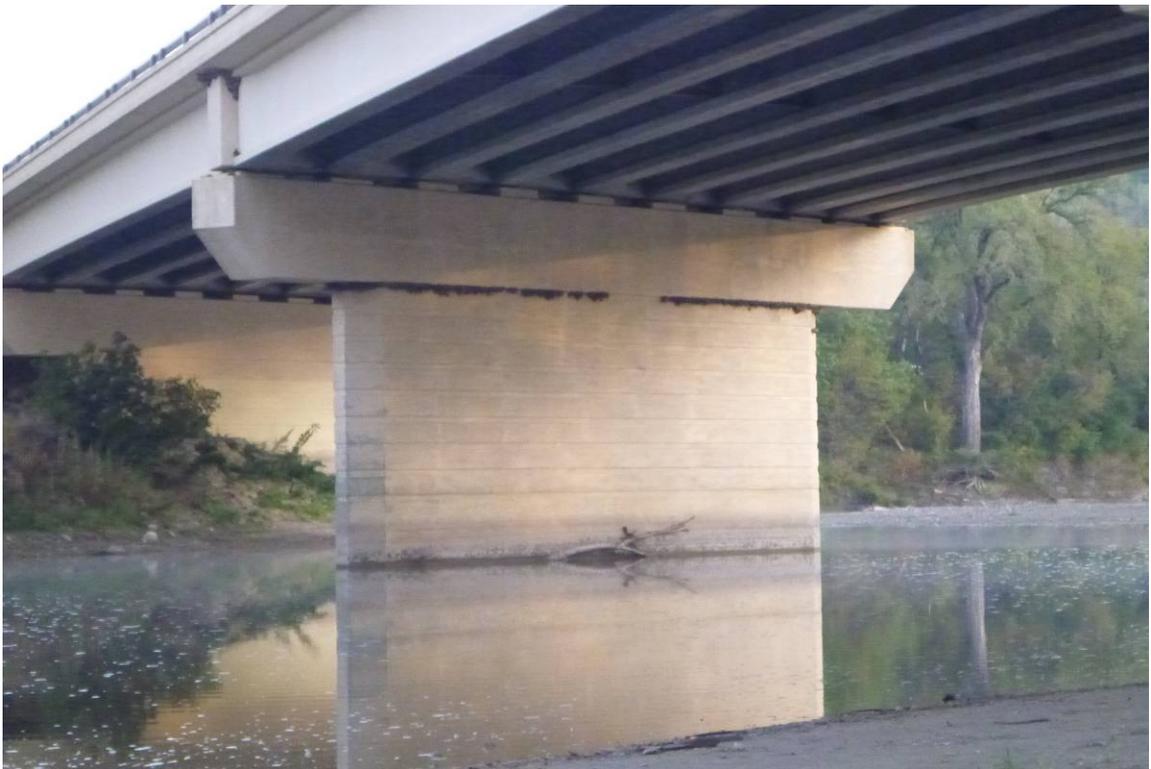
- (C) A light accumulation of timber debris was observed around the upstream nose and along the east face of Pier 2, extending from the channel bottom to 1 foot above the waterline.

Photograph 2. View of Pier 2, Looking West.

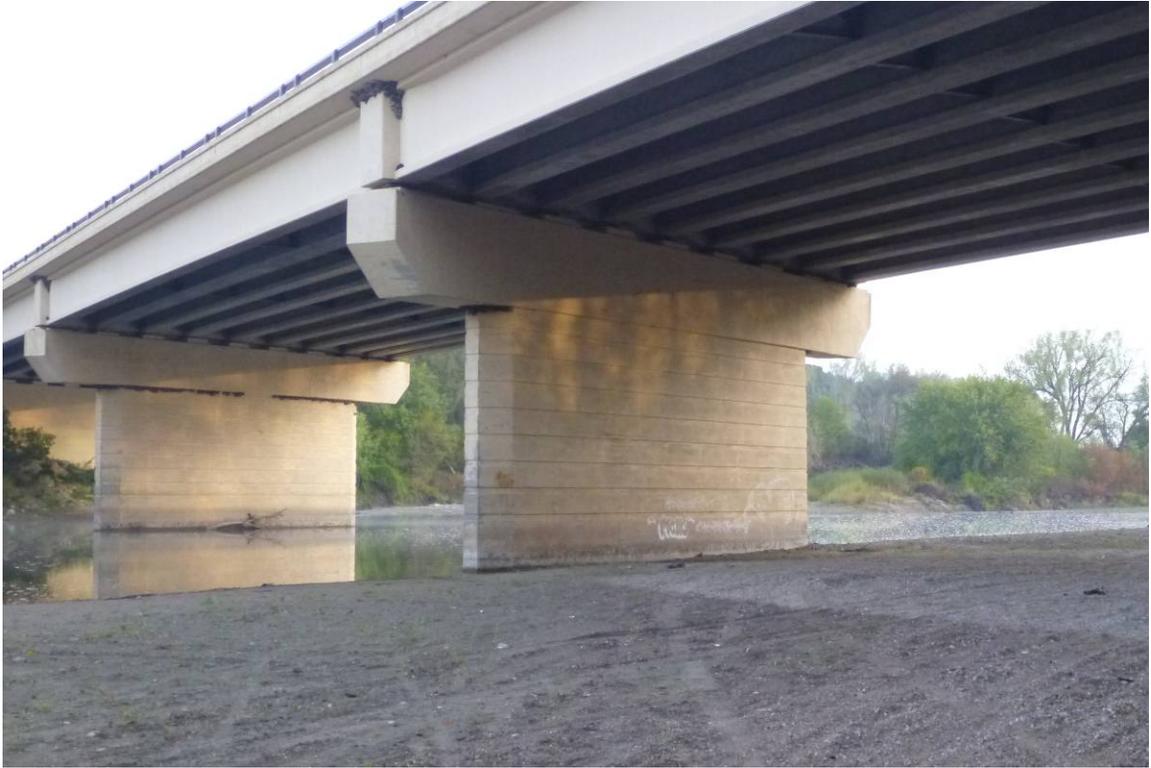
Photograph 3. View of Pier 3, Looking West.

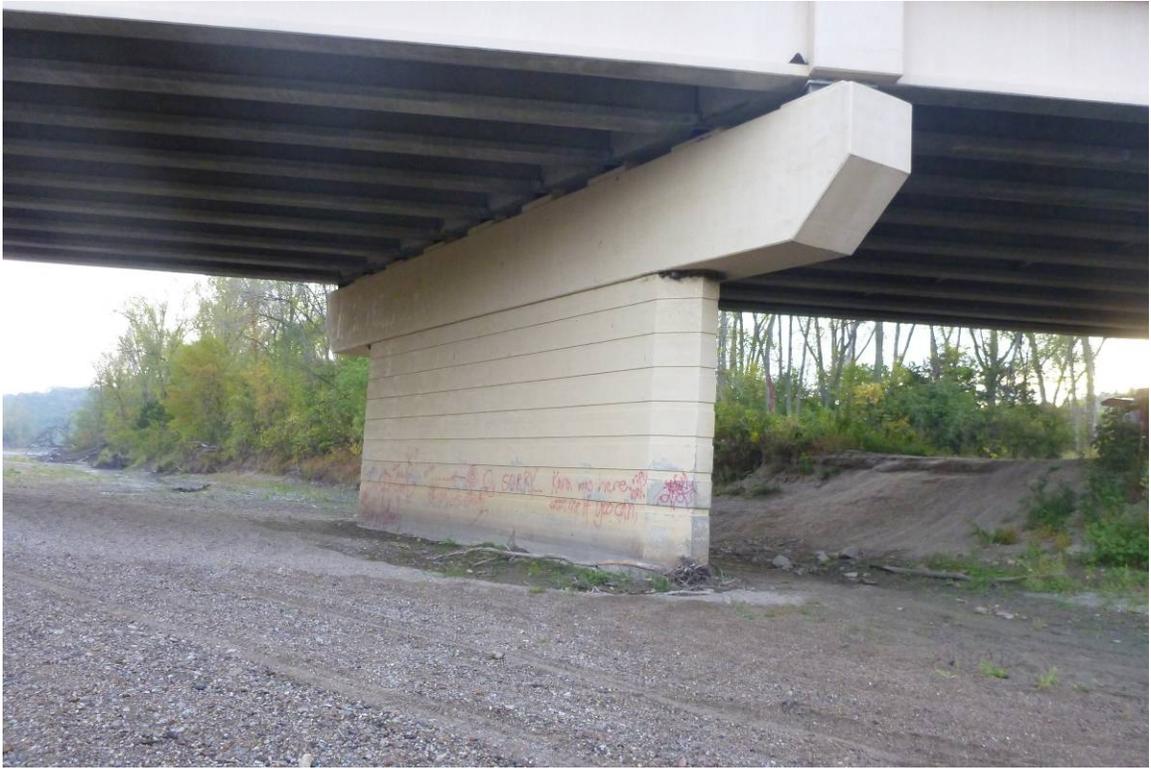
Photograph 4. View of Pier 4, Looking West.

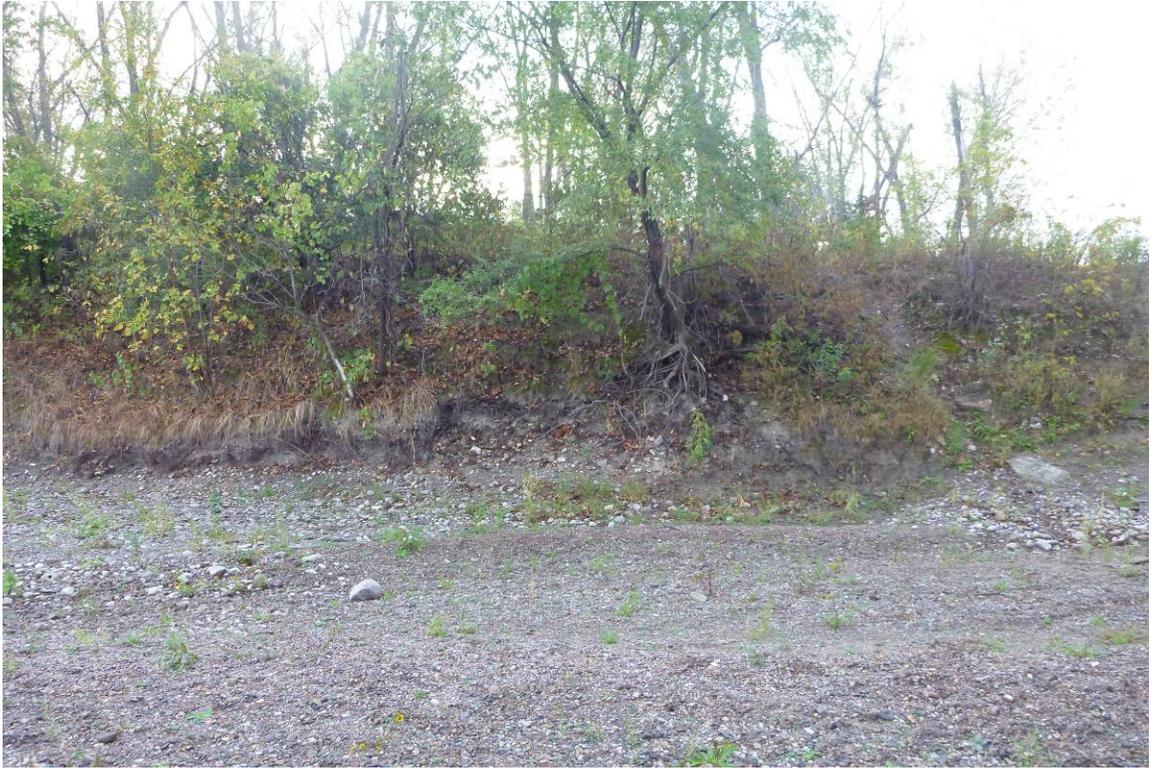
- (D) Both river banks exhibited steep vertical slopes due to erosion. The erosion along the northerly bank cuts past / through Pier 1.

Photograph 5. View of Bank Erosion on Downstream Side, Looking East.

- (A) Monitor the vertical erosion along the river banks and the scour depressions around the upstream nose of Piers 2 and 3 during future inspections.

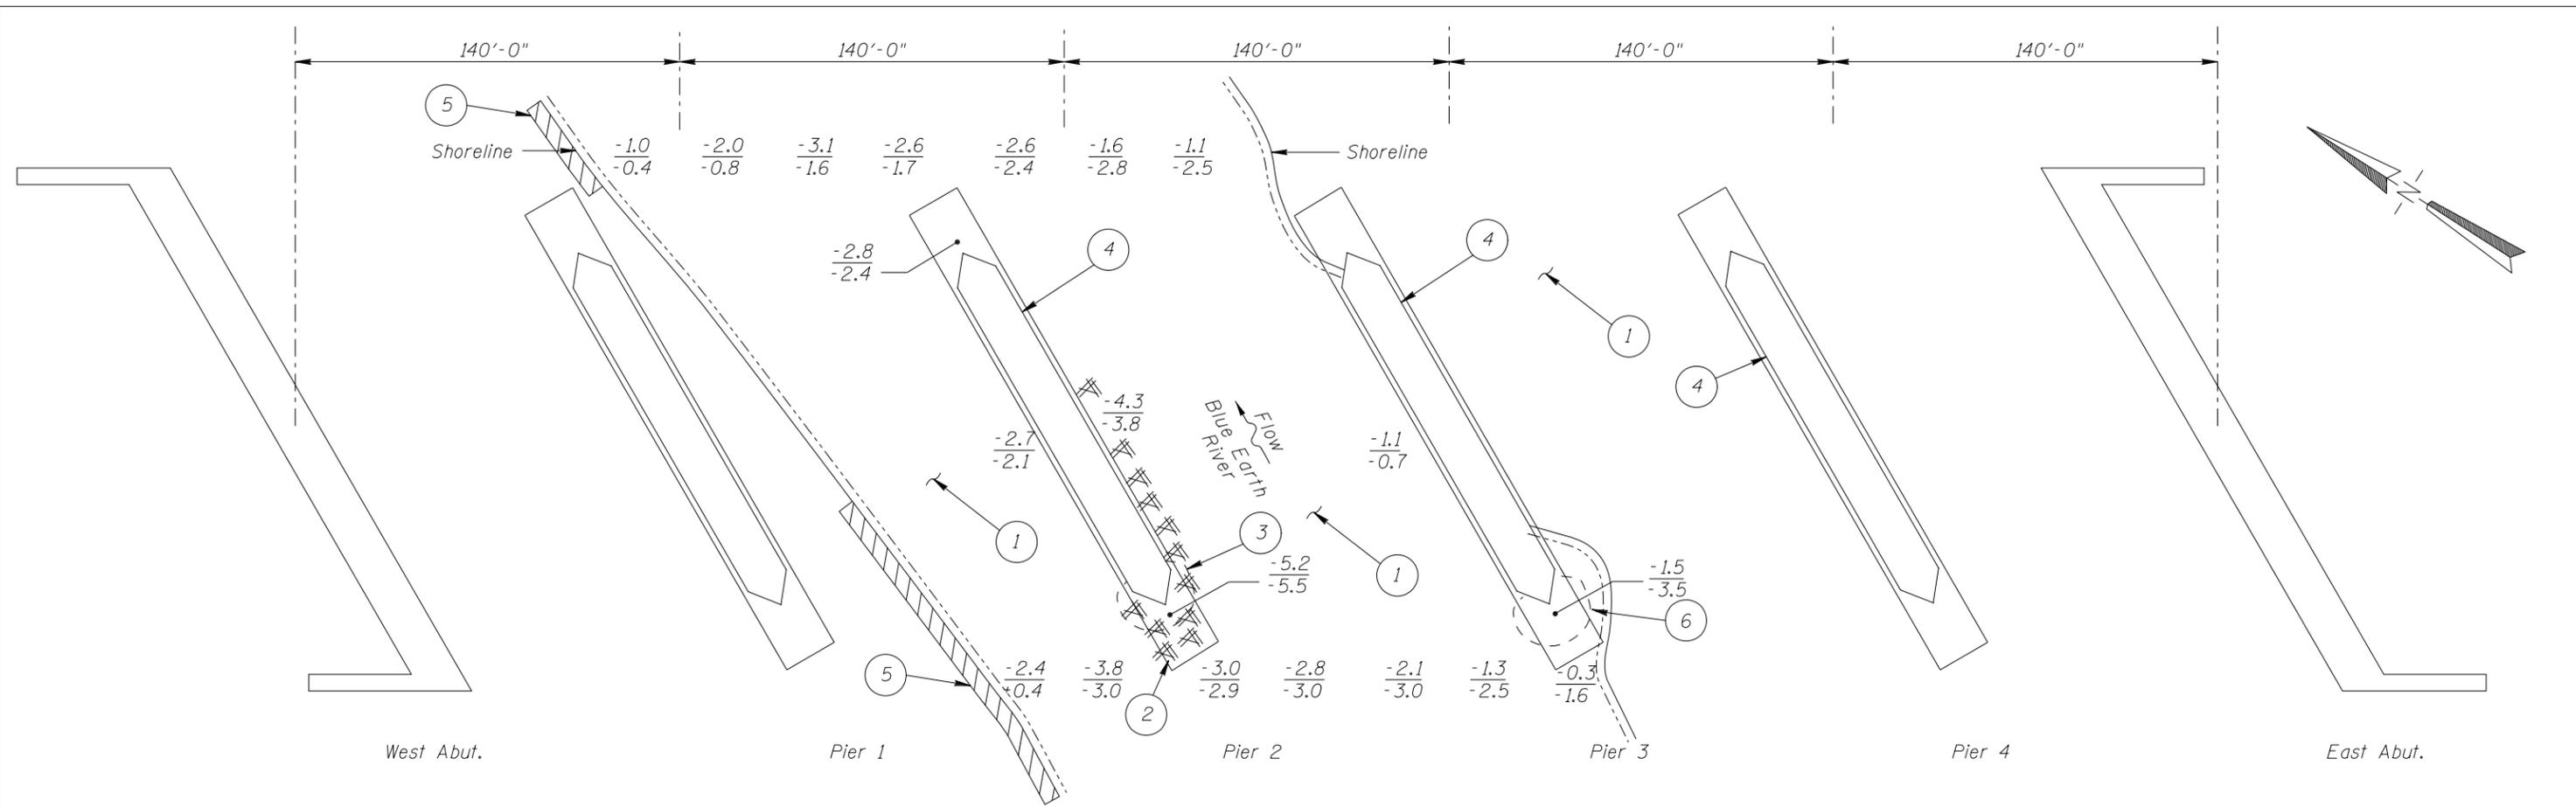
SOUNDING PLAN

- 1 The channel bottom material around the substructure units consisted of sand, gravel, and 2 to 4 feet diameter cobbles with up to 1 inch of probe rod penetration.
- 2 Light accumulation of timber debris was observed around the upstream nose and along the east face of Pier 2, extending from the channel bottom to 1 foot above the waterline.
- 3 Scour depression with a 5 foot radius and 2.5 feet of depth was observed around the upstream nose of Pier 2.
- 4 Overall the concrete of the piers was in good condition and only exhibited random vertical cracks.
- 5 Vertical bank erosion was observed along the river bank, consisting of up to 15 feet high vertical cut embankments.
- 6 A 3 feet radius scour depression 1.5 feet deep was observed at the upstream end of Pier 3.
