UNDERWATER BRIDGE INSPECTION REPORT

STRUCTURE NO. 07581

CSAH 42

MINNESOTA RIVER

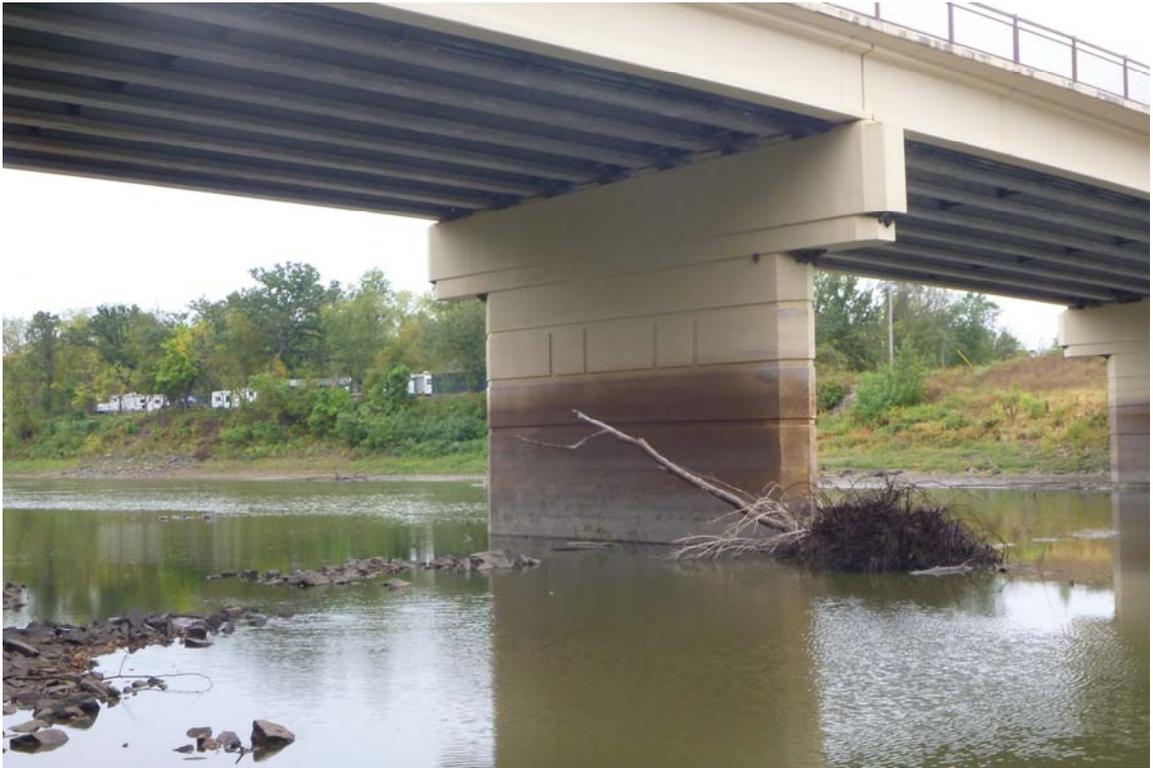
- (D) Moderate accumulation of timber, consisting primarily of 1.5 foot diameter tree and associated drift pieces, was observed across the upstream nose of Pier 2 extending from the channel bottom to 2 feet above the waterline and up to 12 feet off the pier nose.

- (E) A 1 foot diameter tree was observed along the channel bottom at the upstream nose and along the north face of Pier 1.
- (F) The footing was exposed around mostly of the perimeter of Pier 2 apart from the downstream corner along the north face. Vertical face exposure varied from a few inches at the upstream end, 1.5 feet at the downstream end to 5.5 feet maximum near the center along the south face of the pier.

Photograph 1. View of Pier 2, Looking South.

- (A) Monitor footing exposure at Pier 2 during future underwater inspections and consider counter measures to mitigate scour at Pier 2.
- (B) Monitor timber debris at Piers 1 and 2 during future underwater inspections.
- (C) Reinspect the submerged substructure units at the normal maximum recommended (NBIS) interval of sixty (60) months.

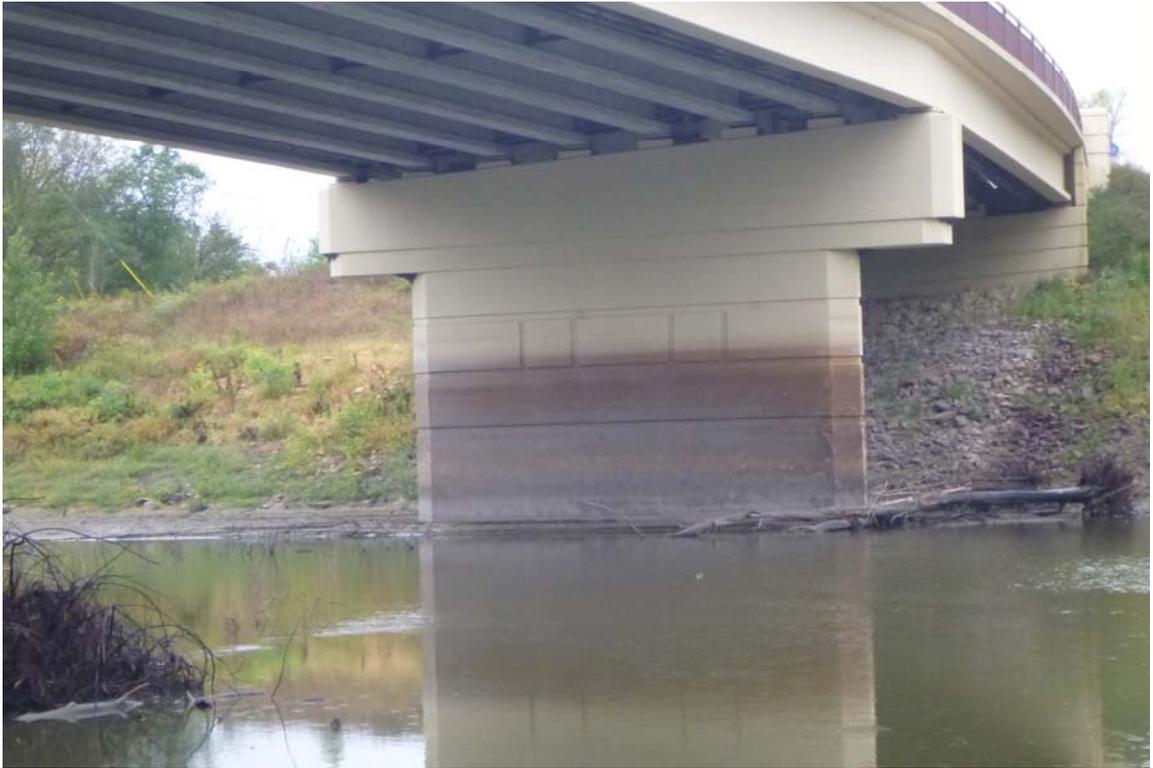
Photograph 2. View of Pier 1, Looking South.

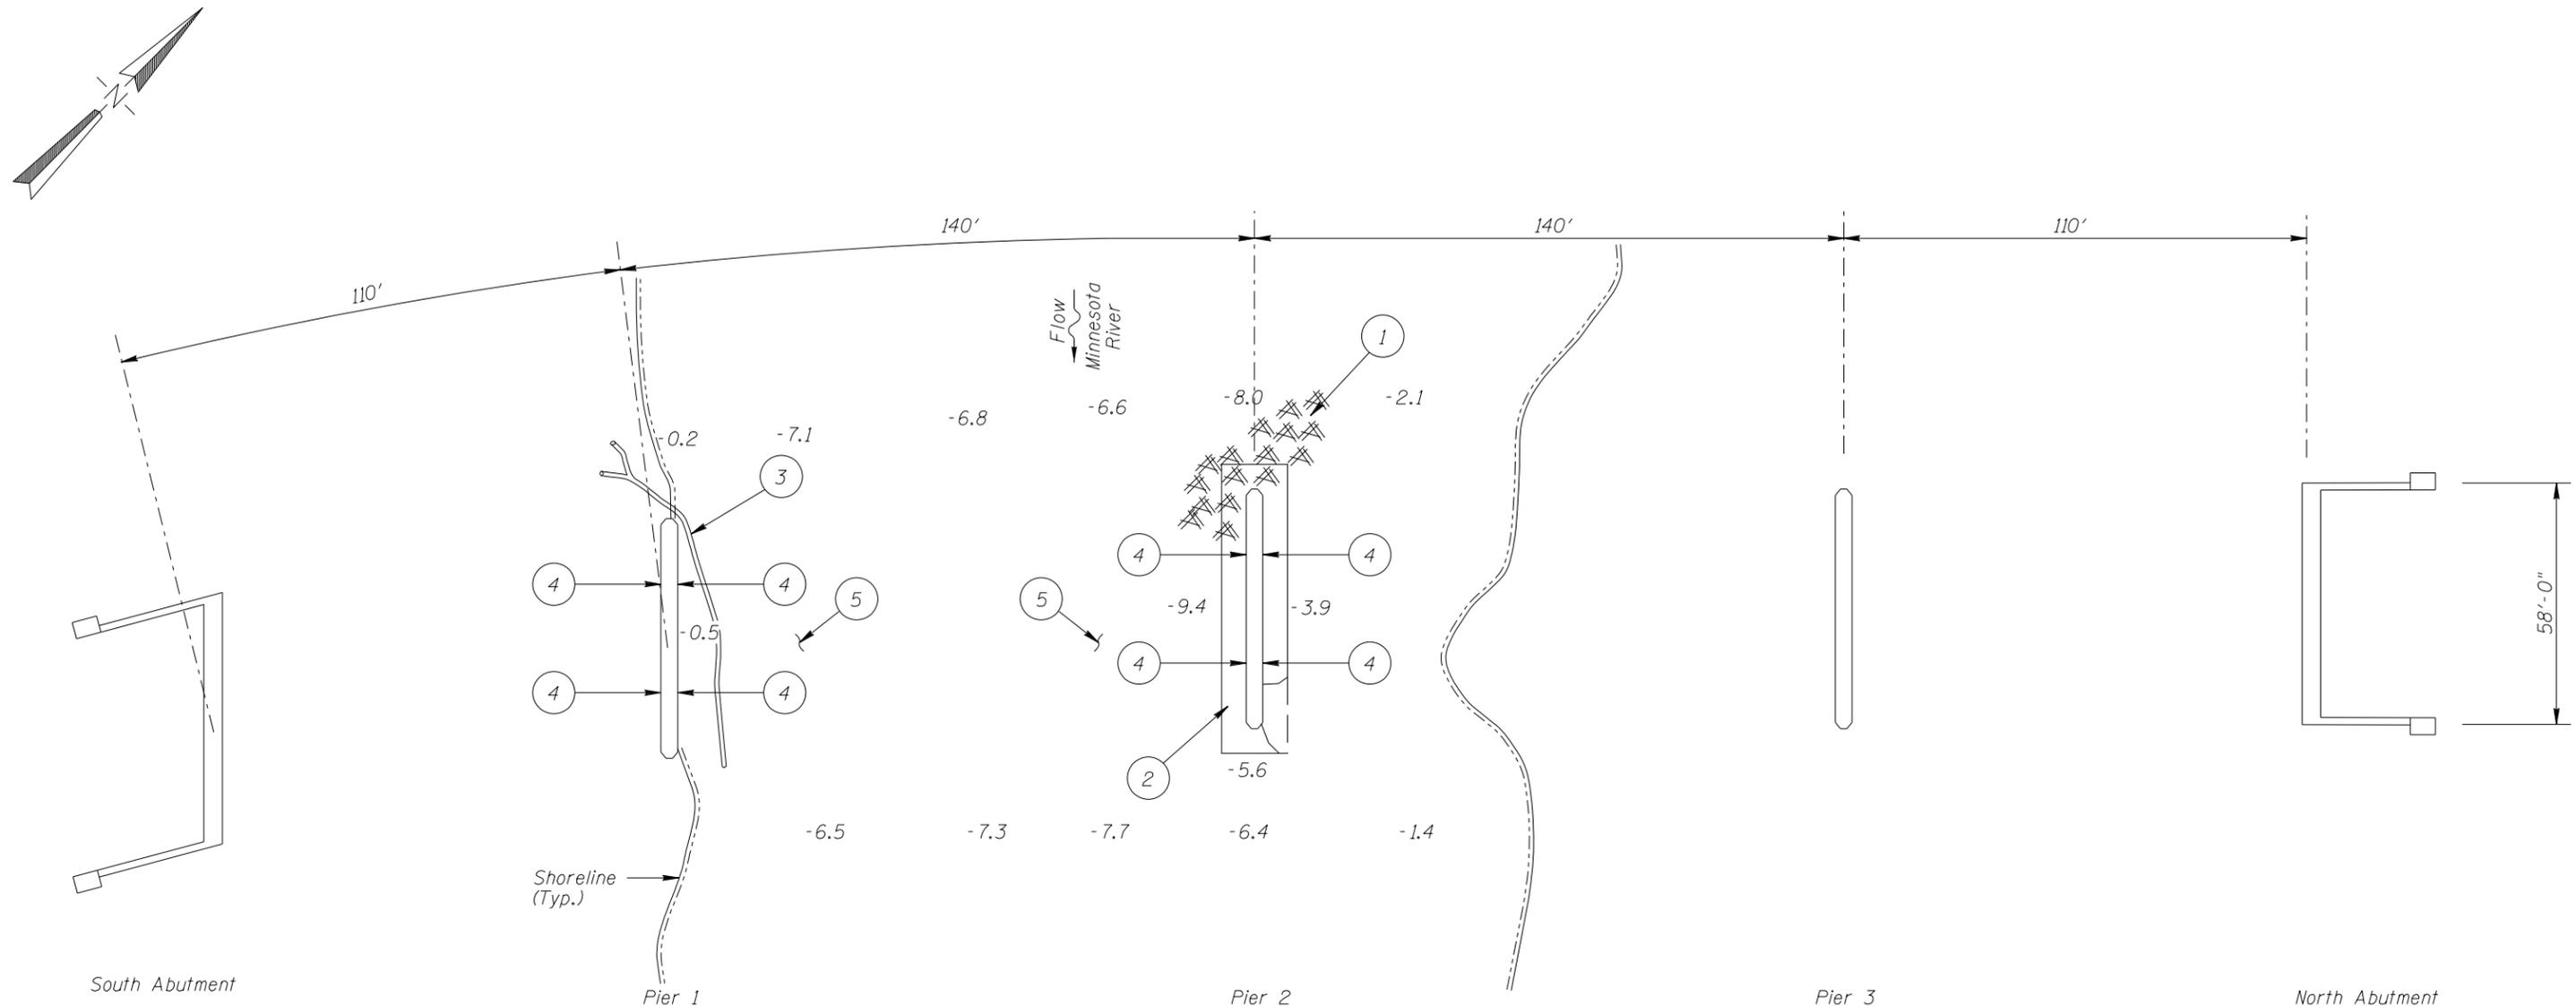
INSPECTION AND SOUNDING PLAN

- 1 A moderate accumulation of timber debris, consisting primarily of 1.5 foot diameter tree and associated drift pieces, was observed across the upstream nose of Pier 2, extending from the channel bottom to 2 feet above the waterline and up to 12 feet off the pier nose.

- 2 Footing was exposed around the entire perimeter of Pier 2 apart from the downstream corner along the north face. Vertical face exposure varied from few inches at the upstream end, 1.5 feet at the downstream end, to 5.5 feet maximum near the midpoint along the south face of the pier.

- 3 A 1 foot diameter tree was observed along the channel bottom at the upstream nose and along the north face of pier 1.
- 4 1/8 inch wide diagonal cracks were observed near the upstream and downstream 1/4 points on the faces of both piers. Extending from top of footing (or channel bottom) to approx. 3 feet above the waterline.

- 5 The channel bottom material around Piers 1 and 2 primarily consisted of soft silt allowing up to 1.5 feet of probe rod penetration with some randomly scattered riprap along the north face of Pier 2.
