UNDERWATER BRIDGE INSPECTION REPORT

STRUCTURE NO. 08520

MINNESOTA RIVER

SEPTEMBER 12, 2012

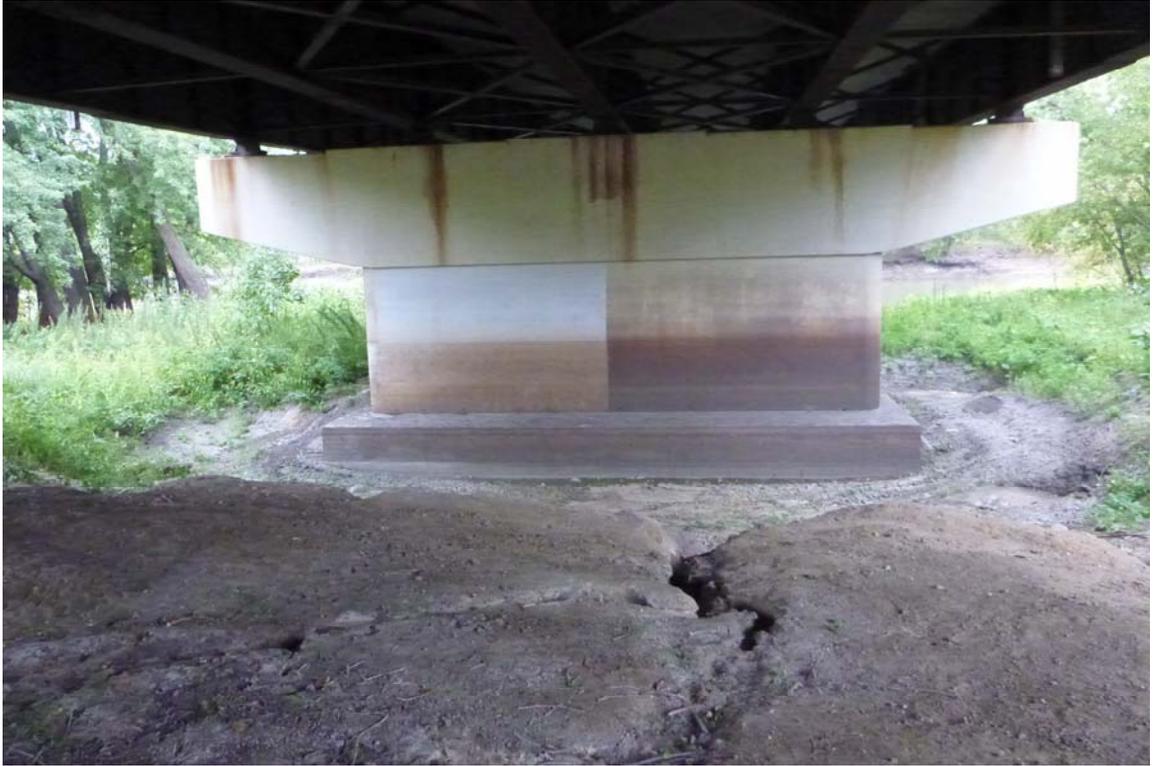
Photograph 1. View of Pier 3, Looking Southwest.

- ④ The top of the footing was exposed at Pier 3 around the majority of the pier with up to 1.5 feet of vertical face exposure due to a scour depression measuring 10 feet in radius. Pier 3 was located out of the waterway at the time of inspection.

- (A) Because the bridge has been evaluated to be scour critical, consider countermeasures to mitigate scour at Piers 1 and 3 to prevent any further foundation exposure.

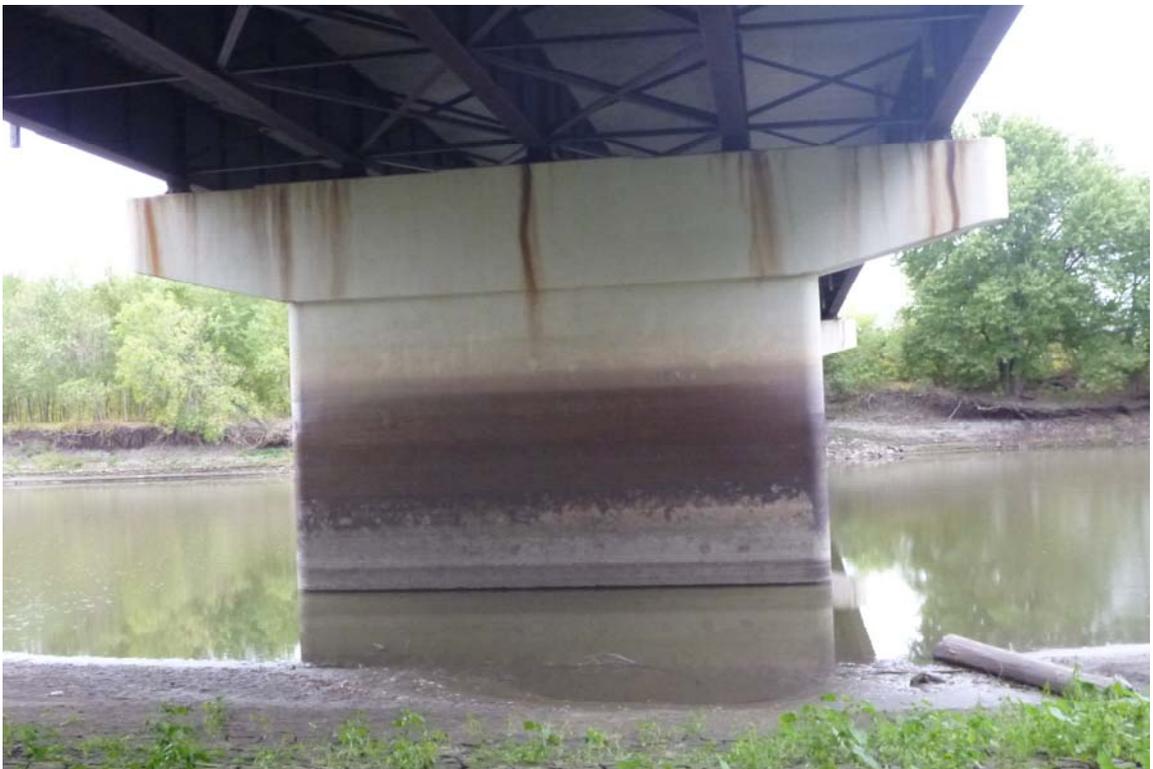
Photograph 2. View of Pier 2, Looking Southwest.

- ① The channel bottom consisted of firm gravel and riprap, typically 6 inches in diameter, with up to 2 inches of probe rod penetration.
- ② The channel bottom around Pier 2 consisted of soft silt with up to 2 feet of probe rod penetration.

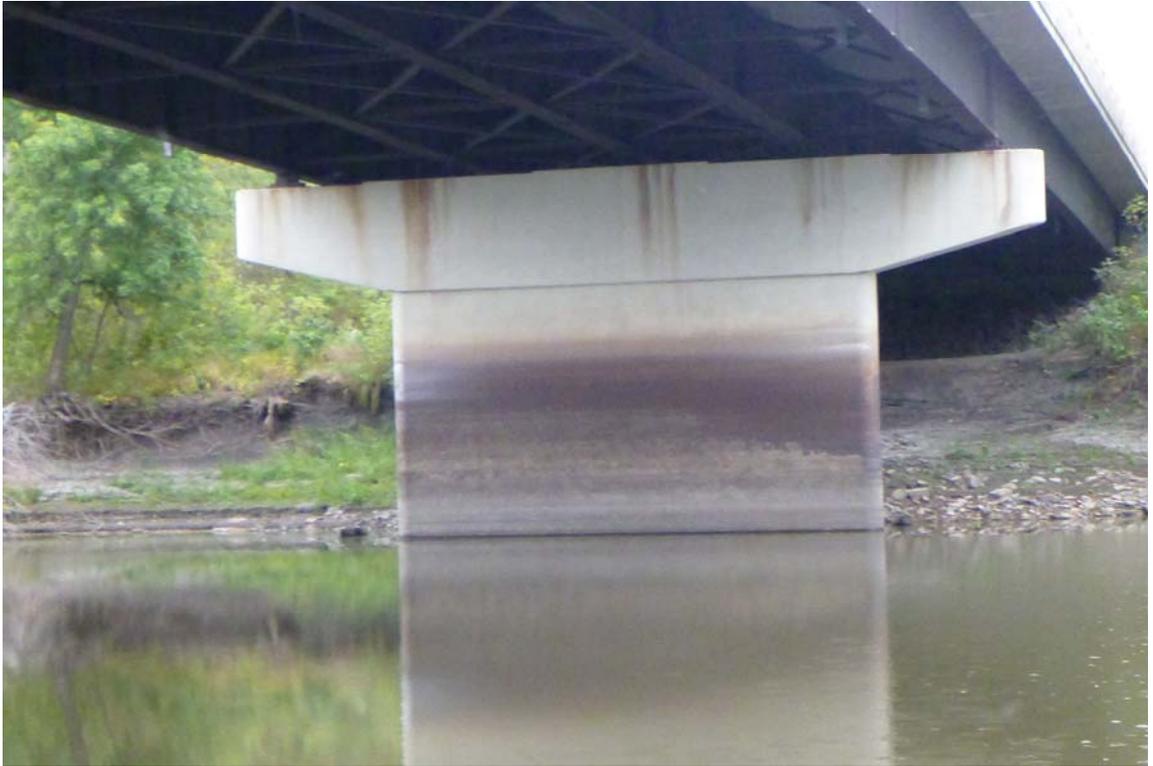
Photograph 3. View of Pier 1, Looking Southwest.

- ③ The top of the footing was exposed at Pier 1 from the upstream quarter point on the west face, around the upstream and downstream nose, and along the entire east face with up to 4.5 feet of vertical face exposure along the east face. The seal was also exposed up to 8 inch of vertical exposure.

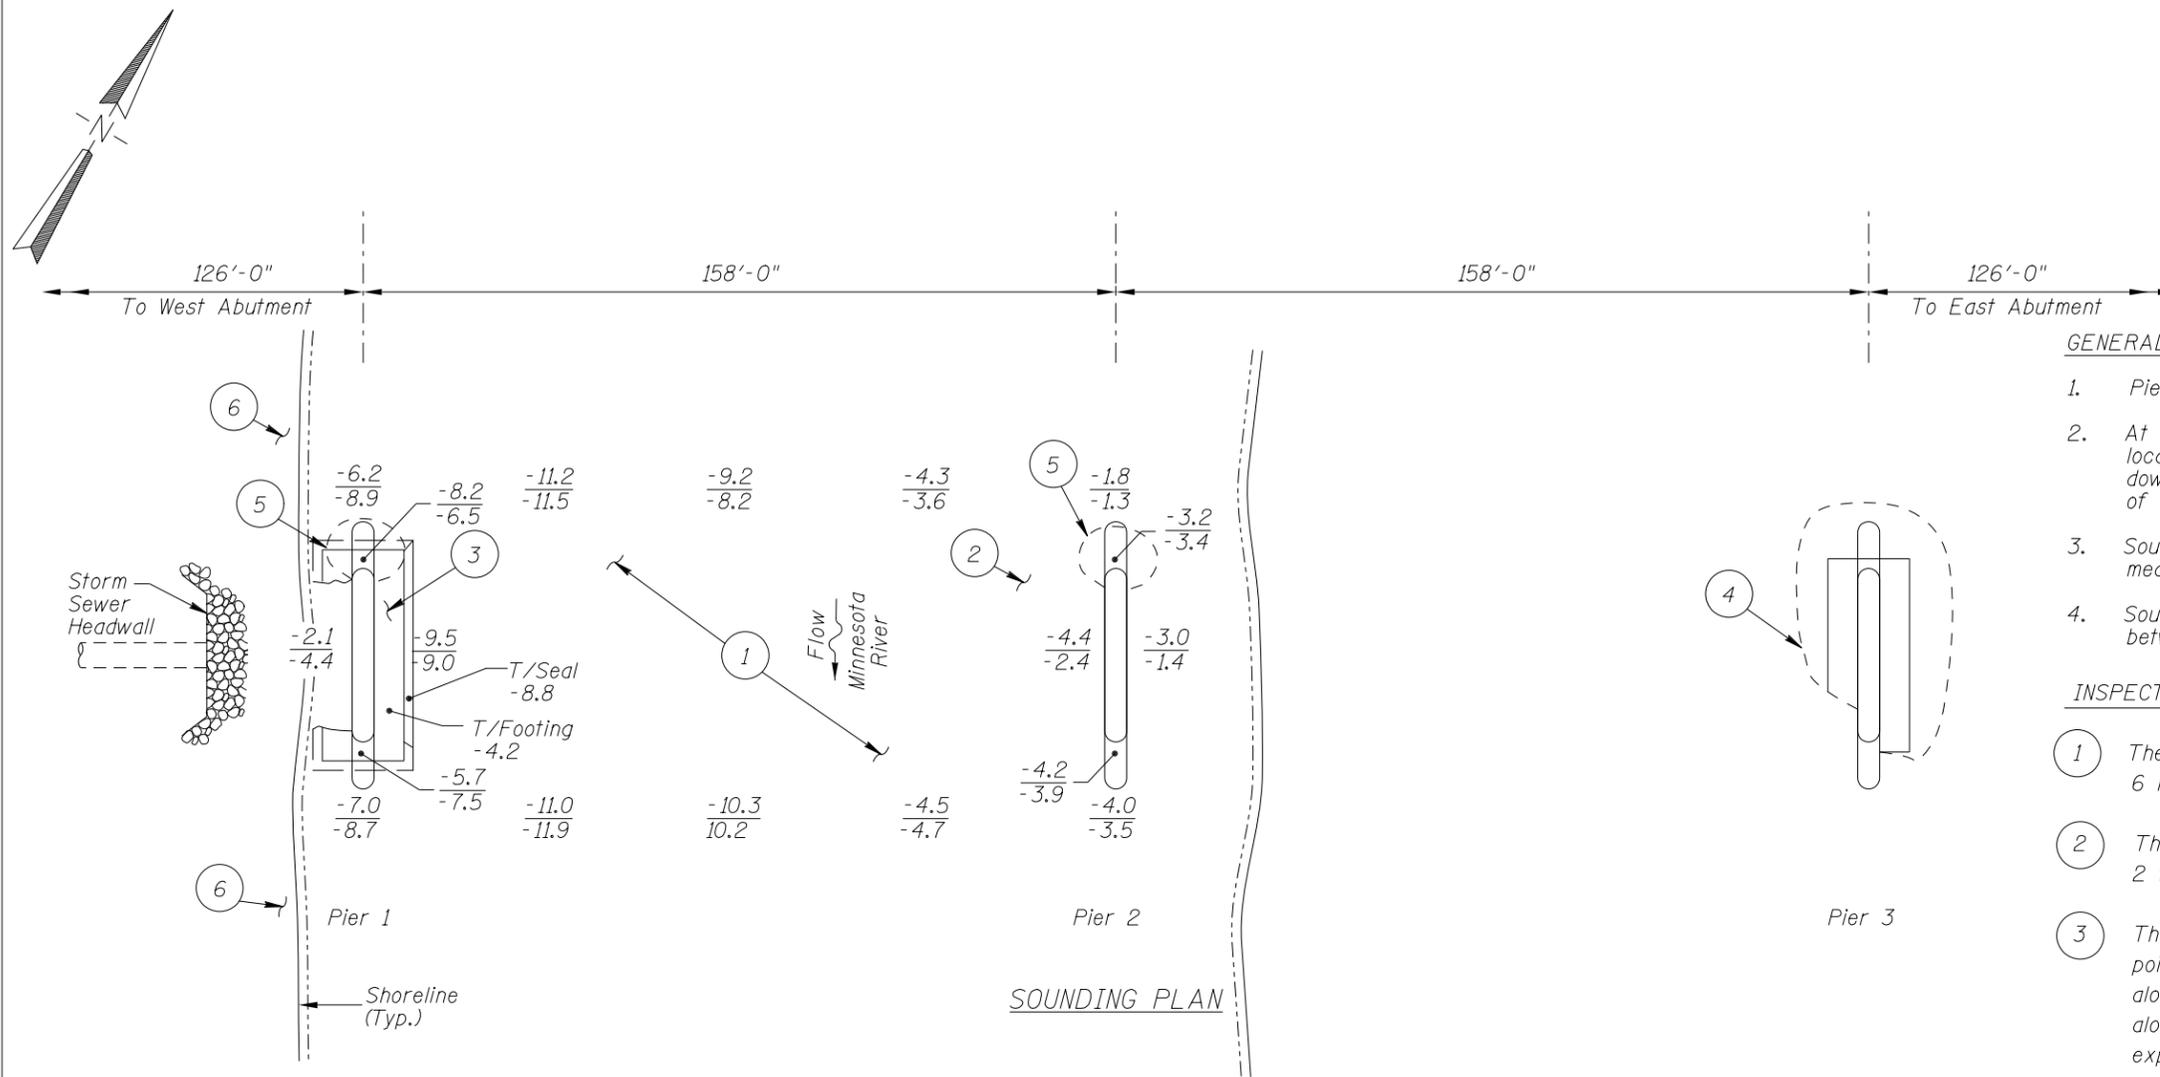
**SOUNDING PLAN**

- ⑤ A scour depression 6 feet in radius, 2 feet deep was observed at the upstream noses of Piers 1 and 2.
- ⑥ Vertical bank erosion was observed upstream and downstream of the structure along the west embankment.
