UNDERWATER BRIDGE INSPECTION REPORT

STRUCTURE NO. 08527

CSAH NO. 13/35

MINNESOTA RIVER

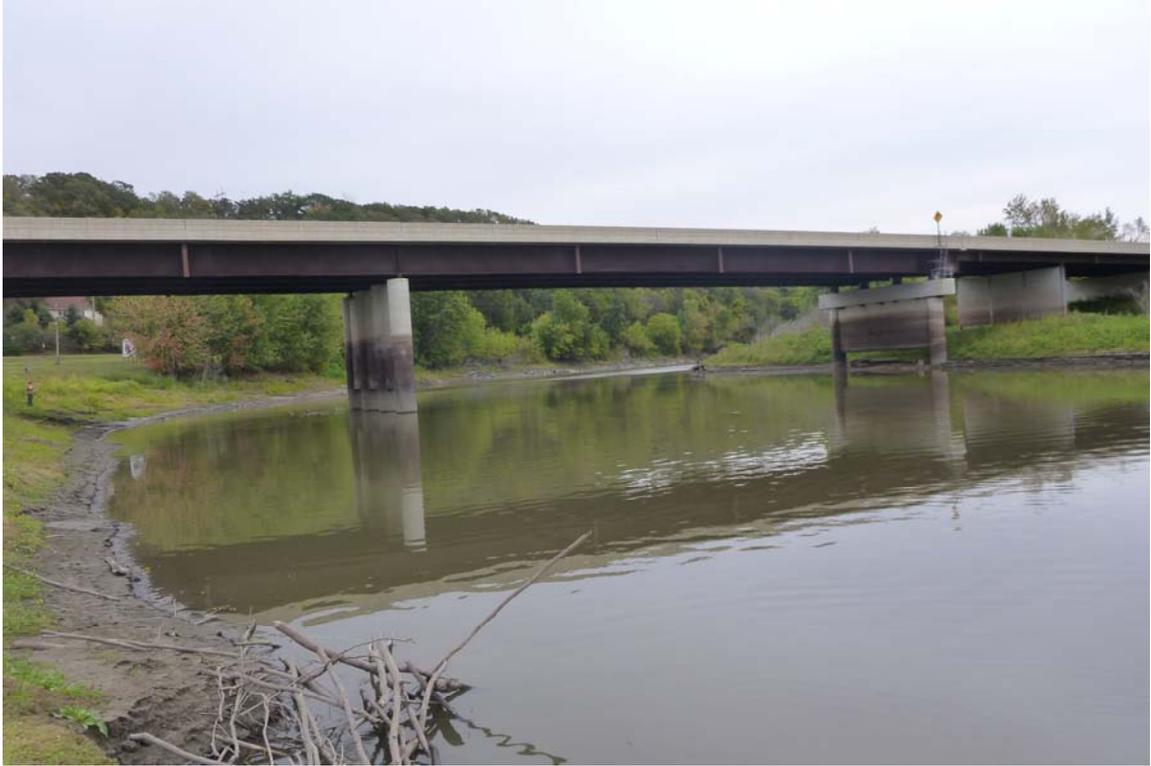
Photograph 1. Overall View of the Structure, Looking Northeast.

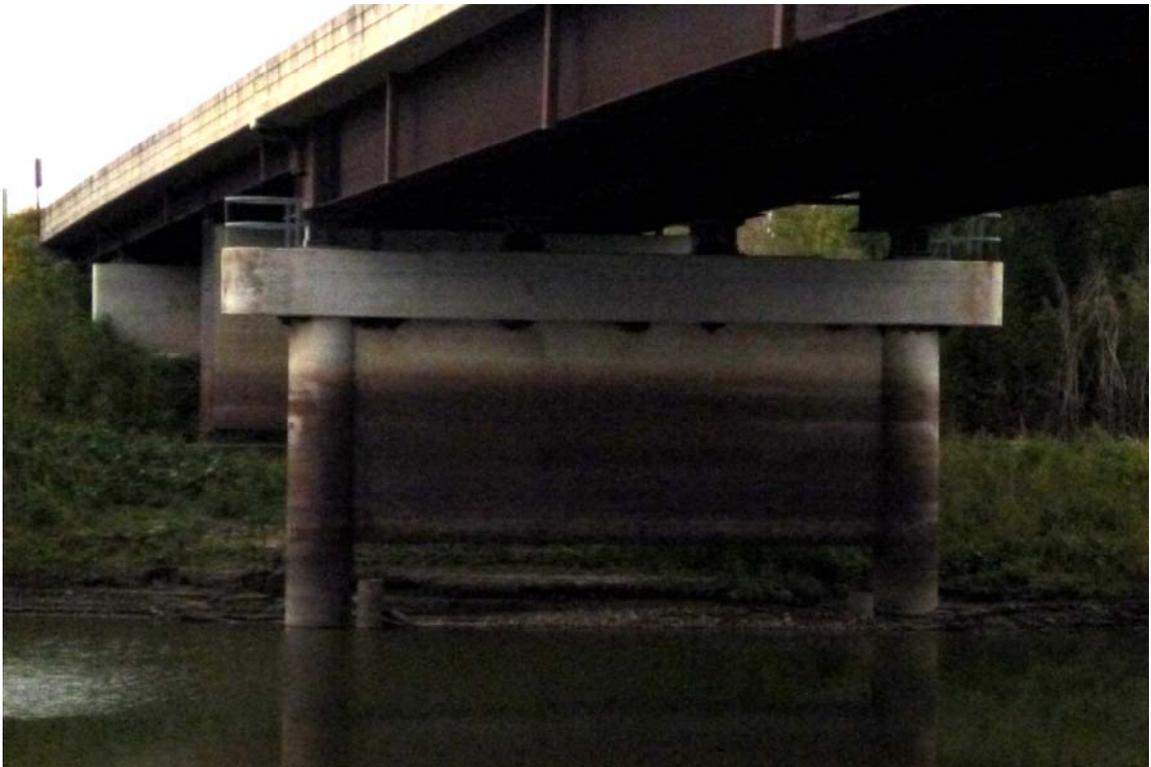
Photograph 2. Overall View of Pier 1, Looking Southeast.

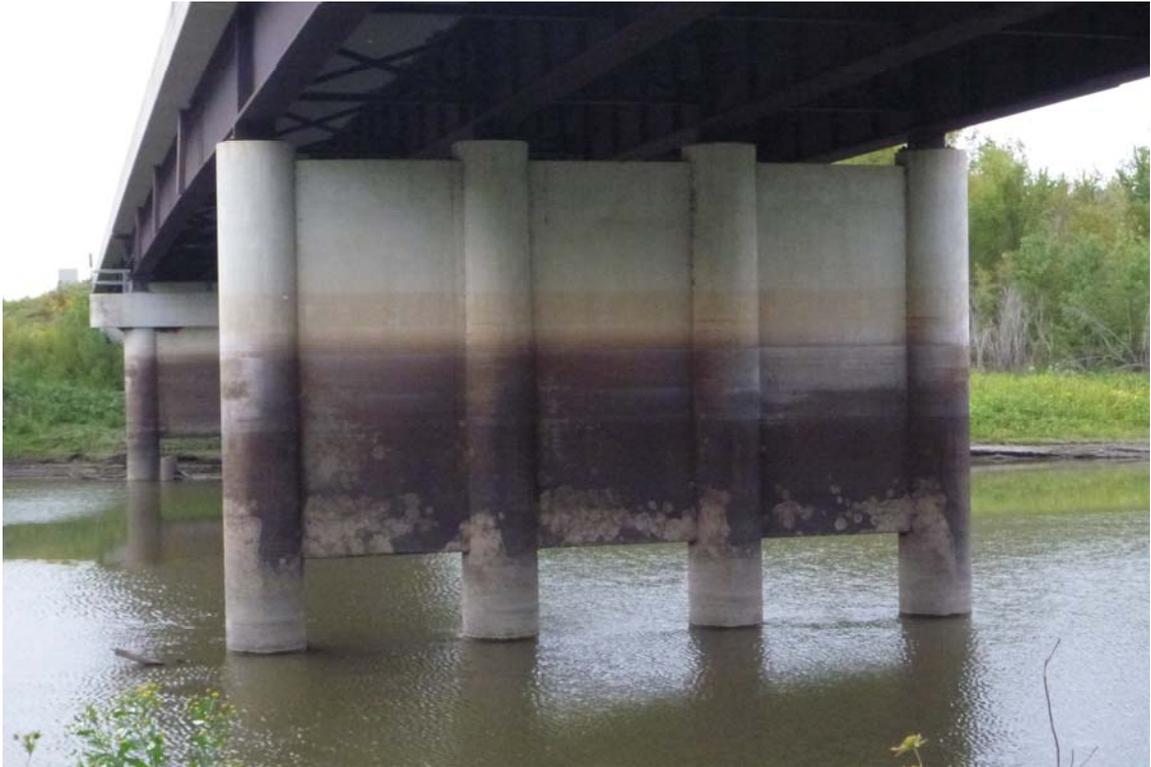
Photograph 3. View of Pier 2, Looking Southeast.

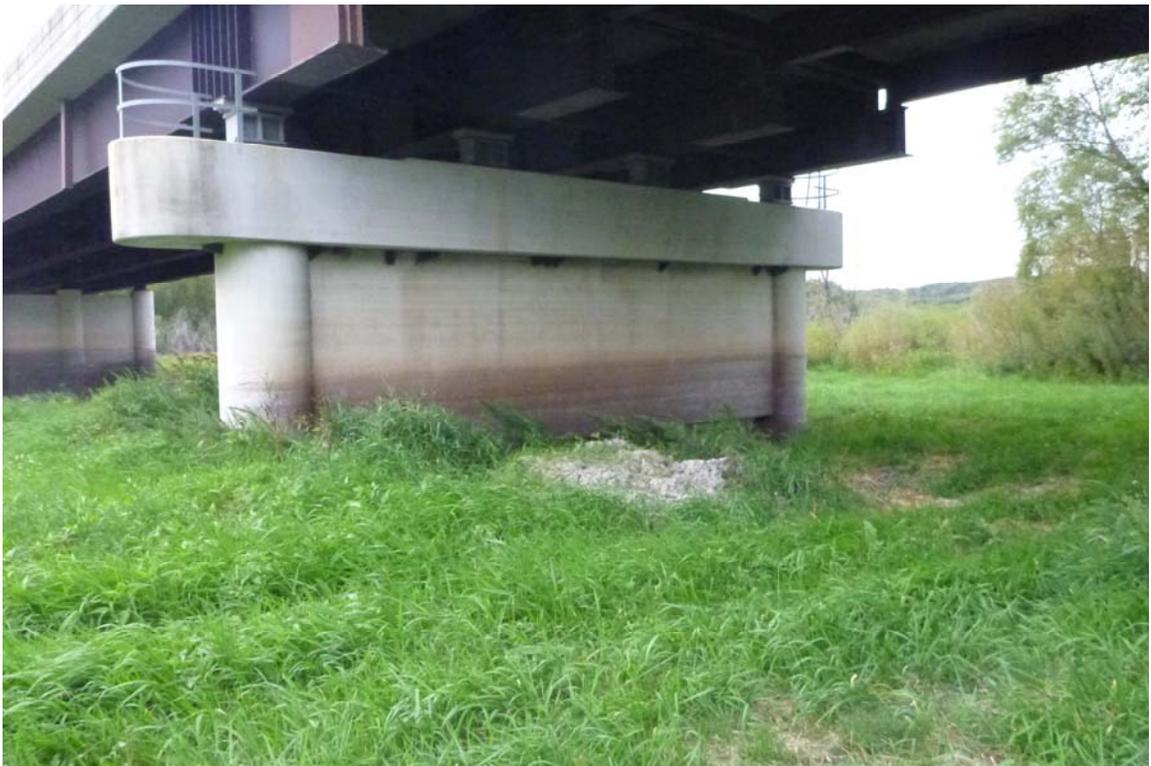
Photograph 4. View of Bent 2, Looking Southeast.

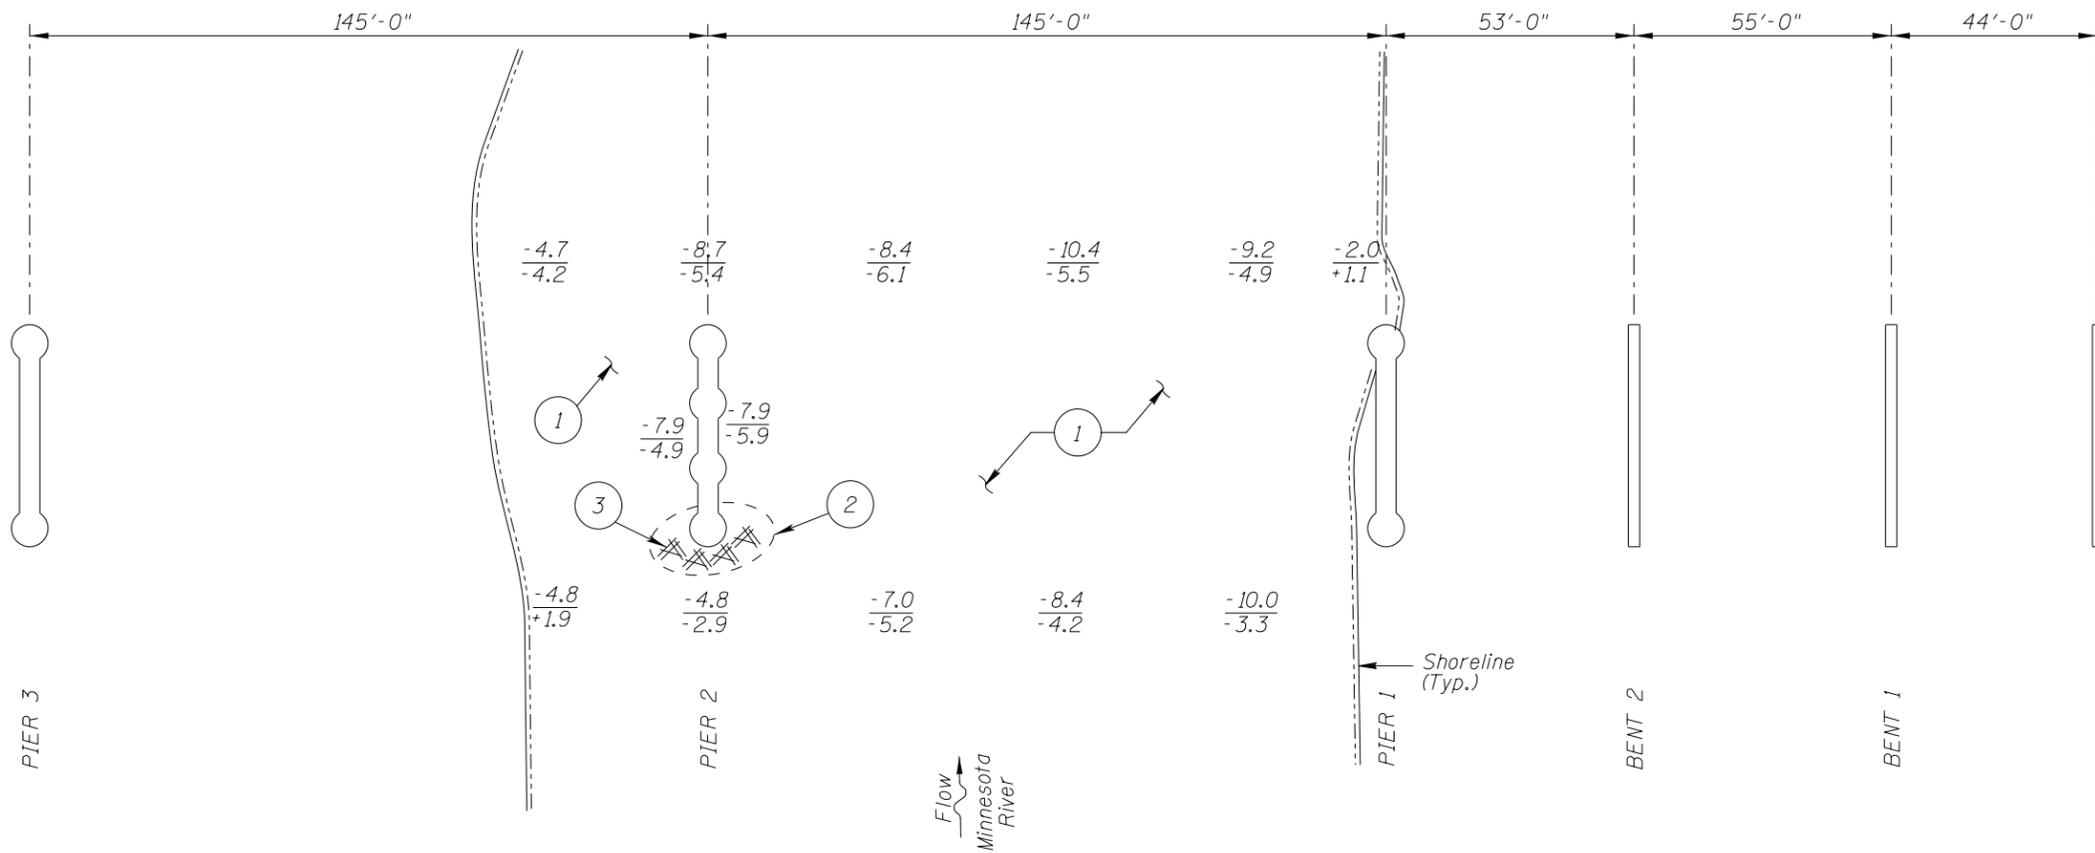
INSPECTION AND SOUNDING PLAN

- INSPECTION NOTES:**
- 1 Channel bottom material consisted of soft to medium silty sand with 1.5 feet of maximum probe rod penetration.
 - 2 Minor scour depression 5 feet radius by 1 to 2 feet deep was observed at the upstream end of Pier 2.
 - 3 Moderate accumulation of timber debris consisting of 1 foot diameter and smaller logs and branches was observed at the upstream end of Pier 2 from the channel bottom up 5 feet, and also between downstream two columns, a light accumulation of timber debris consisting of 8 inches diameter and smaller branches extended from channel bottom up 3 feet.

- (A) Monitor the accumulations of timber debris around Pier 2, and if found to be progressing in the future, removal operations may be necessary at that time.
- (B) Reinspect the submerged substructure units at the normal maximum recommended (NBIS) interval of sixty (60) months.
