UNDERWATER BRIDGE INSPECTION REPORT

STRUCTURE NO. 08529
COTTONWOOD STREET
OVER THE
COTTONWOOD RIVER
DISTRICT 7 – BROWN COUNTY

SEPTEMBER 12, 2012
PREPARED FOR THE
MINNESOTA DEPARTMENT OF TRANSPORTATION
BY
COLLINS ENGINEERS, INC.
AND
WSB & ASSOCIATES, INC.
JOB NO. 2107

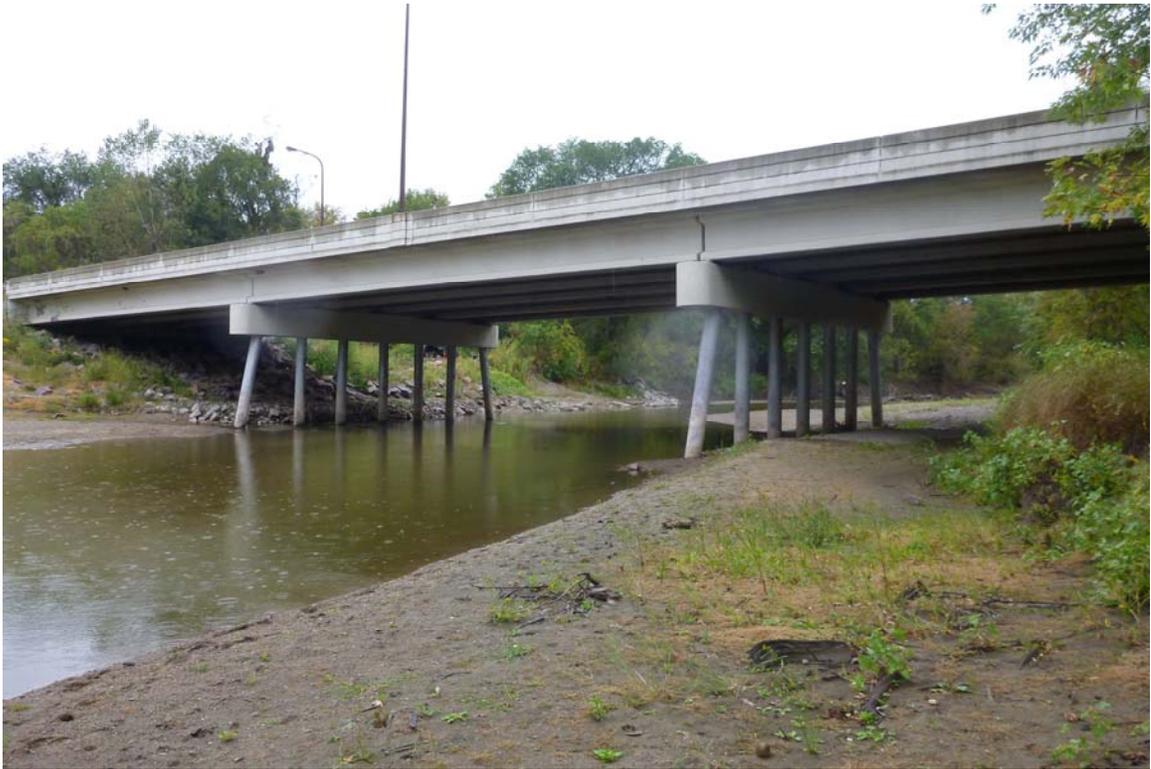
Photograph 1. Overall View of the Structure, Looking West.

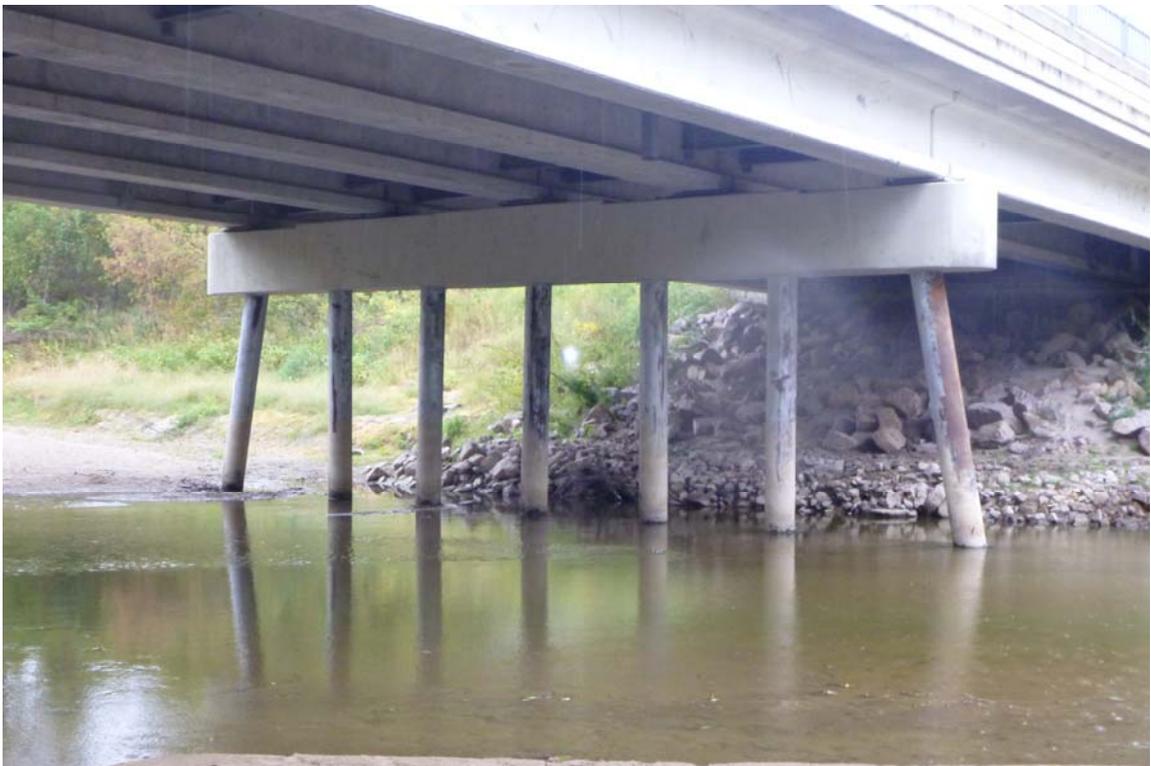
Photograph 2. View of Pier 1, Looking South.

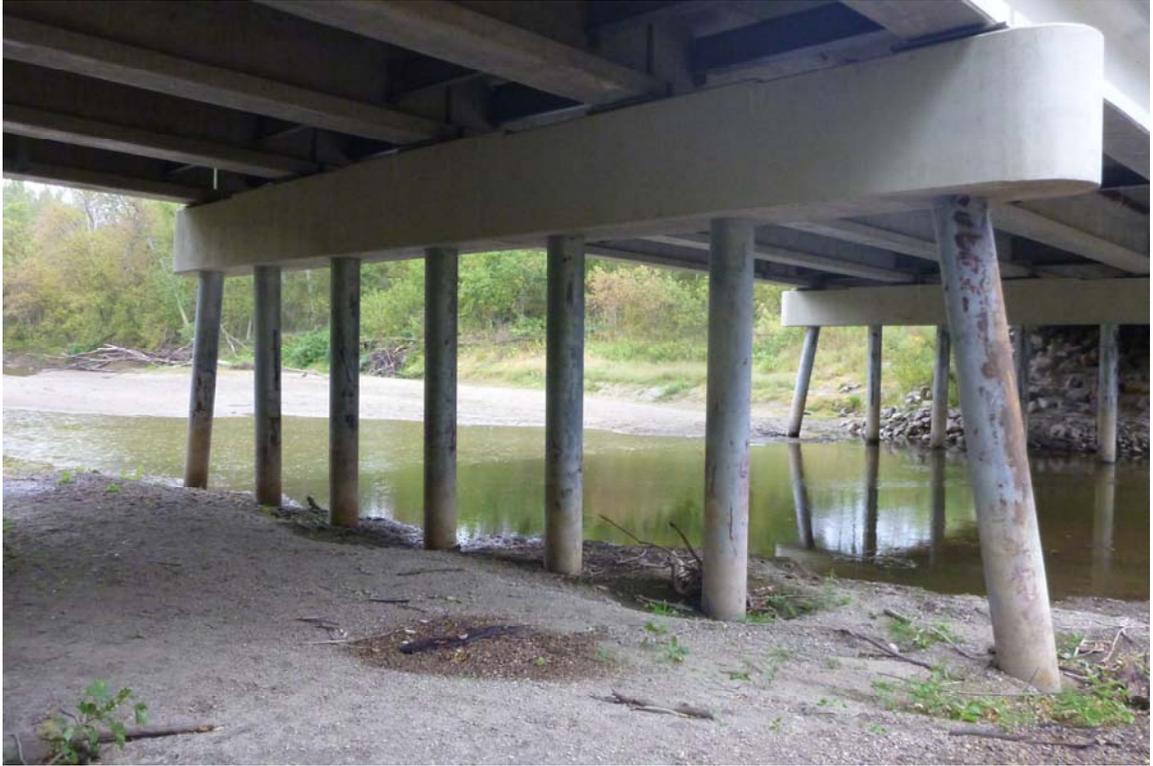
Photograph 3. View of Pier 2, Looking South.

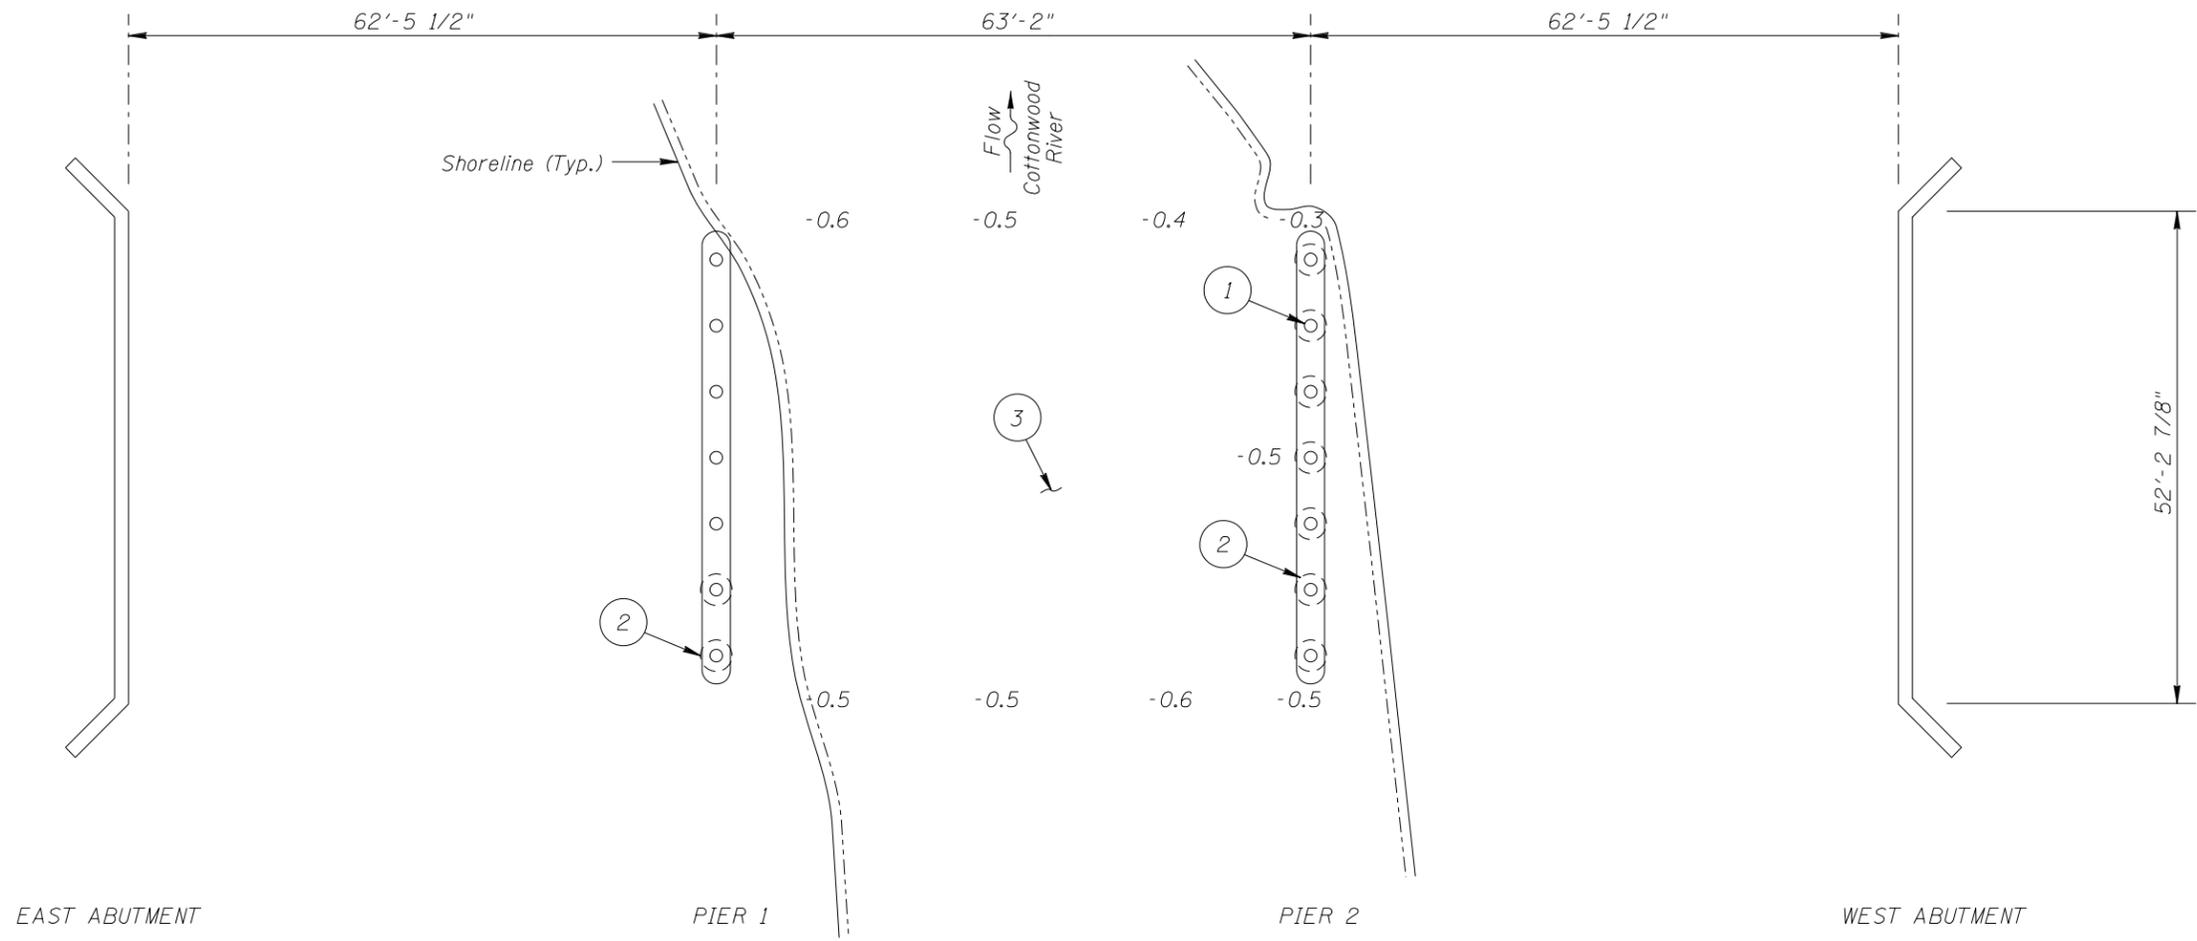
SOUNDING PLAN

- ① Steel piles exhibited 20% coating failure with light surface corrosion.
- ② Minor scour depressions around piles 1 foot deep and 1 foot radius.
- ③ The channel bottom material consisted of silty sand silt allowing 6 inches of probe rod penetration.
