UNDERWATER BRIDGE INSPECTION REPORT

STRUCTURE NO. 32501  
CSAH NO. 4  
OVER THE  
DES MOINES RIVER  
DISTRICT 7 – JACKSON COUNTY

SEPTEMBER 26, 2012  
PREPARED FOR THE  
MINNESOTA DEPARTMENT OF TRANSPORTATION  
BY  
AYRES ASSOCIATES & COLLINS ENGINEERS, INC.  
JOB NO. 7423

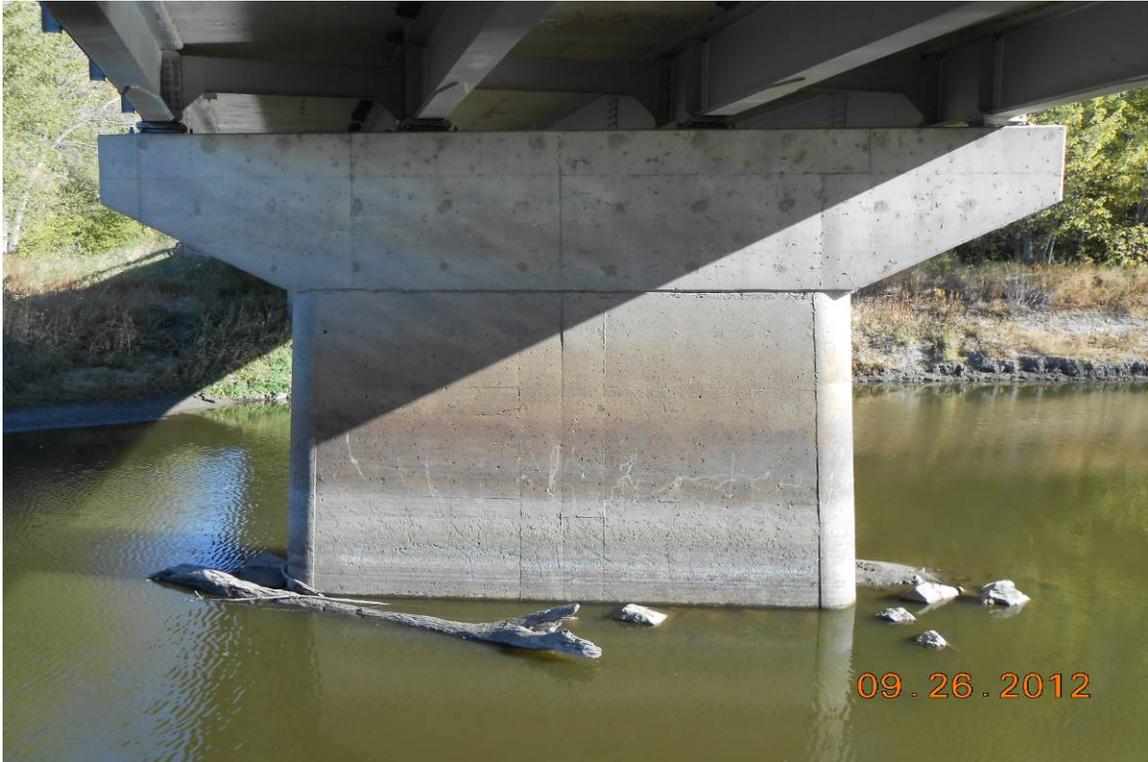
- (A) The concrete of Pier 1 was smooth, sound, and in good condition.
- (B) Large rocks were observed around the perimeter of Pier 1. The rocks extended away from the pier 4 to 5 feet.
- (C) A 10 inch diameter log was observed at the upstream nose of Pier 1.

Photograph 2. View of Pier 1, Looking North.

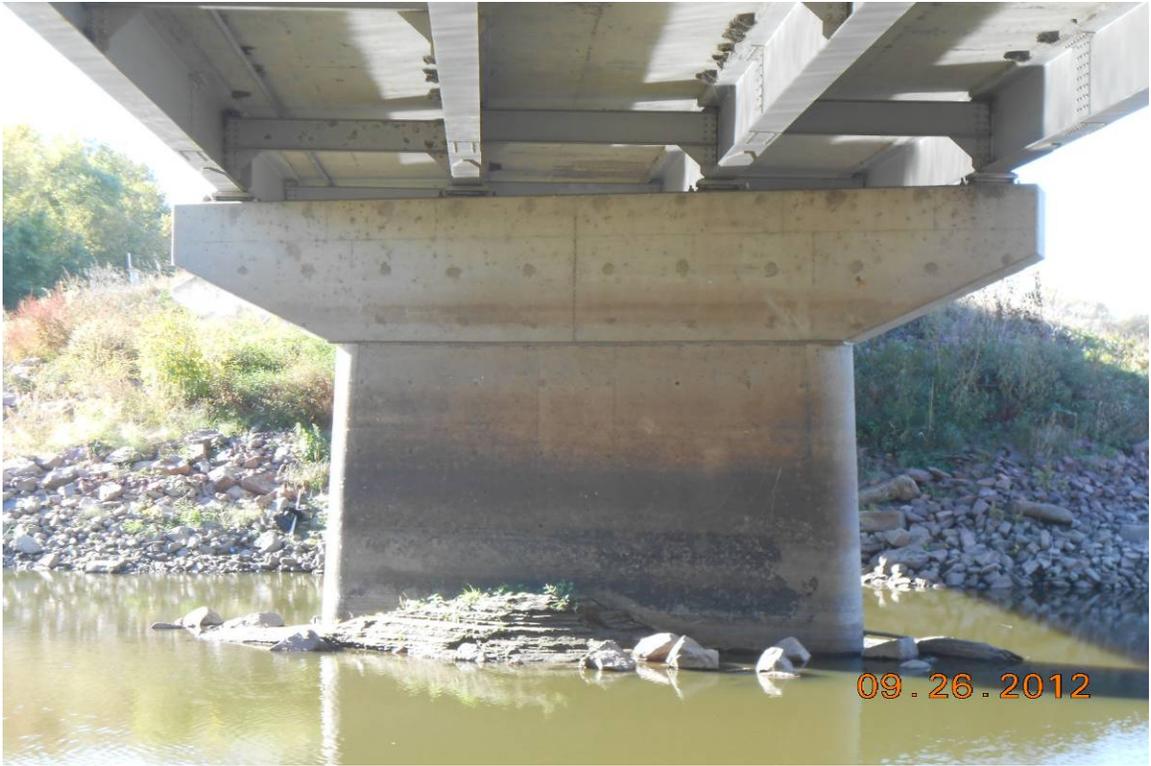
Photograph 3. View of Pier 1, Looking South.

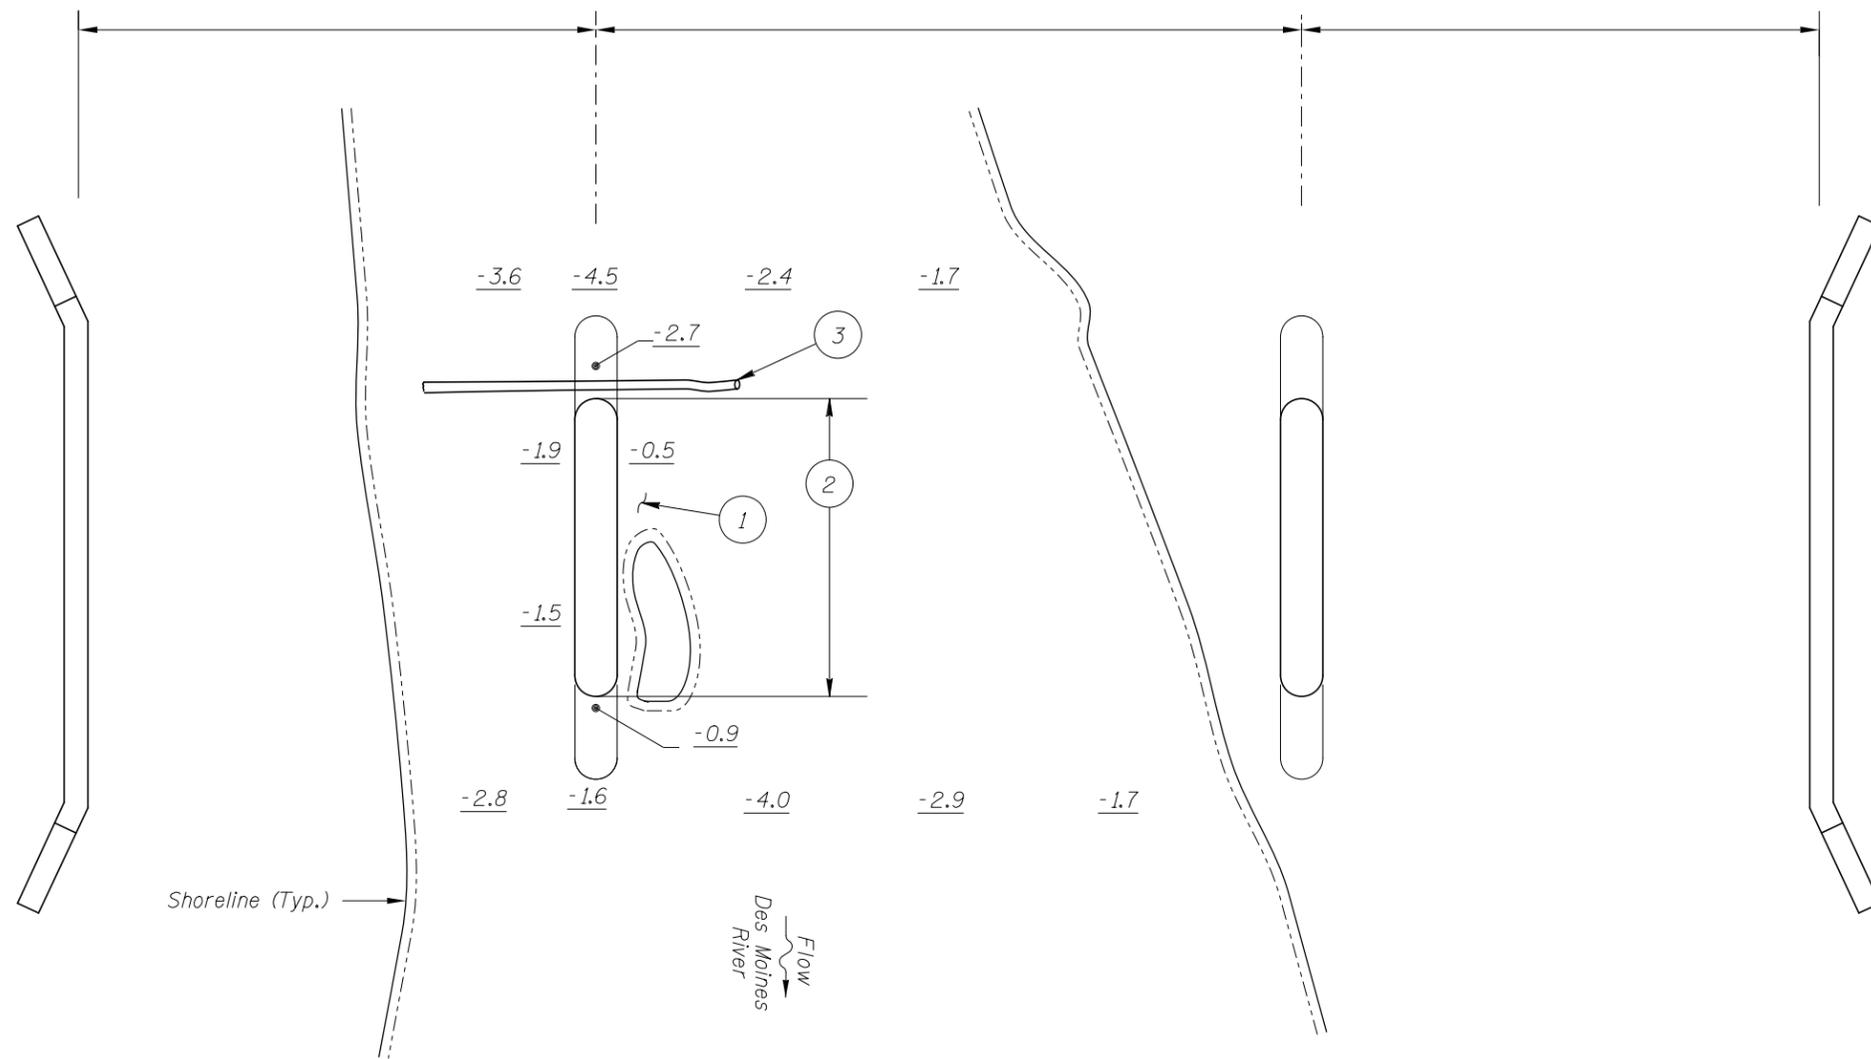
**INSPECTION AND SOUNDING PLAN**

- ① Large rocks were observed on the channel bottom around the perimeter of Pier 1. The rocks extended 4 to 5 feet off the face of Pier 1.
- ② Overall the concrete surface of Pier 1 was smooth and sound.
- ③ A 10 inch diameter log was observed at the upstream nose of Pier 1.

- (A) Reinspect the submerged substructure units at the normal maximum recommended (NBIS) interval of sixty (60) months.
