UNDERWATER BRIDGE INSPECTION REPORT

STRUCTURE NO. 40508

CANNON RIVER

SEPTEMBER 13, 2012

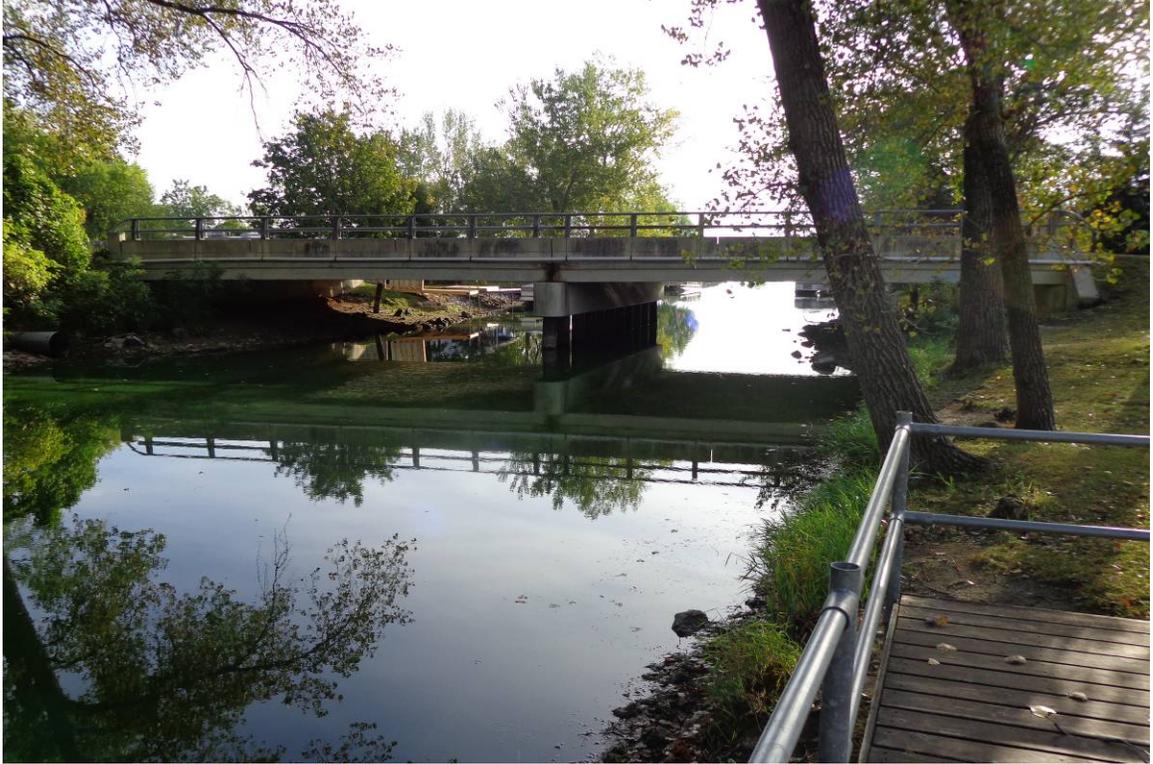
Photograph 1. Overall View of Structure, Looking Northeast.

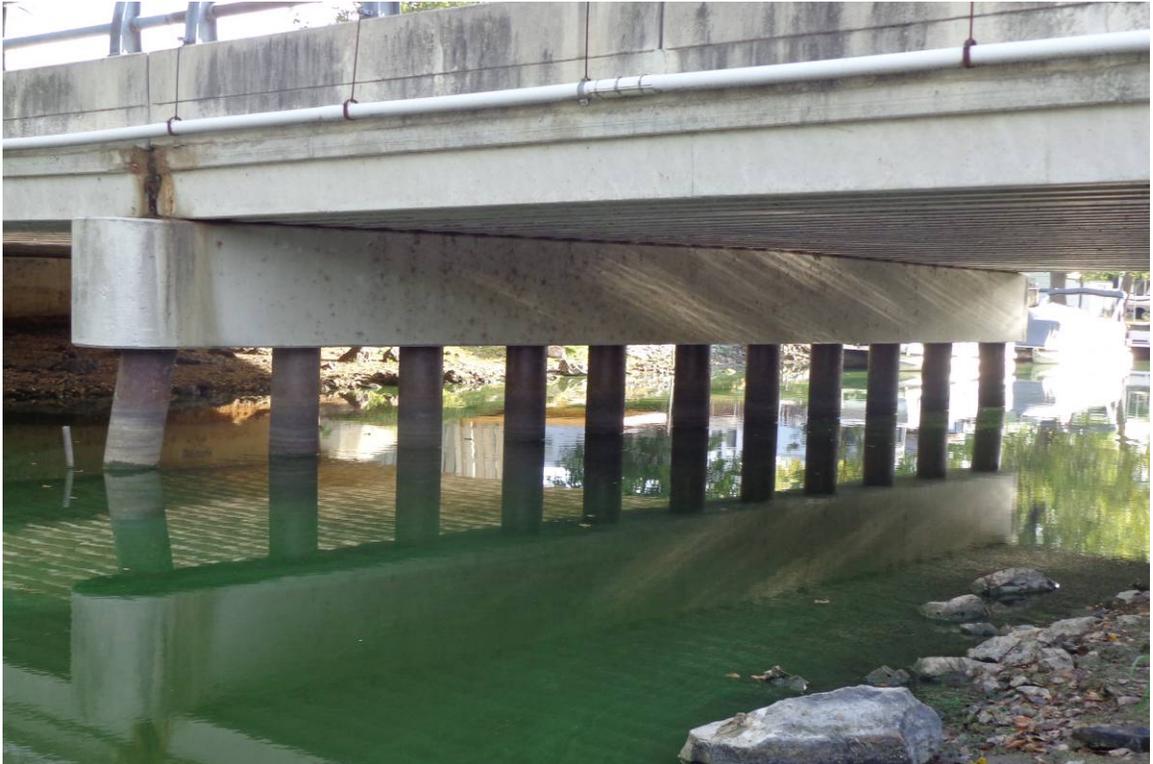
The substructure unit inspected below water at Bridge No. 40508, Center Pier, was found to be in good condition with steel pile shells exhibiting loss of paint coating and light surface corrosion from 2 feet above the waterline to the channel bottom. The channel bottom around the substructure units appeared stable with no significant scour or debris accumulations and no significant changes since the previous underwater inspection.

Photograph 2. View of Center Pier, Looking Northeast.

- (A) Reinspect the submerged substructure units at the normal maximum recommended (NBIS) interval of sixty (60) months.

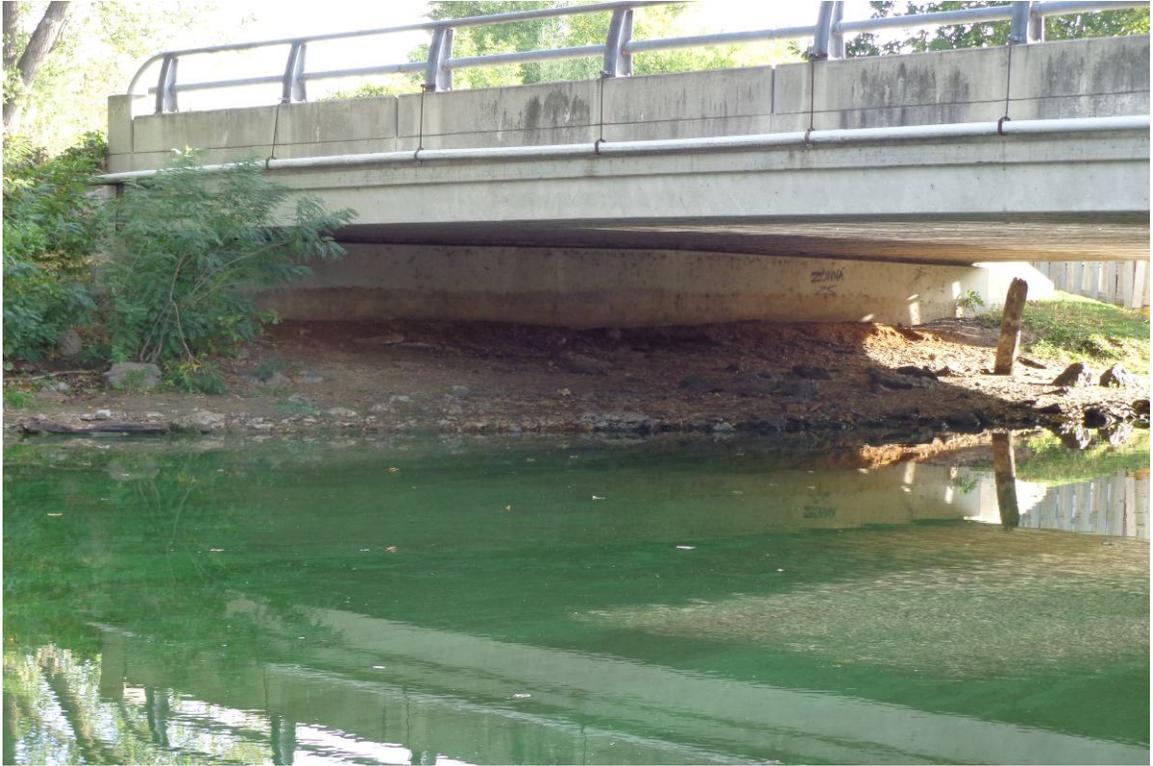
Photograph 3. View of North Abutment, Looking Northeast.

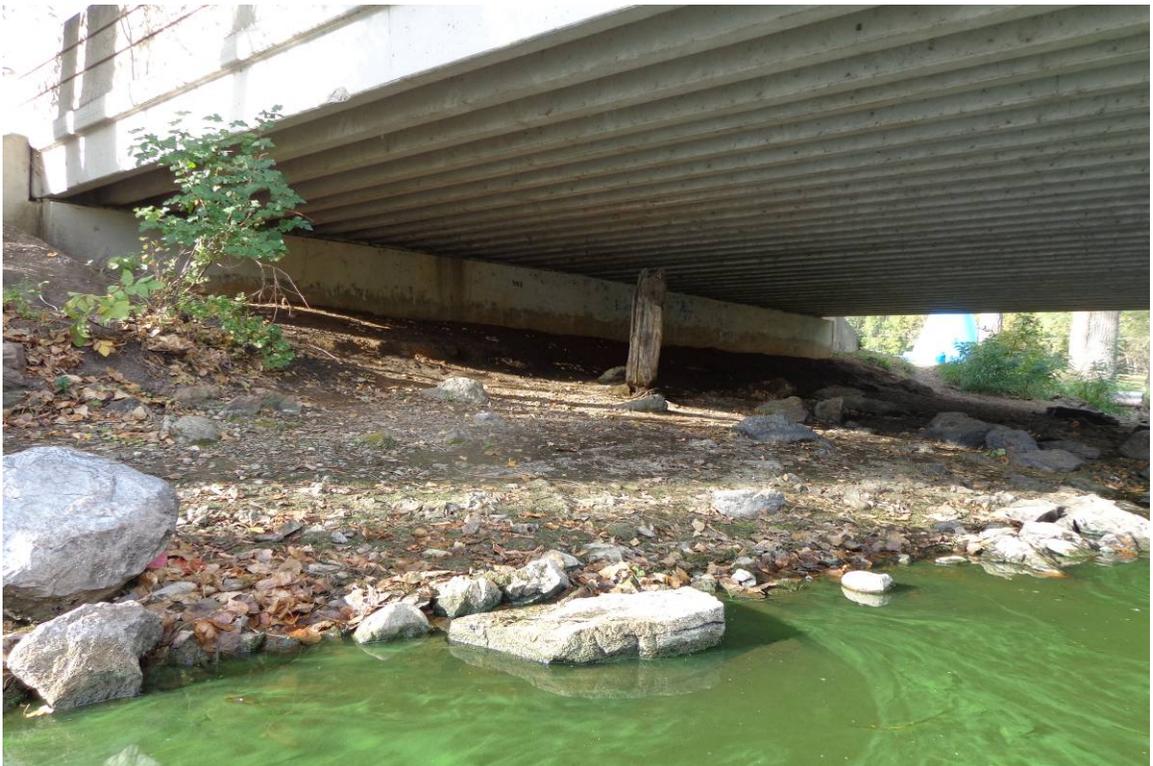
Photograph 4. View of South Abutment, Looking Southwest.

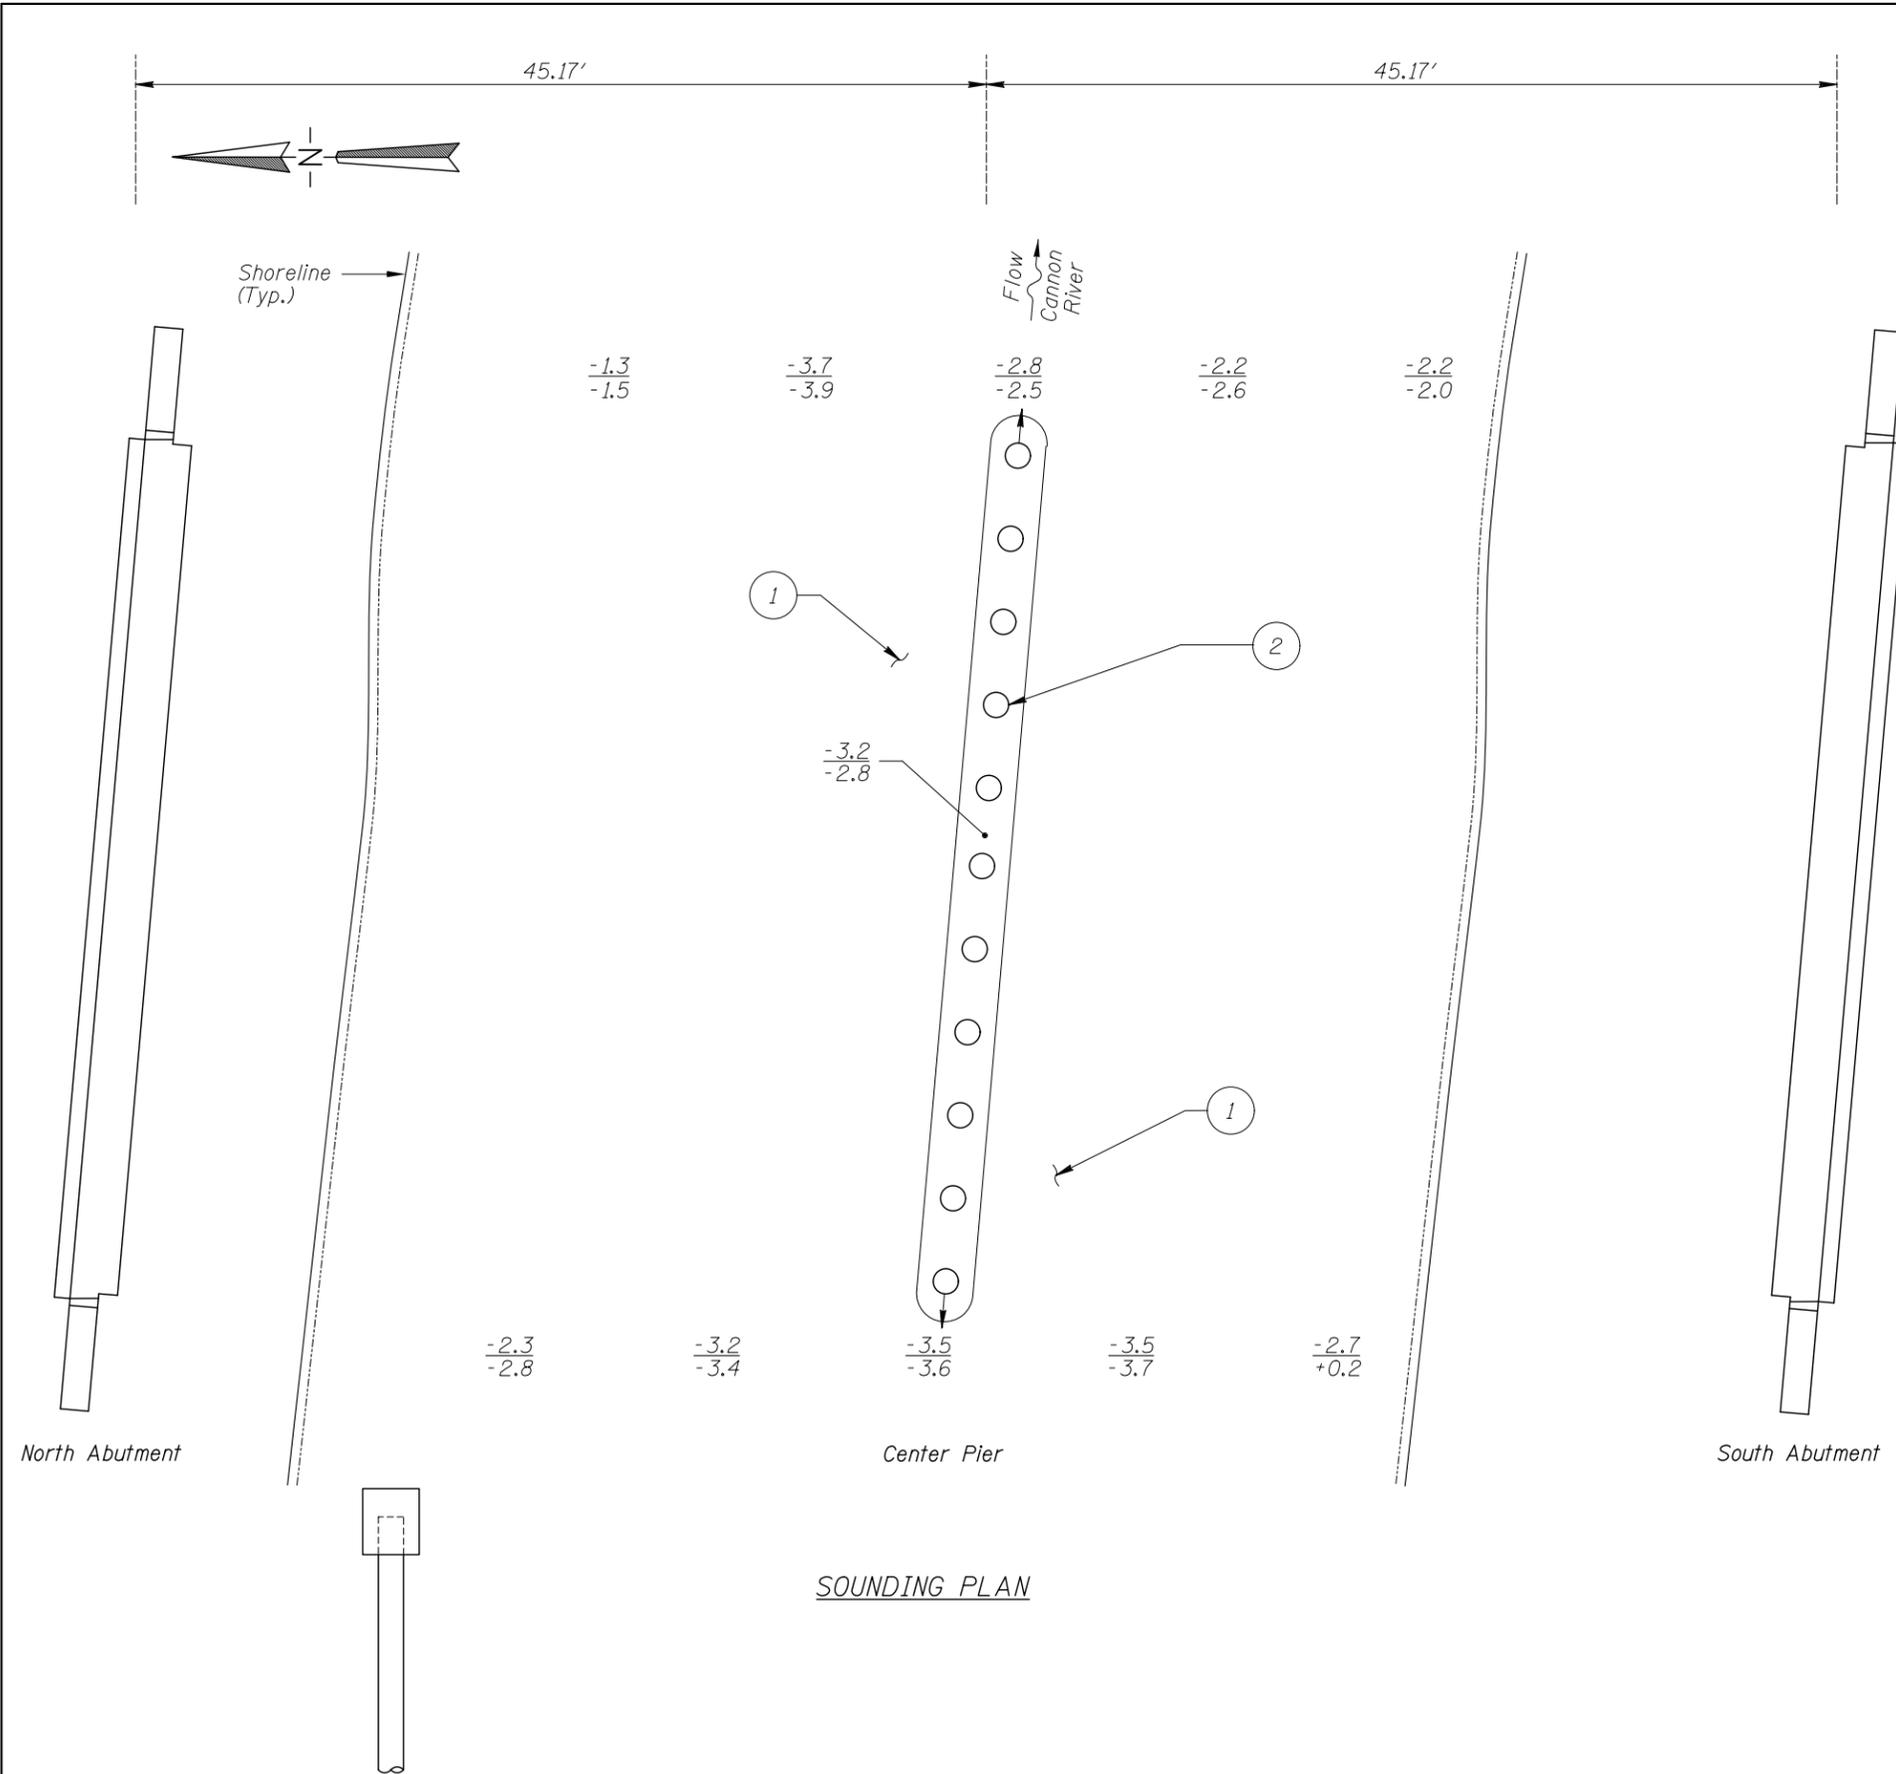
SOUNDING PLAN

- 1 The channel bottom material consisted of sand and gravel with 4 inches of maximum probe rod penetration at the west nose. The channel bottom at the east nose consisted of sand and gravel with 6 to 8 inch diameter stones and 2 inches of maximum probe rod penetration.
- 2 The steel pipe piles exhibited loss of paint coating with light surface corrosion over 100 percent of the surface area from channel bottom to 2 feet above the waterline.
