UNDERWATER BRIDGE INSPECTION REPORT

STRUCTURE NO. 52504

CSAH NO. 24

MINNESOTA RIVER

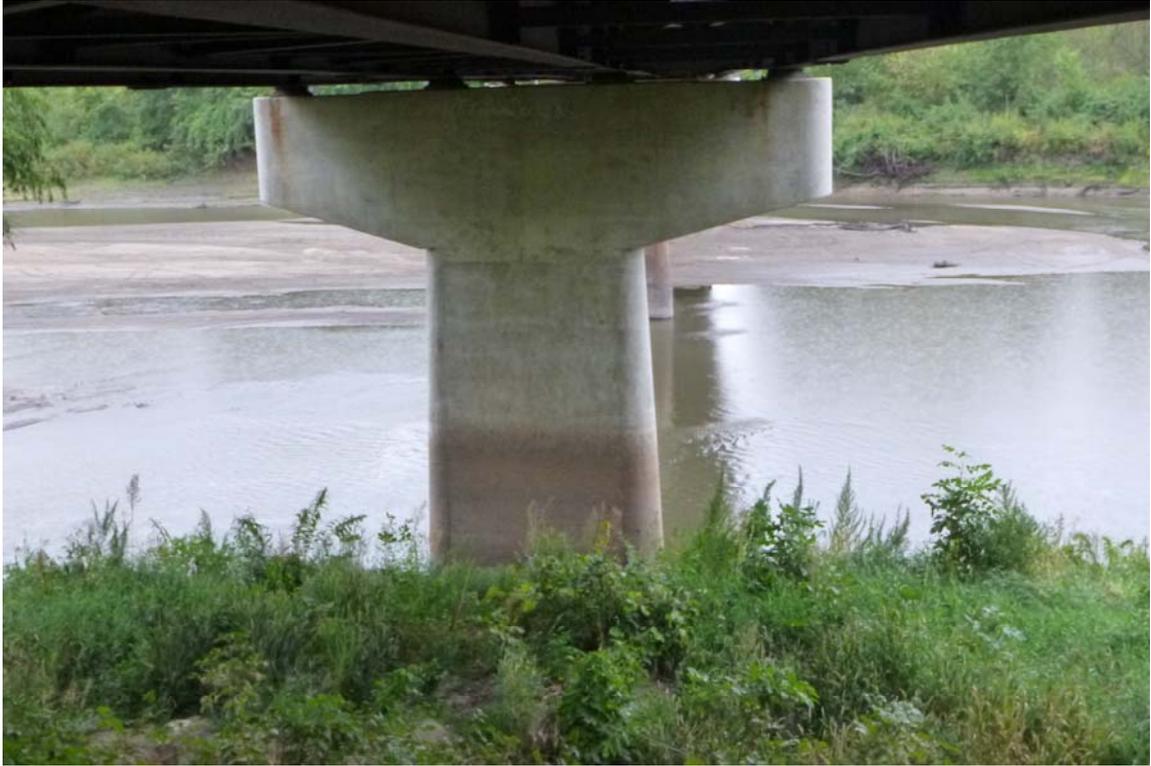
Photograph 1. View of Pier 1, Looking South.

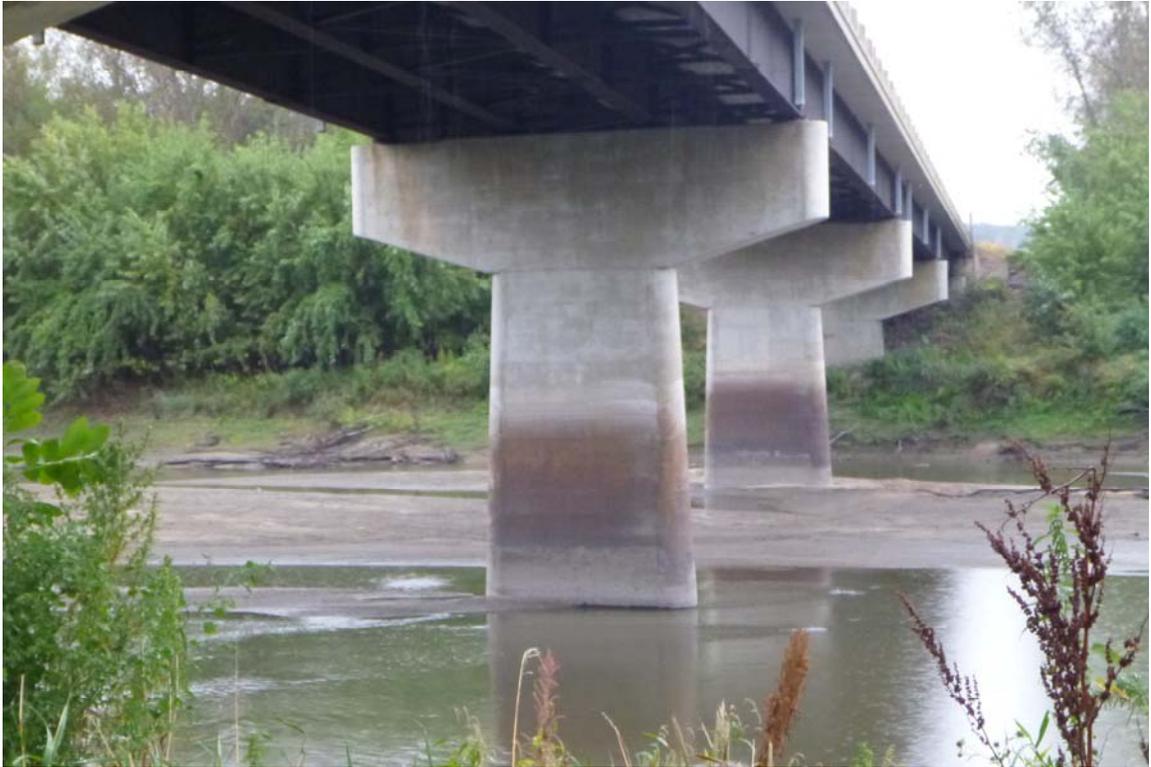
- (A) Overall, the concrete below water was in good condition with no structurally significant defects observed.
- (B) A scour depression was observed around the upstream nose of Piers 2 and 3, and measured up to 2 feet in depth by approximately 6 feet in radius.

Photograph 2. View of the Pier 2, Looking South.

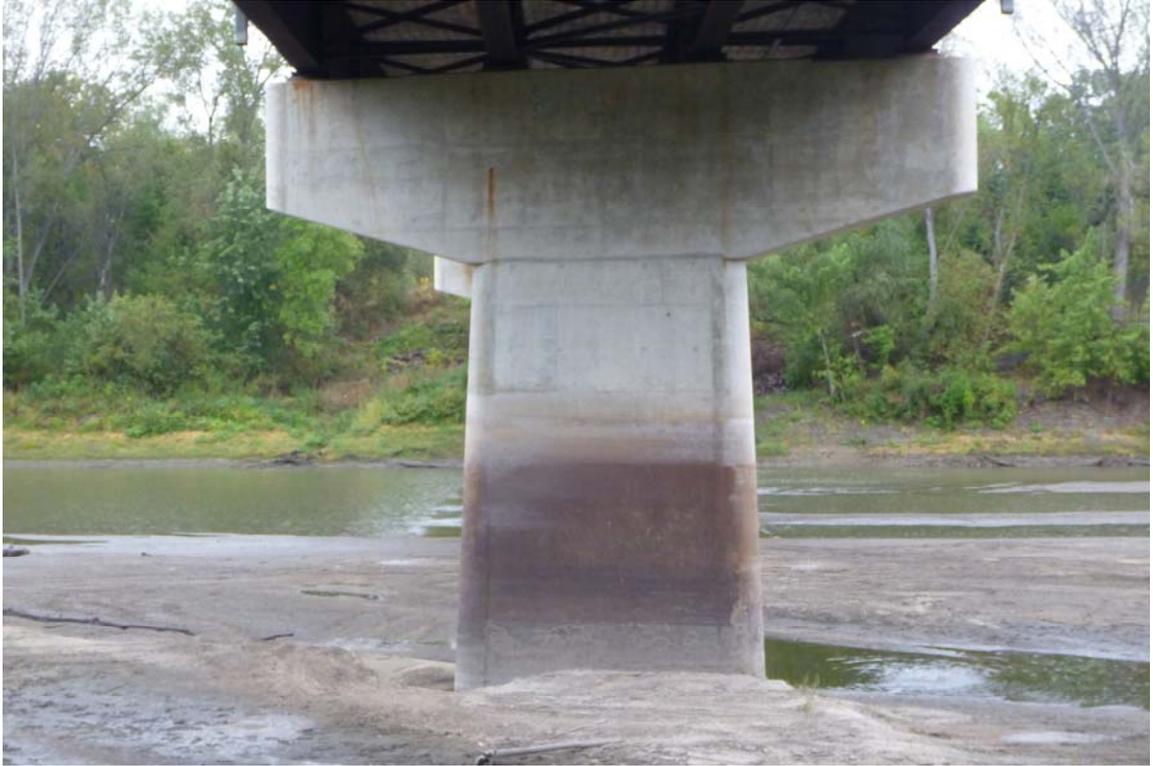
Photograph 3. View of Pier 3, Looking North.

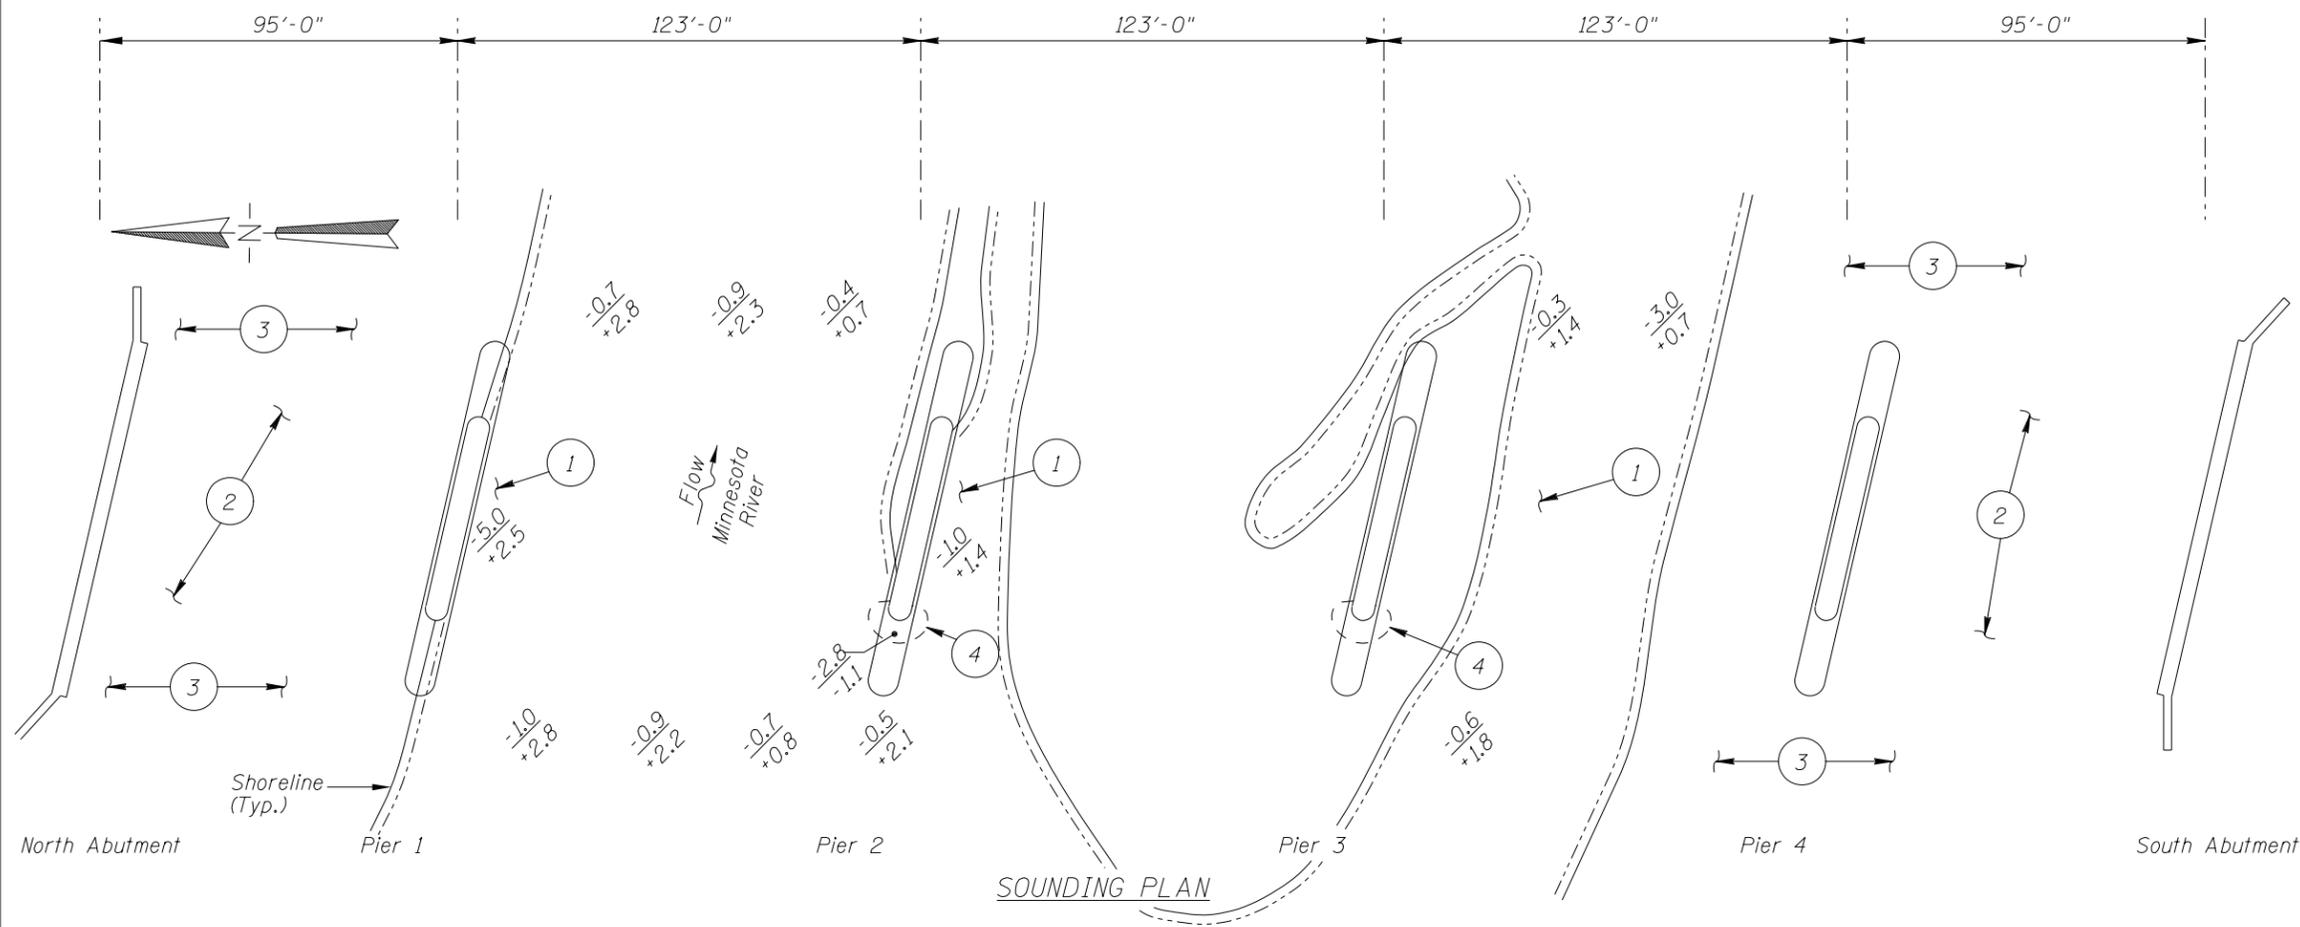
| <b>INSPECTION AND SOUNDING PLAN</b> | | |

- 1 The channel bottom material around the pier consisted of sand with up to 1 foot of probe rod penetration.
- 2 The riverbanks beneath the bridge consisted of silty sand along the shoreline with riprap in front of the abutment walls.
- 3 The upstream and downstream shorelines exhibited steep vertical erosion of the banks.
- 4 A scour depression was observed around the upstream nose of Piers 2 and 3 and measured up to 2 feet deep by approximately 6 feet in radius.
