UNDERWATER BRIDGE INSPECTION REPORT

STRUCTURE NO. 7105

DES MOINES RIVER

MINNESOTA DEPARTMENT OF TRANSPORTATION
UNDERWATER BRIDGE INSPECTION

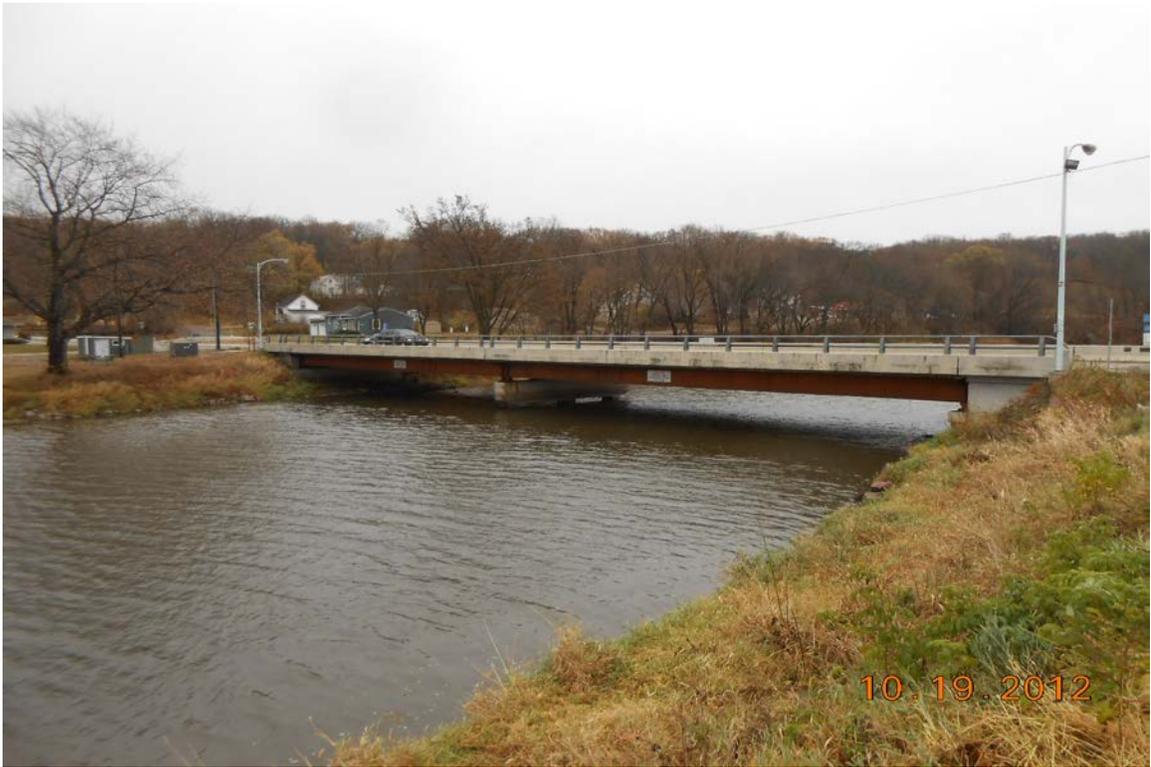
Photograph 1. Overall View of Structure, Looking Southeast.

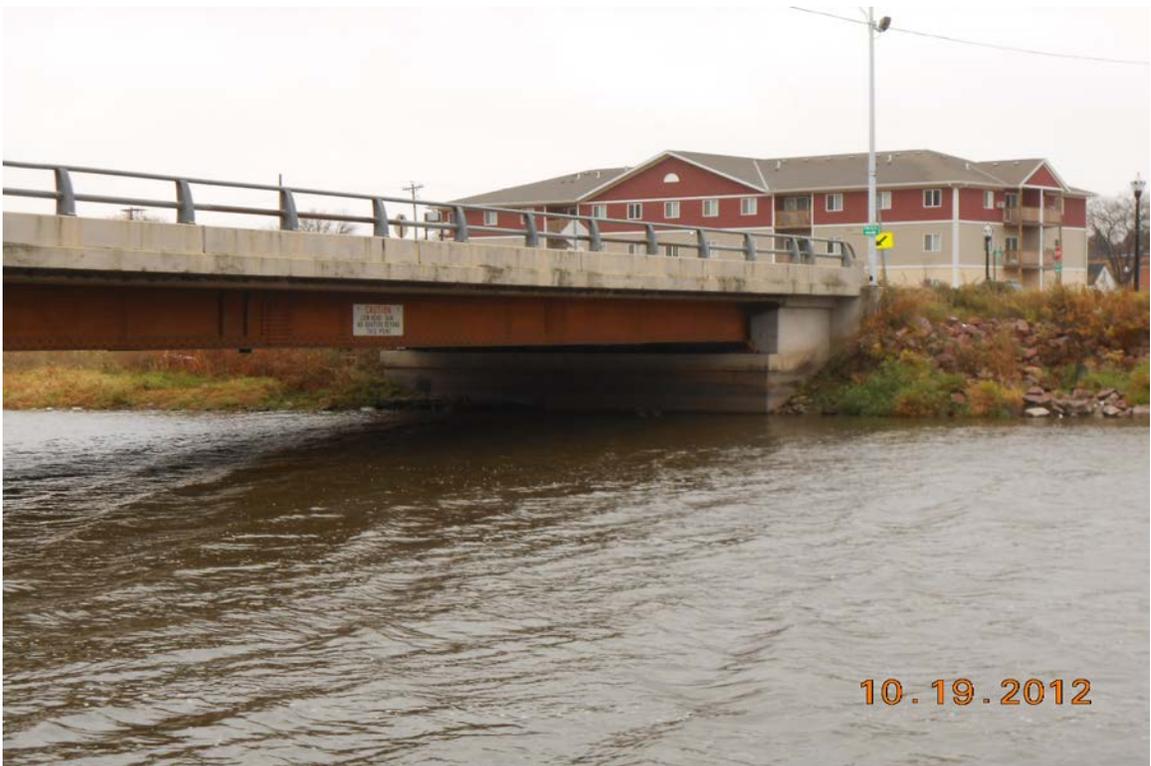
Photograph 2. View of West Abutment, Looking Southwest.

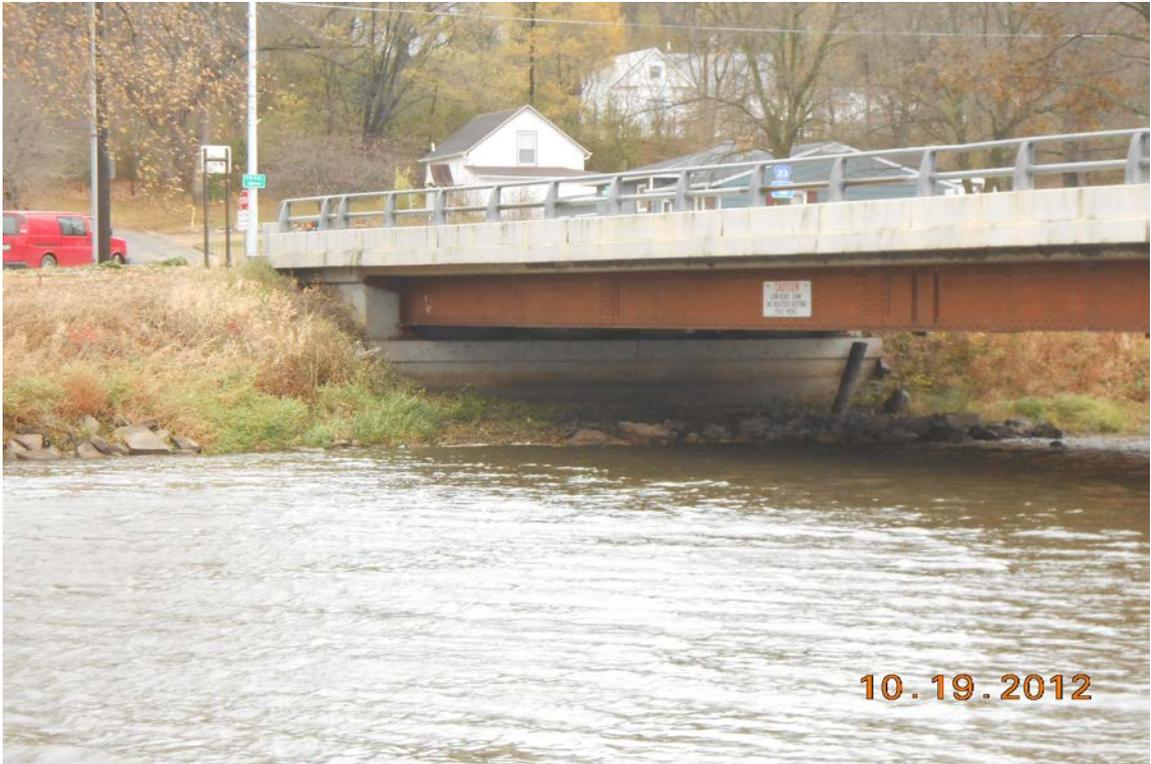
Photograph 3. View of East Abutment, Looking Southeast.

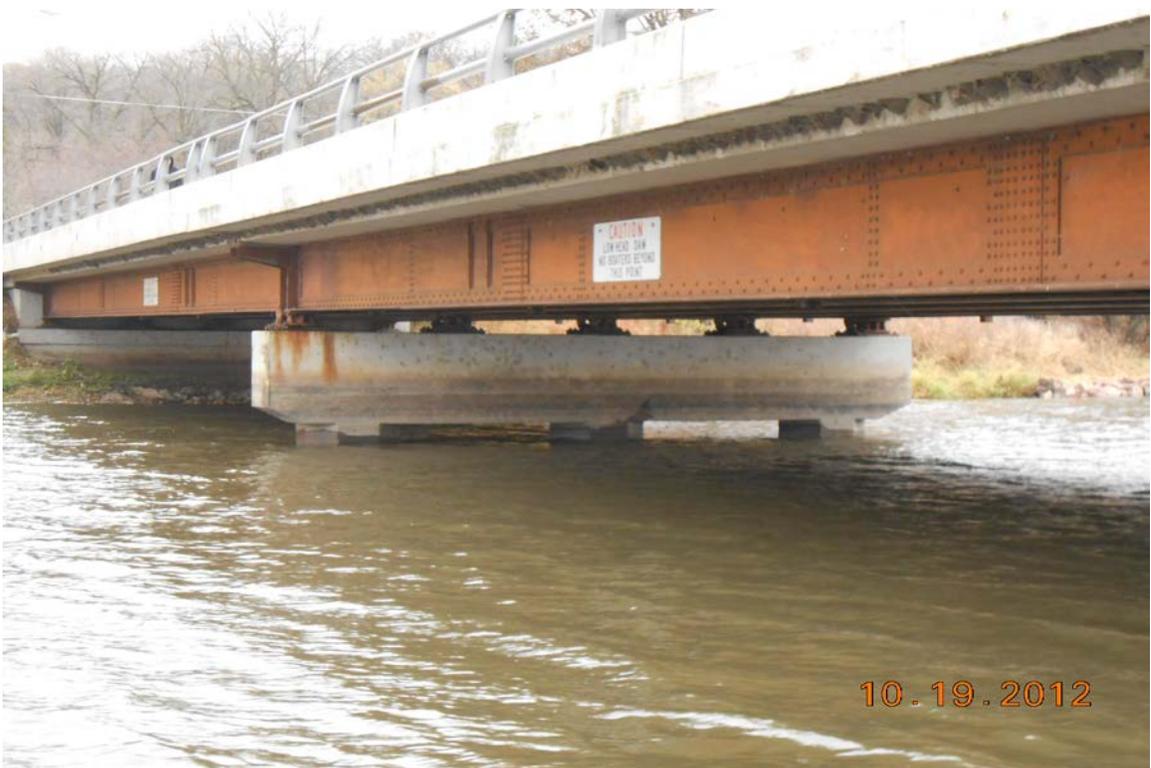
- (A) Random areas of honeycombing were observed on the downstream column of Pier 1 measuring up to 10 inches in diameter and 1 inch deep
- (B) A moderate accumulation of debris, consisting of abandoned piles and boulders, was observed around each column at Pier 1 from the streambed up 4 feet extending 4 feet away from the columns.

Photograph 4. View of Pier 1, Looking Southeast

- (A) Reinspect the submerged substructure units at the normal maximum recommended (NBIS) interval of sixty (60) months.

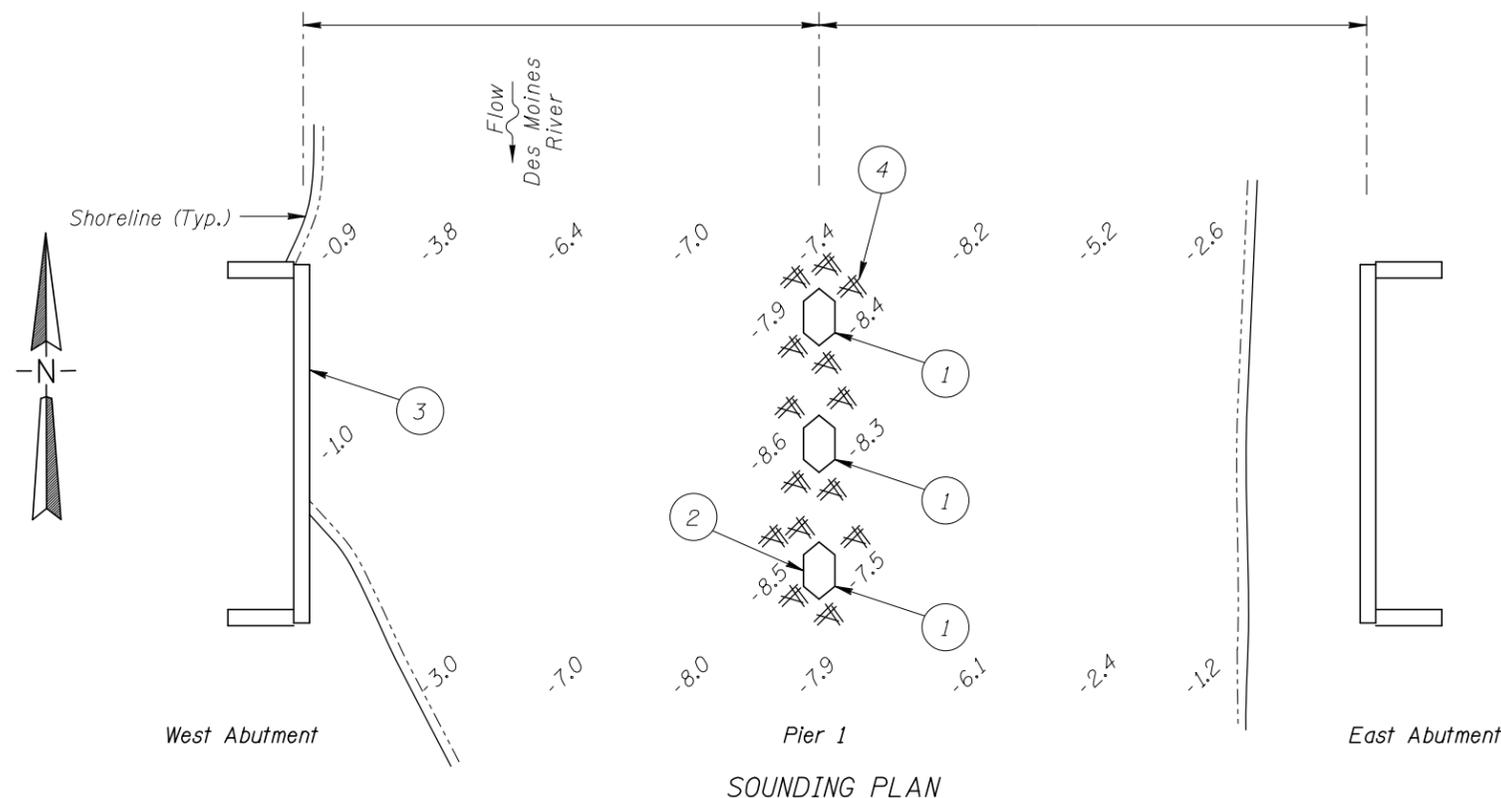
SOUNDING PLAN

- ① The concrete columns of Pier 1 were sound and in good condition with no structurally significant defects.
- ② Random areas of honeycombing were observed at the downstream column of Pier 1 up to 10 inches in diameter and 1 inch deep.
- ③ The concrete at the West Abutment was sound and in good condition with no structurally significant defects.
- ④ Moderate debris, consisting of abandoned piles and boulders, was observed around each column from the streambed up 4 feet extending 4 feet away from the columns.
