UNDERWATER BRIDGE INSPECTION REPORT

STRUCTURE NO. 7150

BLUE EARTH RIVER

SEPTEMBER 11, 2012

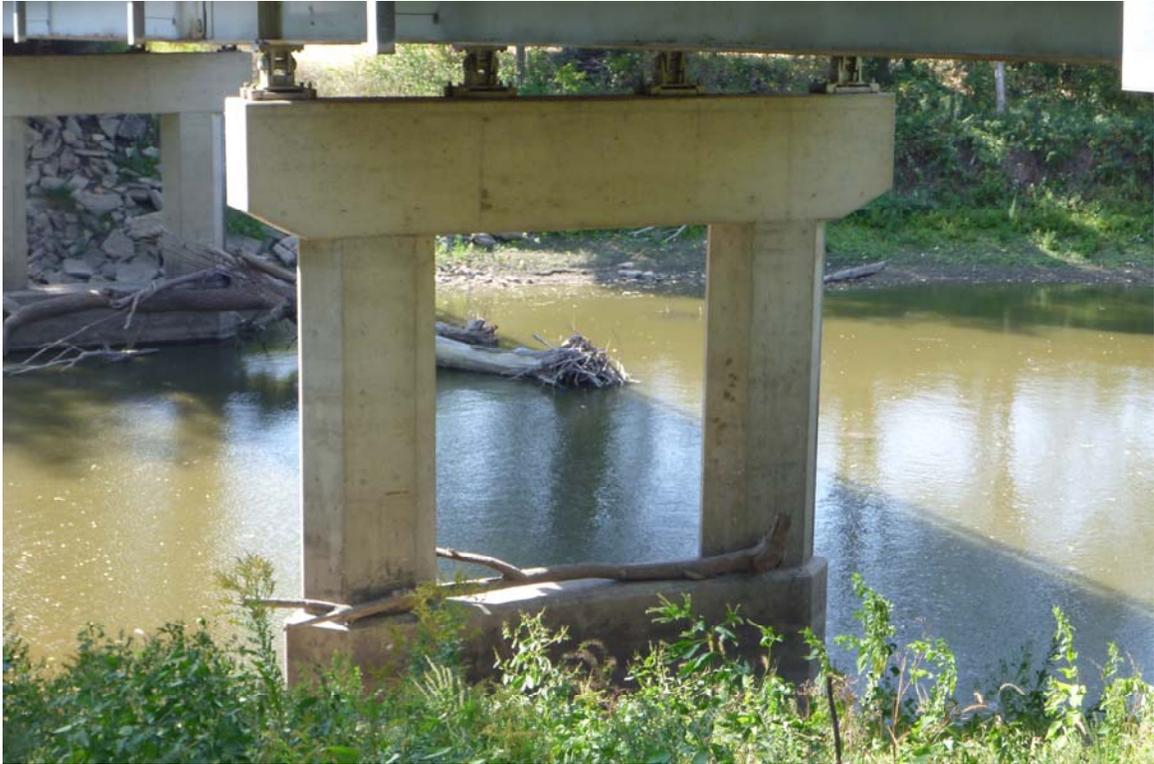
- (A) The top of the footing was exposed from the upstream nose to the upstream quarter point along the south face of Pier 1 with up to 8 inches of vertical face exposure detected.

- (B) The footing was exposed along the upstream half of the north face of Pier 2 with up to 3 inches of vertical face exposure detected.
- (C) An area of surface concrete section loss, 1.5 feet wide by 6 inches high with a penetration of 1/4 inch, was observed 1.5 feet above the waterline on the south face of the downstream end of Pier 1.

Photograph 1. View of Pier 1, Looking South.

- (A) Monitor the timber debris at Pier 2 during future inspections.
- (B) Monitor pier footing exposure during future inspections.
- (C) Reinspect the submerged substructure units at the normal maximum recommended (NBIS) interval of sixty (60) months.

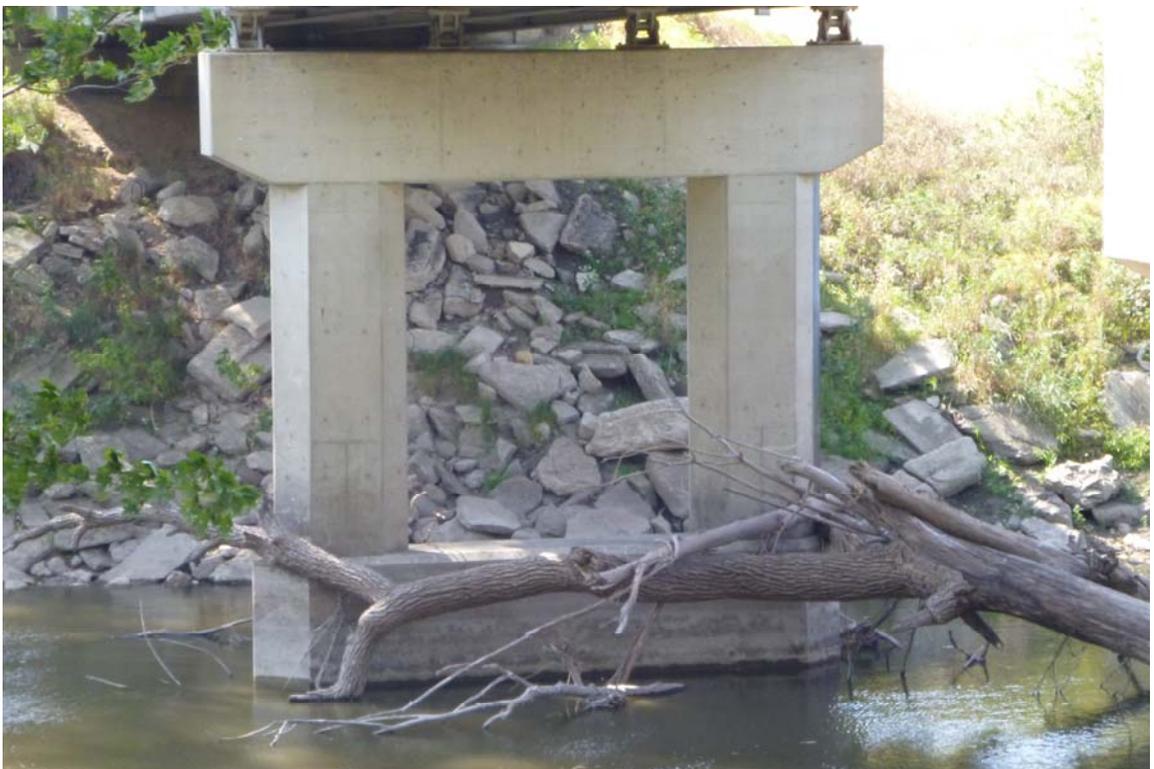
- (D) A band of light to moderate scaling from 3 feet to 1 foot above the waterline was observed 5 feet across the downstream end of Pier 2, with penetrations up to 1/2 inch deep.

- (E) Moderate to heavy accumulation of timber debris was observed along both faces and the upstream nose of Pier 2 extending from the channel bottom to 8 feet above the waterline. The debris extended up to 25 feet off the pier nose and up to 8 feet off the pier faces.

Photograph 2. View of Pier 2, Looking South.

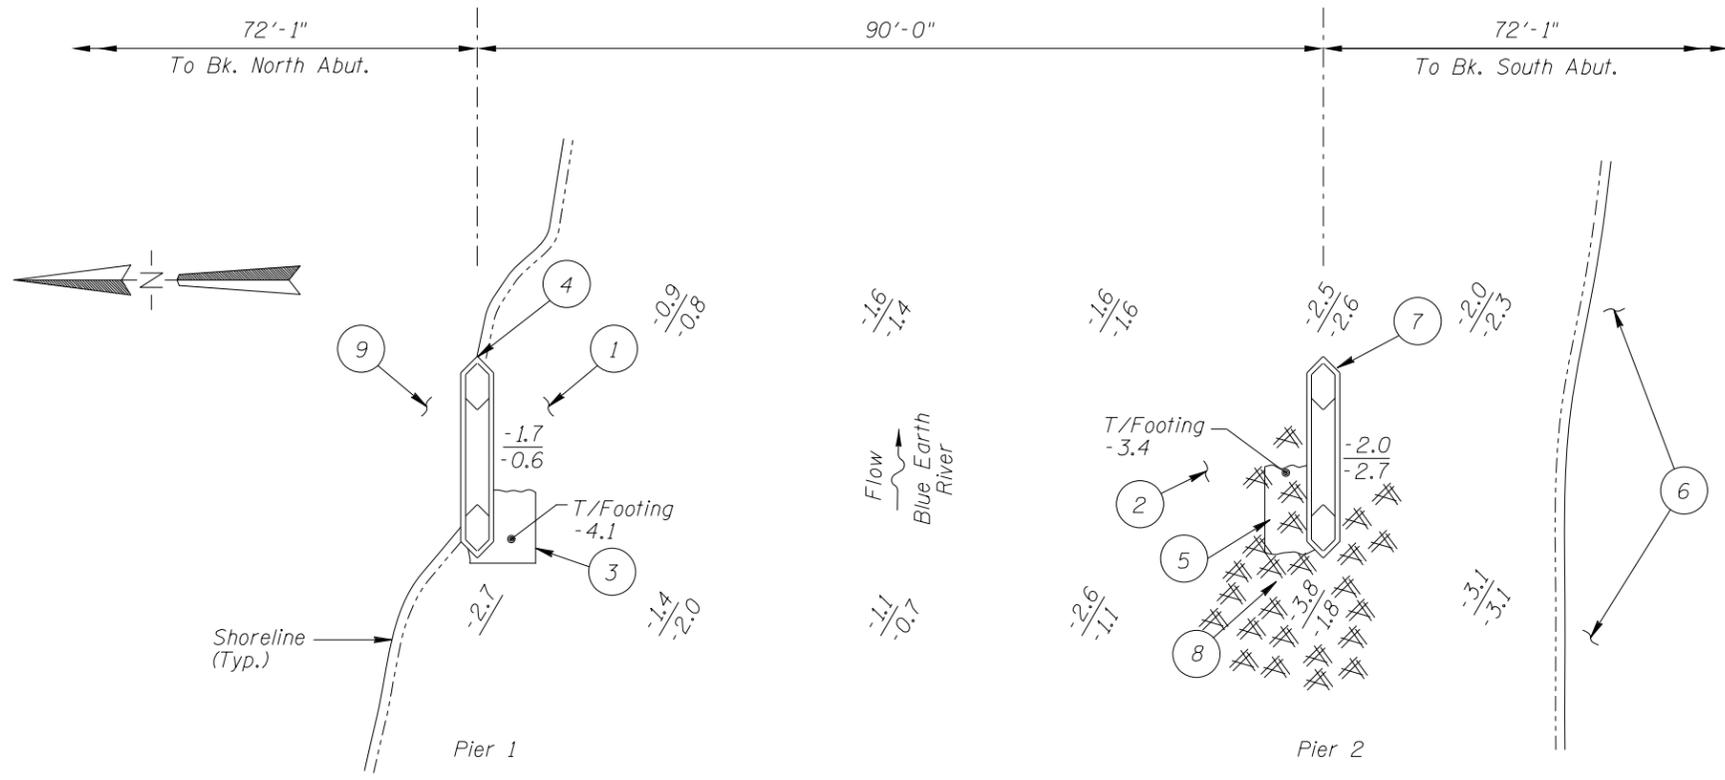
SOUNDING PLAN

- The channel bottom consisted of gravel overlaid with fine silty sand with 2 inches of probe rod penetration.
- The channel bottom consisted of fine silty sand with 3 inches of probe rod penetration.

- The top of the footing was exposed from the upstream nose to the upstream quarter point along the south face of Pier 1 with 8 inches of maximum vertical face exposure detected.

- An area of section loss, 6 inches wide by 1.5 feet high with a penetration of up to 1/4 inch, was observed at 1.5 feet above the waterline on the downstream nose of Pier 1.

- The footing was exposed along the upstream half of the north face of Pier 2 with 3 inches of maximum vertical face exposure detected.
- The South Abutment was well protected with heavy riprap and large pieces of concrete.

- A band of light to moderate scaling was observed 5 feet across the downstream end from 3 feet to 1 foot above the waterline with penetrations up to 1/2 inch deep.

- A moderate to heavy accumulation of timber debris was observed along both faces and the upstream nose of Pier 2 extending from the channel bottom to 8 feet above the waterline. The debris extended up to 25 feet off the pier nose and up to 8 feet off the pier faces.

- Up to 1.5 foot diameter riprap was protecting the north embankment along the north face of Pier 1.
