UNDERWATER BRIDGE INSPECTION REPORT

STRUCTURE NO. 7274

LE SUEUR RIVER

SEPTEMBER 11, 2012

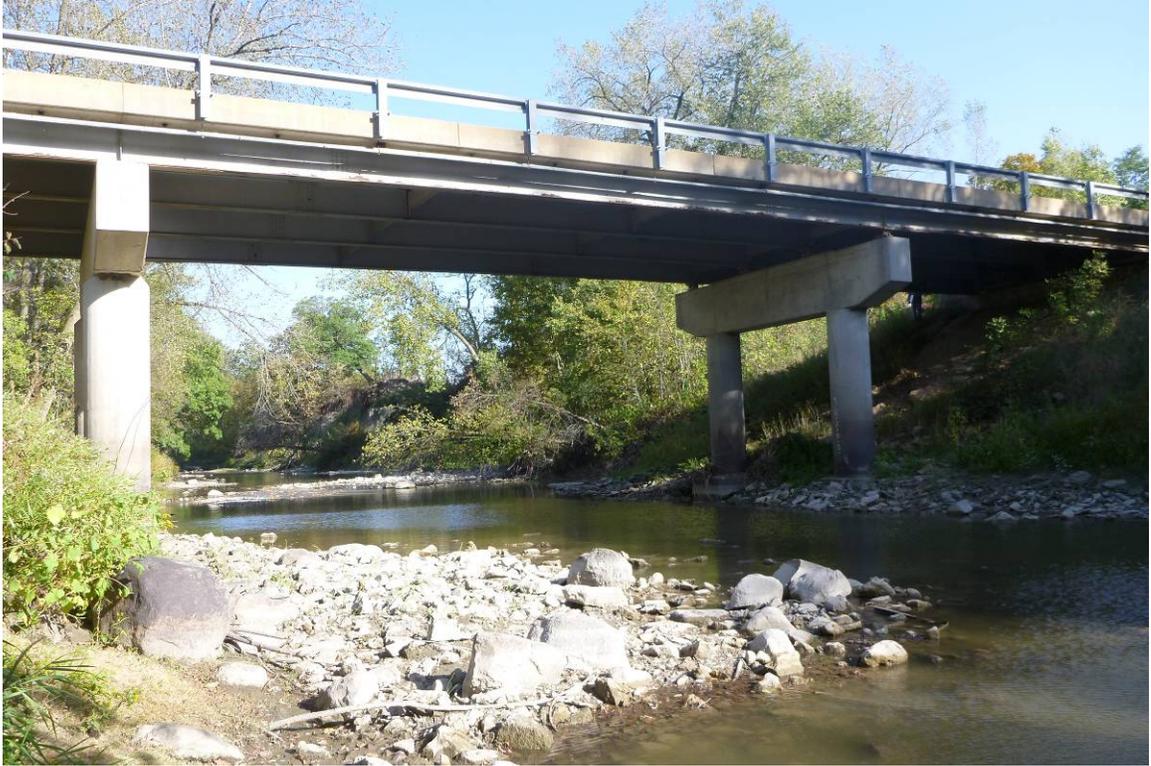
Photograph 1. Overall View of Bridge, Looking Southeast.

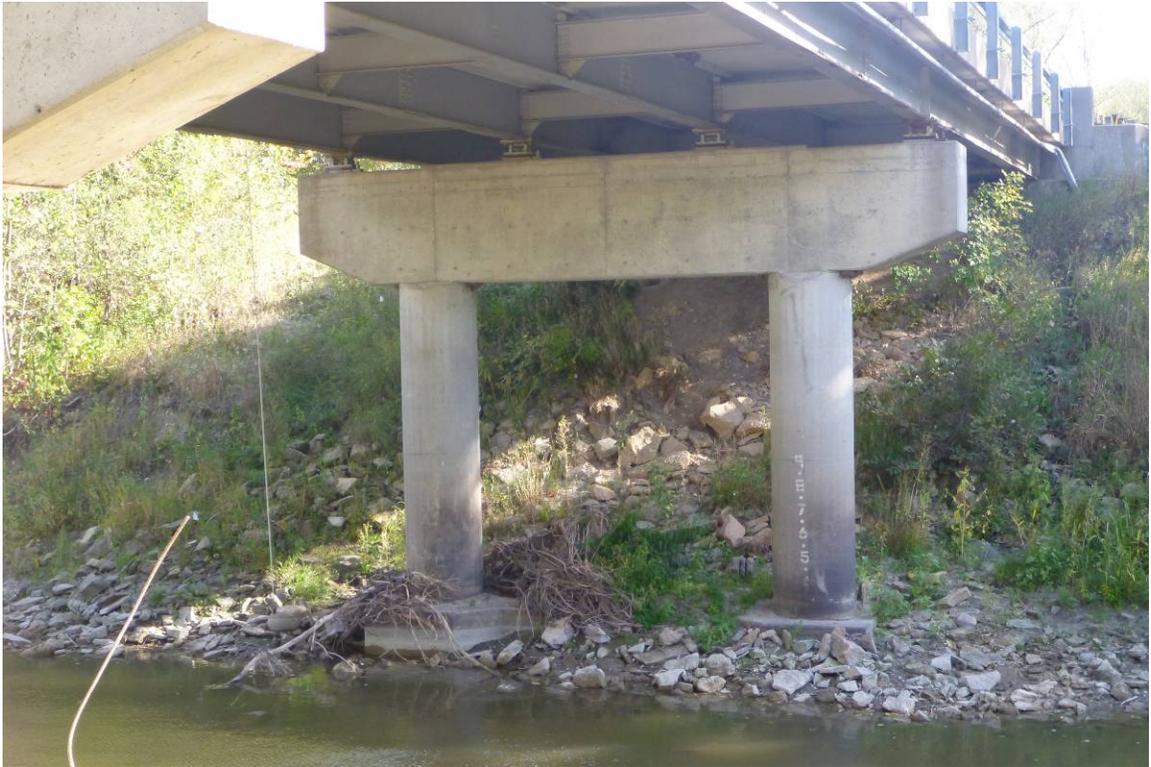
Photograph 2. View of Pier 1, Looking South.

- 6 The top of the diaphragm was exposed along the north face of Pier 1 with up to 2.2 feet of vertical face exposure at the upstream end.

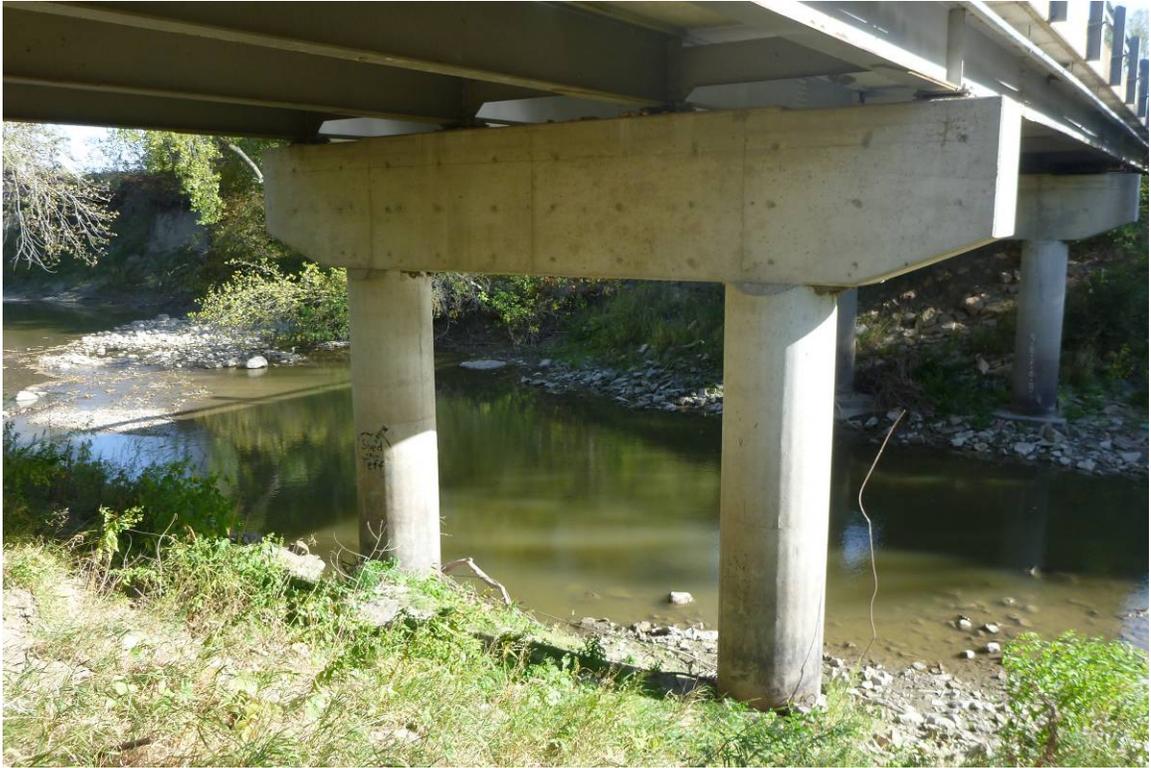
Photograph 3. View of Pier 2, Looking South.

- 4 The top of the diaphragm was exposed along the south face of Pier 2 with up to 2.1 feet of vertical face exposure at the upstream end and there was heavy section loss with exposed aggregate and reinforcing steel along the entire exposed portion. Up to 1 foot of penetration was present for the section loss.

- 5 Two horizontal steel reinforcing bars were completely exposed and were no longer embedded in the concrete diaphragm and four vertical bars were exposed at the diaphragm of upstream column of Pier 2.

- (A) Ideally, the deteriorated concrete of the diaphragm at Pier 2 should be repaired. Continue to monitor the diaphragm deterioration until repairs are accomplished.

Ideally, the deteriorated concrete of the diaphragm at Pier 2 should be repaired by removing the unsound concrete and reforming with a concrete mix designed to promote high durability and low permeability. Continue to monitor the diaphragm deformation until repairs are accomplished.

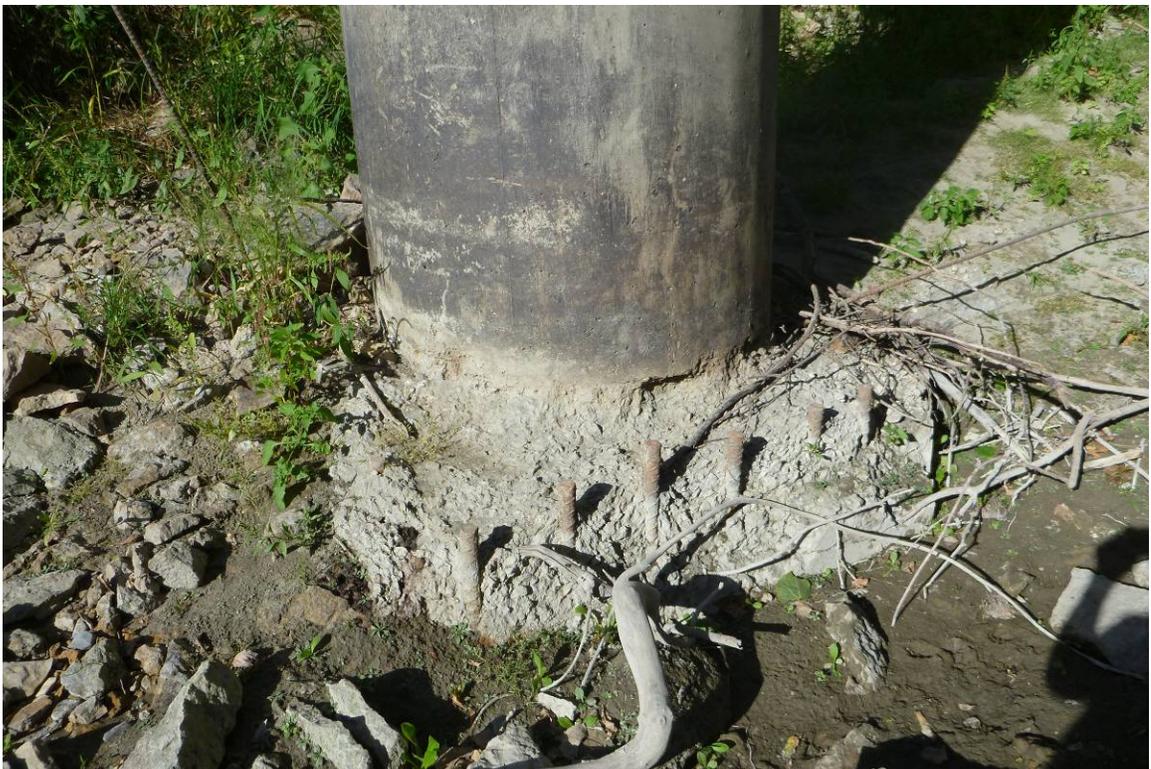
Photograph 4: View of Section Loss at the Downstream end of Pier 2, Looking Northeast.

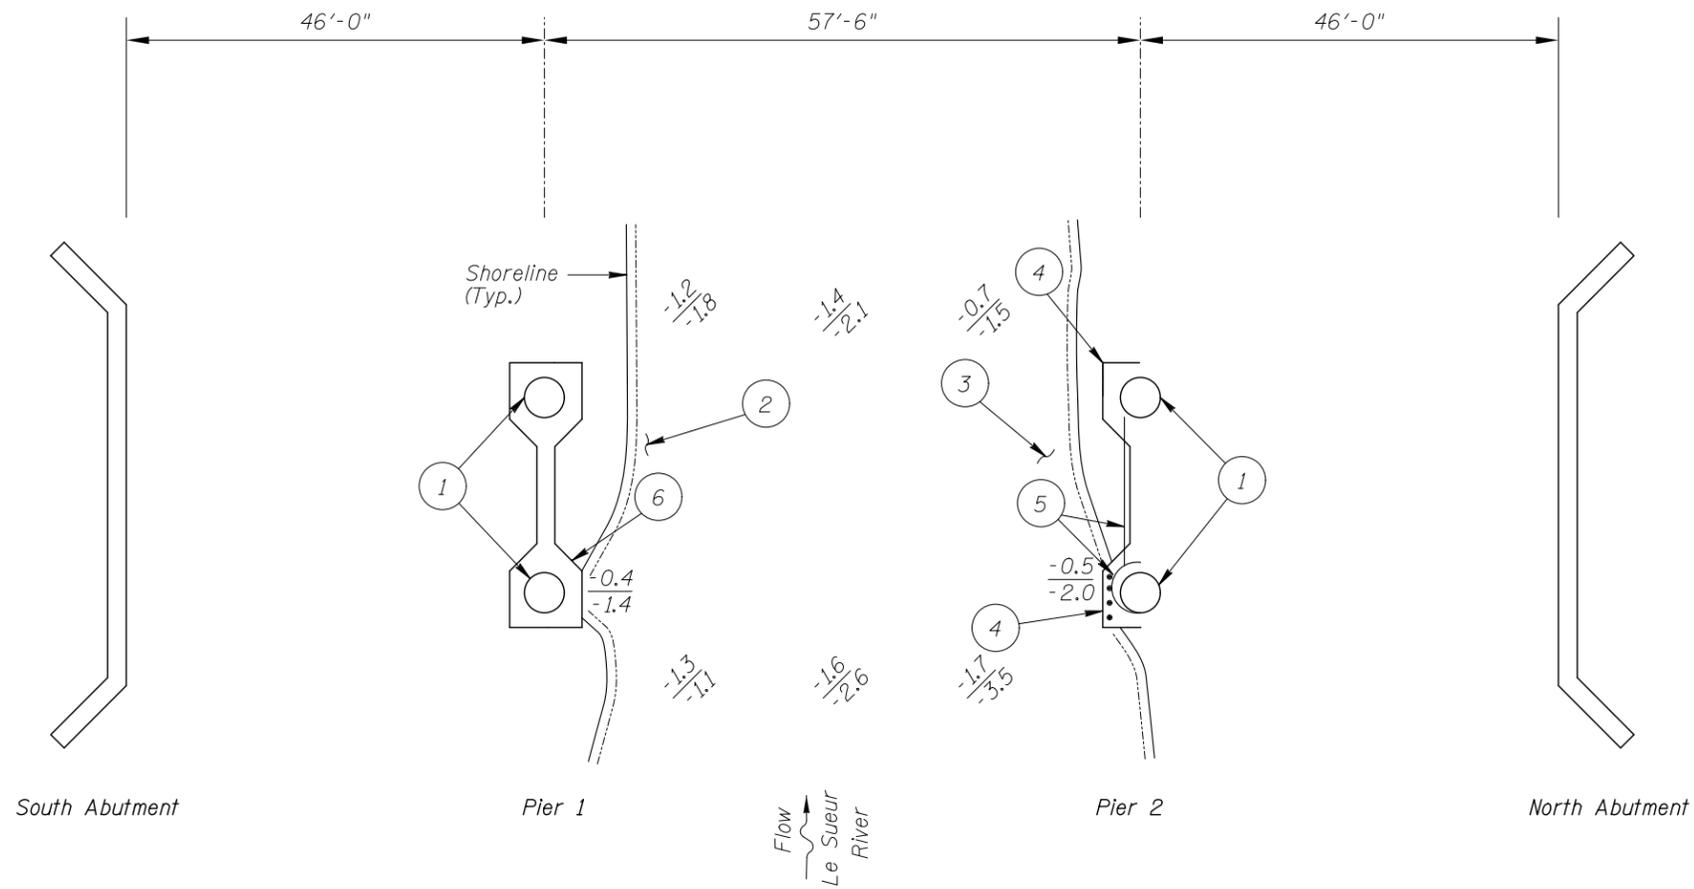
INSPECTION AND SOUNDING PLAN

- 1 Overall, the concrete columns were in good and sound condition.
- 2 The channel bottom at Pier 1 consisted of riprap with no probe rod penetration.
- 3 The channel bottom at Pier 2 consisted of sandy gravel and riprap with a probe rod penetration of 1 inch.
