UNDERWATER BRIDGE INSPECTION REPORT

STRUCTURE NO. 83001

WATONWAN RIVER

JOB NO. 2107

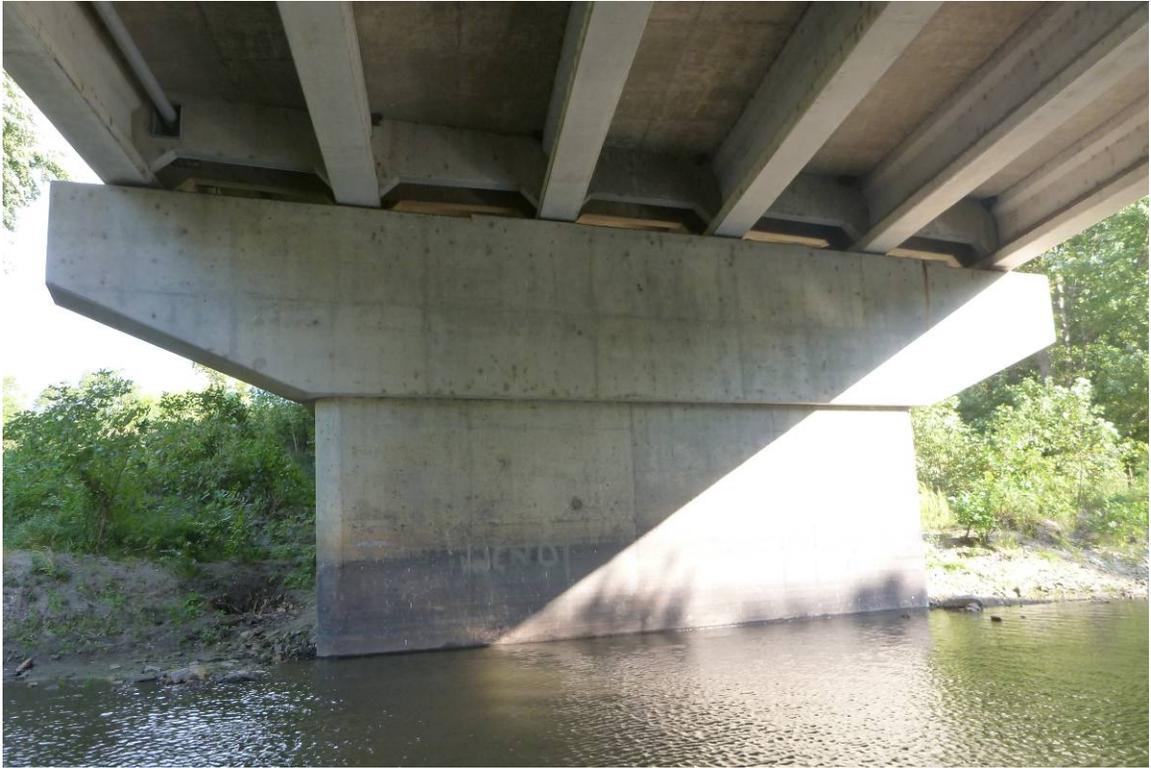
- (A) The channel bottom material consisted of silty sand with cobbles and random riprap allowing up to 2 inches of probe rod penetration.
- (B) Concrete surfaces of Piers 1 and 2 were smooth and sound with no appreciable defects noted.

Photograph 1. View of Pier 2, Looking North.

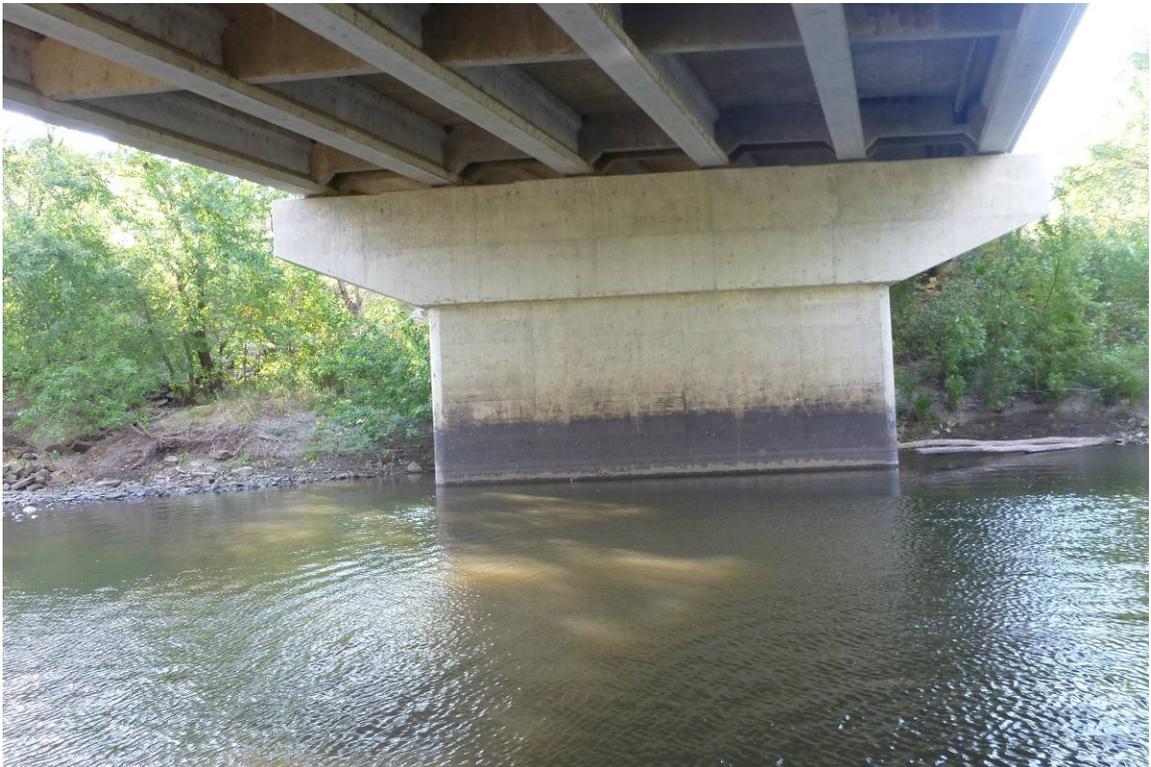
Photograph 2. View of Pier 1, Looking South.

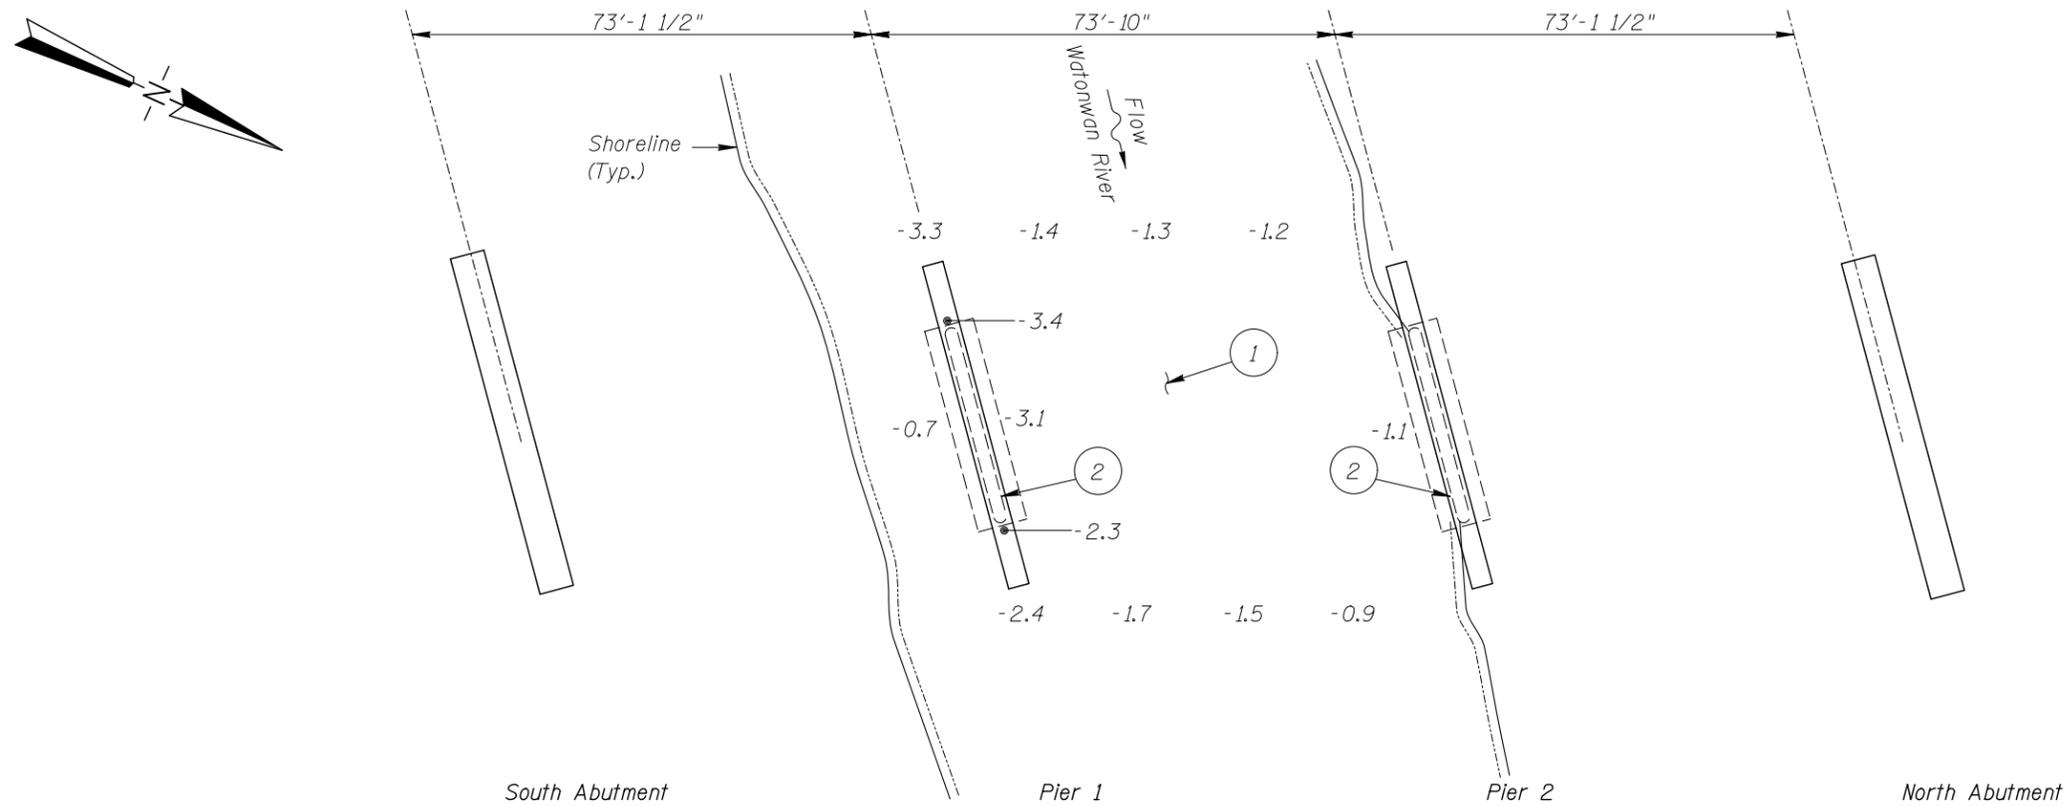
SOUNDING PLAN

- ① The channel bottom material consisted of firm silty sand with cobbles and random riprap allowing up to 2 inches of probe rod penetration.
- ② The concrete of both piers was typically smooth and sound with no appreciable defects.
