UNDERWATER BRIDGE INSPECTION REPORT

STRUCTURE NO. 6391

MINNESOTA RIVER

COLLINS ENGINEERS, INC.

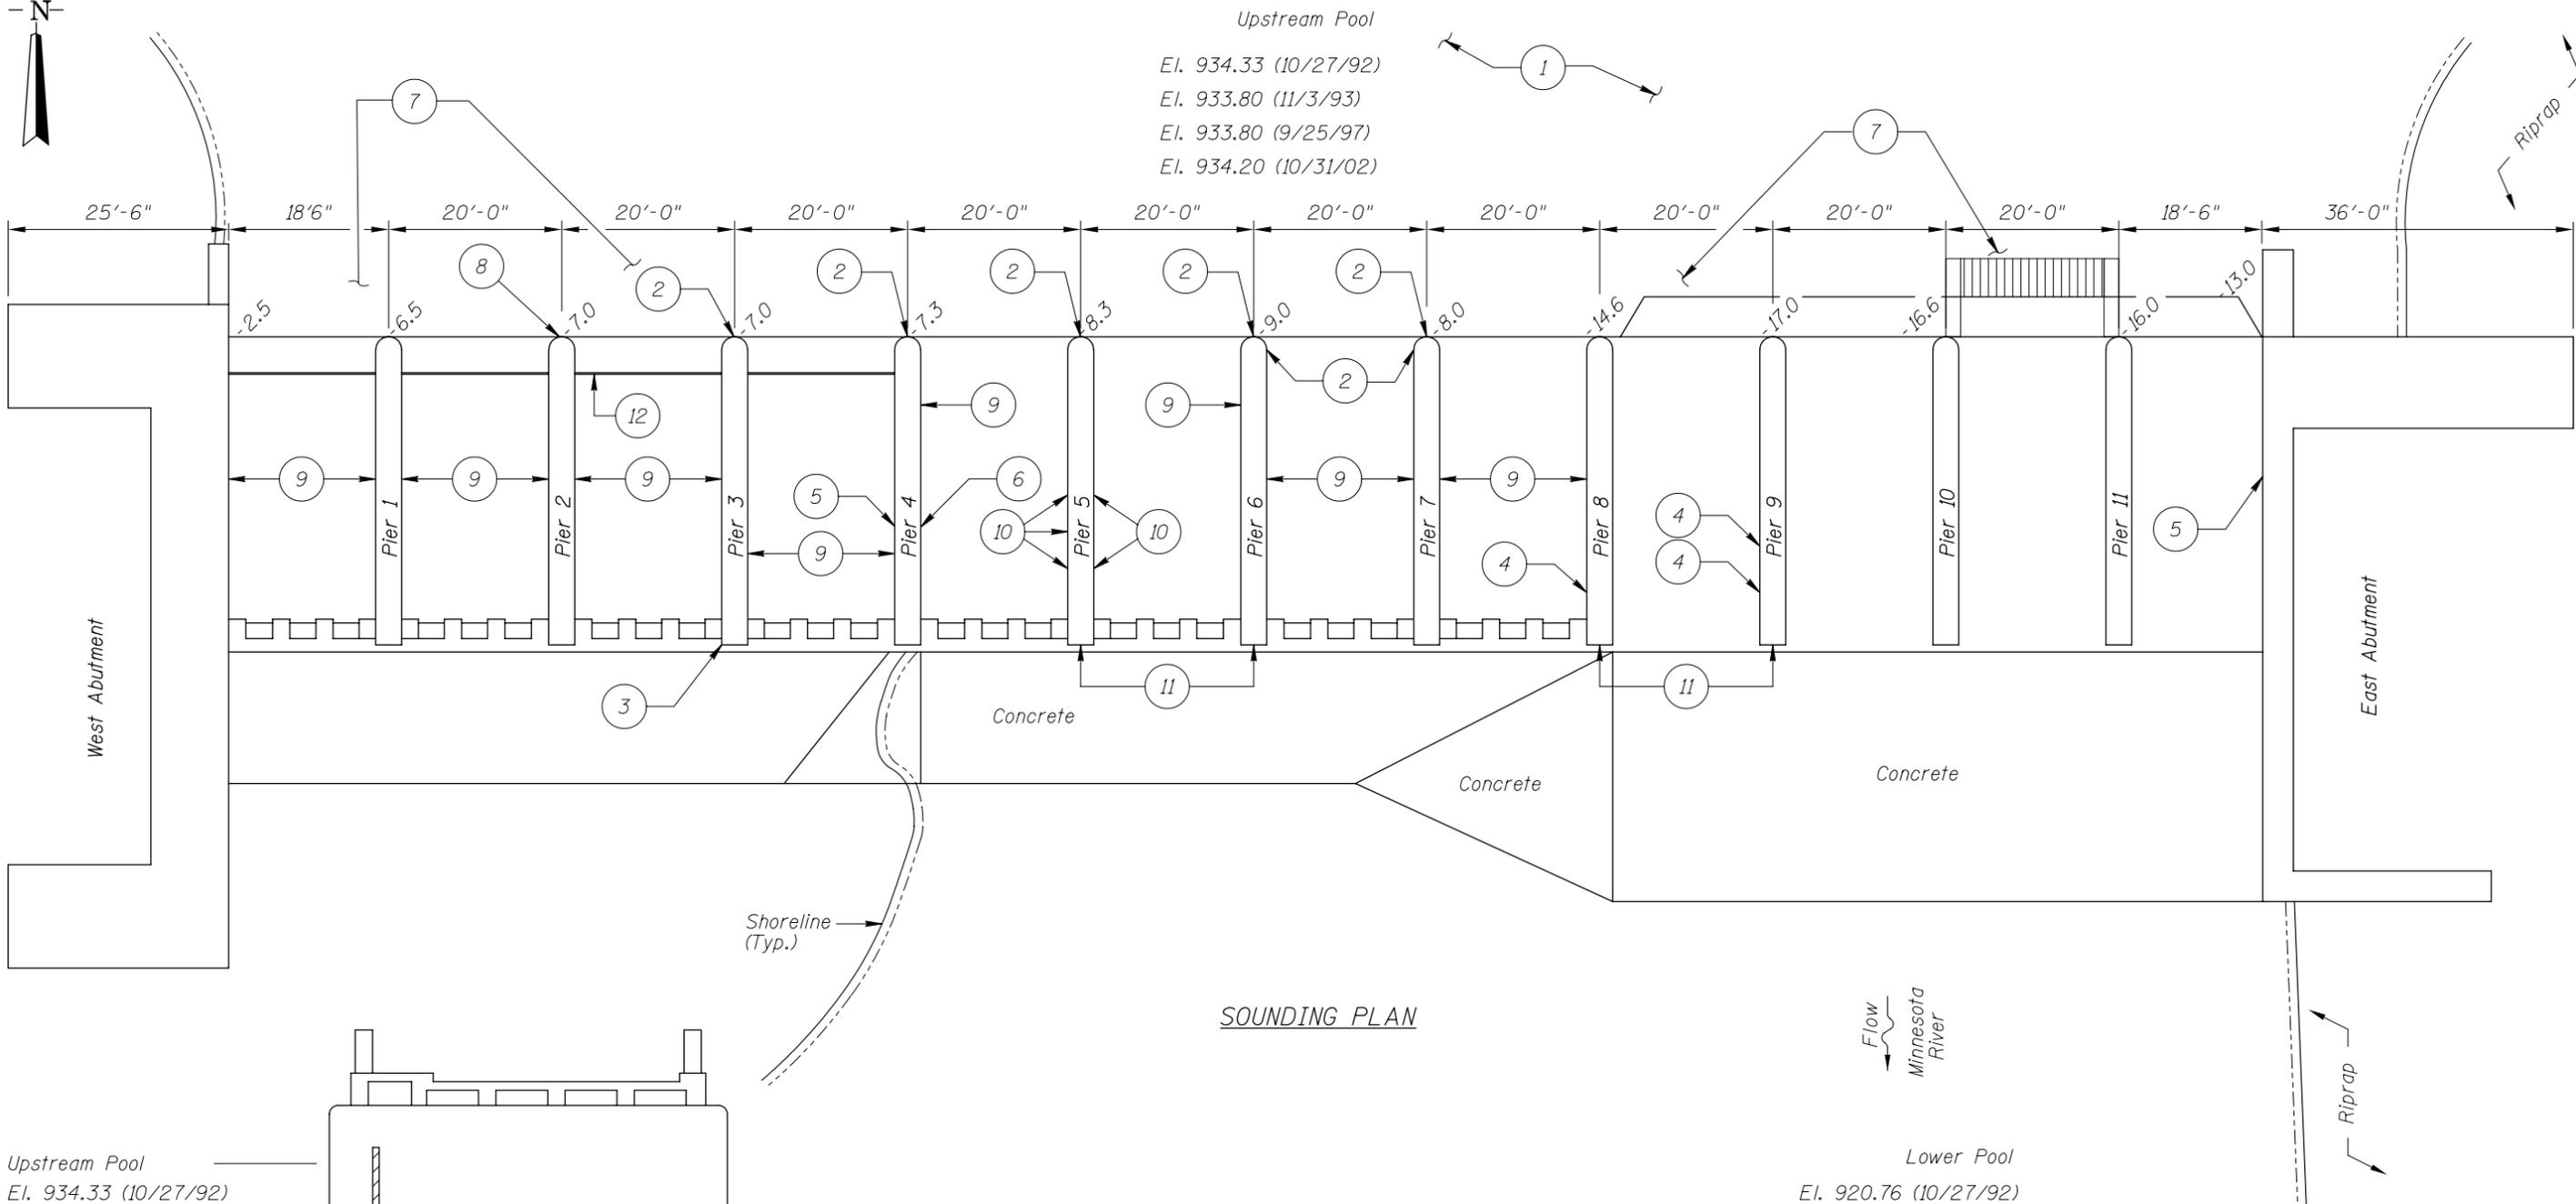
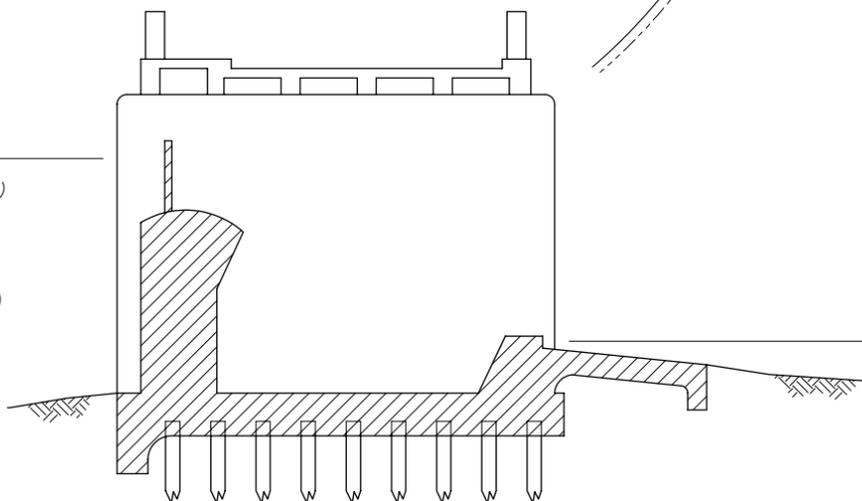
TYPICAL SECTION OF DAM & PIER
 N.T.S.

SOUNDING PLAN

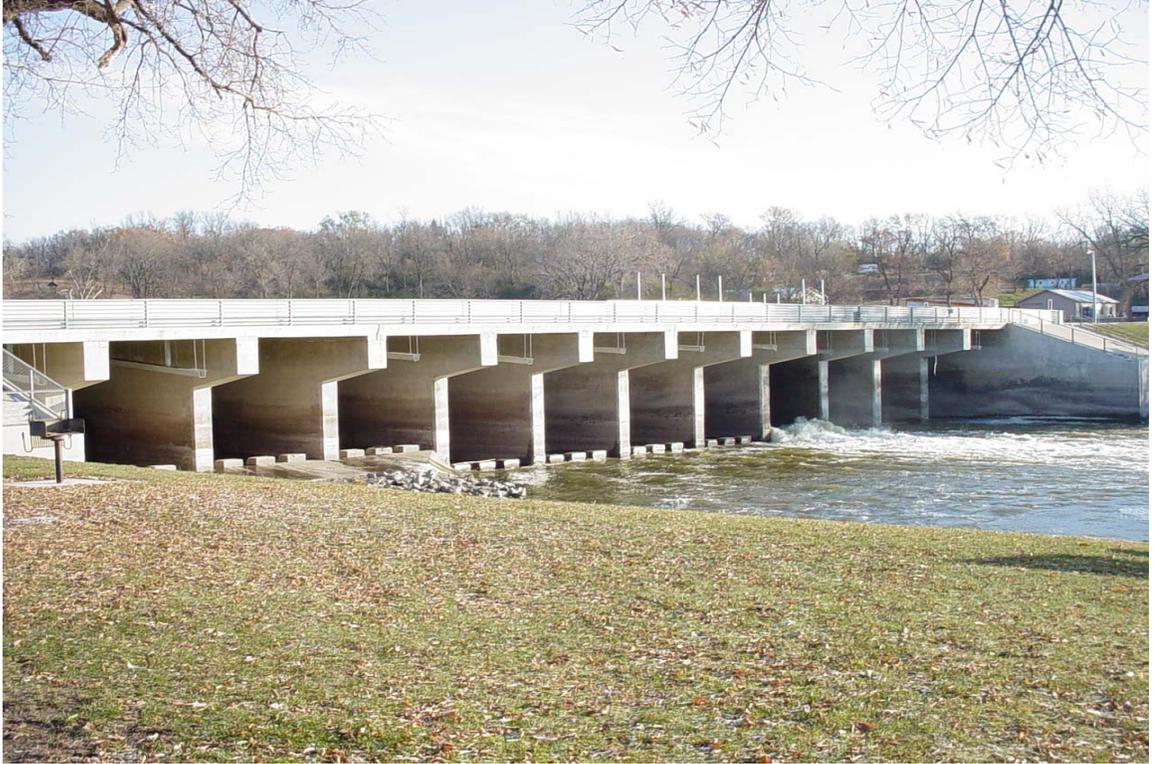
Photograph 1. Overall View of the Structure, Looking Northeast.

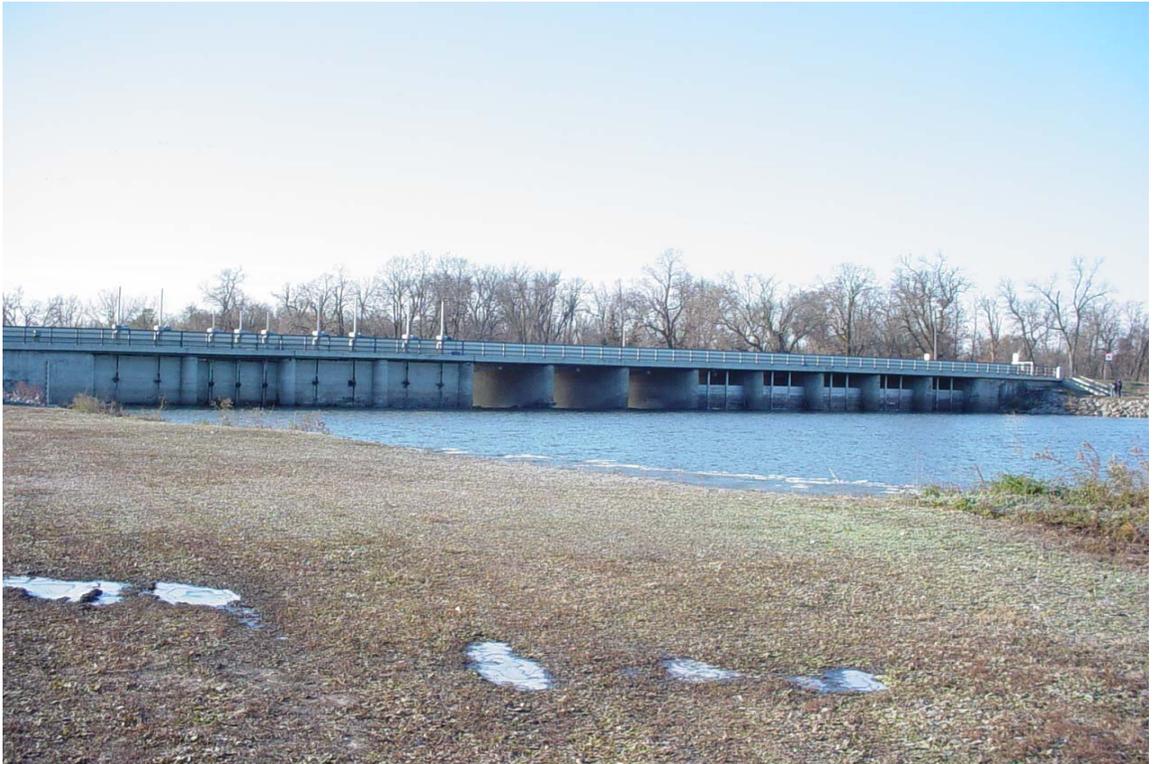
Photograph 2. Overall View of the Structure, Looking Southwest

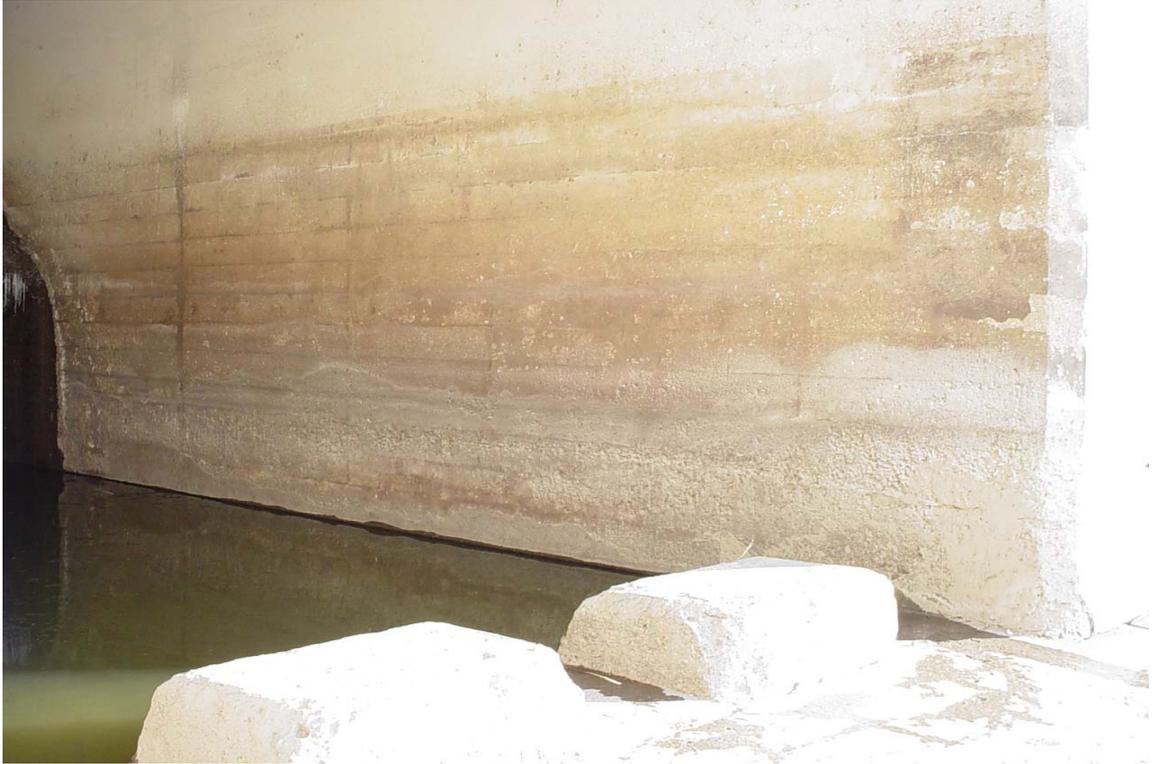
Photograph 3. View of the West Face of Pier 1, Looking Northeast.

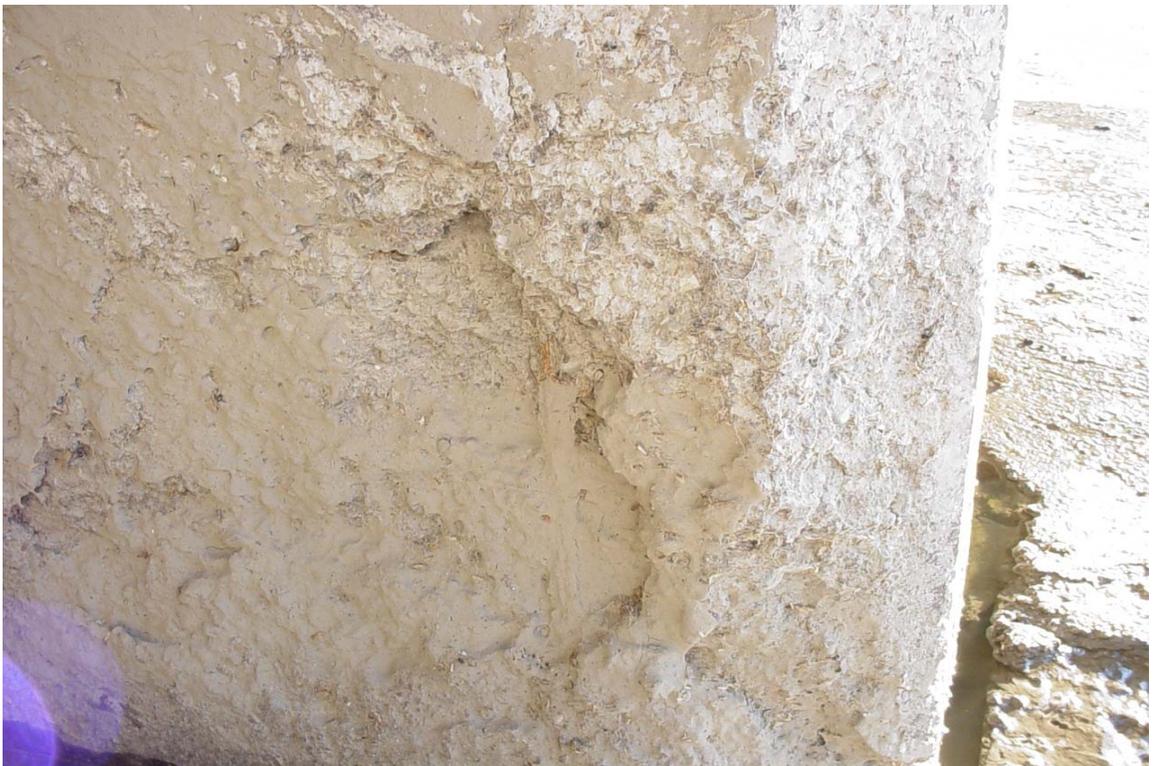
- (A) There was moderate to heavy scaling (relate to ice damage) throughout most of the pier faces from 8 feet above the waterline to approximately 3 feet below the waterline. The scaling displayed penetrations of up to 3 inches with, in some cases, exposed reinforcing steel that exhibited less than 10% section loss.
- (B) Several spalls with exposed reinforcing steel that exhibited less than 10% section loss were observed at random locations on most of the piers.
- (C) Timber debris was observed scattered on the upstream channel bottom with pieces that were up to 10 inches in diameter.

Photograph 4. View of the Upstream Nose of Pier 3, Looking East. Note the Deteriorated Condition of the Concrete.

- (A) To prevent further, more detrimental deformations repair all areas of spalling or heavy scaling with exposed reinforcing steel with a concrete grout mix designed to provide high durability with a low permeability.

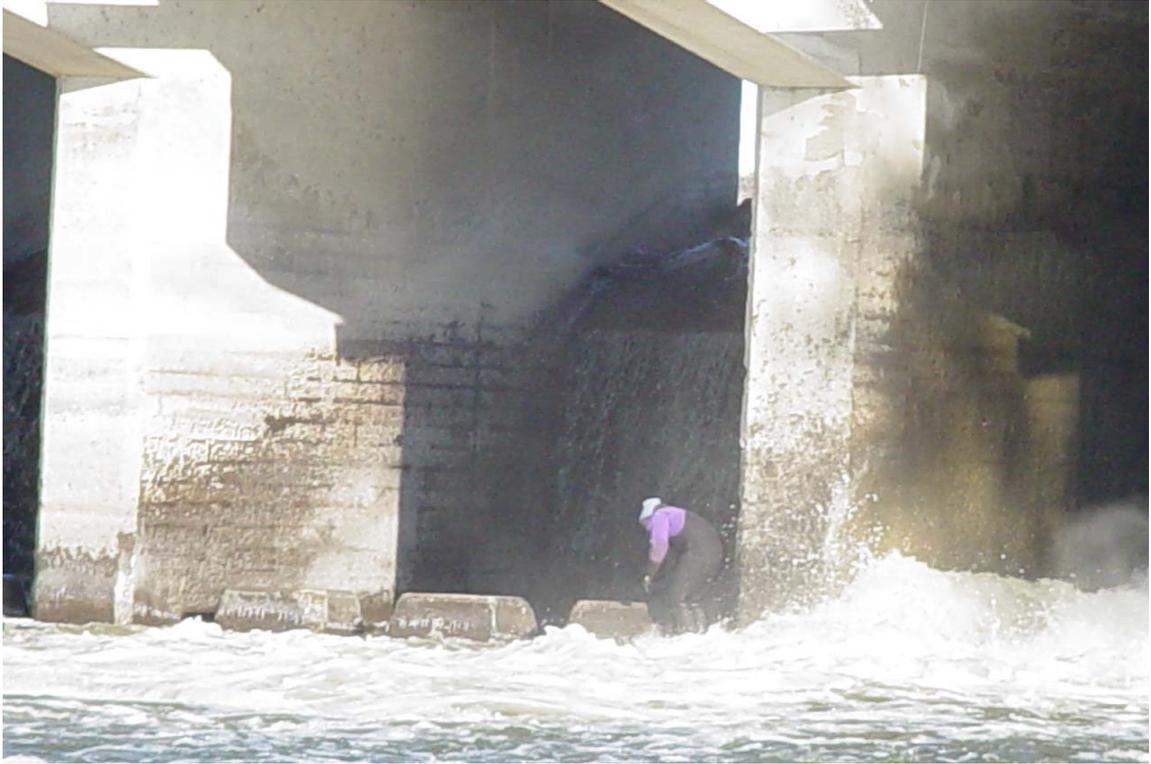
Photograph 5. View of Piers 7 and 8, Looking Northwest.

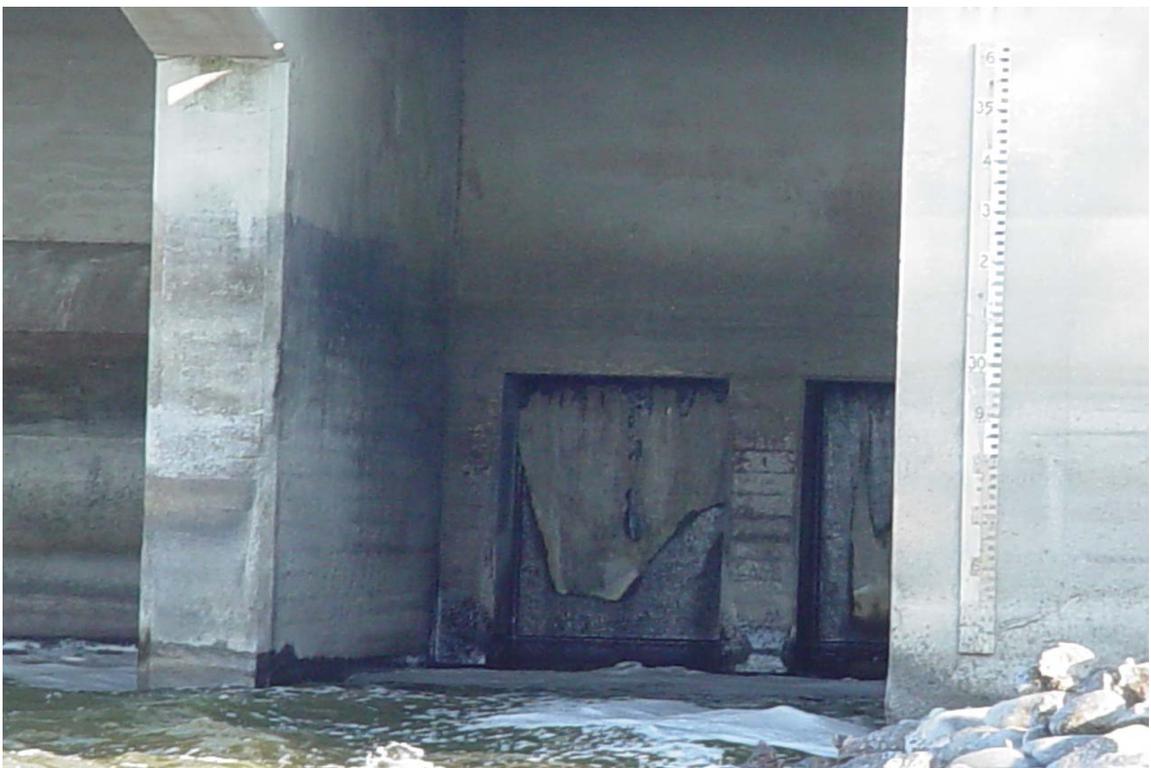
Photograph 6. View of Pier 11 and the East Abutment, Looking Northwest.
