UNDERWATER BRIDGE INSPECTION REPORT

STRUCTURE NO. 6611

MINNESOTA RIVER

DISTRICT 8 - CHIPPEWA COUNTY

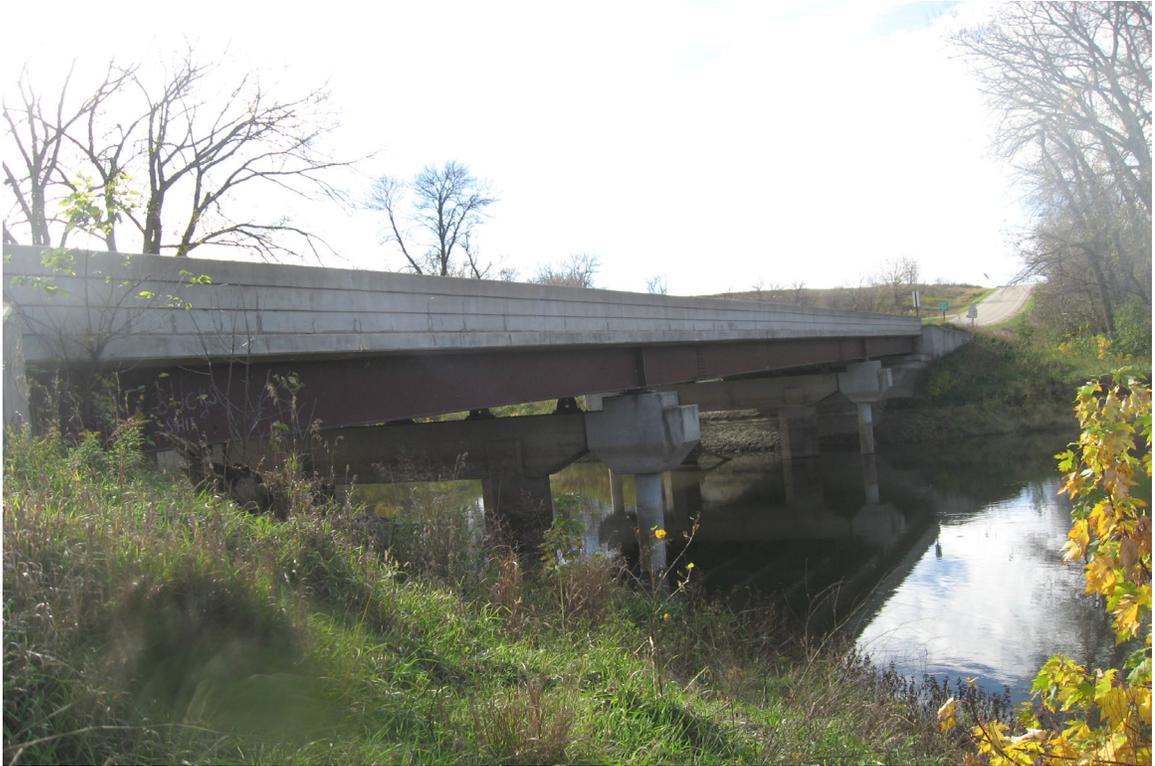
Photograph 1. Overall View of the Structure, Looking Southwest.

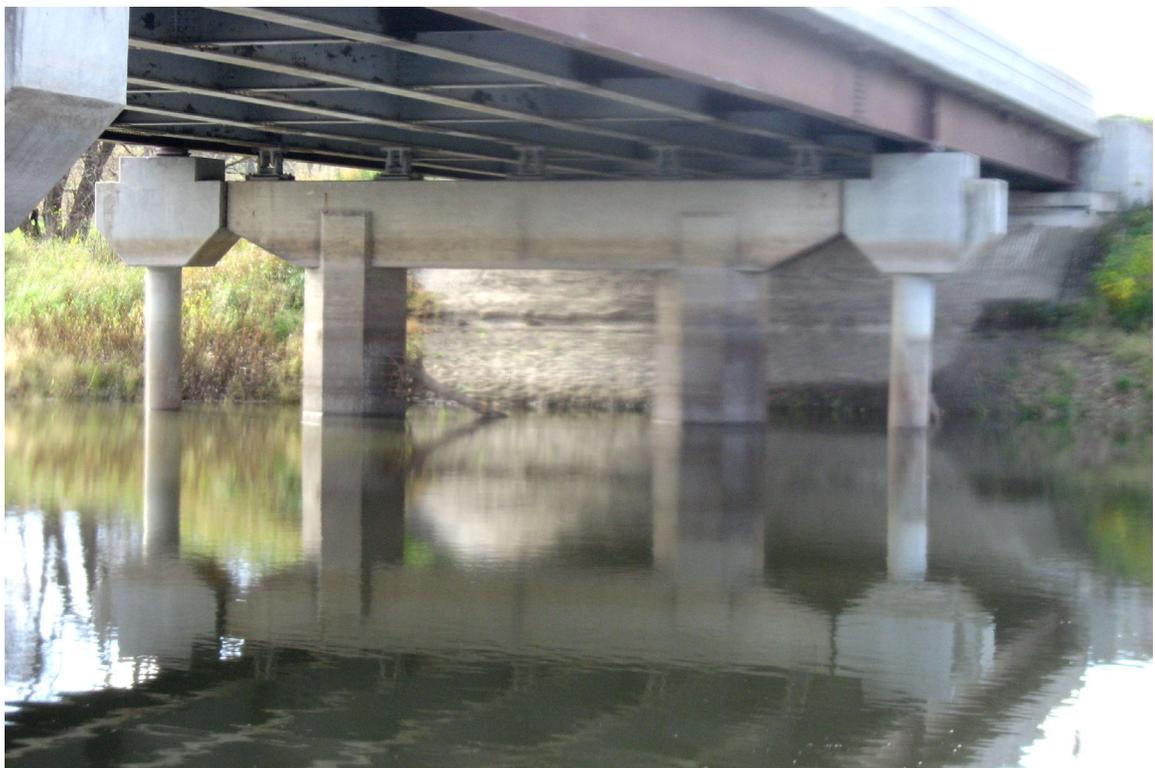
Photograph 2. View of Pier 1, Looking Southwest.

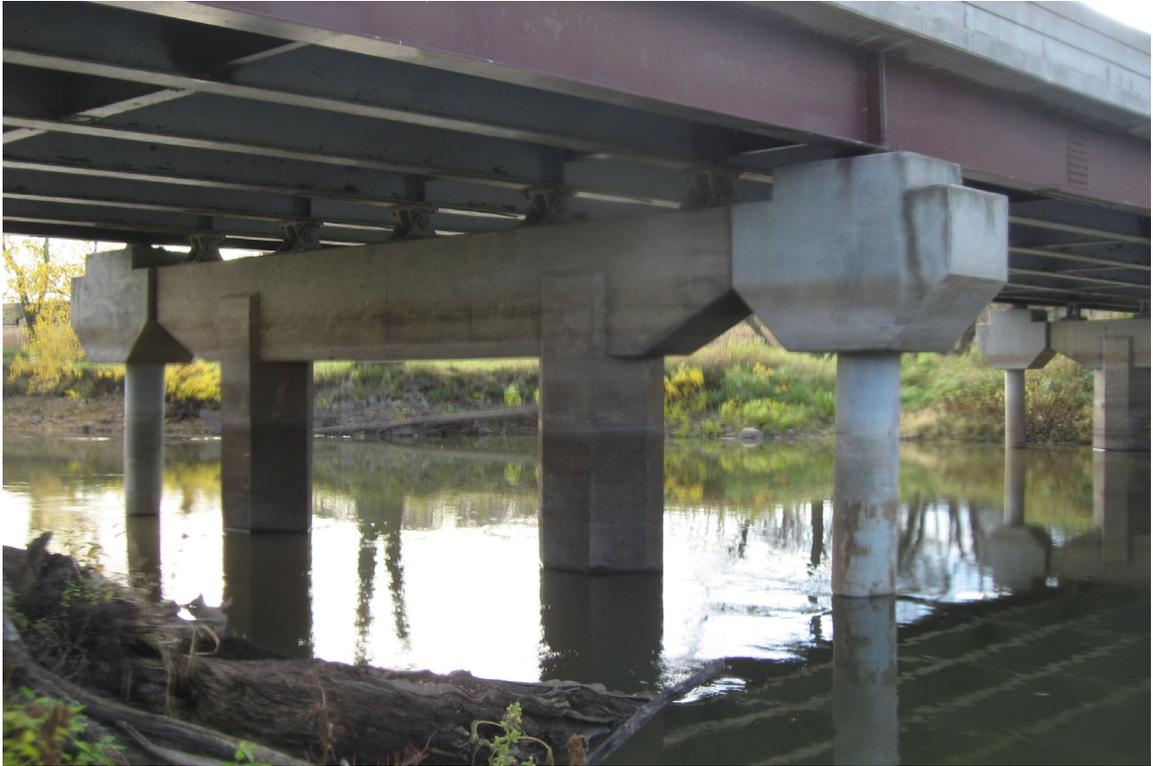
Photograph 3. View of Pier 2, Looking Southwest.

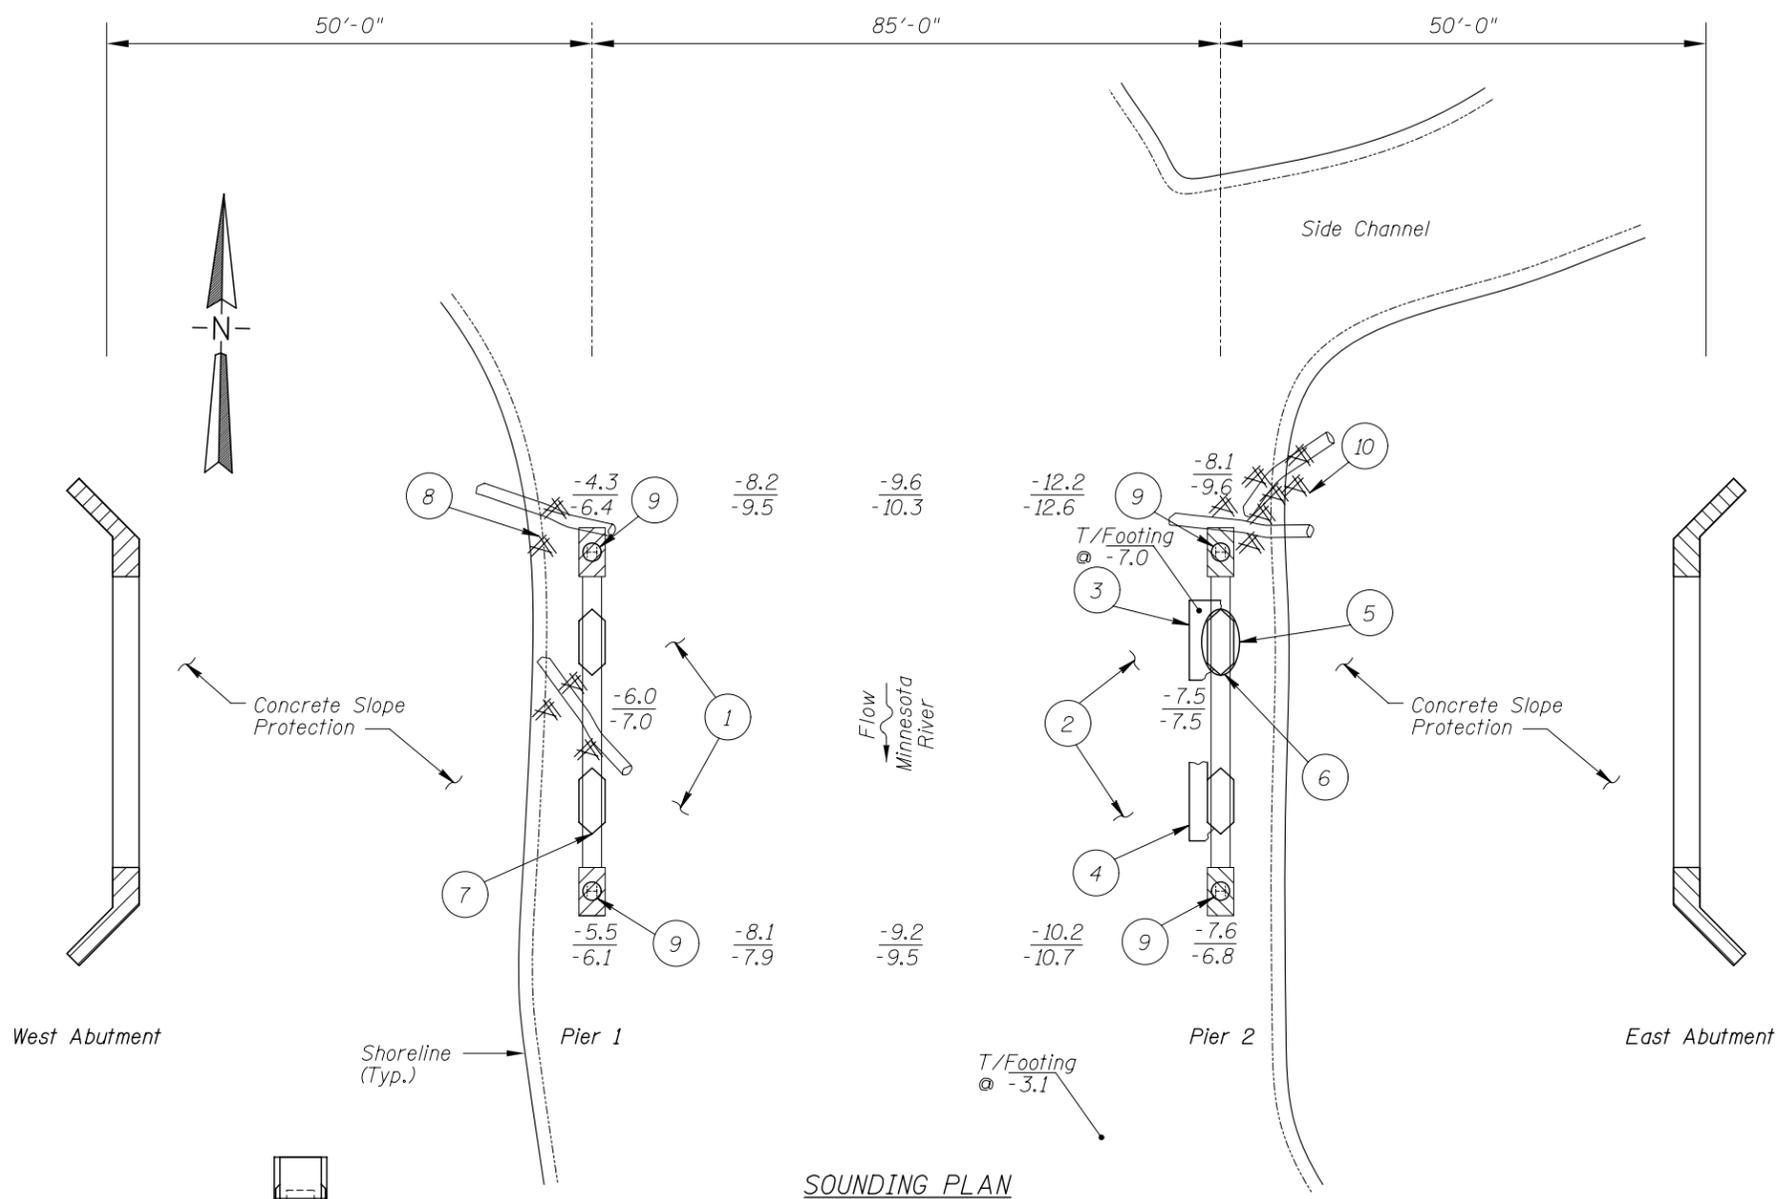
SOUNDING PLAN

- 1 The channel bottom consisted silty organic material with 6 inches of probe rod penetration.
- 2 The channel bottom consisted of sand and riprap up to 1 foot in diameter, with minimal probe rod penetration.

- 3 The footing was exposed along the upstream concrete column and west side of Pier 2 with 1 foot of vertical face exposure.
- 4 The footing was exposed along the downstream concrete column and west side of Pier 2 with 6 inches of vertical face exposure.

- 5 The upstream concrete column was encased in steel sheeting that extended from the top of the footing to 16 inches above the waterline. Light corrosion was observed on 100 percent of the surface area of the steel sheeting.

- 6 A gap in the steel sheeting, up to 1/4 inch wide, extended from the top of the sheeting to 2 feet below the waterline at the south end of the column.

- 7 Minor areas of section loss were observed from the waterline to the channel bottom at the downstream end of the concrete column at Pier 1.
- 8 A moderate accumulation of timber debris, with pieces up to 1 foot in diameter, was observed along Pier 1, mainly at the west side of the pier.

- 9 The steel pipe piles exhibited minor surface corrosion.
- 10 A moderate accumulation of timber debris consisting of logs and branches up to 1 foot in diameter was observed at the upstream end of Pier 2 and towards the shore, extending from channel bottom up 5 feet.

- (A) Monitor the footing exposure at Pier 2 during future underwater inspections for further vertical face exposure and possible undermining of the footing.
