UNDERWATER BRIDGE INSPECTION REPORT

STRUCTURE NO. 7149

CSAH NO. 101

MINNESOTA RIVER

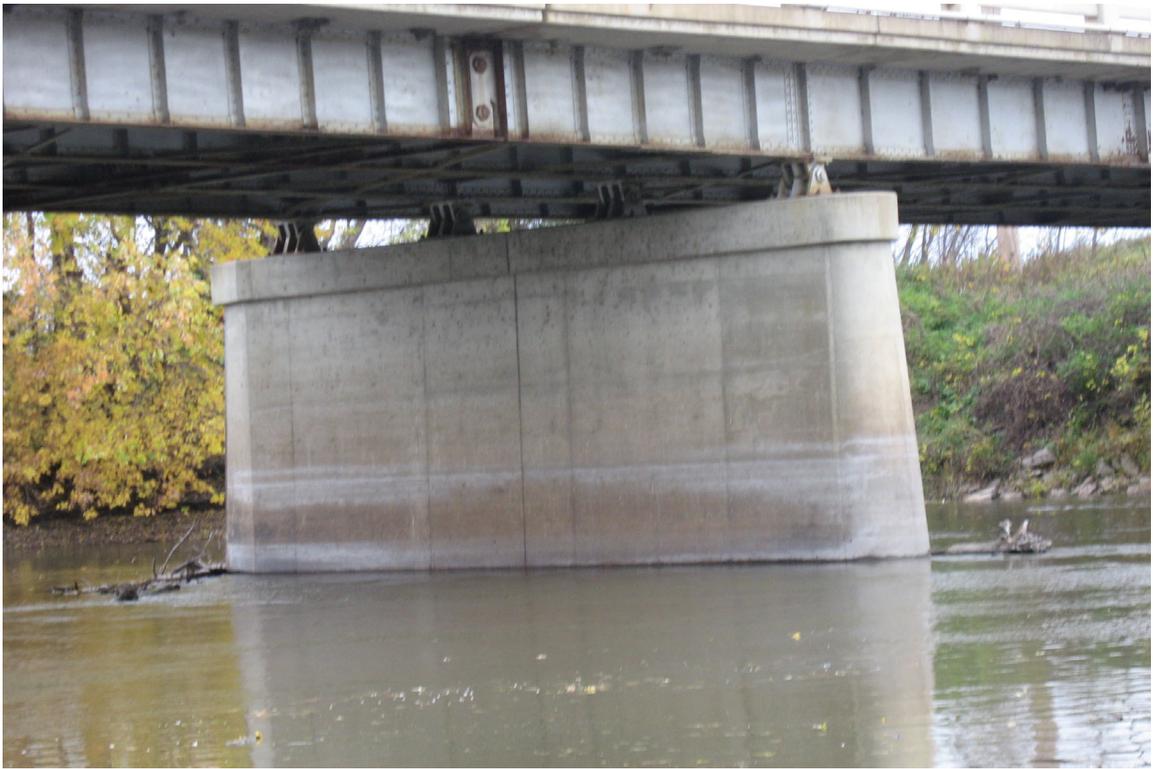
Photograph 1. View of Pier 1, Looking Northwest.

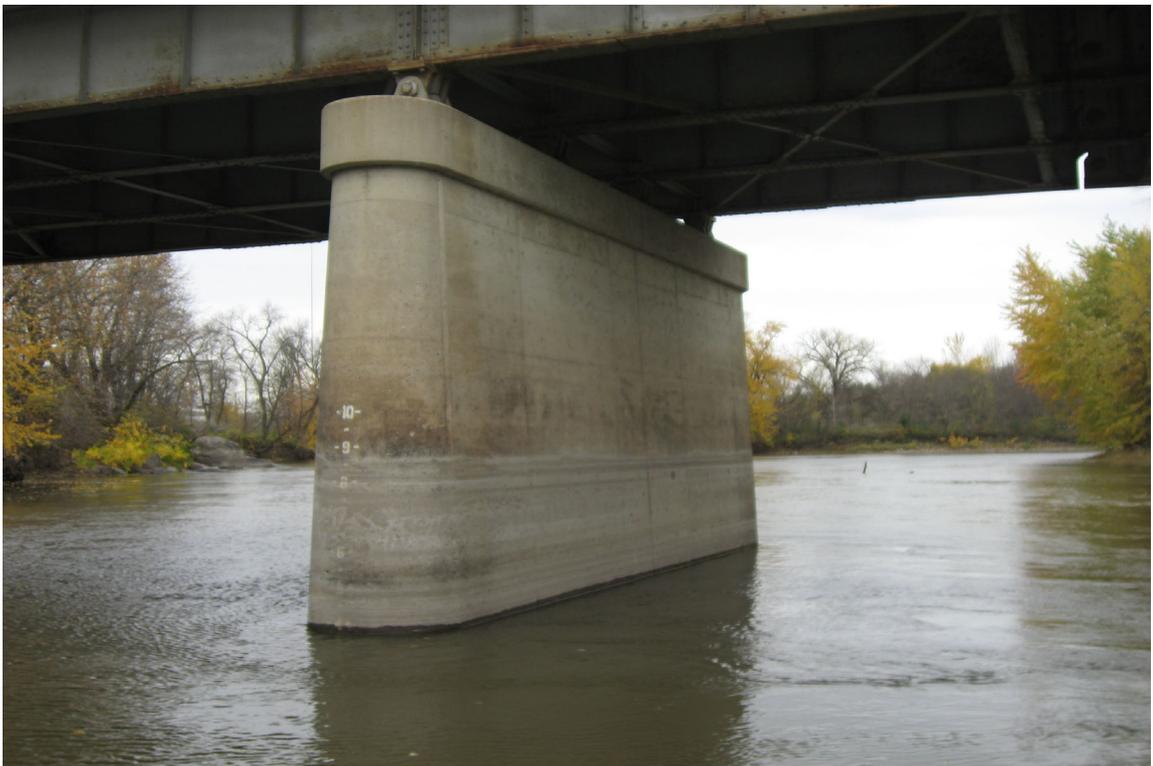
Photograph 2. View of Pier 2, Looking Southwest.

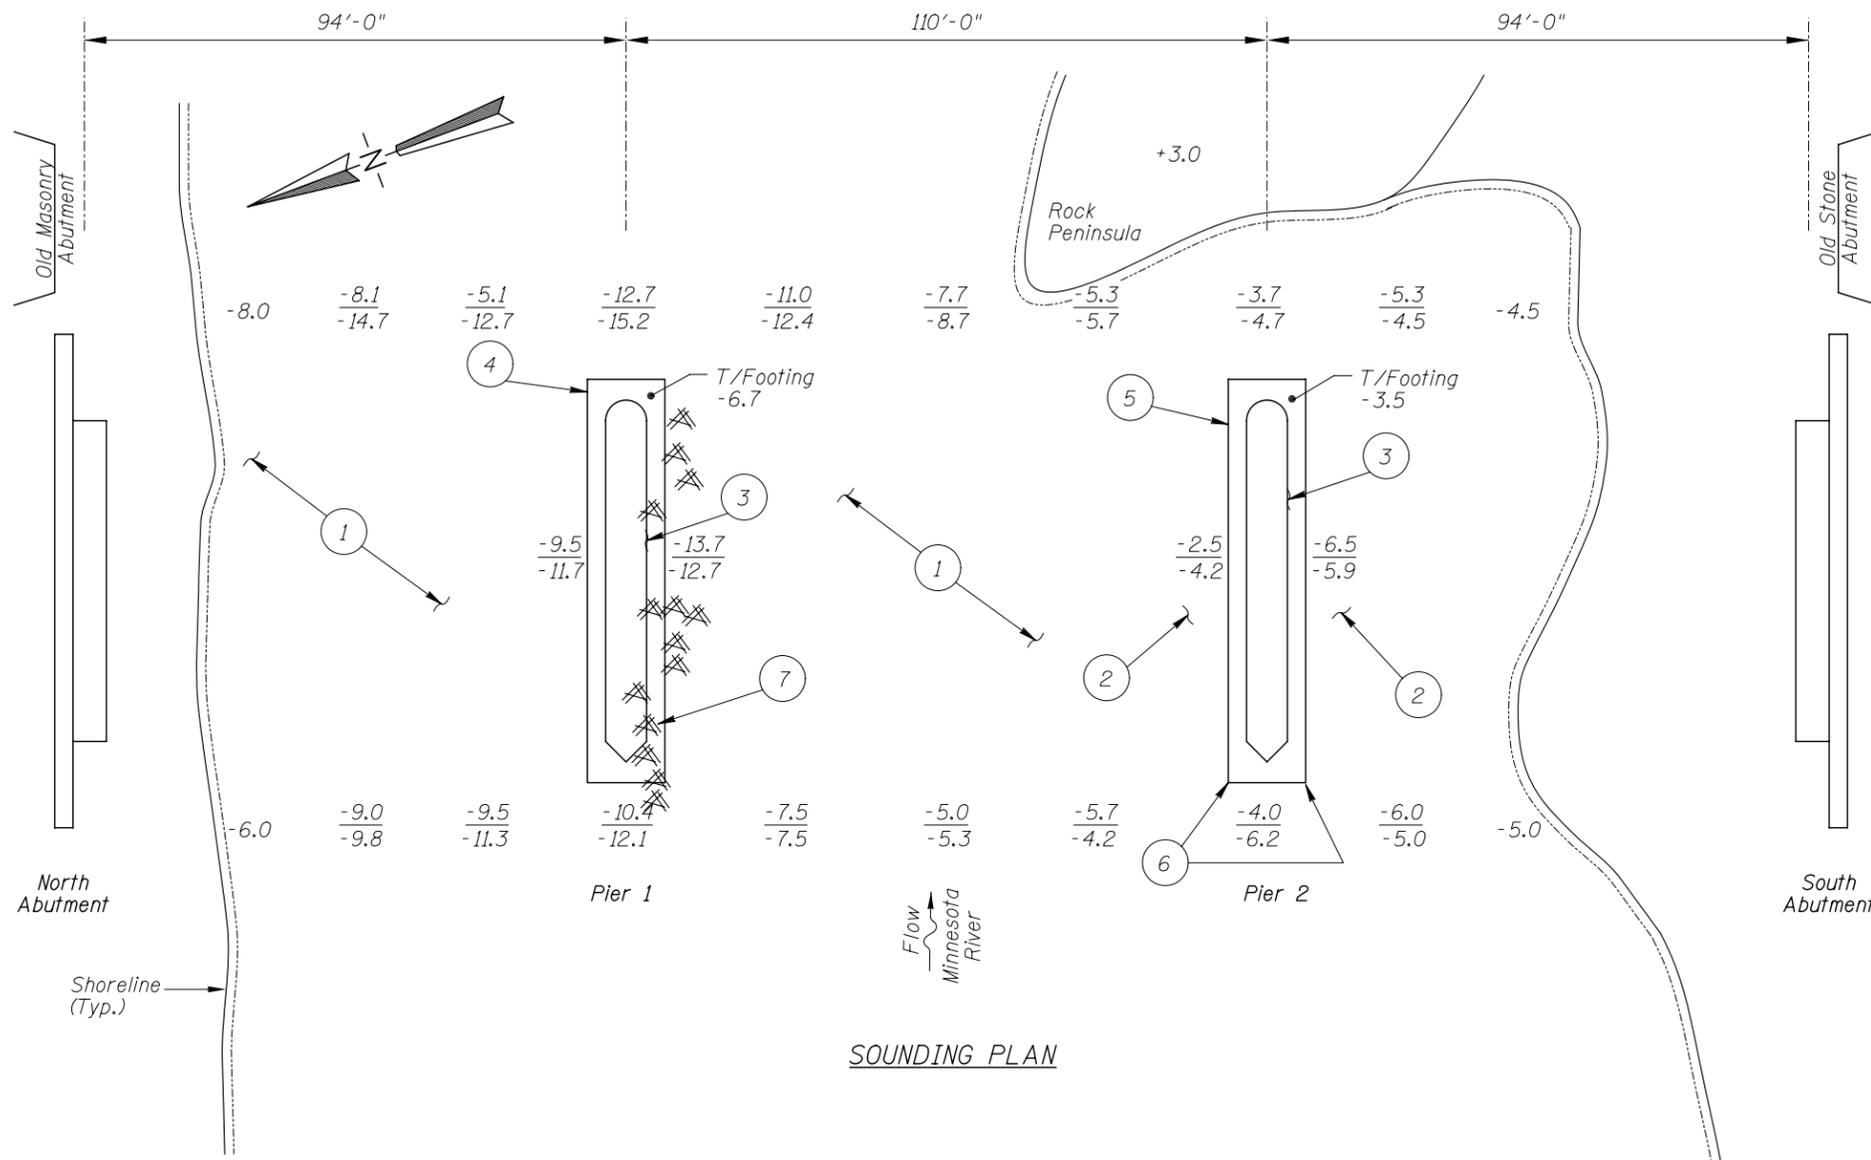
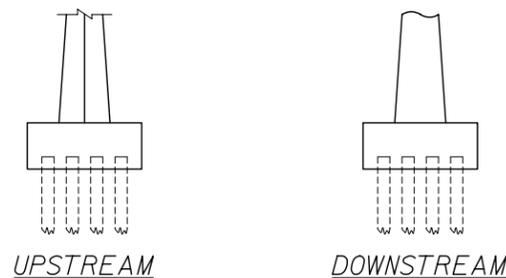
**INSPECTION AND SOUNDING PLAN**

- The channel bottom consisted of firm silty clay with up to 1 inch of probe rod penetration.
- The channel bottom consisted of 1 to 2 foot diameter riprap.

- Overall concrete was smooth and sound with random minor areas of poor consolidation observed along the pier shaft and footing from the channel bottom to the waterline.

- The footing at Pier 1 was completely exposed with undermining ranging from 4 feet at the upstream end to 6 feet at the downstream nose and 7 feet at south face of Pier 1. The steel piles that were exposed exhibited rust nodules up to 1 inch over 15 percent of the surface area.

- The top of the footing at Pier 2 was completely exposed with up to 3 feet of vertical face exposure at the upstream 1/4 point on the north face and all along the south face. No undermining was detected.

- Spall 10 inches in diameter and 2 inches maximum penetration was observed at the upstream corners of the exposed footing at Pier 2.
- A moderate accumulation of timber debris was observed at the upstream nose of Pier 1 and along the south face consisting of 1.5 feet diameter and smaller logs and branches.

**TYPICAL END VIEW OF PIERS**  
(Piles at Pier 1, observed at time of inspection, are not indicated on design drawings dated 1955.)
