UNDERWATER BRIDGE INSPECTION REPORT

STRUCTURE NO. 2110

CSAH NO. 8

MINNESOTA RIVER

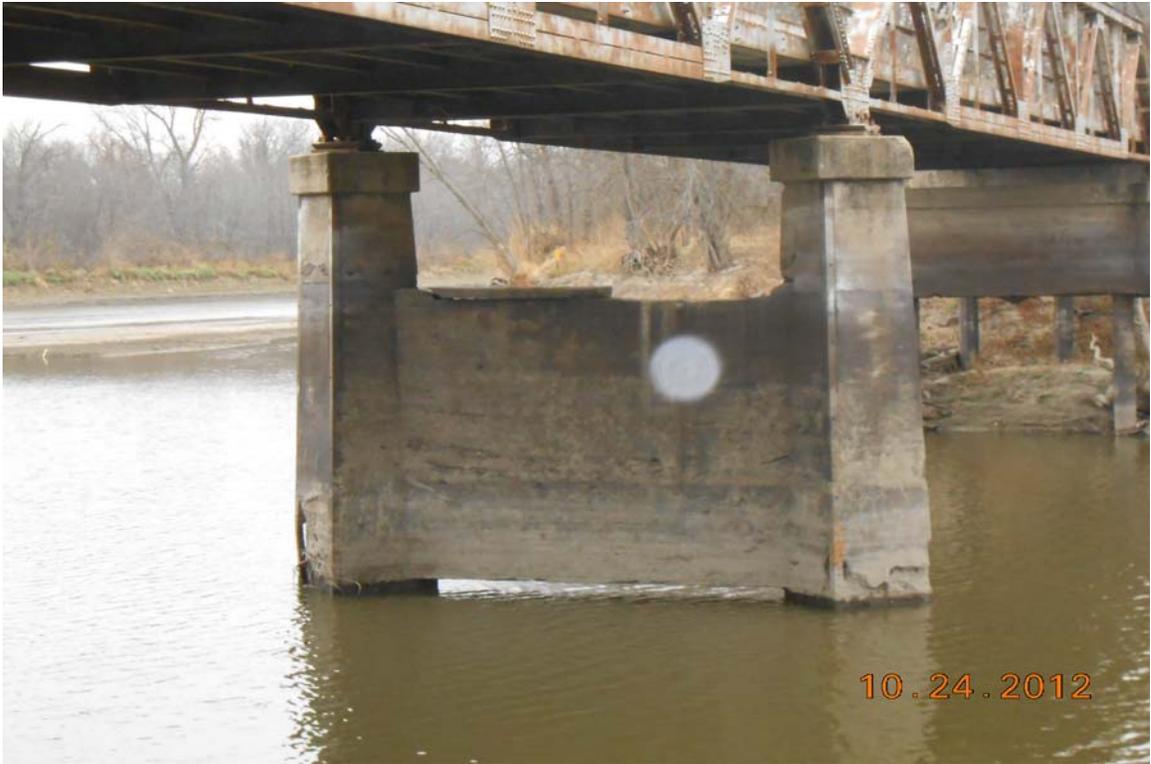
Photograph 1. View of Pier 1, Looking Northwest.

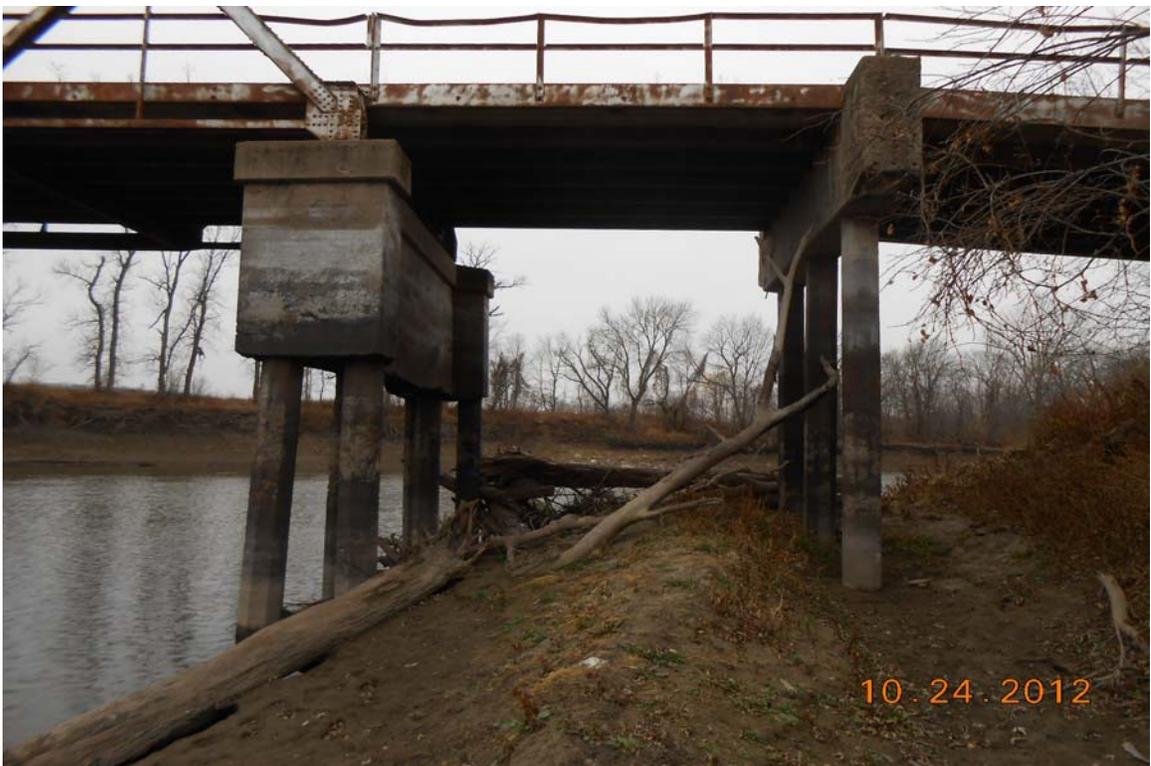
Photograph 2. View of Bents 3 and 4, Looking West.

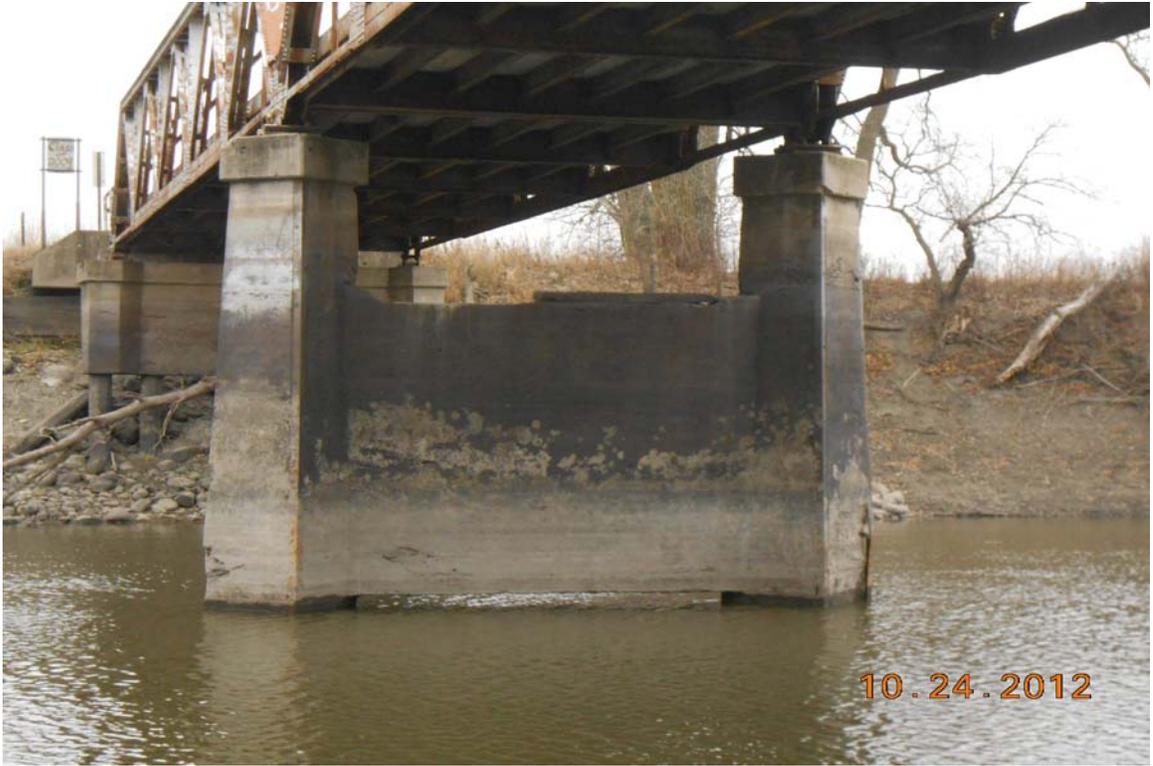
Photograph 3. View of Pier 1, Looking South.

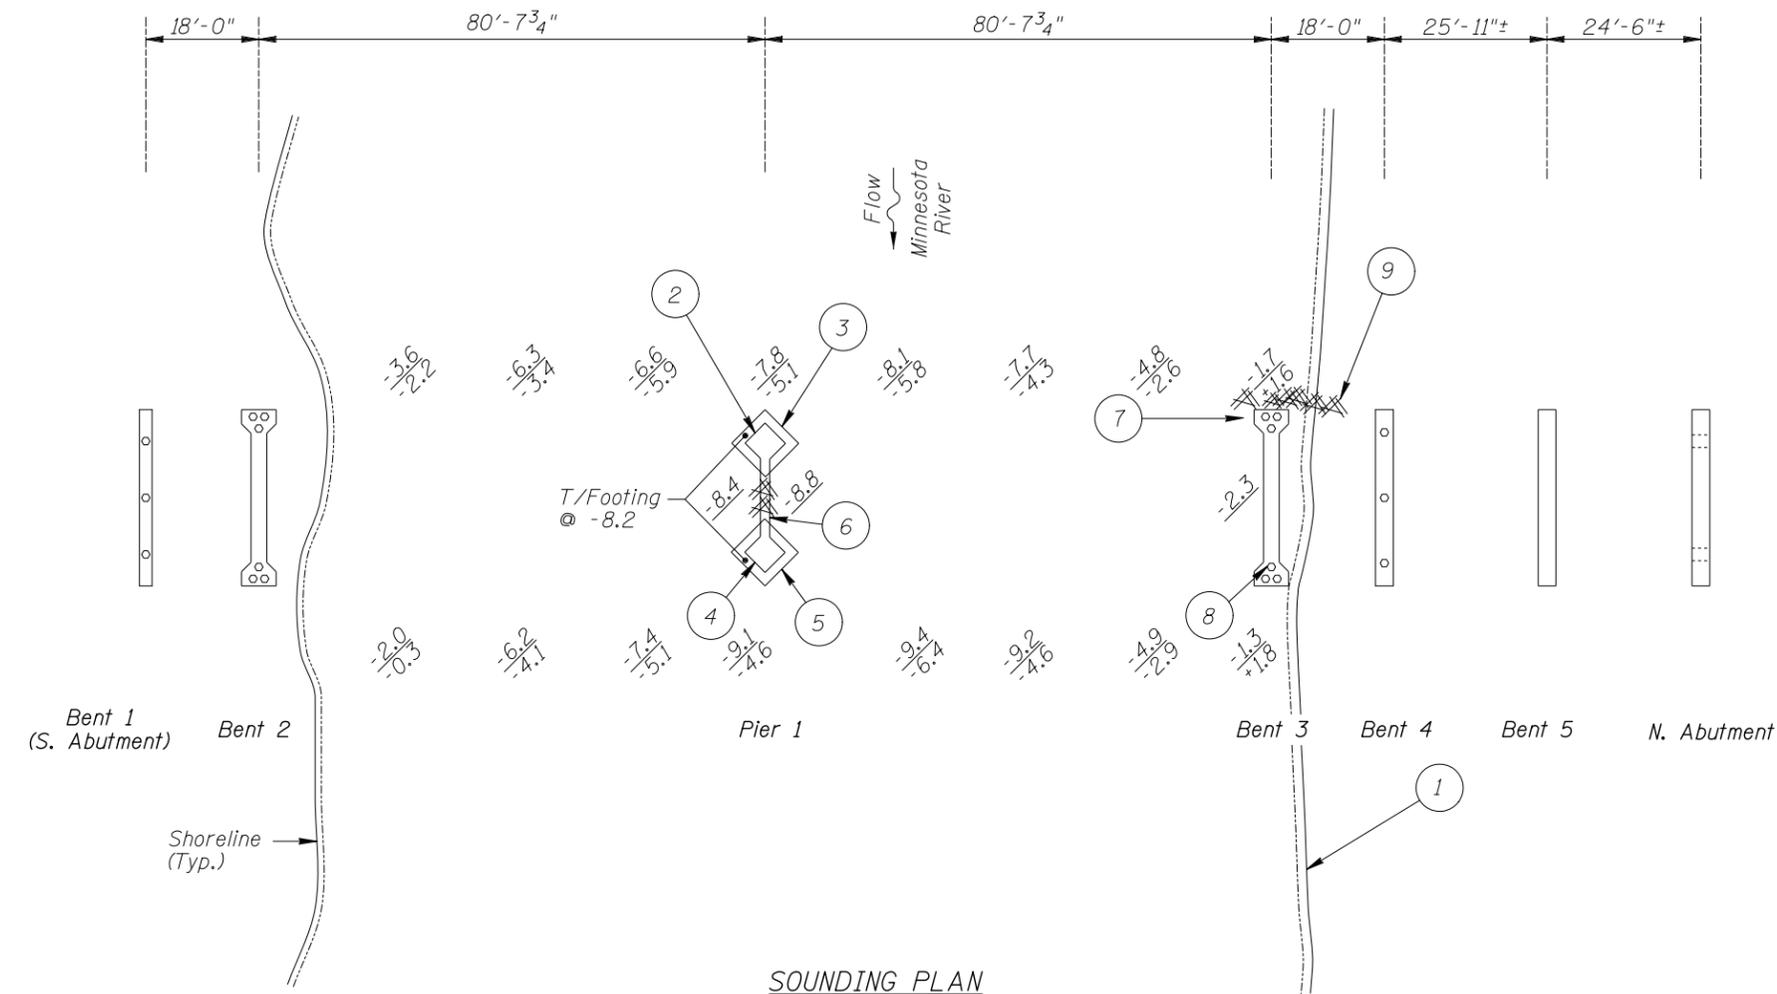
SOUNDING PLAN

- 1 North shoreline exhibited embankment erosion.
- 2 Heavy scaling/section loss on the upstream column located near the waterline with 1 foot of maximum penetration.

- 3 Heavy deterioration/section loss was present on the upstream footing with up to approximately 2 feet of horizontal penetration.
- 4 Moderate scaling with 3 to 4 inches of maximum penetration was present on all faces of the downstream column concentrated near the waterline.

- 5 Moderate to heavy deterioration was present all the way around the footing with up to 12 inches of horizontal penetration.
- 6 The diaphragm wall exhibited light scaling with 1/8 inch typical penetration. Timber debris, consisting of 6 inch to 8 inch diameter branches, was present between the columns below the wall.

- 7 Scaling was observed on all piles of Bent 3 from 5 to 9 feet above the waterline, with 1 inch of maximum penetration.
- 8 Concrete spall along the pile extended from pile cap down 5 feet, measuring up to 1.5 foot wide with 1.5 inches of maximum penetration and exposed reinforcing steel with moderate corrosion.

- 9 A heavy accumulation of timber debris, consisting of logs and branches up to 2 feet in diameter, was observed at the upstream end of Bent 3 extending from the channel bottom to 1 foot above the waterline.
