UNDERWATER BRIDGE INSPECTION REPORT

STRUCTURE NO. 6391

MINNESOTA RIVER

MINNESOTA DEPARTMENT OF TRANSPORTATION  
UNDERWATER BRIDGE INSPECTION

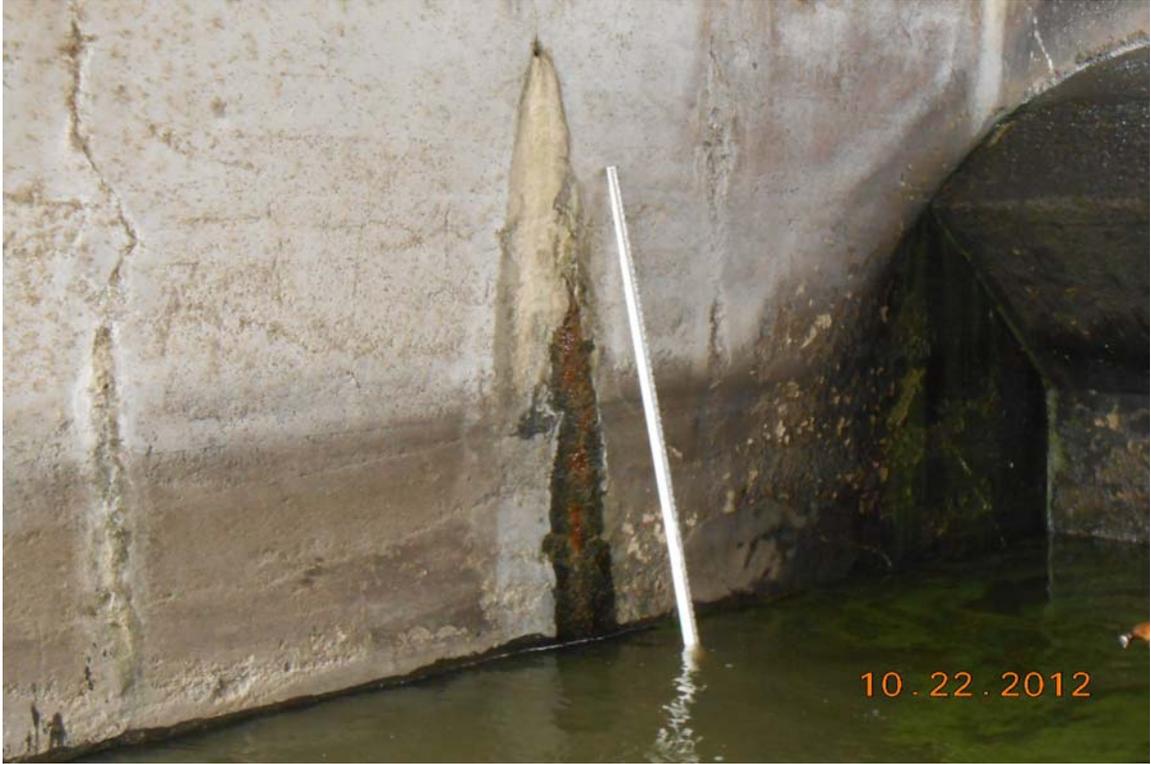
Photograph 3. View of Crack in West Abutment Wall.

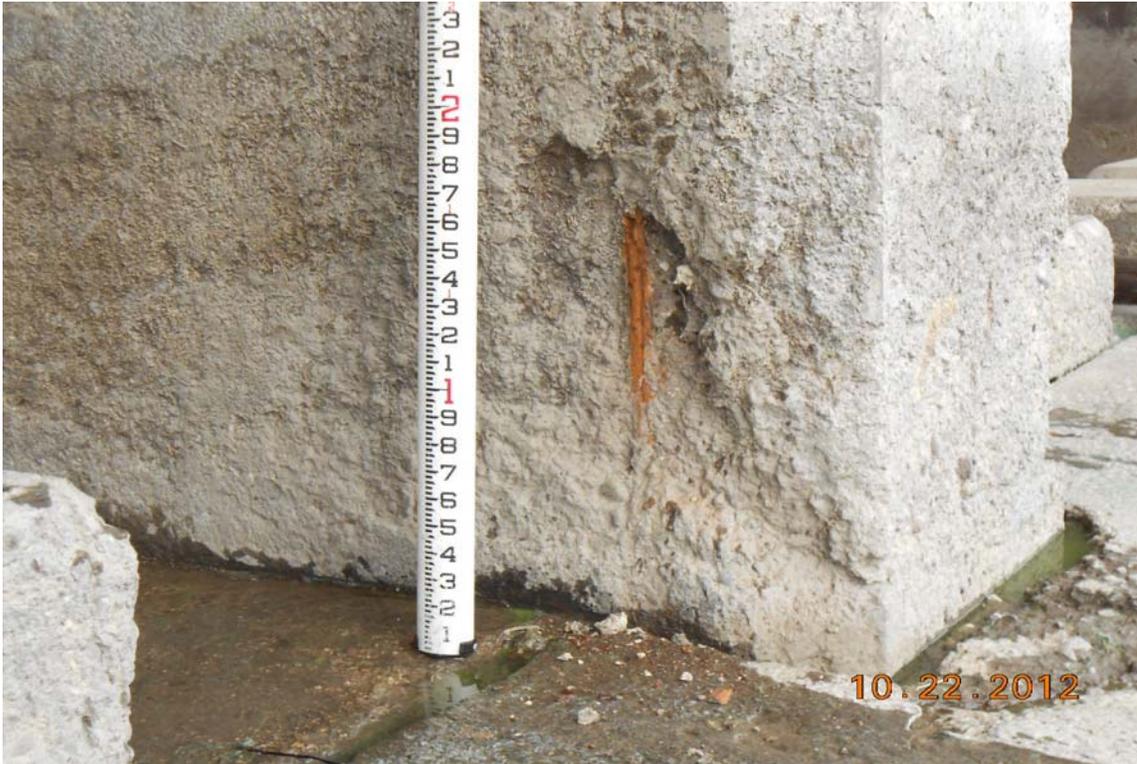
- (A) There was moderate to heavy scaling (likely related to ice damage) throughout most of the pier faces from the concrete apron up 8 feet. The scaling displayed penetrations of up to 3 inches with, in some cases, exposed reinforcing steel that exhibited less than 10% section loss.
- (B) Numerous spalls with exposed reinforcing steel that exhibited less than 10% section loss were observed at random locations on most of the piers.
- (C) Timber debris was observed scattered on the upstream channel bottom with pieces of drift up to 1 foot in diameter.

Photograph 16. Typical Heavy Scaling/Void with Exposed Steel.

- (A) To prevent further, more detrimental deterioration repair all areas of spalling or heavy scaling with exposed reinforcing steel with a concrete grout mix for underwater applications designed to provide high durability and low permeability.
- (B) Monitor the timber debris across the upstream fascia of the bridge, and if found to be increasing in the future, removal operations may become warranted.
- (C) Reinspect the submerged substructure units at the normal maximum recommended (NBIS) interval of sixty (60) months.

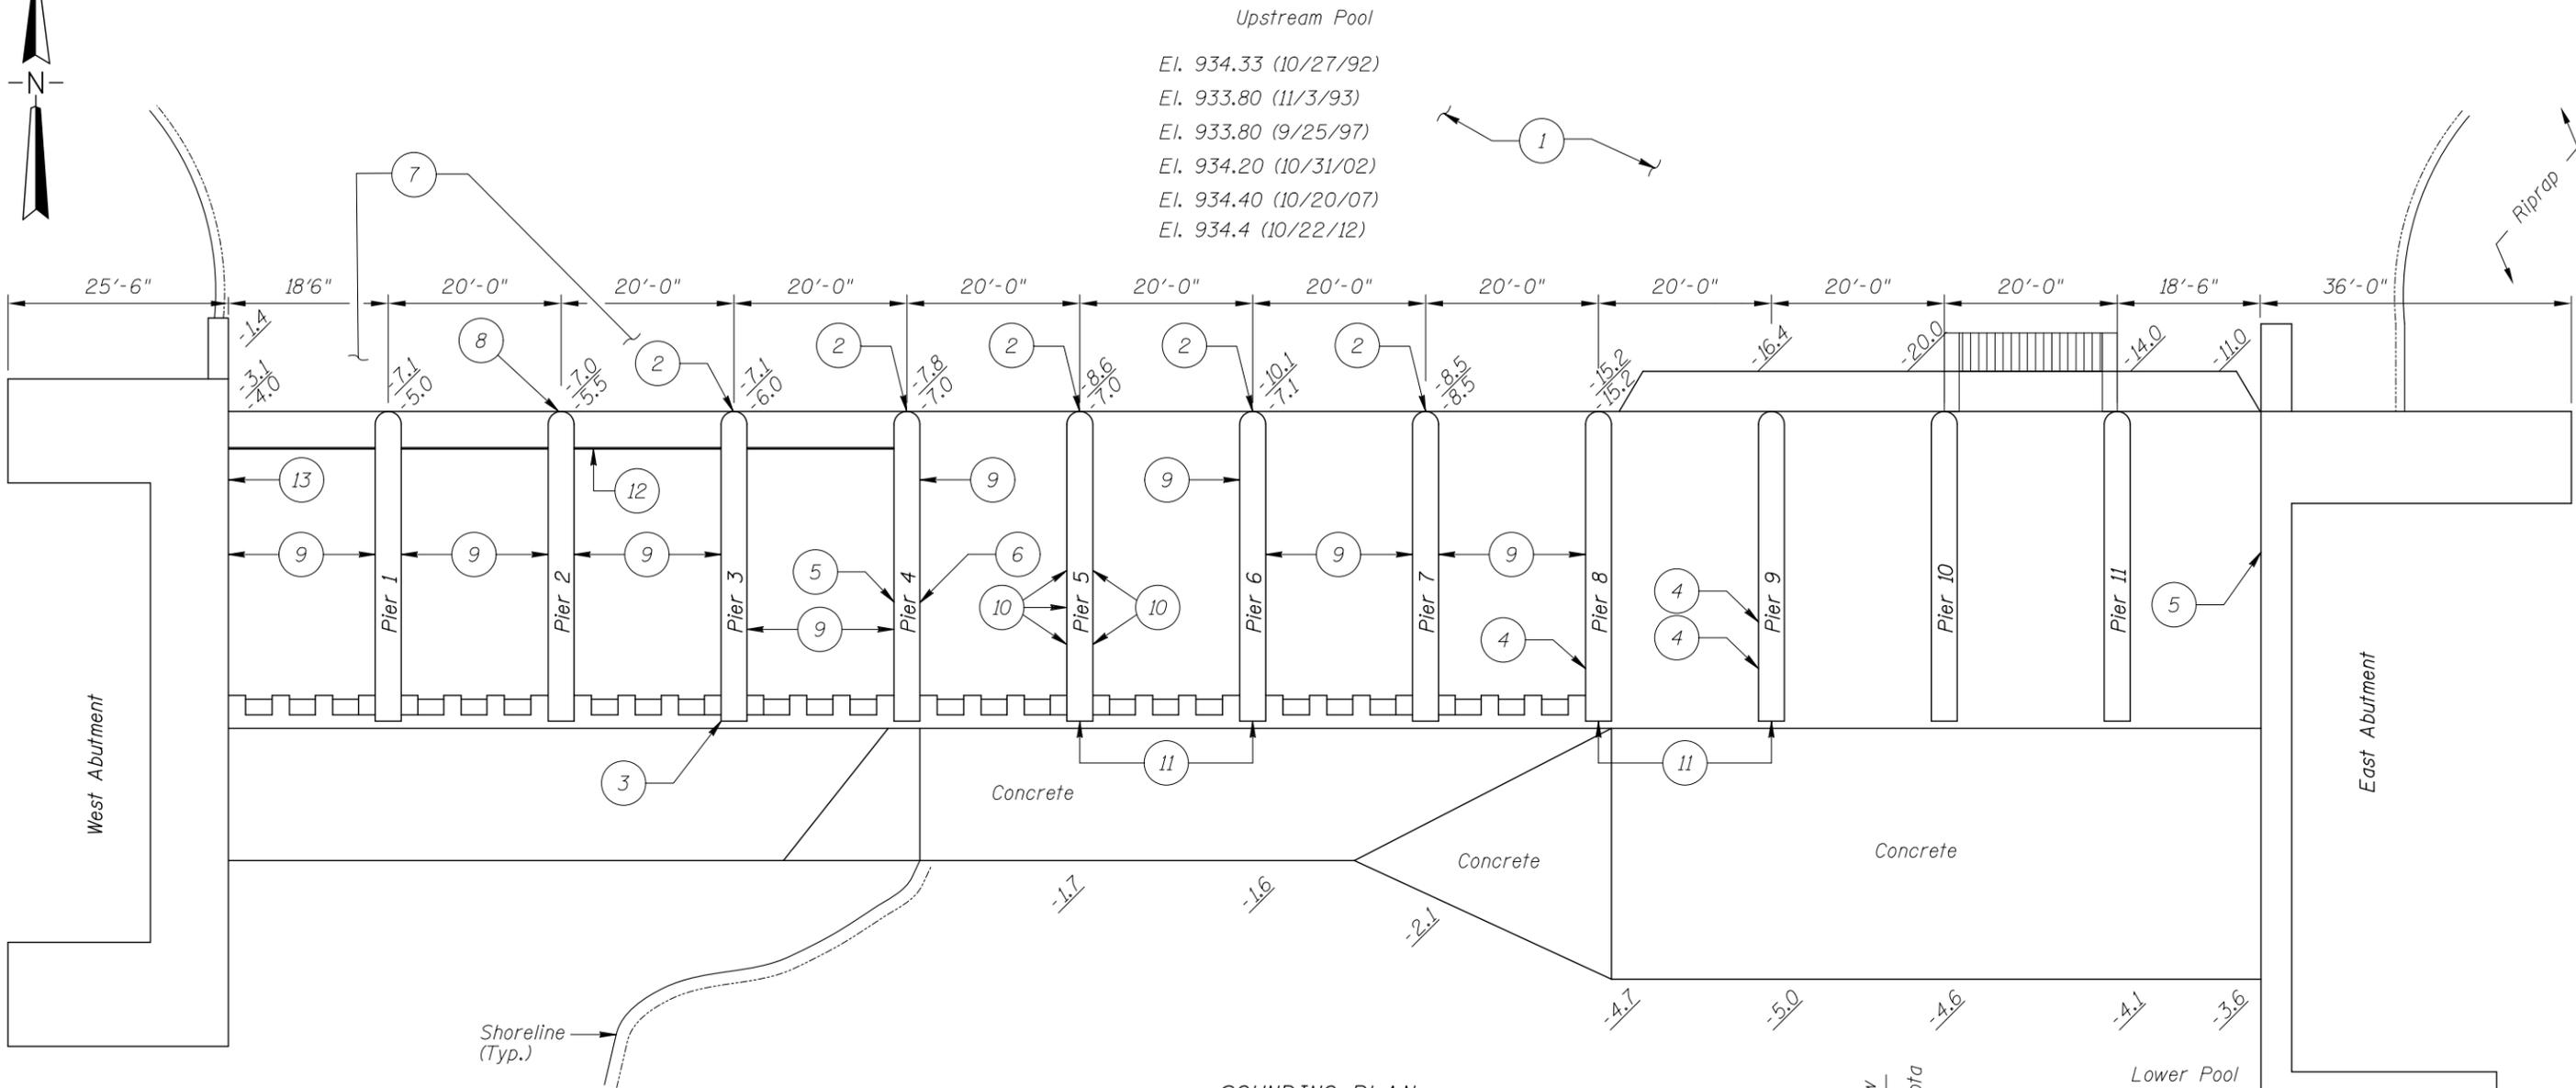
SOUNDING PLAN

- 1 The channel bottom material consisted of silt, sand, and cobbles with up to 6 inches of probe rod penetration.
- 2 Moderate to heavy scaling from 3 feet above the waterline to 5 feet below the waterline around the upstream nose with a maximum penetration of 3 inches and exposed reinforcing steel (less than 10% loss on exposed reinforcing) on Piers 4 and 5. Deterioration typically had up to 2 inches of penetration.

- 3 Spall located 6 inches above the concrete apron measuring 2 feet wide by 2 feet high with up to 3 inches of penetration exposed reinforcing steel that exhibited less than 10% section loss.

- 4 Spall located 7 to 10 feet above the waterline with up to 3 inches of penetration and exposed reinforcing steel that exhibited less than 10% section loss.

- 5 A hairline vertical crack with efflorescence was observed extending from 8 feet above the waterline to the waterline. In addition, there were several small spalls around the crack typically 3 inches in diameter with exposed reinforcing steel that exhibited less than 10% section loss.

- 6 A hairline horizontal crack was observed at 1 foot above the concrete apron with concrete delamination measuring 2 feet high by 1 foot long located at the downstream nose.

- 7 Timber debris was observed scattered on the channel bottom with pieces of drift up to 1 foot diameter.
- 8 Spall located from 1 foot above the waterline to 1 foot above the channel bottom with up to 5 inches of penetration and exposed reinforcing steel that exhibited less than 10% section loss.

- 9 Band of heavy scaling between 8 feet above the waterline and the waterline with typically up to 1/2 inch penetration and random areas of up to 1.5 inches of maximum penetration.

- 10 Scaling from concrete apron slab up 8 feet with penetrations up to 2 inches with exposed reinforcing steel was observed. Exposed reinforcing typically had up to 10% section loss.

- 11 Heavy scaling from concrete apron slab up 6 to 9 feet around the downstream nose with 3 inches of maximum penetration and exposed reinforcing steel that exhibited less than 10% section loss.

- 12 Spall located 1.5 foot above to 2.5 feet below the waterline with up to 3 inches of penetration and exposed reinforcing steel that exhibited less than 10% section loss.

- 13 Up to 1/16 inch vertical crack with oxidation and moisture from the apron slab extending upward.
