UNDERWATER BRIDGE INSPECTION REPORT

STRUCTURE NO. 6610

MINNESOTA RIVER

OCTOBER 20, 2012

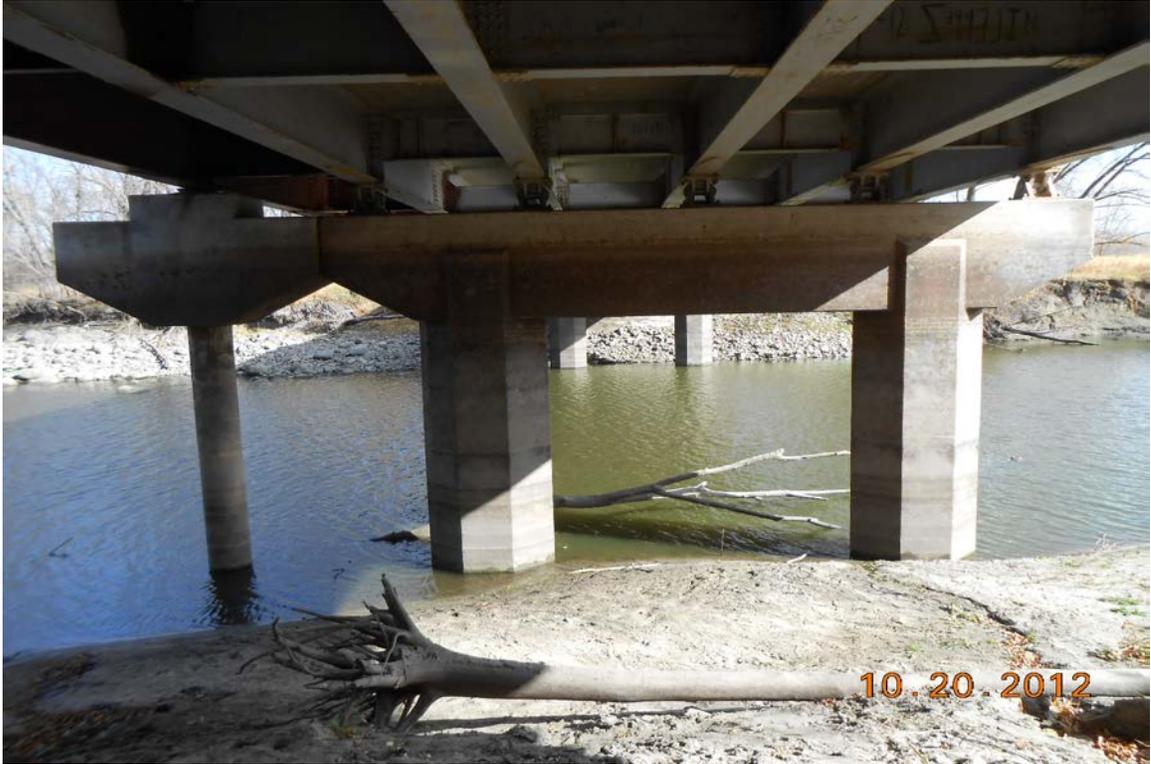
Photograph 1. View of Pier 1, Looking East.

- 1 The channel bottom material around Pier 1 consisted of silty sand with approximately 6 inches of probe rod penetration.
- 2 The channel bottom material around Pier 2 consisted of cobbles, 6 inch diameter riprap, and sandy silt with 4 inches of probe rod penetration.

- 5 A light accumulation of timber debris, consisting of 6 to 8 inch diameter branches, was observed at the upstream end of Pier 1.
- 6 A light to moderate accumulation of timber debris, consisting of up to 1 foot diameter logs, was observed at the upstream nose of Pier 2 and extended to the shoreline, and a light accumulation of timber debris extended along both sides of the pier.

- (A) Monitor the accumulations of timber debris at the piers, and if found to be increasing, removal during routine maintenance to prevent further build-up and to restrict scour influence may be required.
- (B) Because the bridge has been evaluated to be scour critical, specifically monitor the footing exposure during future inspections and after periods of high flows. Consider placement of scour countermeasures if foundation exposure is found to be increasing.
- (C) Reinspect the submerged substructure units at the normal maximum recommended (NBIS) interval of sixty (60) months.

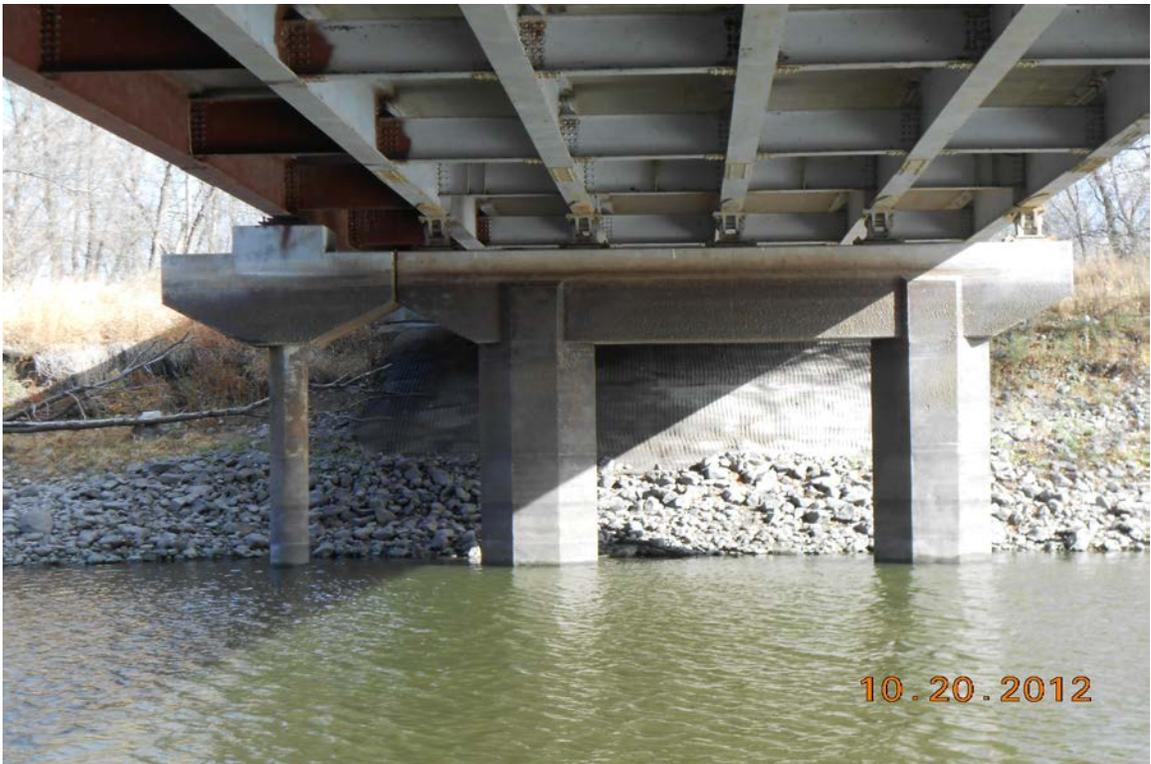
Photograph 2. View of Pier 2, Looking East.

- 3 The footing was exposed along the west side of the middle and downstream columns of Pier 2 with a maximum vertical exposure of 1 foot.
- 4 A small area of section loss was observed 2 feet above the waterline at the downstream nose of Pier 1, measuring 3 square inches with 1 inch of penetration.

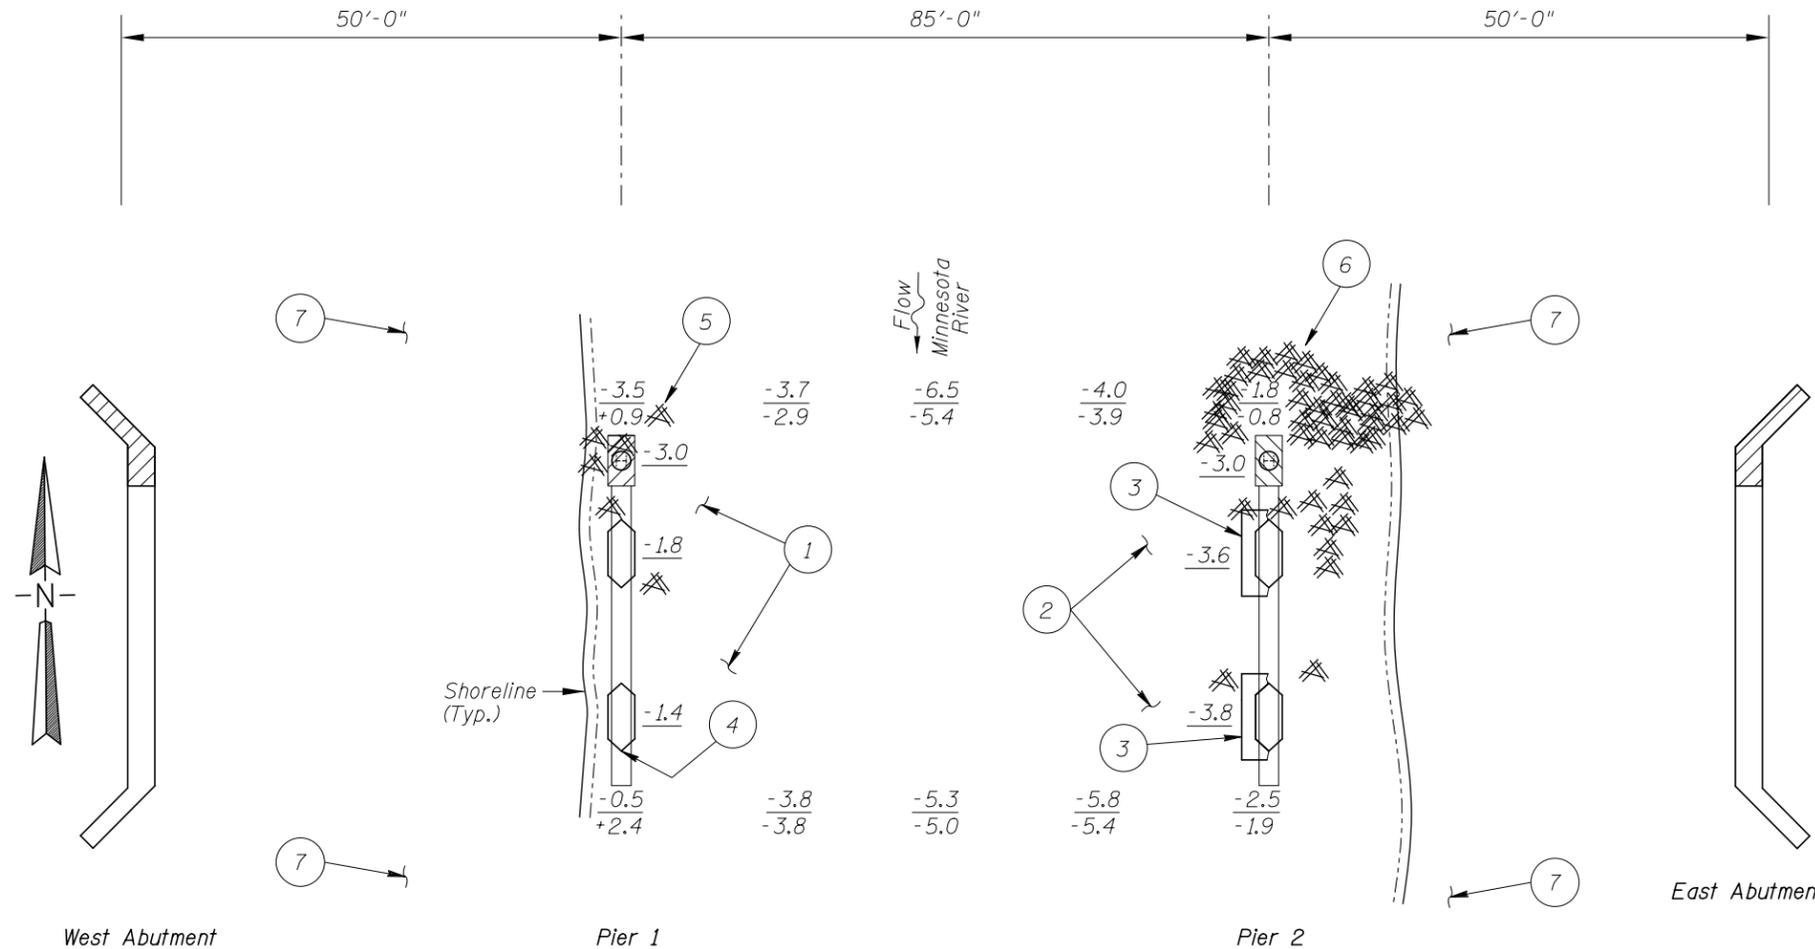
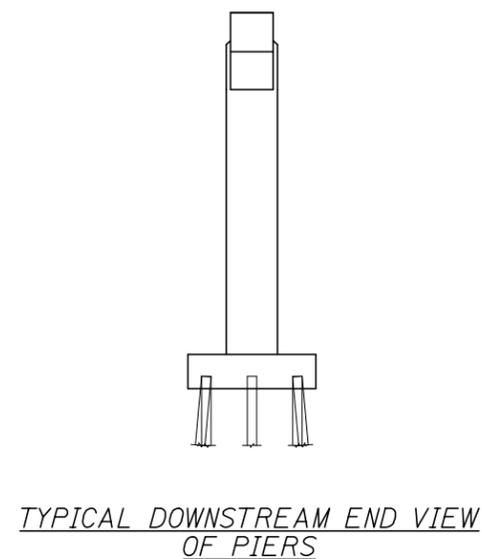
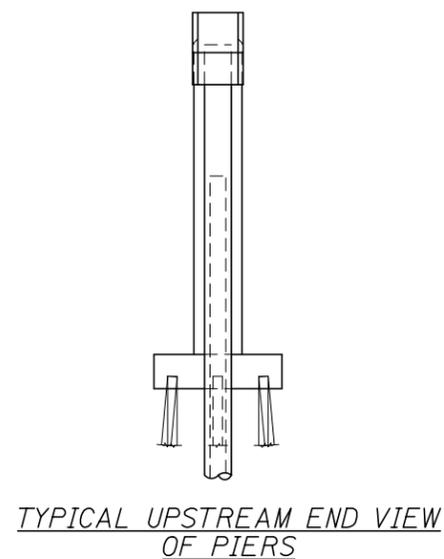
**SOUNDING PLAN**

- 7 Heavy bank erosion resulting in vertical slopes upstream and downstream of the structure on the east and west banks. Banks were well protected at the structure with up to 2 foot diameter riprap and concrete revetment. The west embankment protection was covered with silty sand.
