UNDERWATER BRIDGE INSPECTION REPORT

STRUCTURE NO. 6611

MINNESOTA RIVER

DISTRICT 8 - CHIPPEWA COUNTY

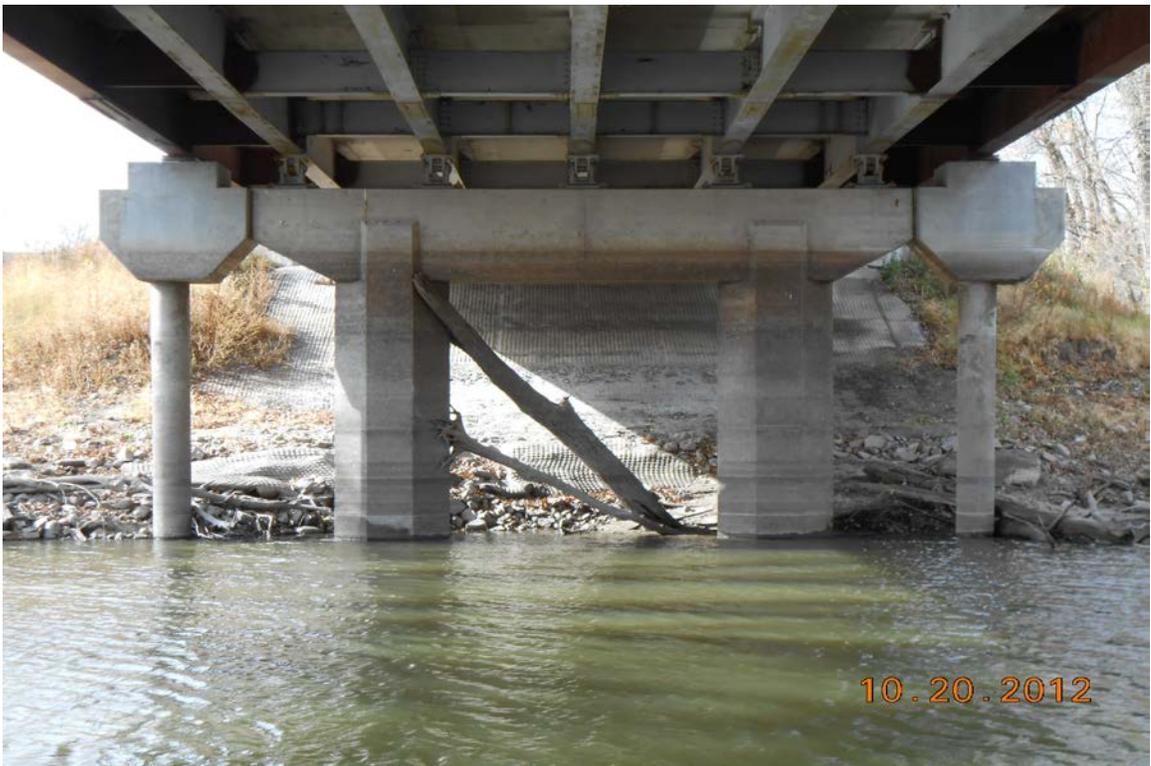
Photograph 2. View of Pier 1, Looking West.

- 7 Minor areas of section loss were observed along the downstream side of the concrete column at Pier 1.
- 8 A moderate accumulation of timber debris was observed along Pier 1, mainly at the west side of the pier.

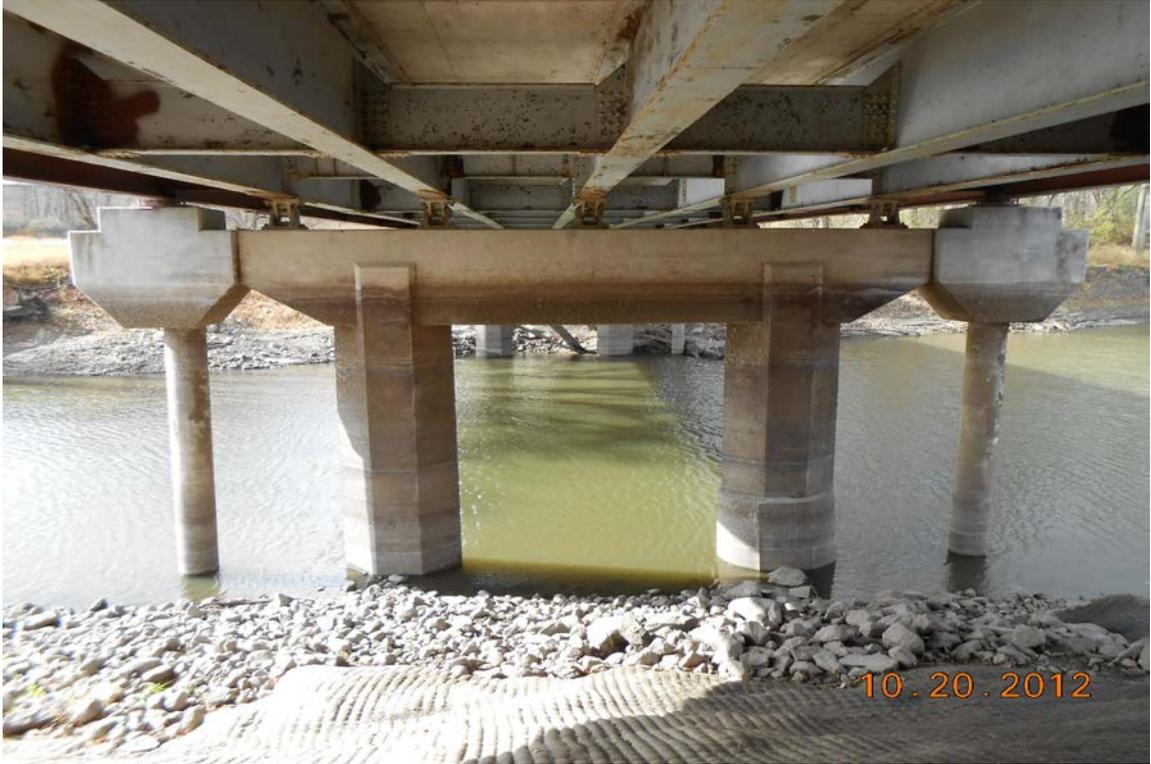
- (A) The footings at Pier 2 were exposed along the west side of the upstream concrete column with 2.2 feet of vertical face exposure and along west side of the downstream concrete column with 1.7 feet of vertical face exposure.
- (B) The upstream concrete column at Pier 2 was encased in steel sheeting that extended from the top of the footing to 6.5 feet above the waterline, and the steel exhibited light corrosion over 100 percent of the surface area. A gap in the steel sheeting, up to 1/4 inch wide, was observed at the north end of the column and extended from the top of the sheeting to 3 feet above the waterline.
- (C) A light accumulation of timber debris, with pieces up to 1 foot in diameter, was observed at the upstream end of Pier 2.
- (D) A moderate accumulation of timber debris was observed along Pier 1, mainly at the west side of the pier.

Photograph 3. View of Pier 2, Looking West.

- (A) Monitor the footing exposure at Pier 2 during future underwater inspections for further vertical face exposure and possible undermining of the footing.
- (B) Reinspect the submerged substructure units at the normal maximum recommended (NBIS) interval of sixty (60) months.

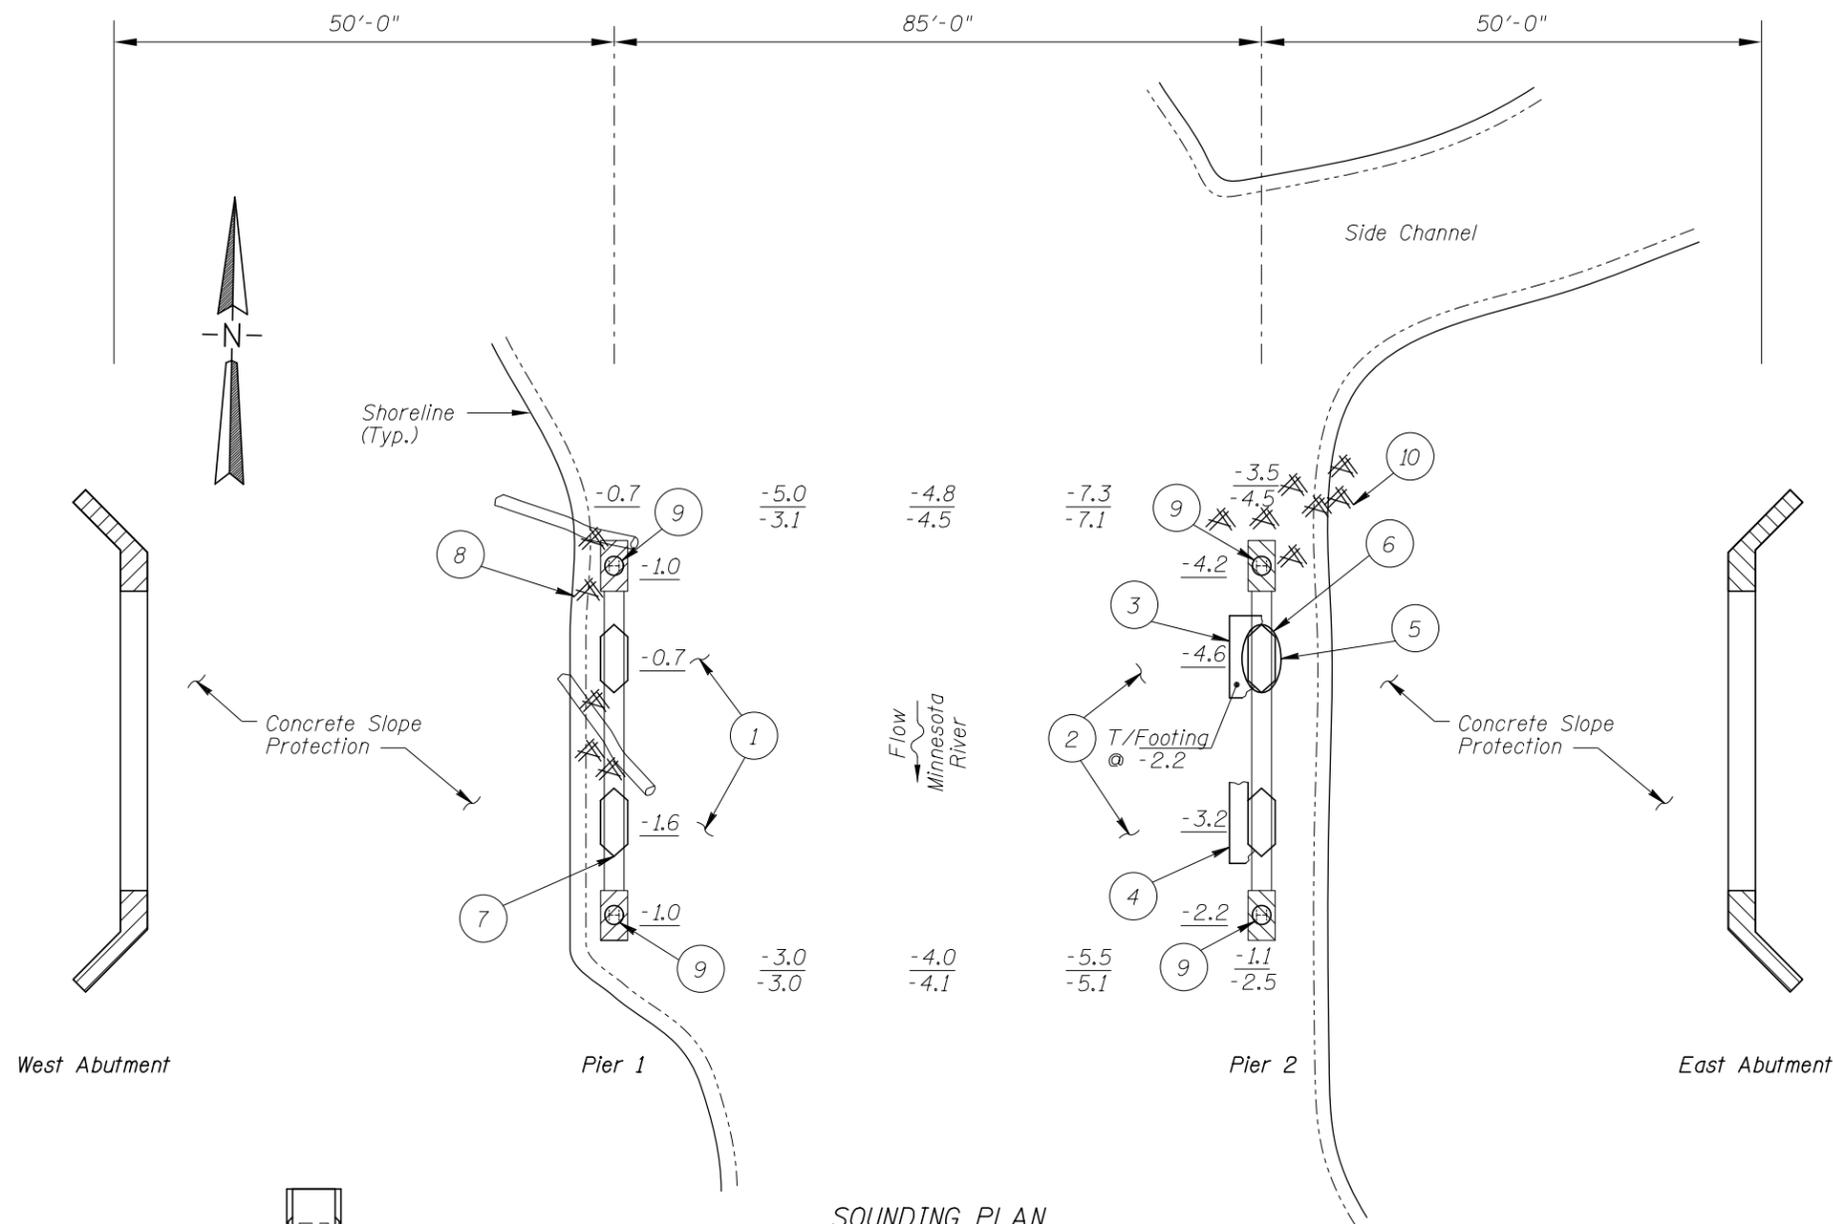
SOUNDING PLAN

- 1 The channel bottom consisted silty organic material with 6 inches of probe rod penetration.
- 2 The channel bottom consisted of sand and riprap up to 1 foot in diameter, with minimal probe rod penetration.

- 3 The footing was exposed along the upstream concrete column on the west side of Pier 2 with 2.2 feet of vertical face exposure.
- 4 The footing was exposed along the downstream concrete column on the west side of Pier 2 with 1.7 feet of vertical face exposure.

- 5 The upstream concrete column was encased in steel sheeting that extended from the top of the footing to 6.5 feet above the waterline. Light corrosion was observed on 100 percent of the surface area of the steel sheeting.

- 6 A gap in the steel sheeting, up to 1/4 inch wide, extended from the top of the sheeting to 3 feet above the waterline at the north end of the column.

- 9 The steel pipe piles exhibited minor surface corrosion.
- 10 A light accumulation of timber debris consisting of branches up to 1 foot in diameter was observed at the upstream end of Pier 2.

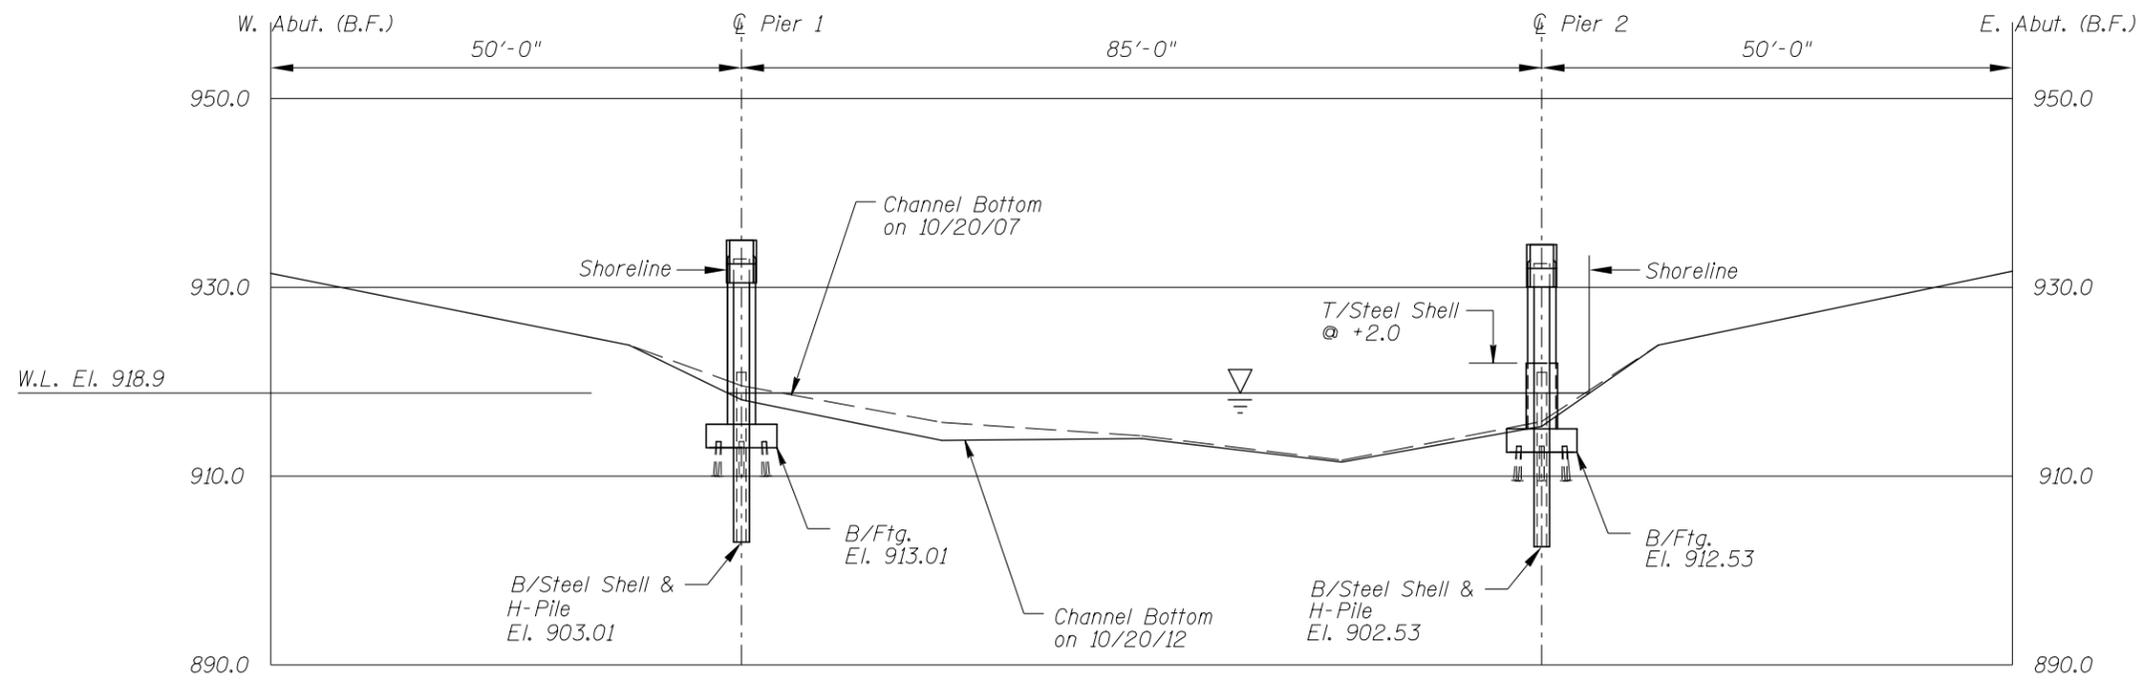
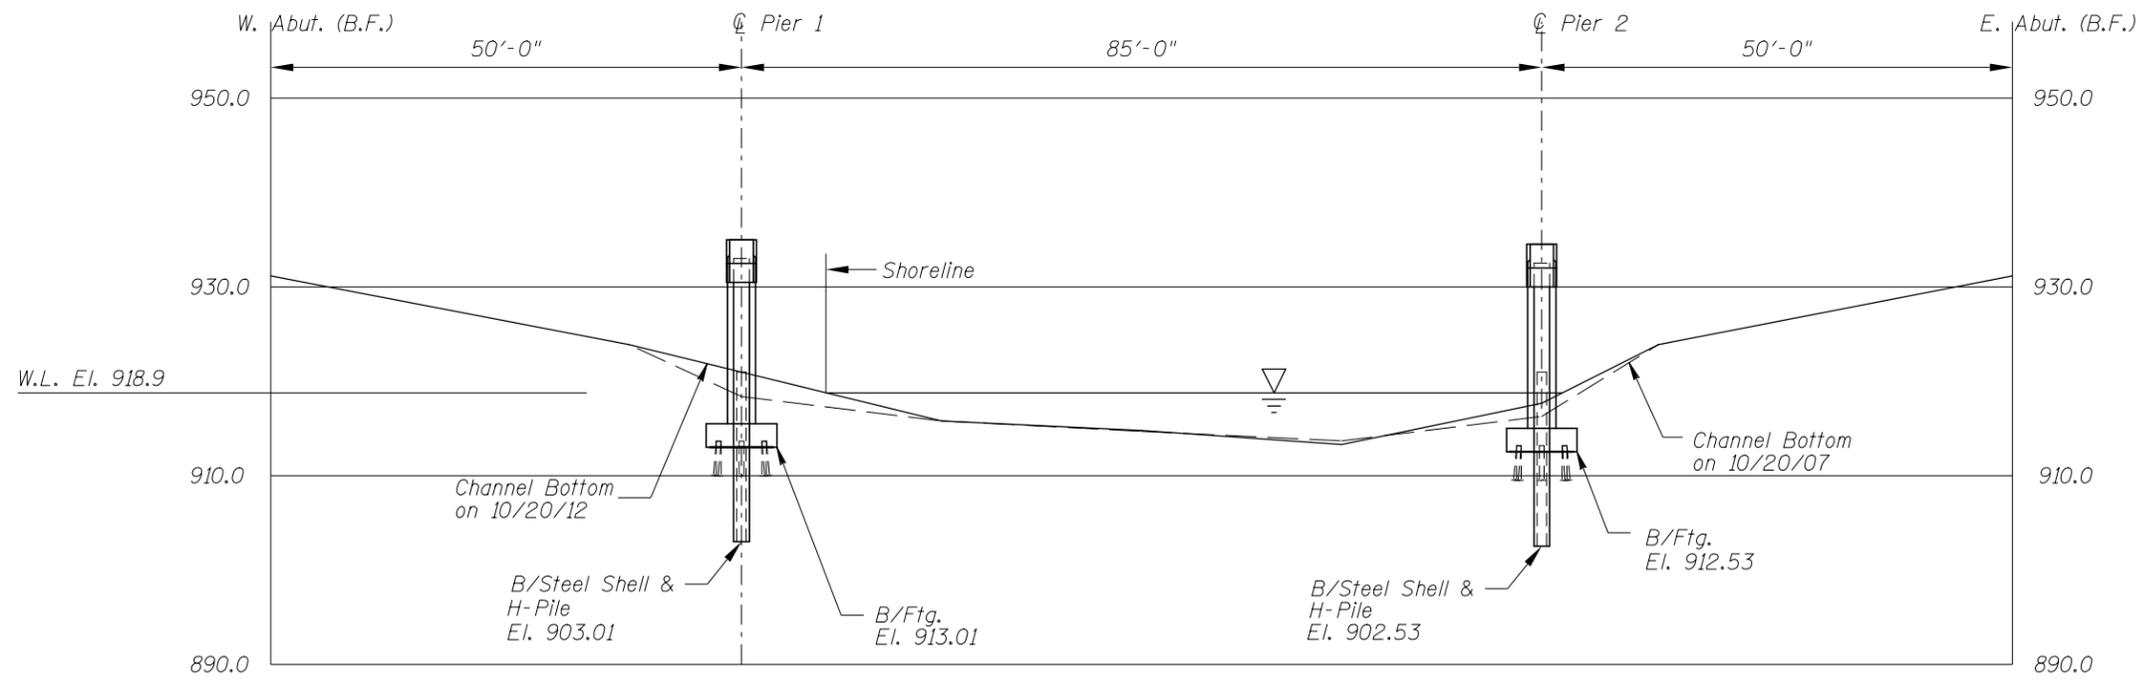
UPSTREAM FASCIA PROFILE

DOWNSTREAM FASCIA PROFILE
