UNDERWATER BRIDGE INSPECTION REPORT

STRUCTURE NO. 7132

CSAH NO. 33

LAC QUI PARLE RIVER

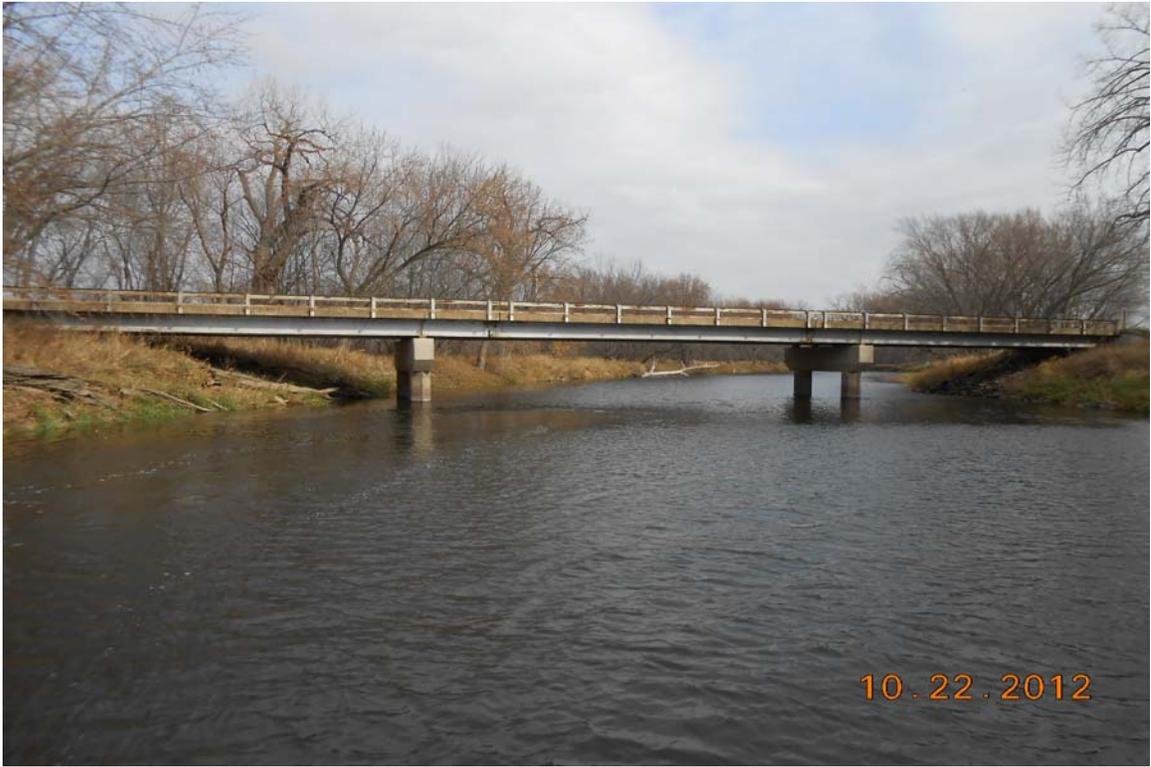
Photograph 1. Overall View of the Structure, Looking East

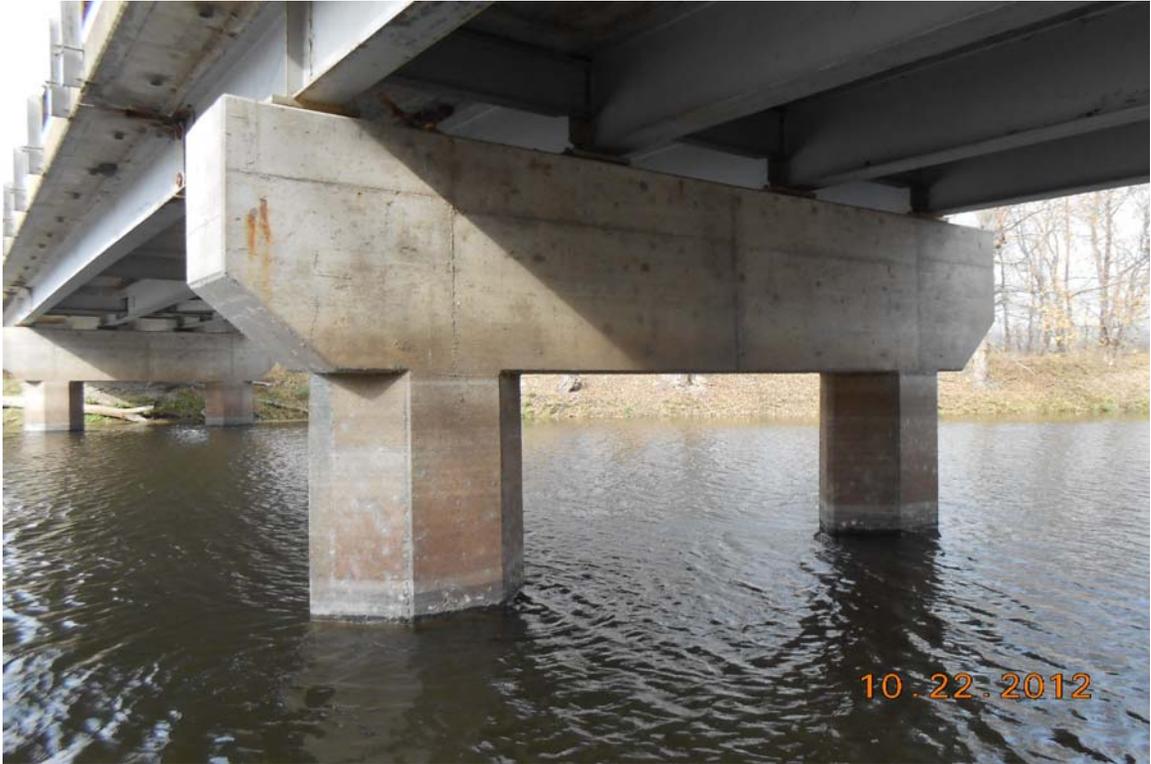
- (A) The upstream and downstream columns of Piers 1 and 2 exhibited scaling up to 1/8 inch deep 1 foot above and below the waterline.
- (B) The streambed material at Piers 1 and 2 consisted of silt with up to 1 foot of probe rod penetration.
- (C) An accumulation of 1 foot diameter and smaller timber debris was observed between the upstream and downstream columns pier 1.

Photograph 2. View of Pier 1, Looking North.

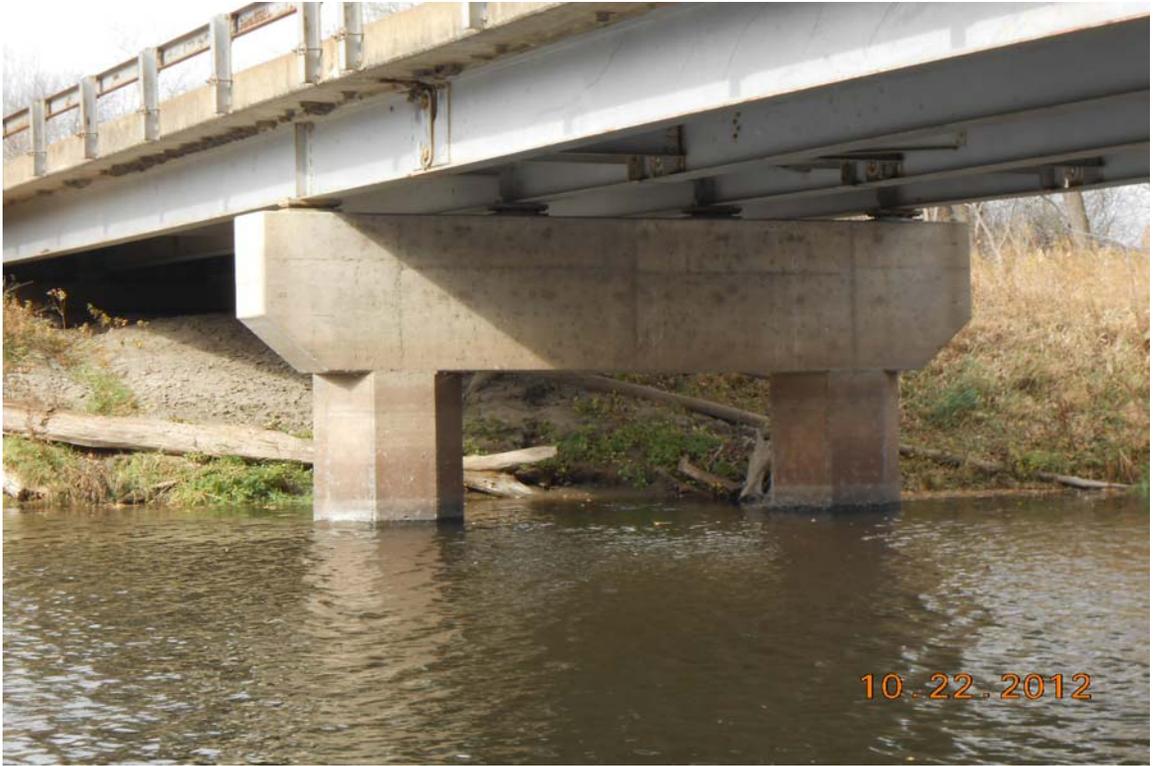
Photograph 3. View of Pier 2, Looking North.

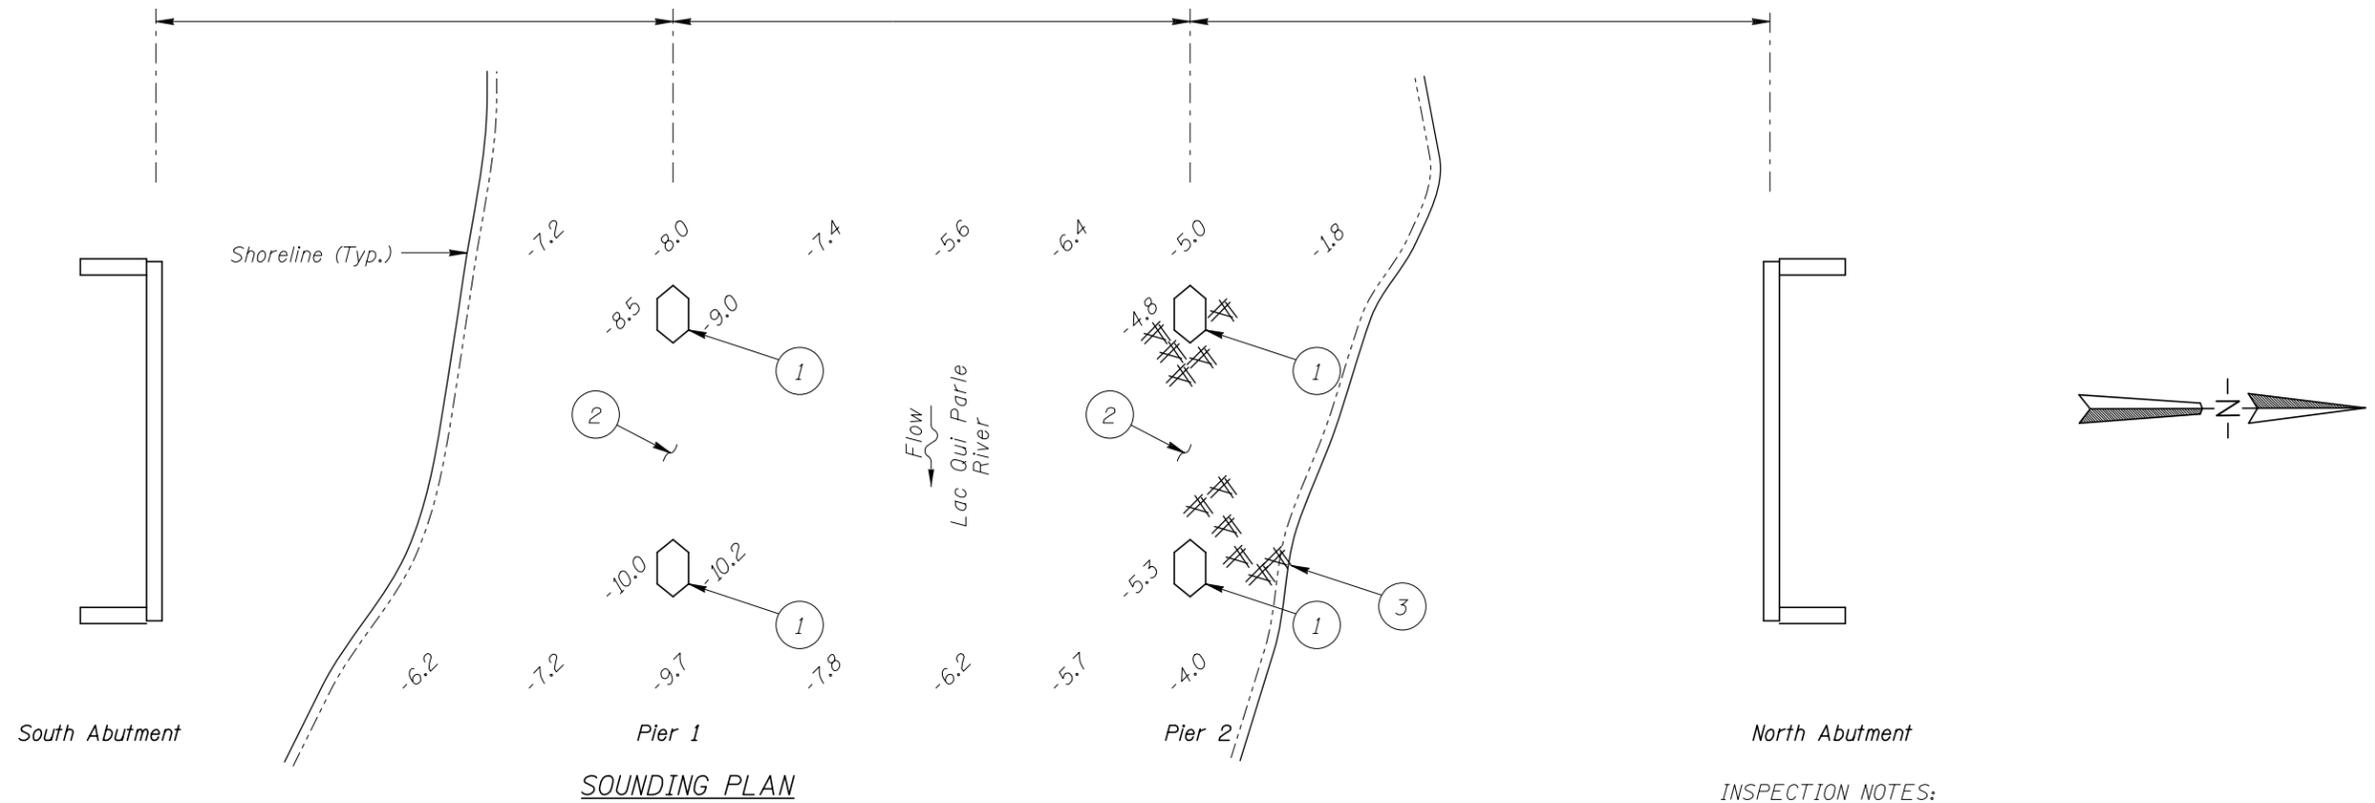
TYPICAL END VIEW OF PIERS

- INSPECTION NOTES:**
- ① The upstream and downstream column of Piers 1 and 2 exhibited scaling up to 1/8 inch deep, 1 foot above and below the waterline.
 - ② The streambed material at Piers 1 and 2 consisted of silt allowing a probe rod penetration of up to 1 foot.
 - ③ 1 foot diameter and smaller timber debris was observed between the upstream and downstream columns at Pier 2.

- (A) Reinspect the submerged substructure units at the normal maximum recommended (NBIS) interval of sixty (60) months.
