UNDERWATER BRIDGE INSPECTION REPORT

STRUCTURE NO. 02501
CSAH NO. 24
OVER THE
RUM RIVER
DISTRICT 5 - ANOKA COUNTY

PREPARED FOR THE
MINNESOTA DEPARTMENT OF TRANSPORTATION
BY
COLLINS ENGINEERS, INC.
JOB NO. 3512 (CEI 103)

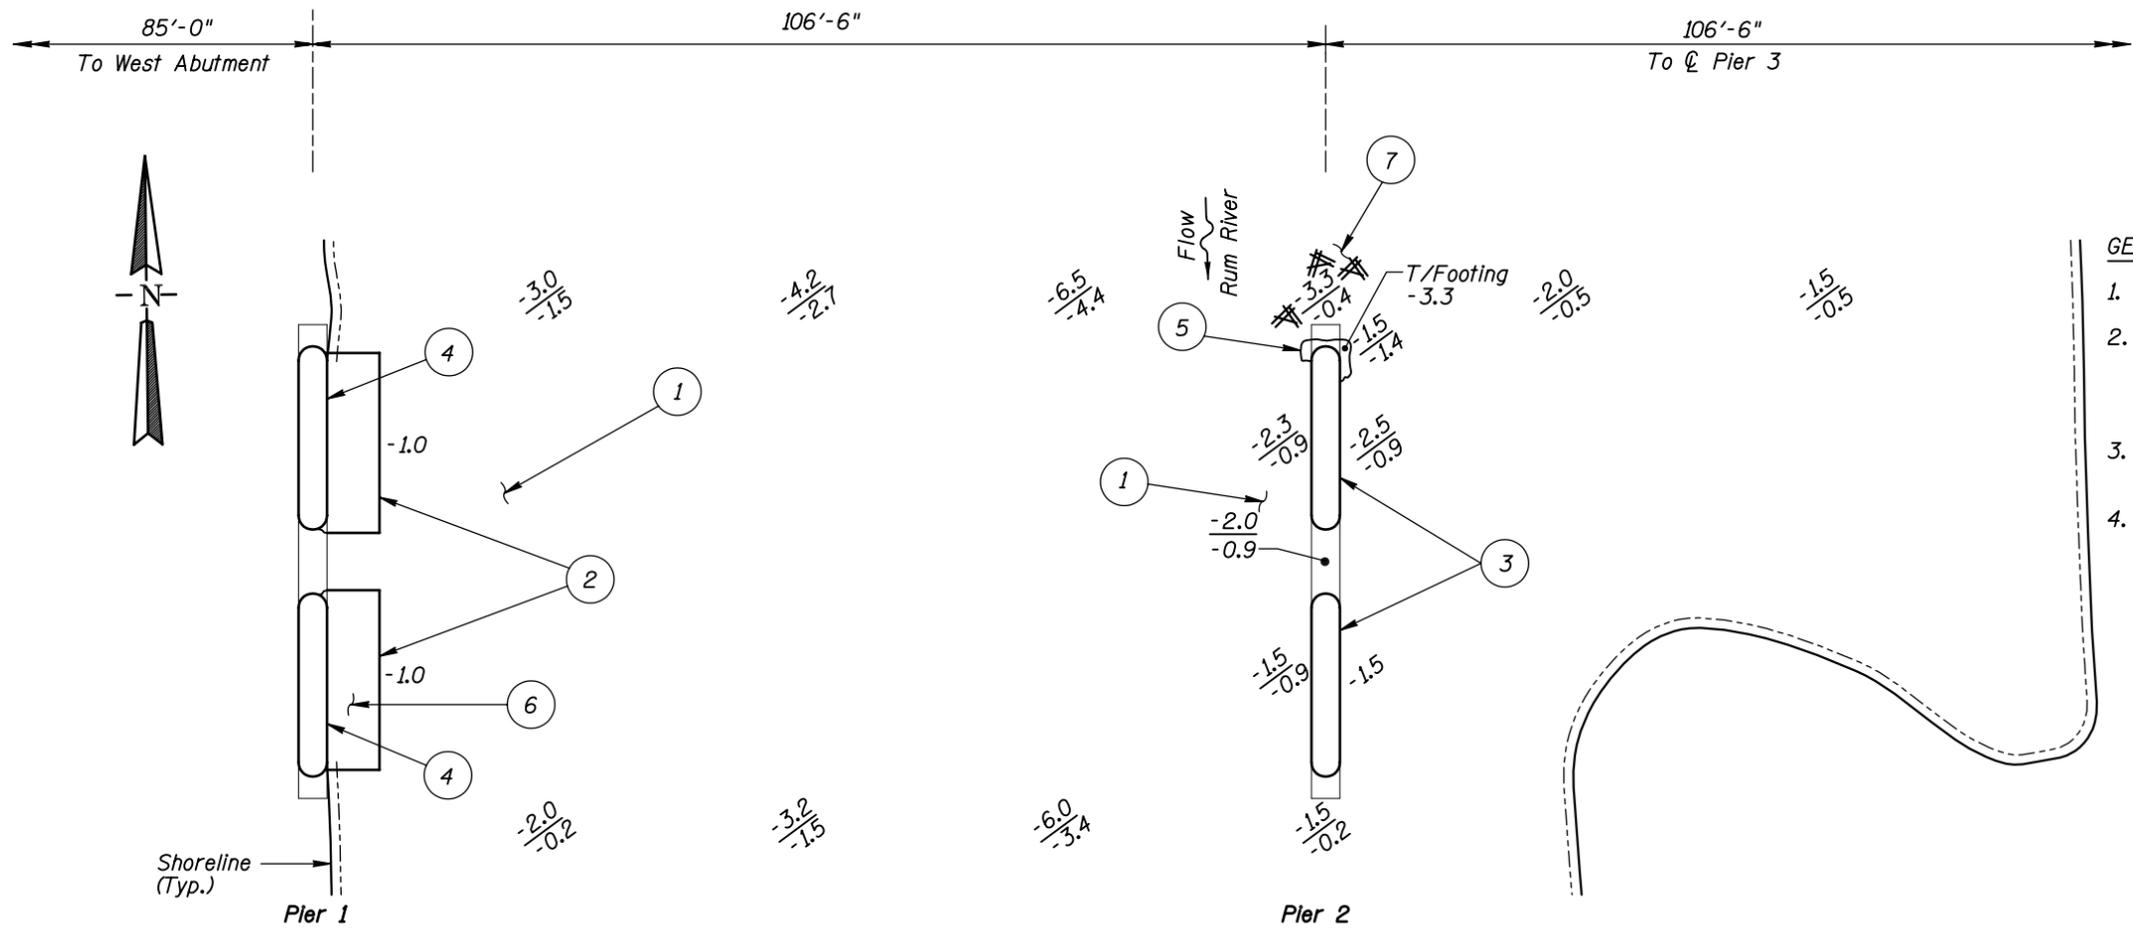
SOUNDING PLAN

- 1 The channel bottom material consisted of 2-foot-diameter and smaller riprap.
- 2 The footing was exposed along the east side of Pier 1 with 1 foot of the vertical face exposed.

- 3 Moderate scaling was observed from the channel bottom to 1 foot above the waterline with a maximum penetration of 1 inch. The heaviest scaling was along the west face and the upstream nose of the pier.

- 4 Light scaling was observed along the east face of the pier from the top of the footing to 2 feet above the footing with a maximum penetration of 1/8 inch.

- 5 A 3-foot-radius area of the top of footing was exposed at the upstream end of the pier with no vertical face exposure.
- 6 Heavy scaling and cracking was observed on the top of the footing from the shaft to the footing edge with a maximum penetration of 5 inches. Numerous 1/16-inch- to 1/2-inch-wide cracks and areas of section loss were also observed on the top of footing from the pier shaft to the edge of the footing.

- 7 A light accumulation of 1-foot-diameter and smaller timber debris was observed at the upstream end of the pier.

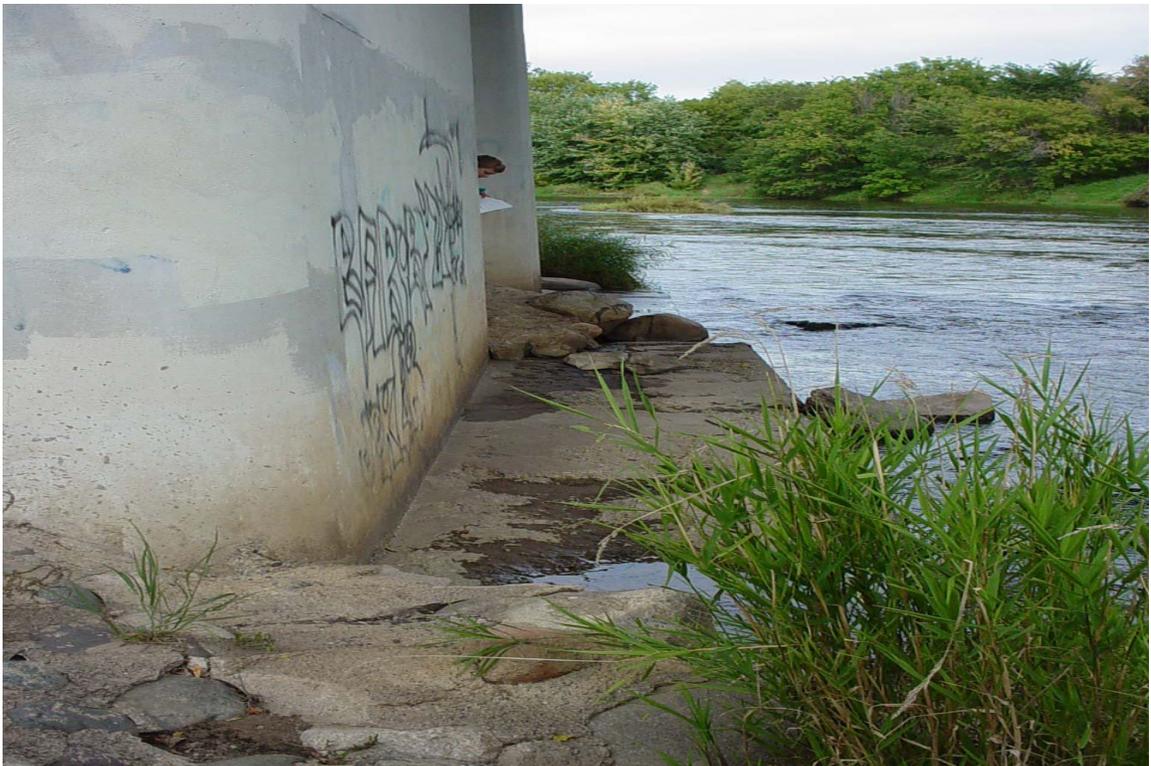
- (A) The top of the footing of Pier 1 was exposed along the east side of the pier with up to one foot of vertical face exposure. Numerous cracks and voids were observed on the top of the downstream portion of the footing with a maximum penetration of 5 inches. Associated transverse cracks, 1/16 to 1/2 inch wide, were observed extending from the pier shaft to the edge of footing.
- (B) At the upstream nose of Pier 2, a 3-foot-radius area of the footing was exposed with no significant defects and no vertical face exposure.
- (C) Light to moderate scaling was observed on Piers 1 and 2, respectively, with a maximum penetration of 1 inch.
- (D) A light accumulation of timber debris was observed at the upstream end of Pier 2.

Photograph 2. View of Pier 1, Looking North.

- (A) Monitor the concrete deterioration of the footing on Pier 1. If found to be progressing to a worse extent in the future, consideration could be given to repair by removing the unsound concrete and reforming with a concrete mix designed to promote high durability and low permeability.

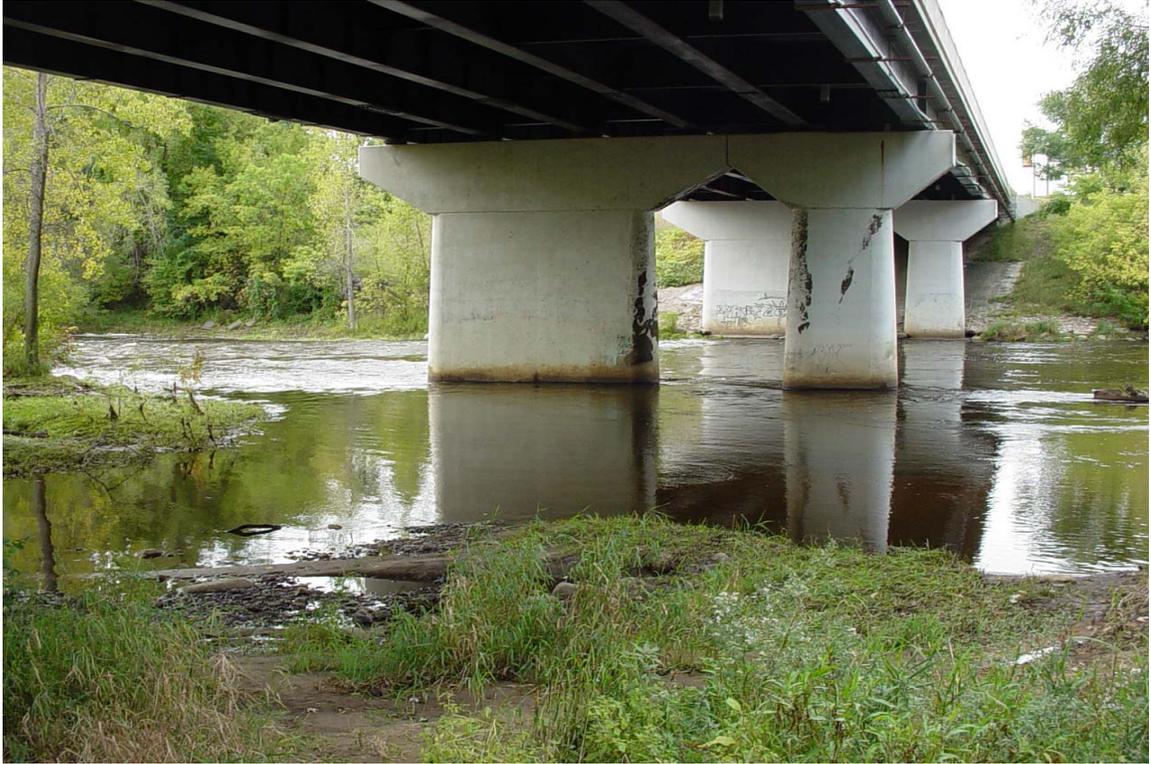
Photograph 3. View of Pier 2, Looking West.

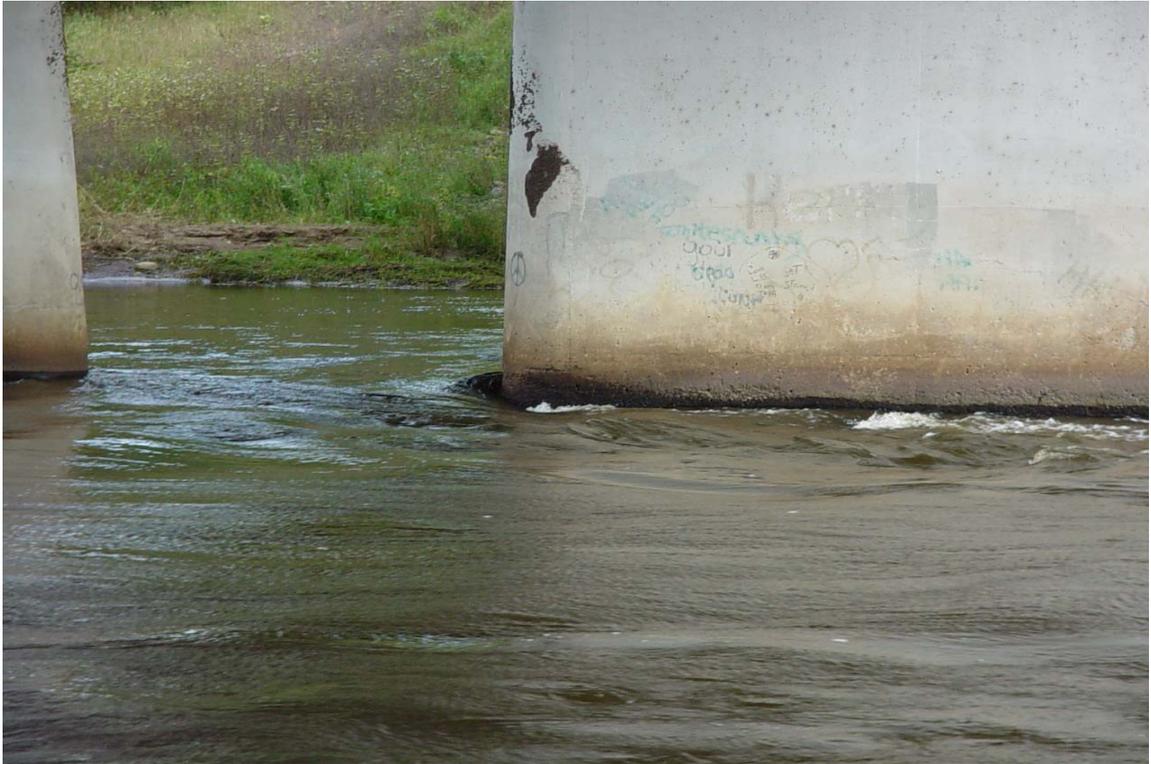
Photograph 4. View of Typical Scaling at the Waterline at Pier 2, Looking East.
