UNDERWATER BRIDGE INSPECTION REPORT

STRUCTURE NO. 02545  
CR NO. 116  
OVER THE  
RUM RIVER  
DISTRICT 5 - ANOKA COUNTY

PREPARED FOR THE  
MINNESOTA DEPARTMENT OF TRANSPORTATION  
BY  
COLLINS ENGINEERS, INC.  
JOB NO. 3512 (CEI 106)

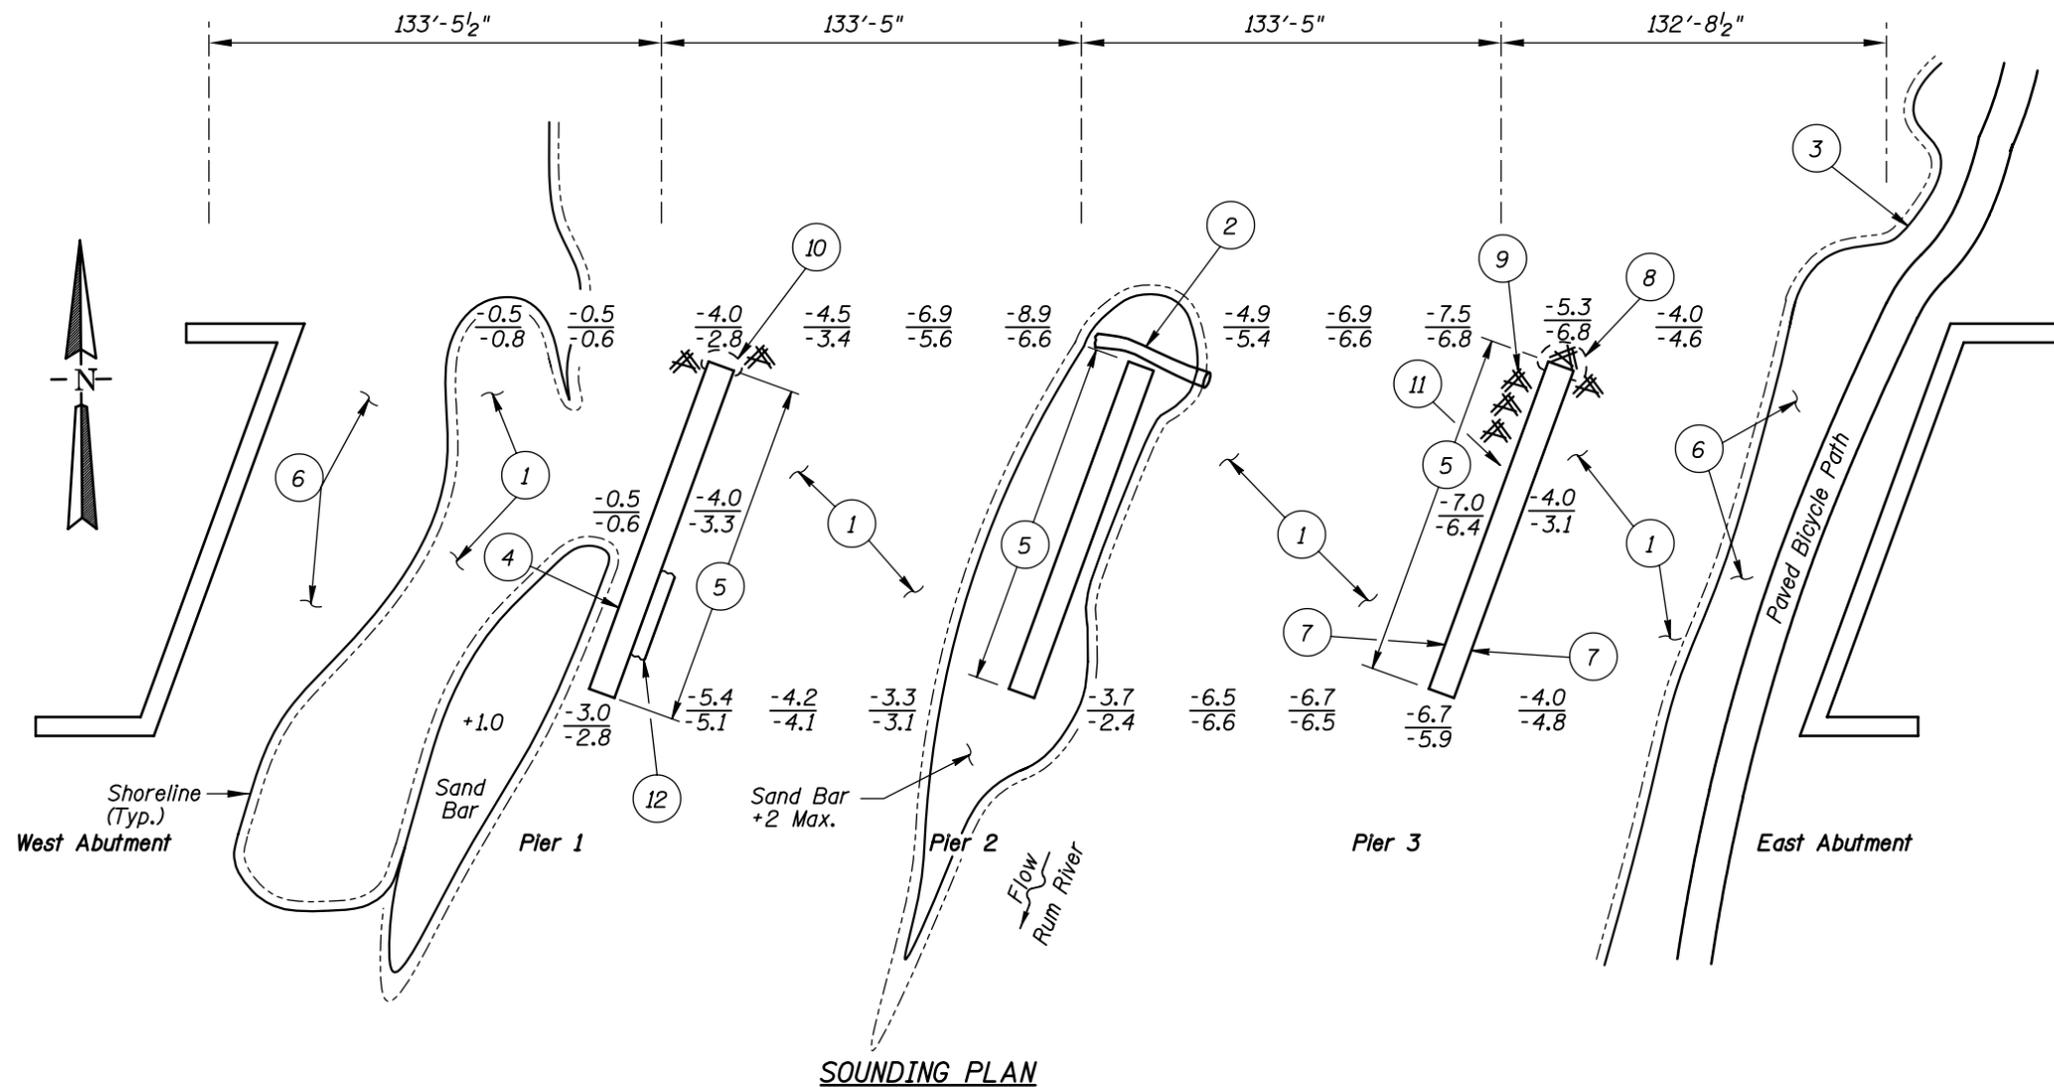
- 1 The channel bottom consisted of sandy gravel with 1 foot of probe rod penetration.
- 2 A 1.5-foot-diameter tree trunk along with 1- to 2-foot-diameter riprap was observed at the upstream end.

- 3 Previously eroded area had been infilled with marshy growth.
- 4 5 hairline vertical cracks were observed along the face of Pier 1 extending from the top of pier to the waterline.

- 5 The concrete was smooth and in good, sound condition.
- 6 The embankments consisted of grouted riprap.
- 7 A hairline crack was observed on both faces of Pier 3 extending from the top of the pier cap to the channel bottom.

- 8 A 3-foot-radius, 1-foot-deep scour pocket was observed at the upstream end of the pier.
- 9 A light accumulation of 4-inch-diameter timber debris was observed at the upstream nose and extending 20 feet along the west face.

- 10 A 4-foot-radius, 1.5-foot-deep scour pocket was observed at the upstream end of the pier with a light accumulation of timber debris.
- 11 The top of footing was detected beneath 2 to 3 inches of sand with the probe rod along the mid portion of the pier.

- 12 The top of footing was exposed along 15 feet of the east face of the pier with 1 to 2 inches of the vertical face exposed.

- (B) Monitor footing exposure and drift accumulations during future underwater inspections.

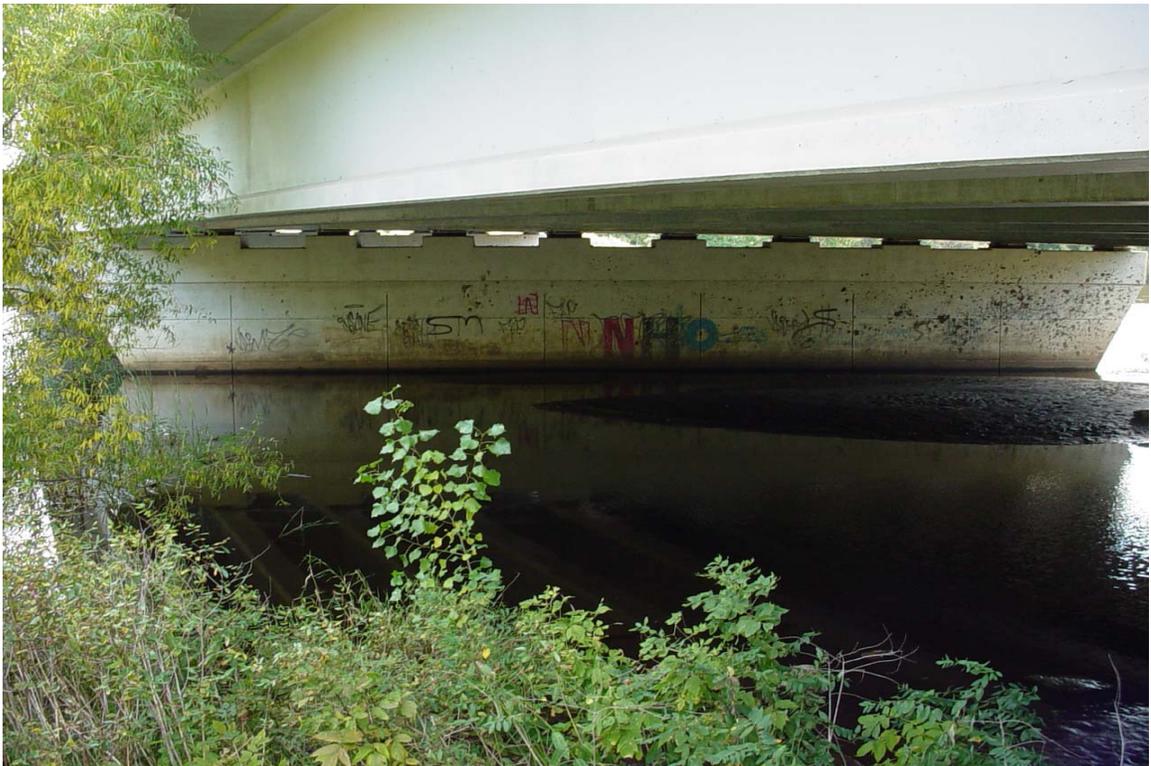
Photograph 2. View of Pier 1, Looking East.

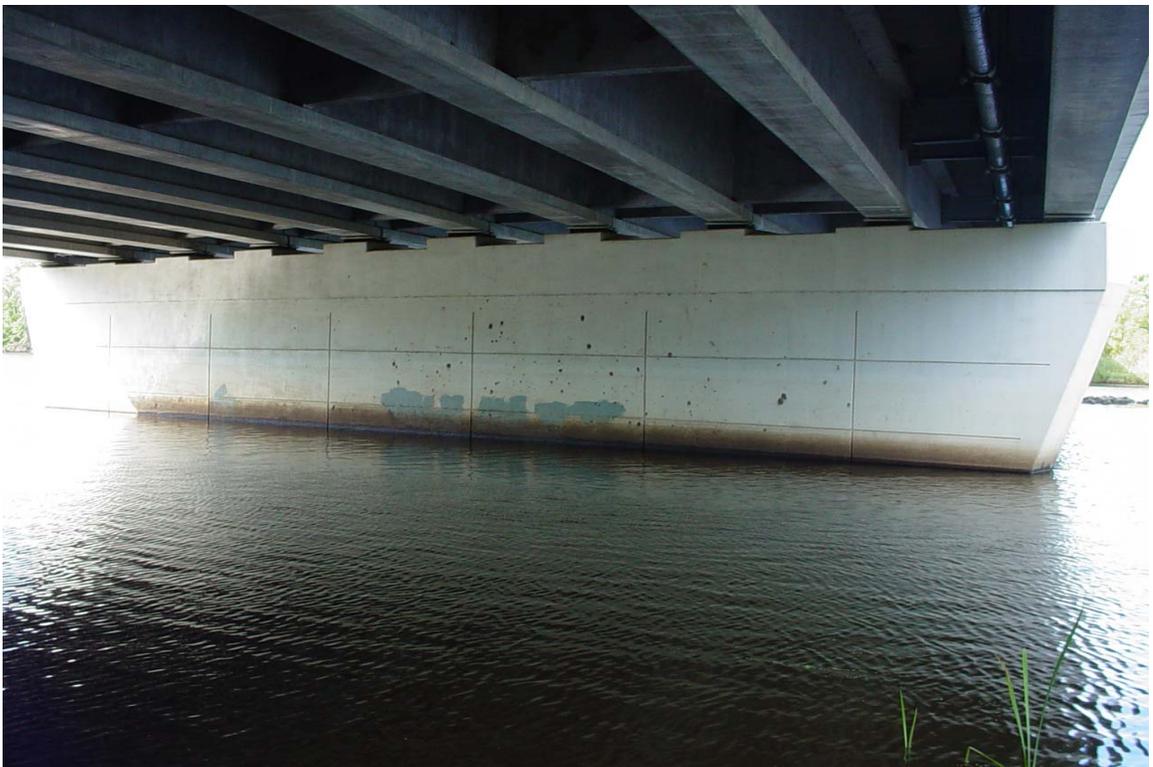
Photograph 4. View of Pier 3, Looking West.
