UNDERWATER BRIDGE INSPECTION REPORT

STRUCTURE NO. 27537  
1<sup>ST</sup> AVENUE  
OVER THE  
EAST CHANNEL OF THE MISSISSIPPI RIVER  
DISTRICT 5 - HENNEPIN COUNTY

PREPARED FOR THE  
MINNESOTA DEPARTMENT OF TRANSPORTATION  
BY  
COLLINS ENGINEERS, INC.  
JOB NO. 3512 (CEI 118)

MINNESOTA DEPARTMENT OF TRANSPORTATION  
UNDERWATER BRIDGE INSPECTION

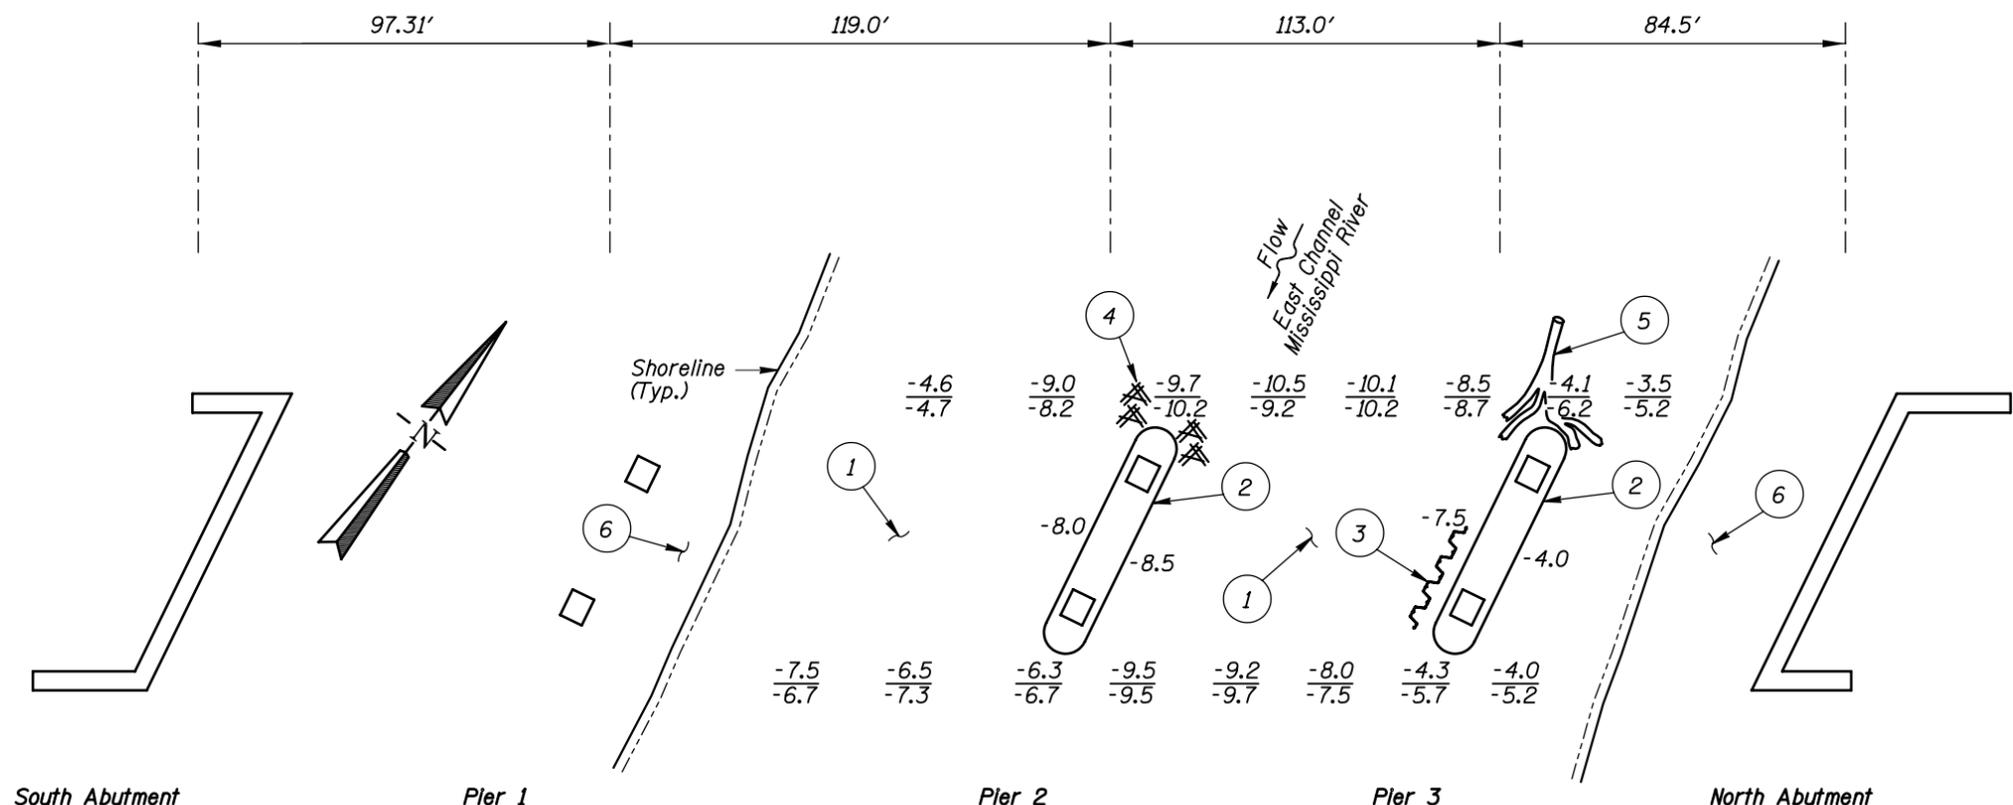
- ① The channel bottom consisted of silty sand and scattered cobbles with up to 1 foot of probe rod penetration.
- ② The concrete piers exhibited light scaling from 1 foot above to 1 foot below the waterline.
- ③ Steel sheet piling was observed along the south face of Pier 3 from the upstream quarter point to the downstream nose and extended 1 foot above the channel bottom.
- ④ A light accumulation of timber debris was observed at the upstream end of Pier 2 on the channel bottom.
- ⑤ A moderate accumulation of timber debris, including a 20-foot-long log that was 1 foot in diameter, was observed at the upstream end of Pier 3.
- ⑥ Both embankments were well armored with grouted riprap.

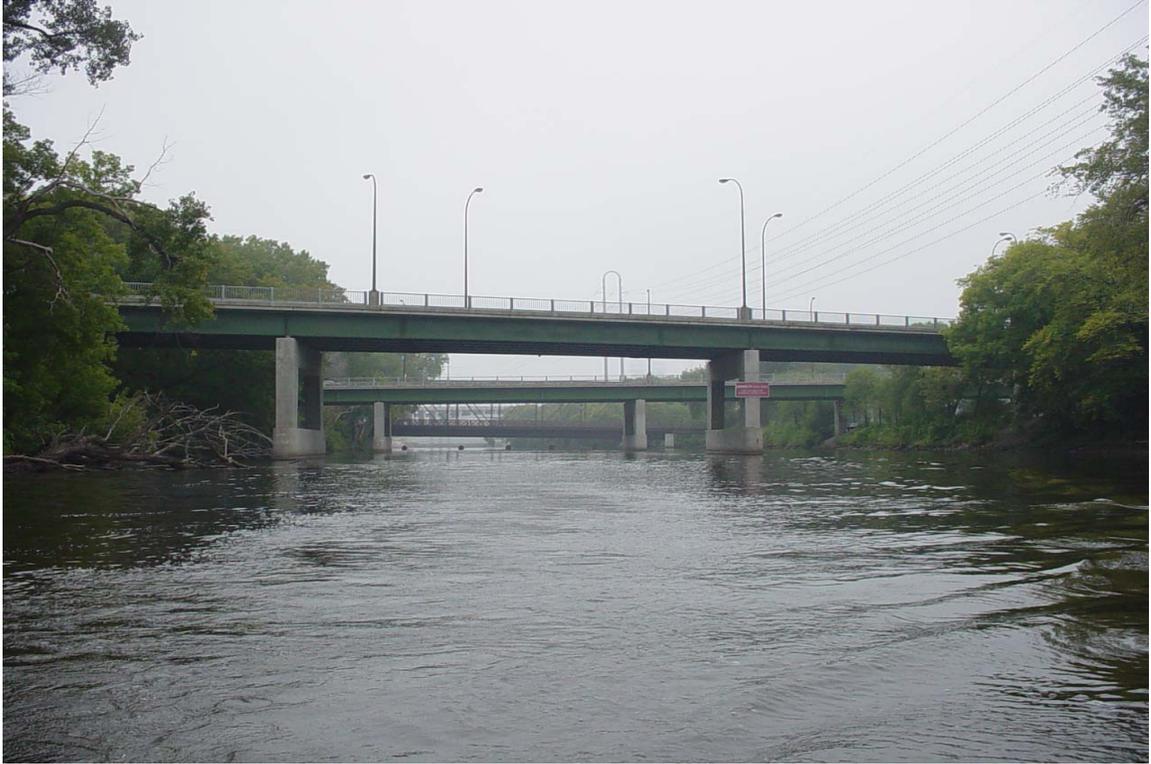
Photograph 1. Overall View of Structure, Looking East.

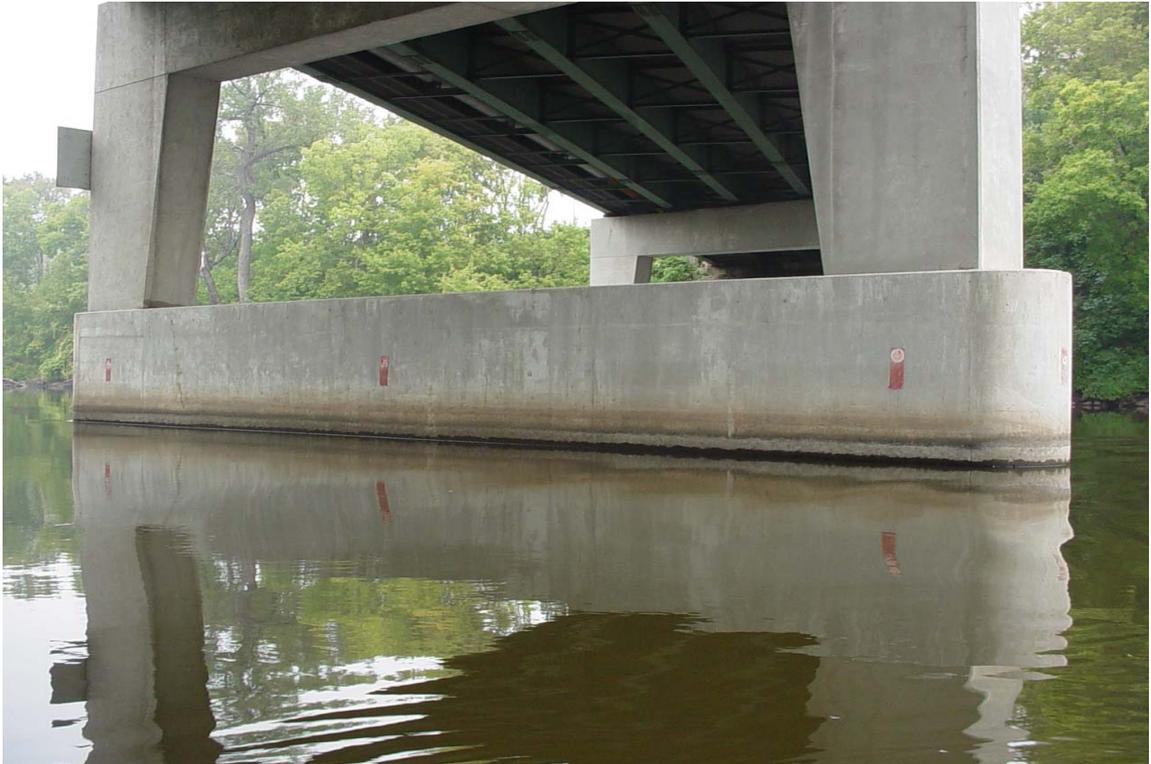
Photograph 2. View of Pier 2, Looking North.

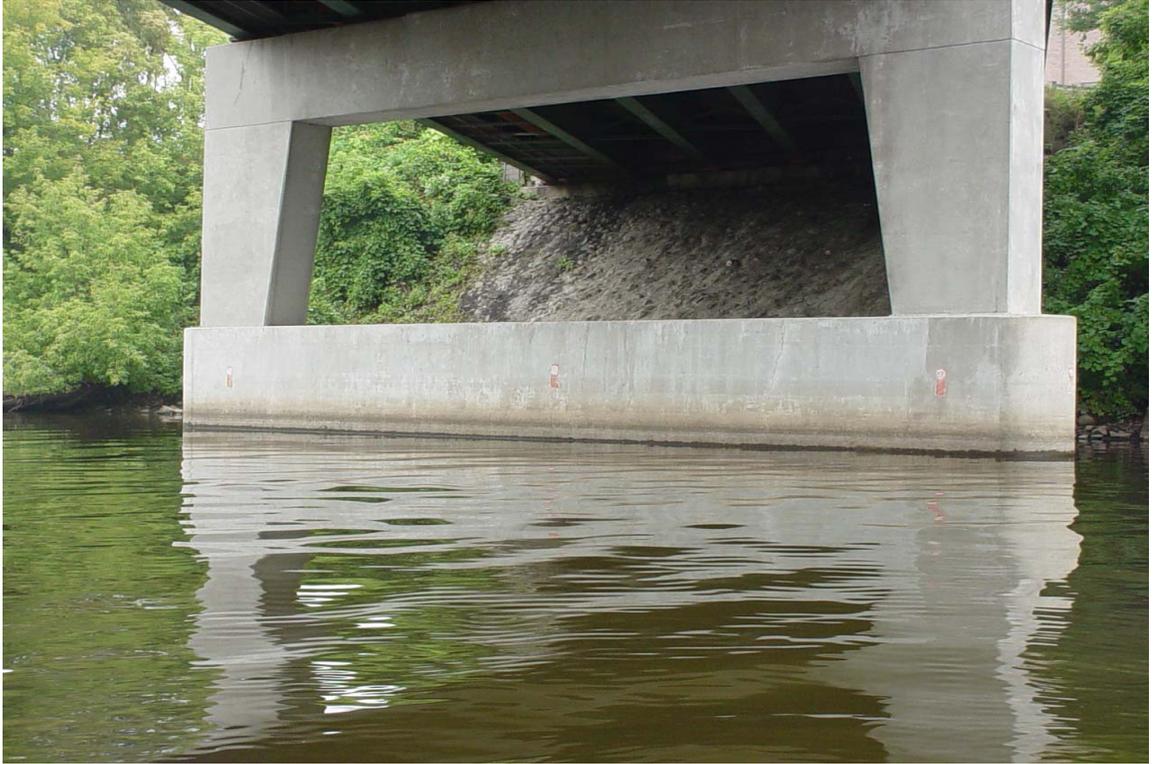
Photograph 3. View of Pier 3, Looking North.
