UNDERWATER BRIDGE INSPECTION REPORT

STRUCTURE NO. 27549

42ND AVENUE

MISSISSIPPI RIVER

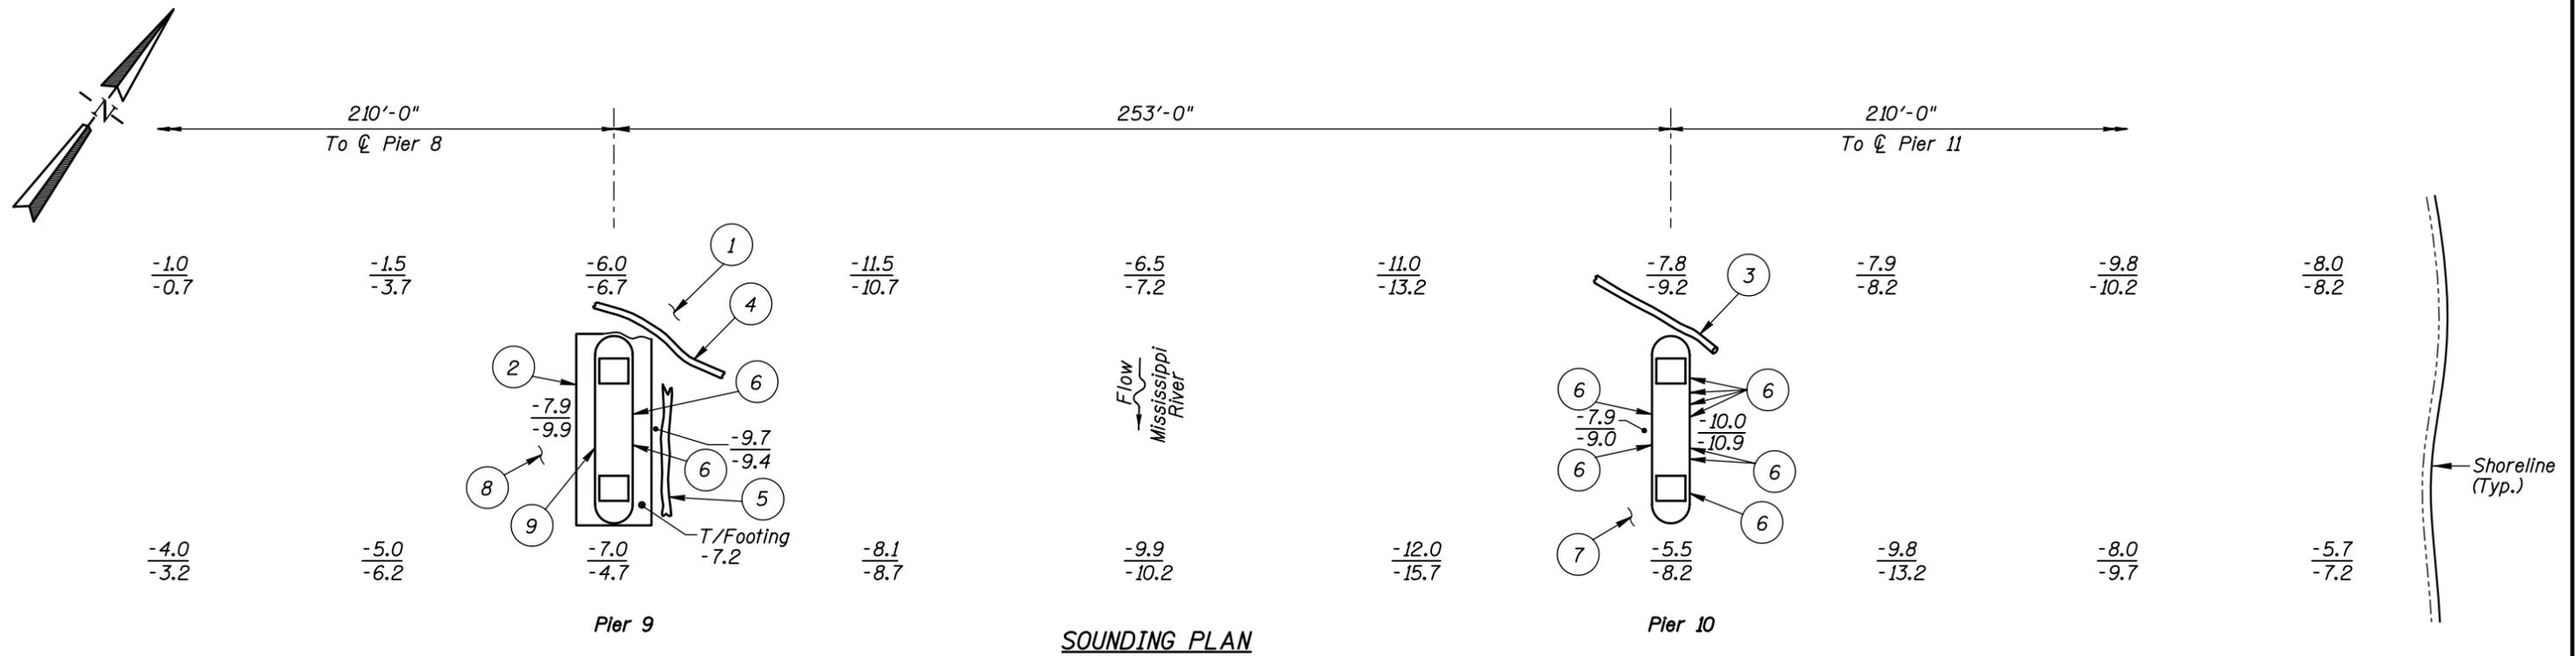
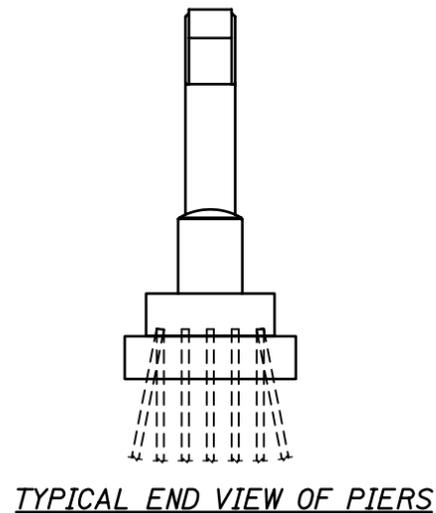
- 1 The channel bottom material around Pier 9 consisted of riprap up to 1 foot in diameter at the upstream nose and sand infilling around the rest of the pier and had up to 1.5 foot of probe rod penetration.

- 2 The top of the footing around the entire perimeter of Pier 9 was exposed with vertical face exposures of 1 foot at the upstream west corner, 4 inches at the downstream west corner, and a maximum of 2.5 feet along the east face.

- 3 An 18 inch diameter log was observed on the channel bottom at the upstream end of Pier 10.
- 4 An 18 inch diameter log was observed on the channel bottom at the upstream end of Pier 9.

- 5 A log that was 18 inches in diameter and 30 feet long was observed on the channel bottom along the east face of Pier 9.
- 6 A vertical hairline crack was observed extending from the top of the web to the waterline.

- 7 The channel bottom material around of Pier 10 consisted of 1 to 3 foot diameter riprap with sand infilling that had up to 8 inches of probe rod penetration.

- 8 The steel I-beams observed in the last inspection at the channel bottom along the west side of Pier 9 have been covered with sand infilling.
- 9 A vertical crack that was up to 1/8 inches wide was observed extending from the top of the web to the waterline.

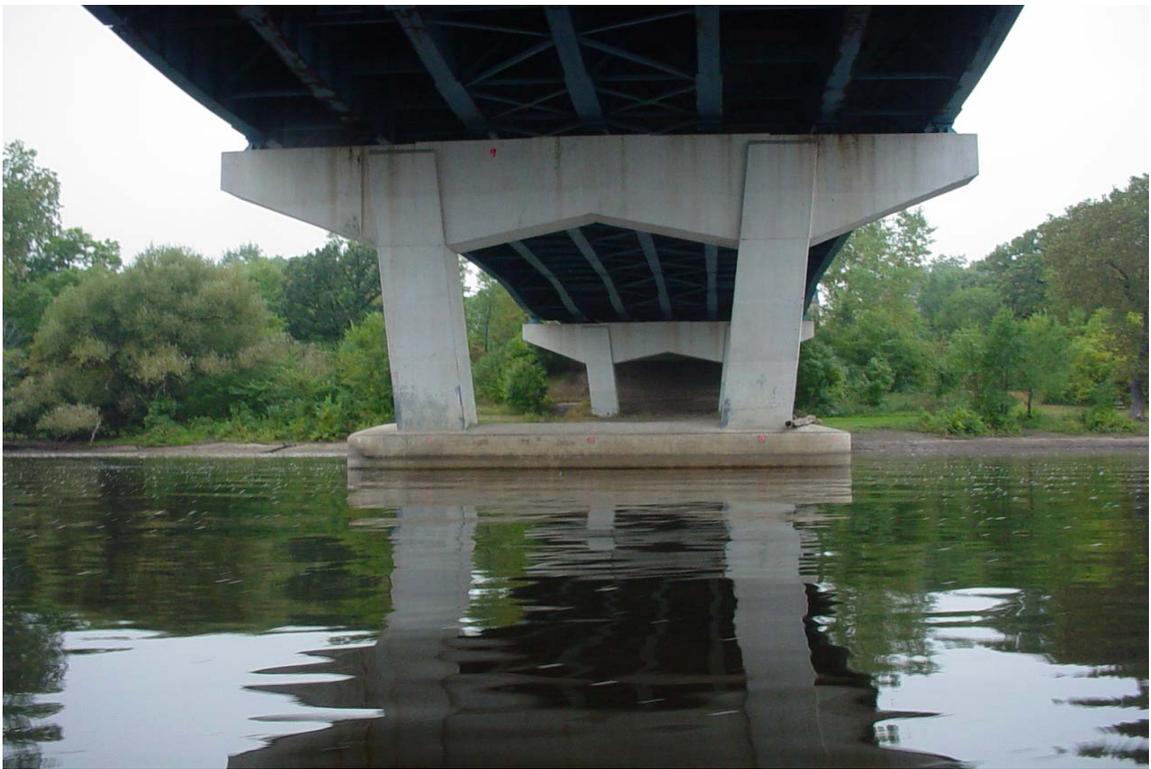
Photograph 2. View of Pier 9, Looking West.

Monitor the footing exposure at Pier 9 during future underwater inspections. The scour evaluation indicates pier foundations are stable for the calculated scour conditions.

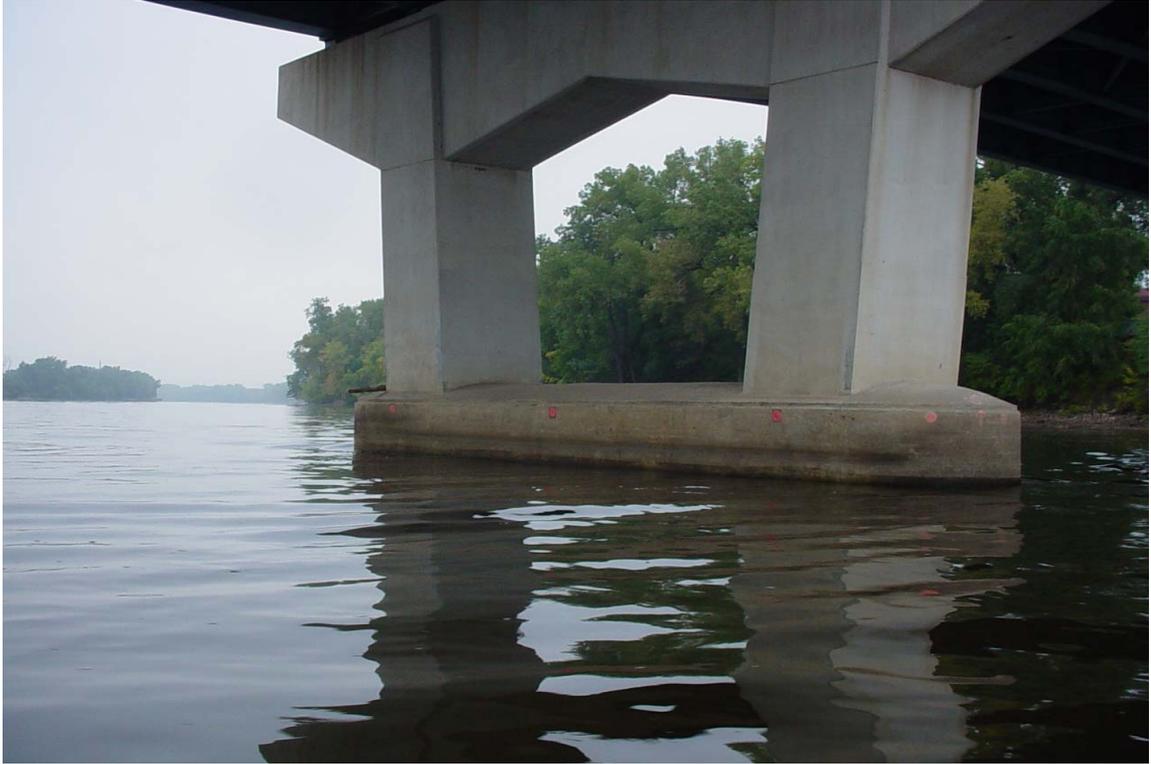
Photograph 3. View of Pier 10, Looking Northeast.

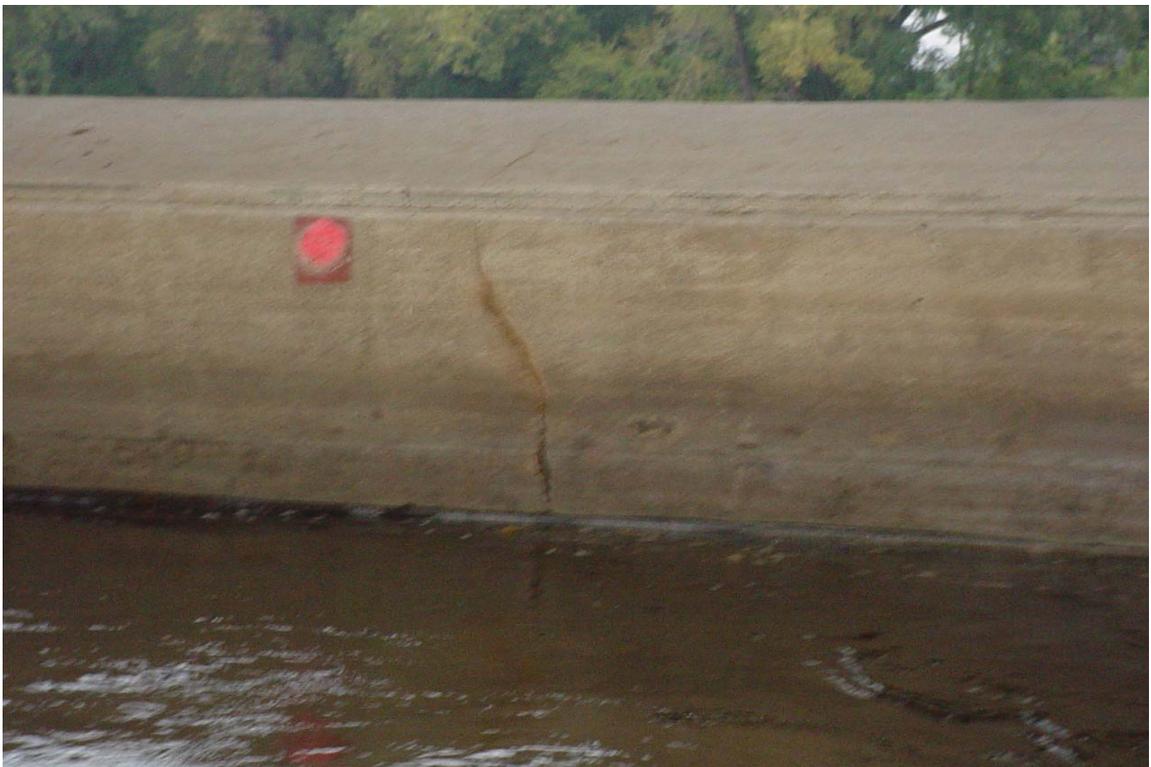
Photograph 4. View of Vertical Crack on West Side of Pier 9.
