UNDERWATER BRIDGE INSPECTION REPORT

STRUCTURE NO. 62082
CR 3 (LAKE STREET)
OVER THE
MISSISSIPPI RIVER
DISTRICT 5- HENNEPIN COUNTY

PREPARED FOR THE
MINNESOTA DEPARTMENT OF TRANSPORTATION
BY
COLLINS ENGINEERS, INC.
JOB NO. 3512

MINNESOTA DEPARTMENT OF TRANSPORTATION
UNDERWATER BRIDGE INSPECTION

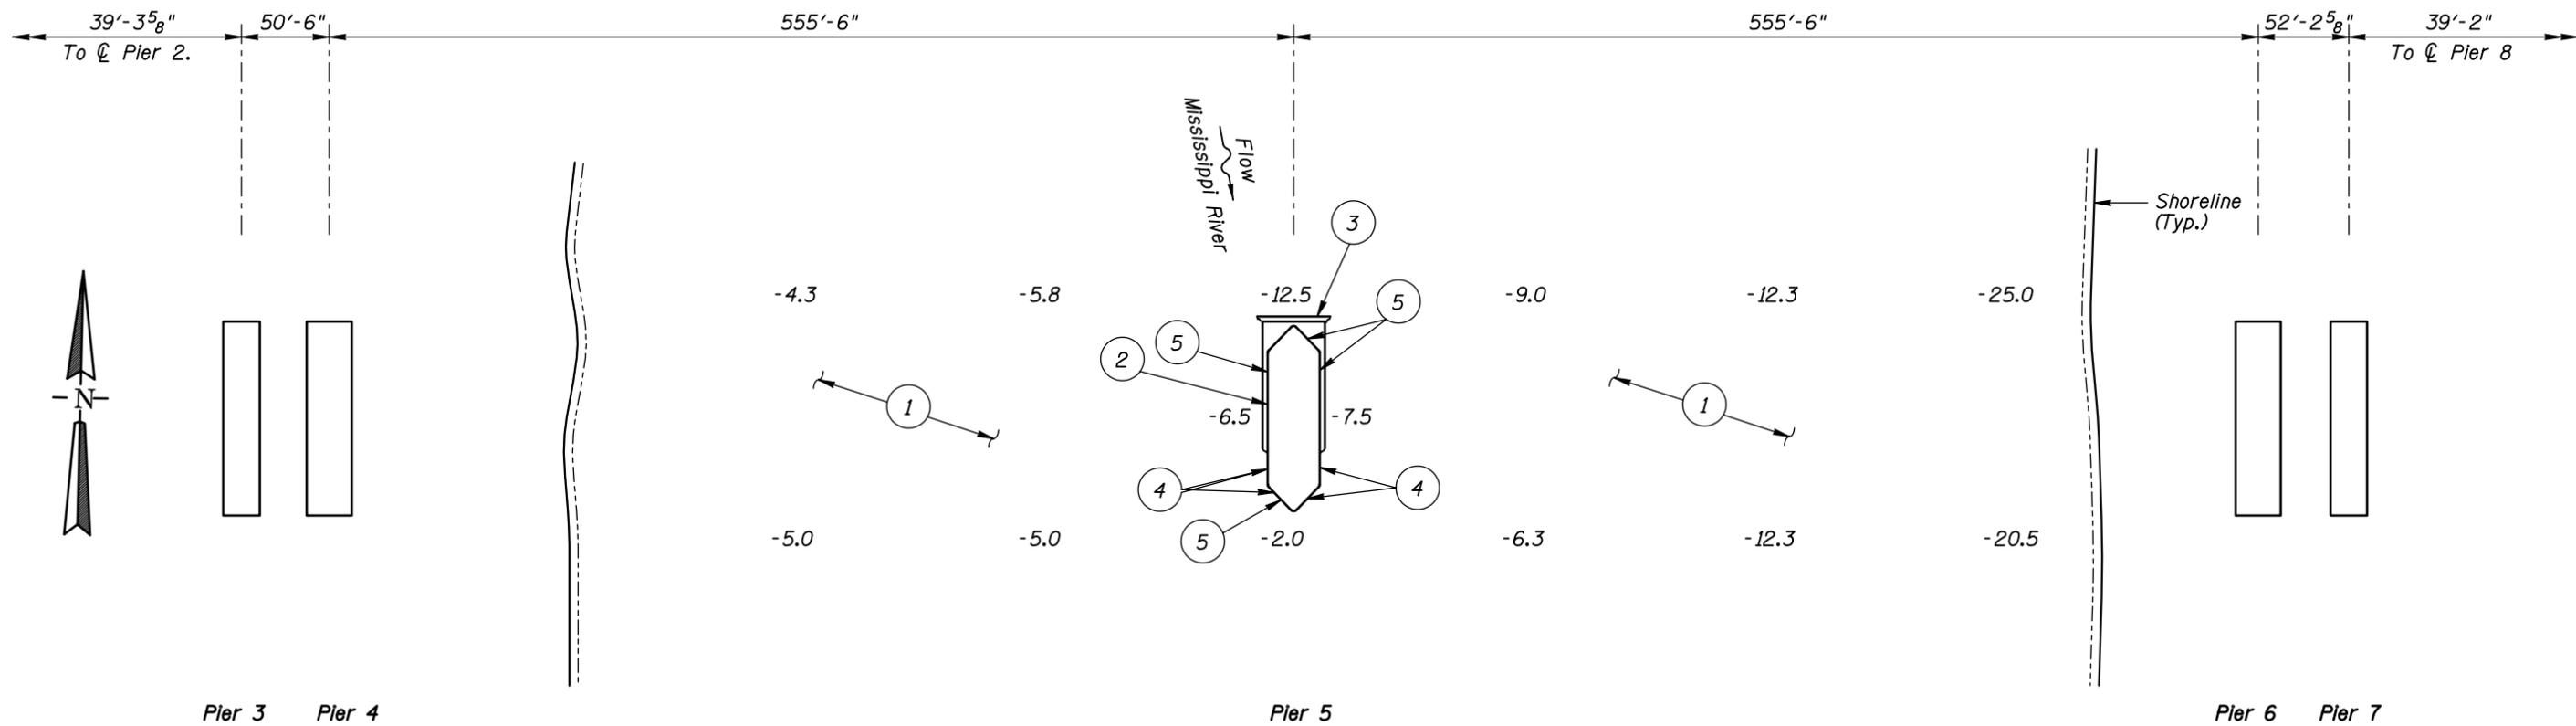
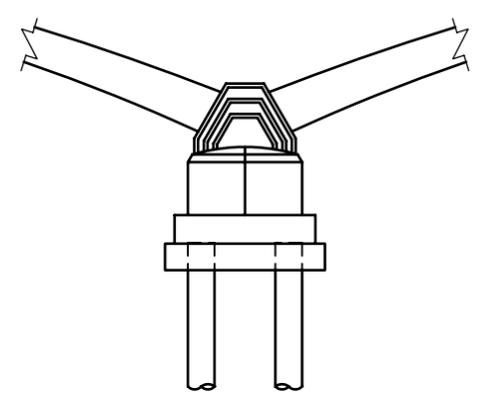
SOUNDING PLAN

- 1 The channel bottom material consisted of sand and concrete rubble with up to 6 inches of probe rod penetration. There was also random pieces of scrap steel scattered around the pier on the channel bottom.

- 2 The concrete around the pier was in good and sound condition with a light layer of aquatic growth that extended from the waterline to the channel bottom.

- 3 Footing exposure was observed at the upstream nose of Pier 5 and extended for 3/4 of the pier length way along both sides of the pier. At the upstream nose, the full 7.5 feet of the vertical face of the footing was exposed and 2 to 4 inches of the vertical face of the seal was also exposed. The footing and seal exposure is due to localized scour, with an approximate depth of 5 to 7 feet, around the upstream end of the pier

- 4 A hairline vertical crack was observed that extended from the top of the pier to the channel bottom.
- 5 A hairline vertical crack was observed that extended from the top of the pier to 1 foot above the waterline.

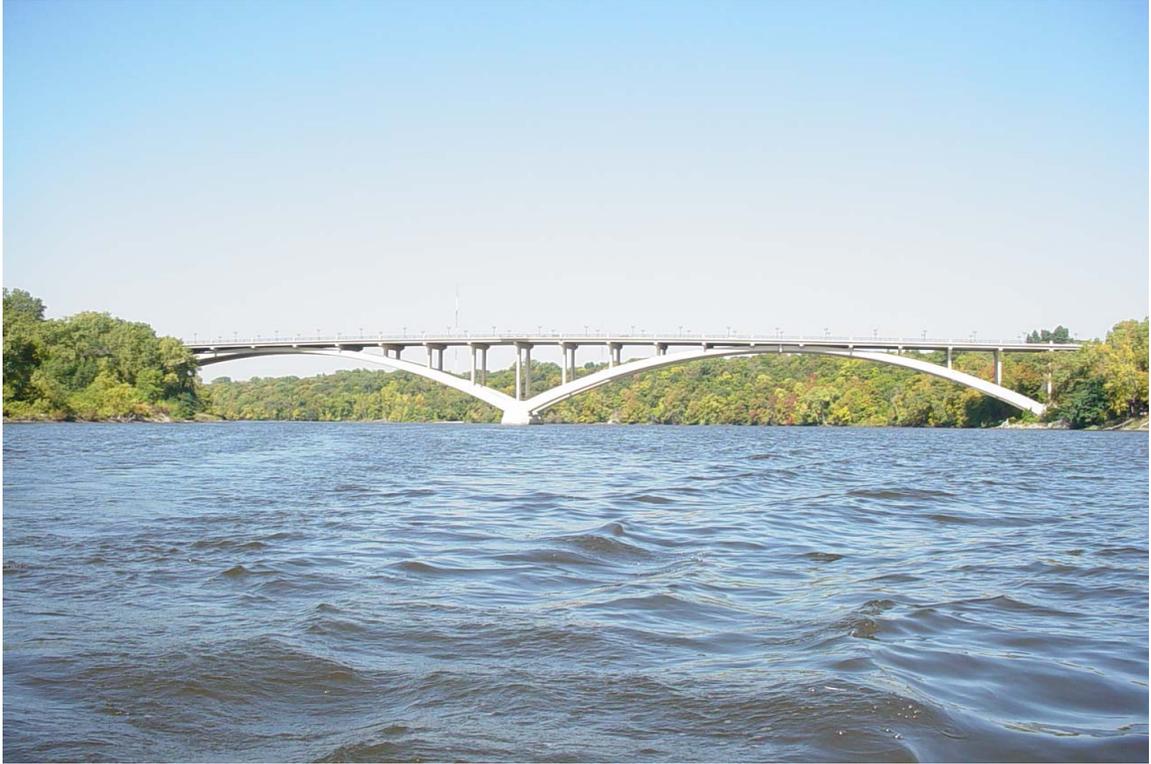
Photograph 1. Overall View of Structure, Looking North.

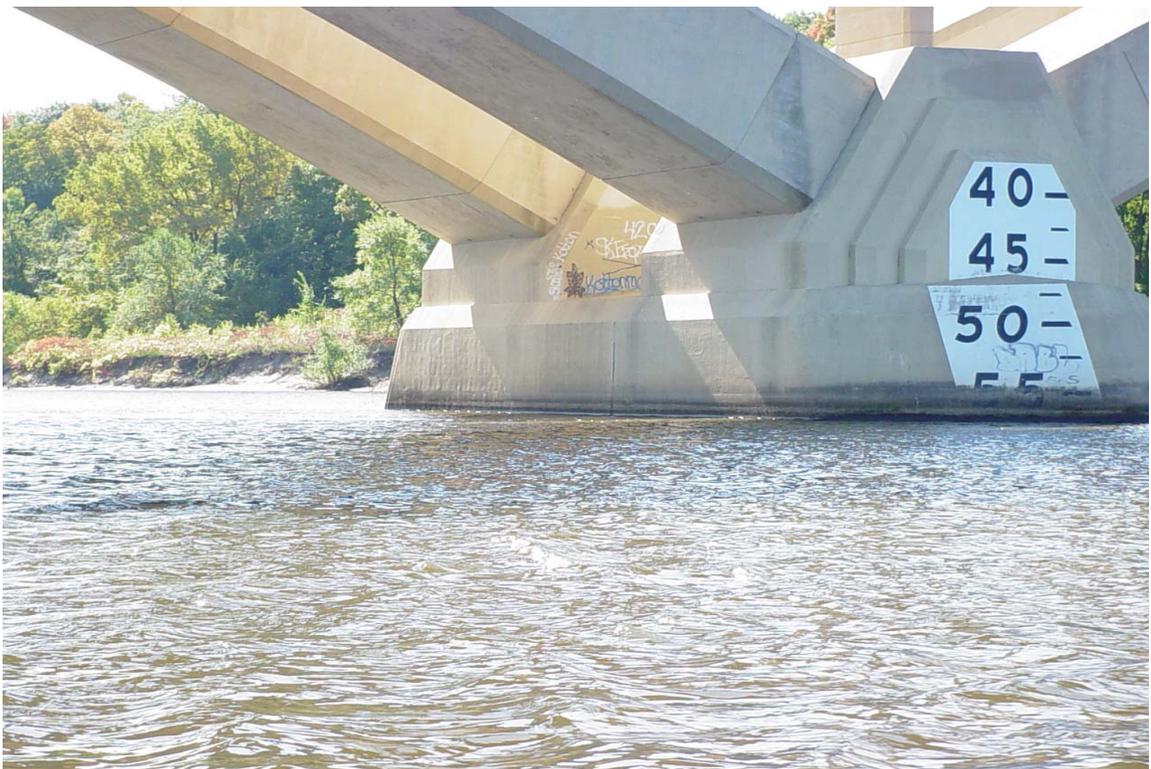
Photograph 2. View of Pier 1, Looking Southwest.
