UNDERWATER BRIDGE INSPECTION REPORT

STRUCTURE NO. 62580  
RASPBERRY ISLAND ROAD  
OVER THE  
MISSISSIPPI RIVER  
DISTRICT 9 - RAMSEY COUNTY

PREPARED FOR THE  
MINNESOTA DEPARTMENT OF TRANSPORTATION  
BY  
COLLINS ENGINEERS, INC.  
JOB NO. 3512

MINNESOTA DEPARTMENT OF TRANSPORTATION  
UNDERWATER BRIDGE INSPECTION

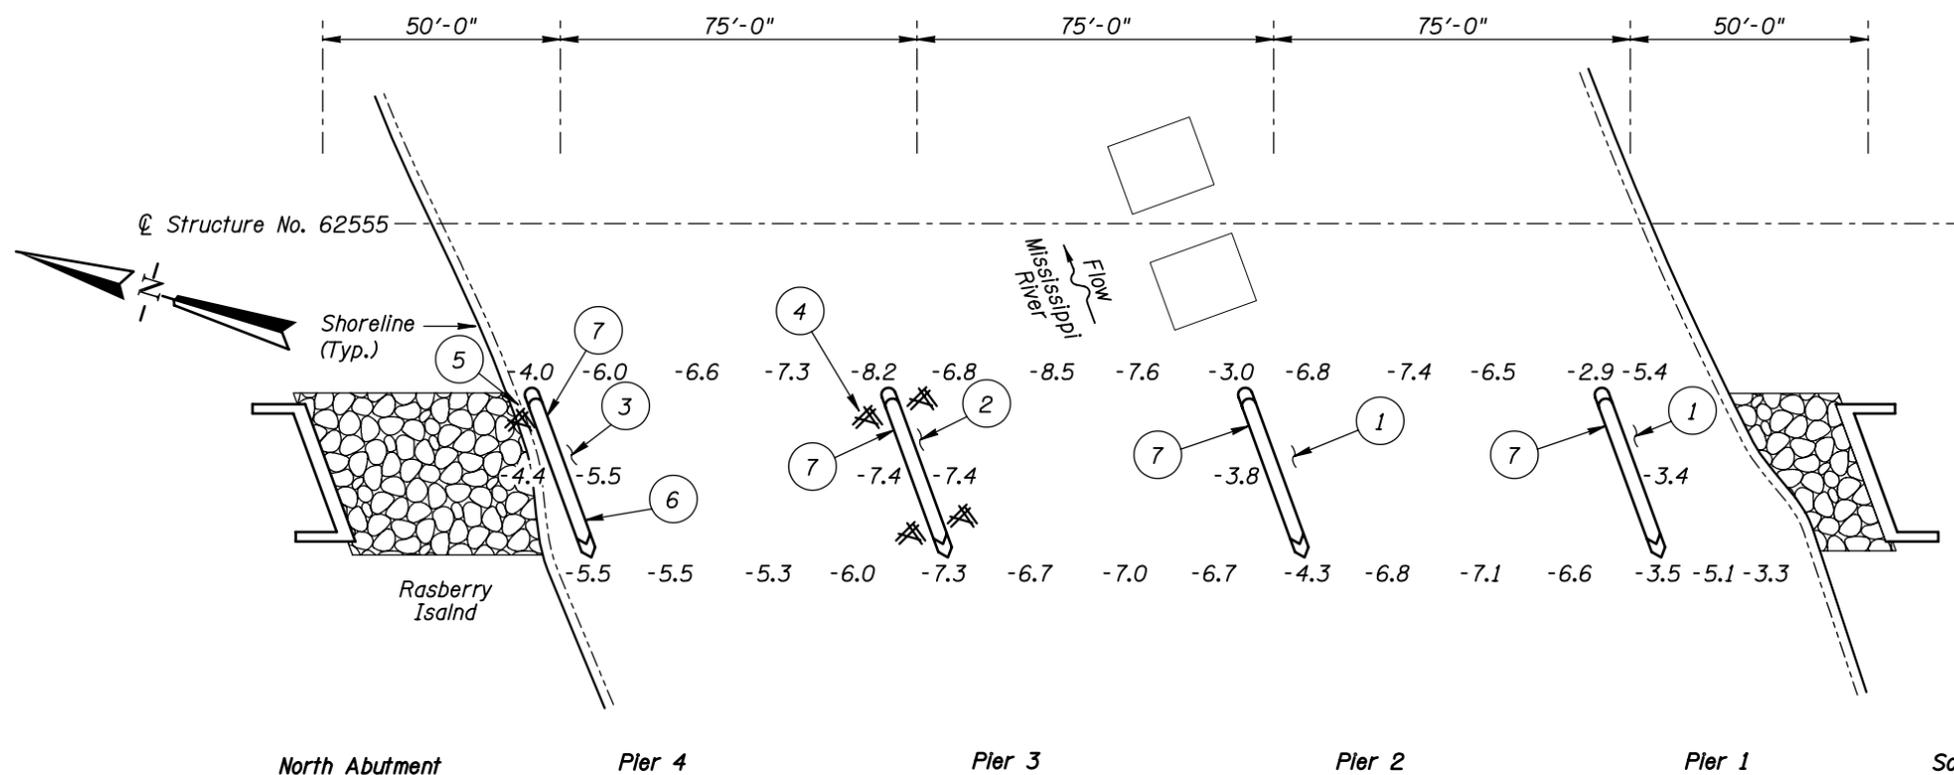
| <b>INSPECTION AND SOUNDING PLAN</b> | | |

- 1 The channel bottom consisted of 2 inch diameter gravel with random riprap at the upstream end.
- 2 The channel bottom consisted of sand with up to 6 inches of probe rod penetration.

- 3 The channel bottom consisted of 6 inch diameter cobbles and gravel.
- 4 A minor accumulation of timber debris, with pieces up to 12 inches in diameter, was observed on the channel bottom randomly scattered throughout the piles of Pier 3.

- 5 Minor timber debris was observed between Pier 4 and the shoreline and consisted of a tree with an 8 foot diameter root ball.
- 6 Timber formwork and steel angles were observed at the base of the concrete shaft of Pier 4. The bottom of the shaft was poorly formed with rough edges and reinforcing steel protruding from the base observed.

- 7 The concrete shaft was in good and sound condition and extended 2 feet below the waterline. The submerged steel piles exhibited light surface corrosion with rust nodules up to 1/16 inch in diameter.

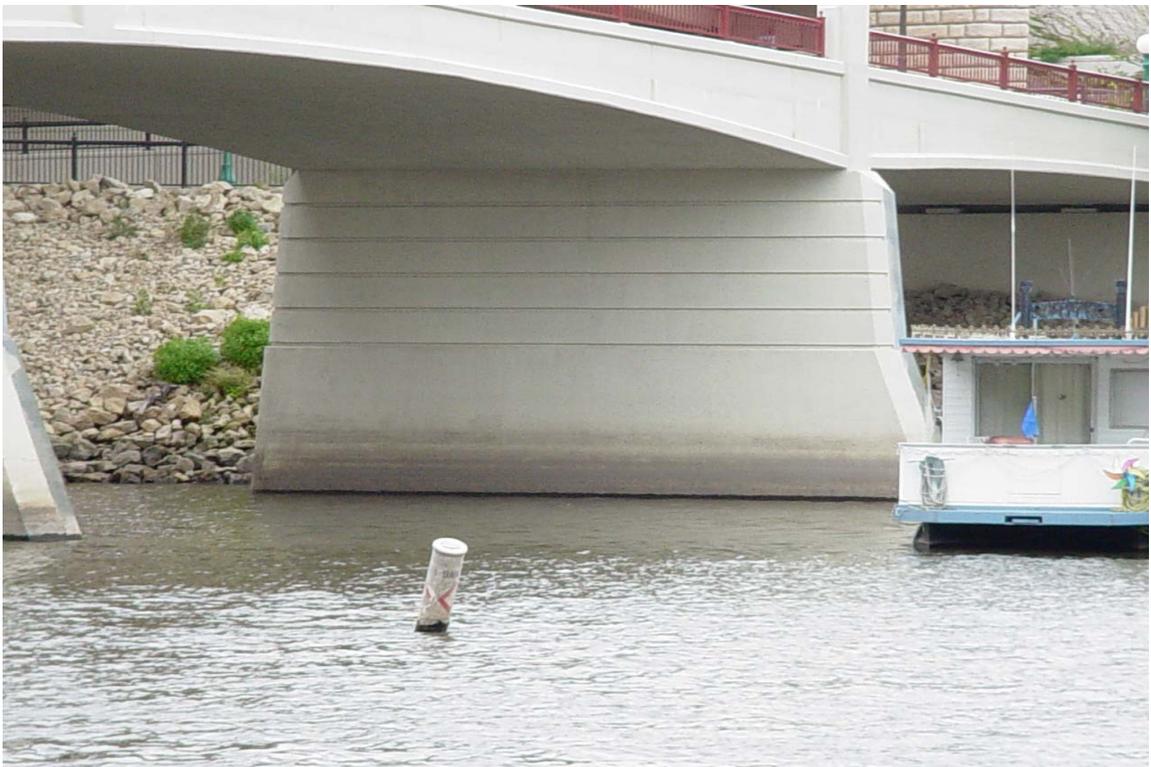
Photograph 2. Overall View of Pier 1, Looking Southeast

| UNIT REFERENCE NO. | UNIT DESCRIPTION | MAXIMUM DEPTH OF WATER | SUBSTRUCTURE | | | | | | CHANNEL | | | | | GENERAL | | | | | |
|---|---|---|---|---|---|---|---|---|---|---|---|---|---|---|---|---|---|---|---|
| | Pier 1 | 3.5' | 7 | 8 | N | 9 | N | 7 | 8 | N | 9 | N | 8 | 8 | 7 | N | N | N | N |

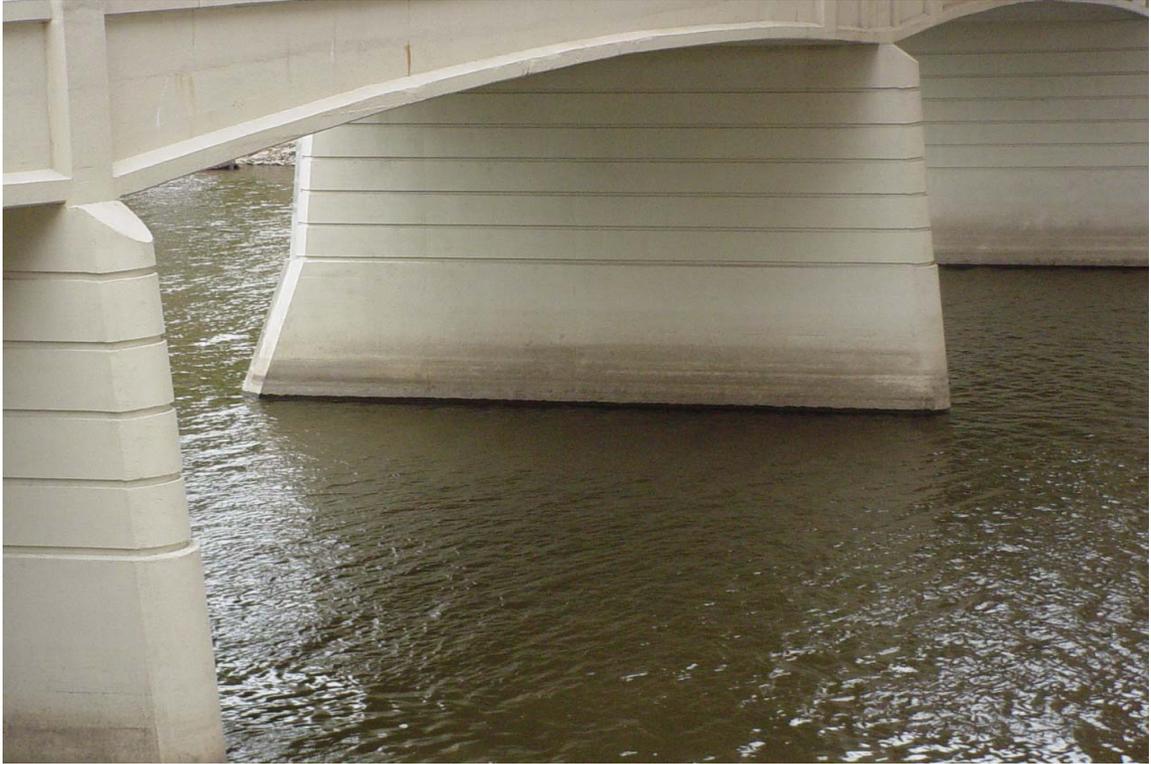
Photograph 3. Overall View of Pier 2, Looking Northwest

| UNIT REFERENCE NO. | UNIT DESCRIPTION | MAXIMUM DEPTH OF WATER | SUBSTRUCTURE | | | | | | CHANNEL | | | | | GENERAL | | | | | |
|---|---|---|---|---|---|---|---|---|---|---|---|---|---|---|---|---|---|---|---|
| | Pier 2 | 4.3' | 7 | 8 | N | 9 | N | 7 | 8 | N | N | N | 8 | 8 | 7 | N | N | N | N |

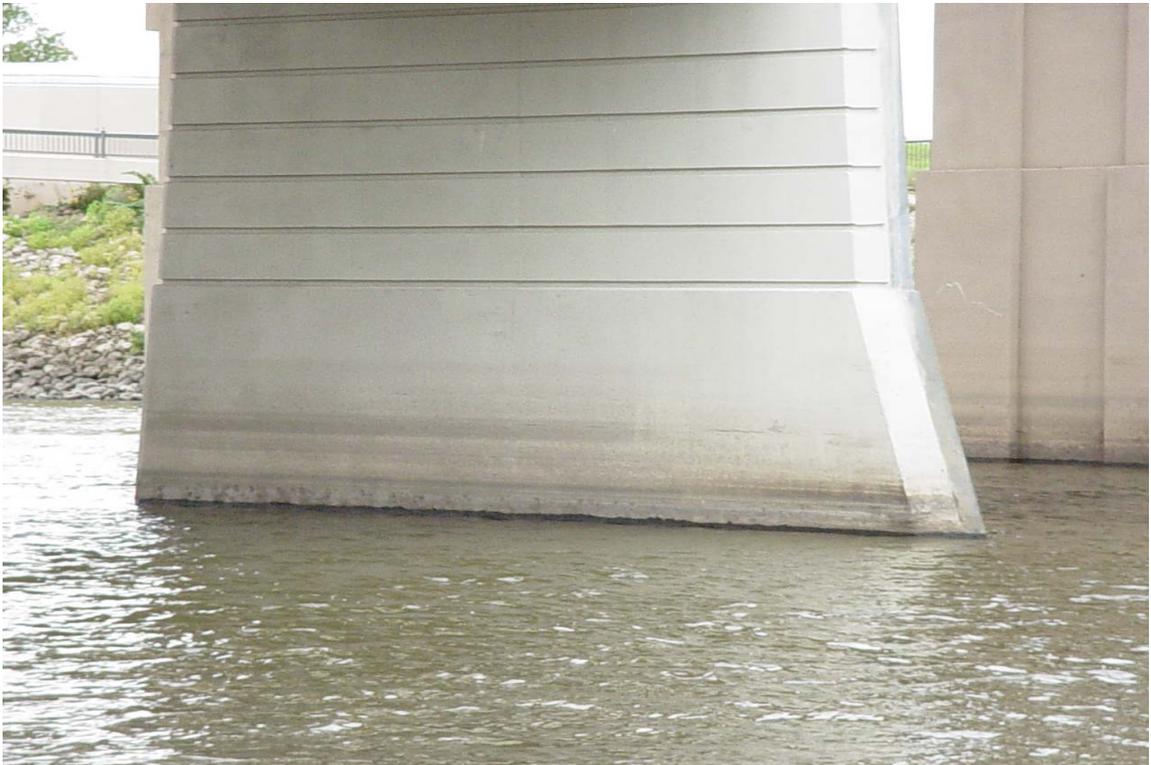
Photograph 4. Overall View of Pier 3, Looking Southeast

| UNIT REFERENCE NO. | UNIT DESCRIPTION | MAXIMUM DEPTH OF WATER | SUBSTRUCTURE | | | | | | CHANNEL | | | | | GENERAL | | | | | |
|---|---|---|---|---|---|---|---|---|---|---|---|---|---|---|---|---|---|---|---|
| | Pier 3 | 8.2' | 7 | 8 | N | 9 | N | 7 | 8 | N | N | 7 | 7 | 8 | 7 | N | N | N | N |

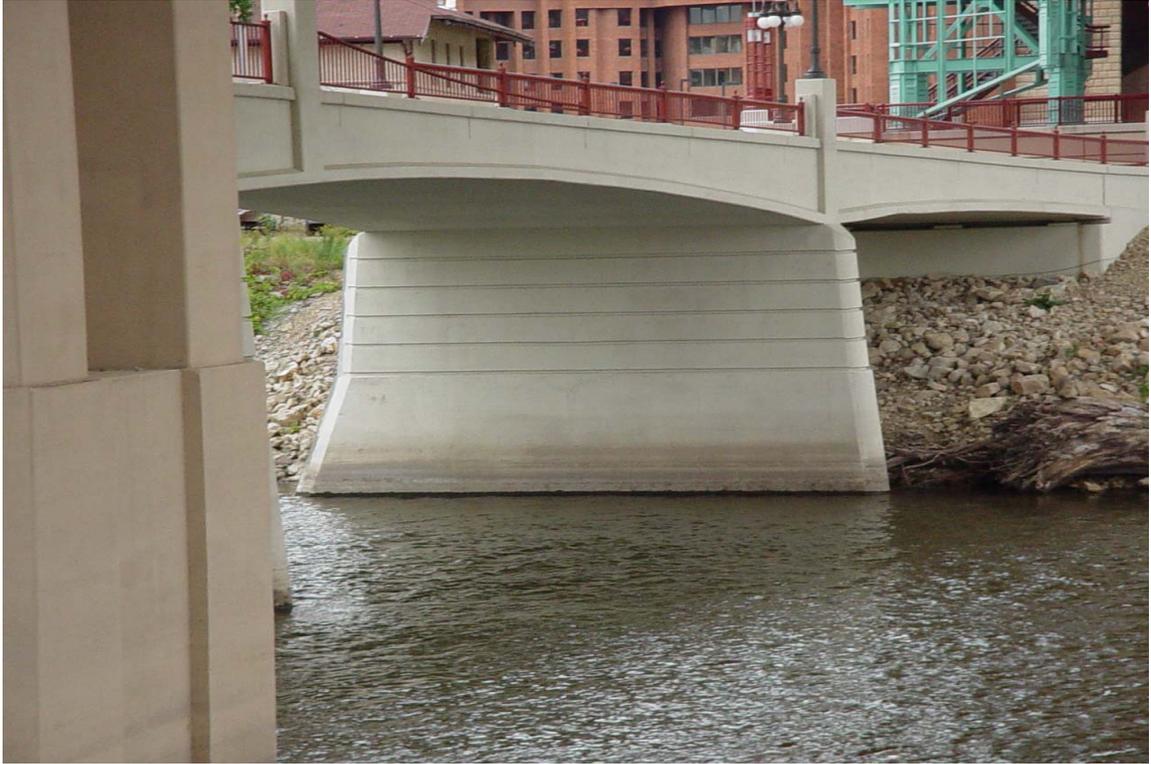
Photograph 5. Overall View of Pier 4, Looking Northwest.

| UNIT REFERENCE NO. | UNIT DESCRIPTION | MAXIMUM DEPTH OF WATER | SUBSTRUCTURE | | | | | | CHANNEL | | | | | GENERAL | | | | | |
|---|---|---|---|---|---|---|---|---|---|---|---|---|---|---|---|---|---|---|---|
| | Pier 4 | 5.5' | 7 | 7 | N | 9 | N | 7 | 8 | N | 9 | 7 | 7 | 7 | 7 | N | N | N | N |
