UNDERWATER BRIDGE INSPECTION REPORT

STRUCTURE NO. L8159

MISSISSIPPI RIVER OVERFLOW

DISTRICT 9 - WASHINGTON COUNTY, CITY OF COTTAGE GROVE

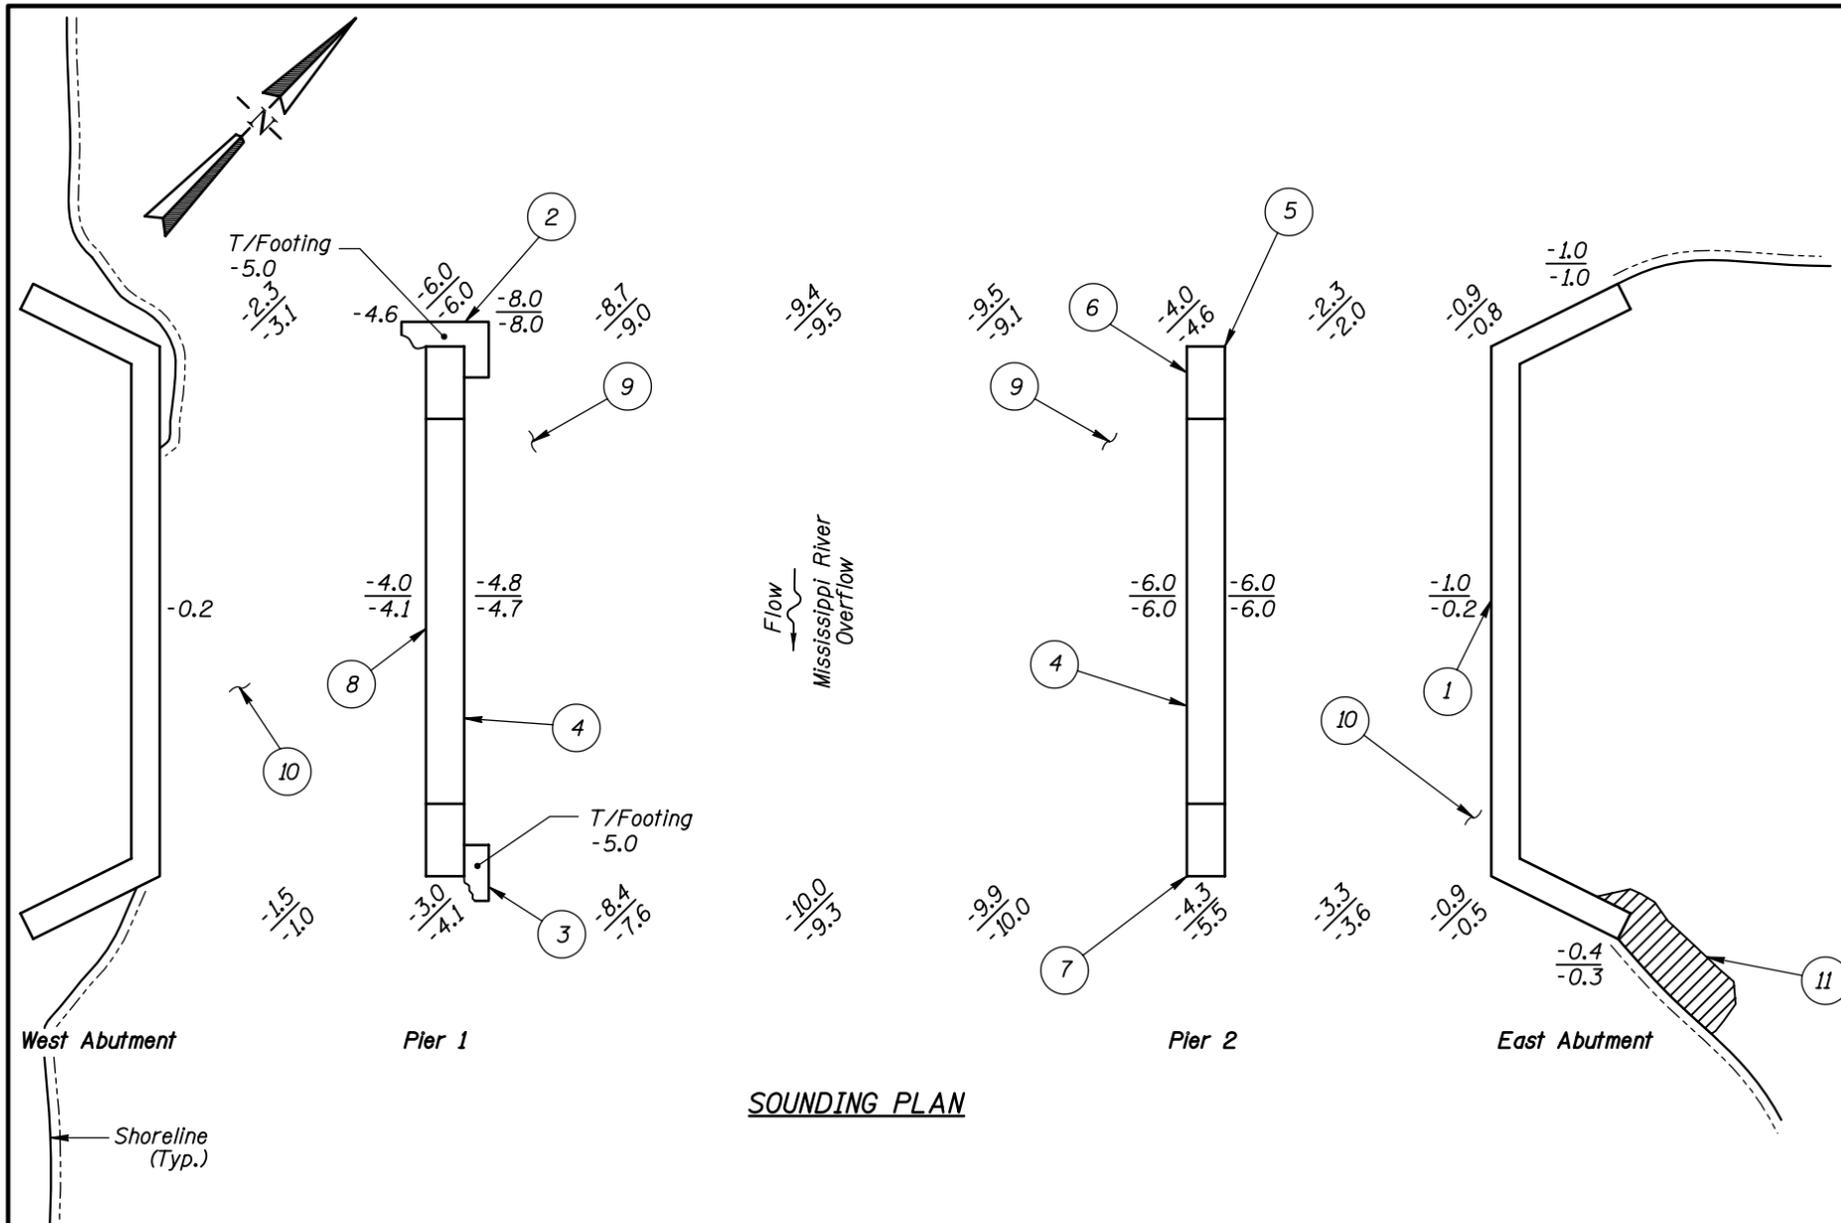
- 1 Three evenly spaced vertical hairline cracks were observed at the center of the East Abutment from the top of the abutment to 1 foot above the waterline.

- 2 The footing at the upstream end of Pier 1 was exposed with up to 3 feet of vertical face exposure at the North corner.
- 3 The footing at the downstream end of Pier 1 was exposed with up to 2 feet of vertical exposure.

- 4 A 6-inch-wide band of minor scaling was observed at the waterline at Piers 1 and 2.
- 5 An area of section loss, 3 inches in diameter, was observed 6 inches above the channel bottom on the upstream end of Pier 2 with up to 1 inch of penetrtrion.

- 6 Two areas of section loss, 6 inches in height and 12 inches wide, were observed 4 feet below the waterline with up to 1 inch of penetration.
- 7 An area of section loss, 6 inches in diameter, was observed on the corner at the channel bottom with up to 2 inches of penetration.

- 8 An area of section loss, 8 inches in diameter, was observed at the waterline with 1.5 inches of penetration.
- 9 The channel bottom consisted of sand, riprap, and broken concrete with a probe rod penetration of 1 inch.

- 10 The channel bottom consisted of firm sandy gravel with no appreciable probe rod penetration.
- 11 The embankment at the south wingwall of the East Abutment was eroded.

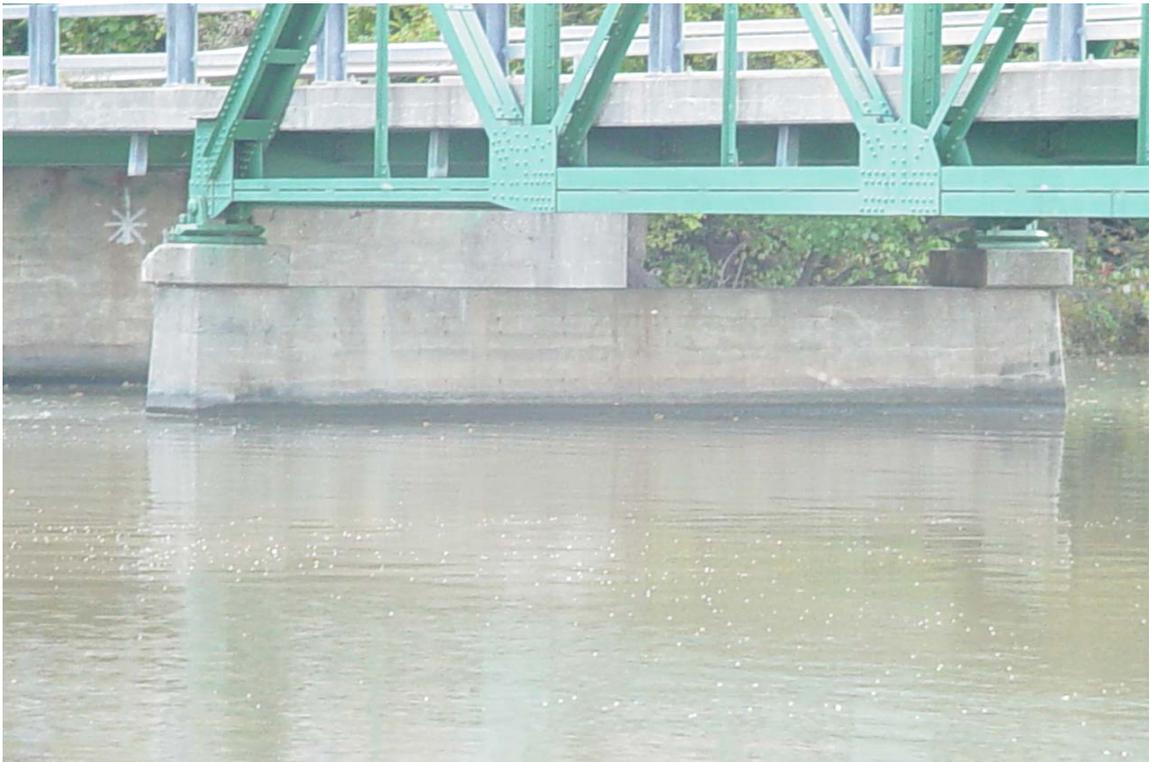
- (A) Three evenly spaced vertical hairline cracks were located near the center of the East Abutment extending from the top of the abutment to 1 foot above the waterline.
- (B) The footing at Pier 1 was partially exposed at the upstream and downstream ends with a maximum vertical face exposure of 3 feet at the upstream end and 2 feet at the downstream end.
- (C) Several areas of section loss were observed below the waterline at the upstream and downstream ends of Pier 2 with a maximum penetration of 2 inches.
- (D) An area of section loss, 8 inches in diameter, was observed at the waterline on the center of Pier 1 with a penetration of 1.5 inches.

Photograph 2. View of Pier 1, Looking West.

- (A) No plans for the structure were available at the time of the inspection. It is recommended that existing plans be reviewed to determine the foundation type and depth at Pier 1 in regard to the footing exposure. It is also recommended that the scour analysis be reviewed to determine if the exposed footing was considered in the coding of Item 113. Based on the findings from the plans and scour analysis, countermeasures may be warranted, such as placing riprap around the exposed footing at Pier 1 to prevent further exposure.

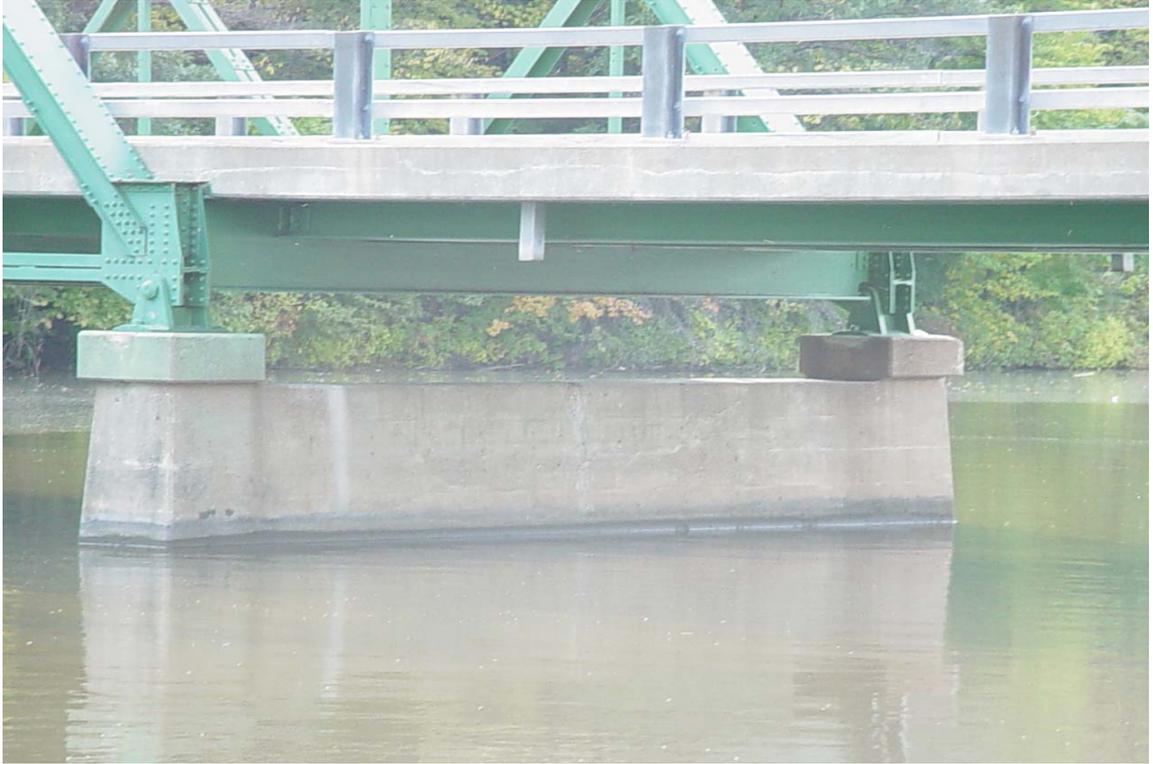
Photograph 3. View of Pier 2, Looking West.
