UNDERWATER BRIDGE INSPECTION REPORT

STRUCTURE NO. 2501

RUM RIVER

JOB NO. 5221 (CEI 103)

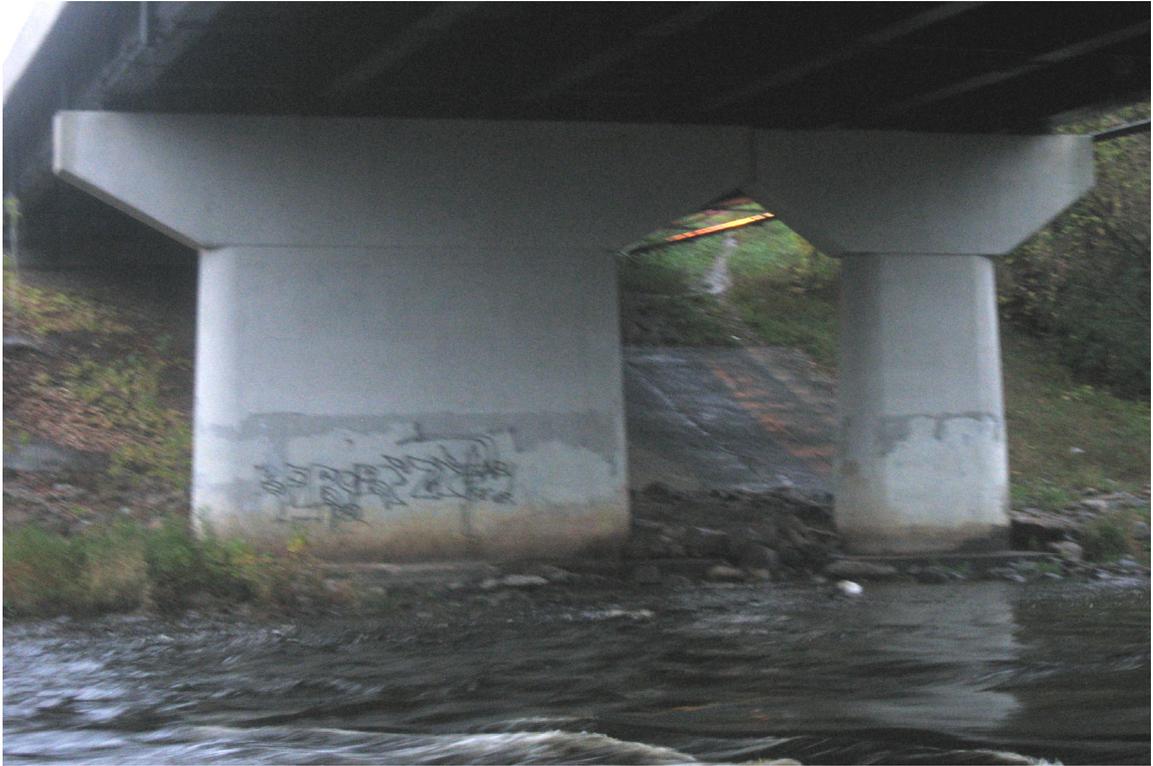
- (A) The top of footing and up to 1.5 feet of vertical face was exposed along the east side of Pier 1.
- (B) Moderate scaling was observed around the entire perimeter of the downstream shaft of Pier 2 from the channel bottom to 2 feet above the waterline with a maximum penetration of 2 inches. The heaviest scaling was along the west face and the upstream nose.
- (C) Heavy scaling, section loss and cracking was observed on the top of the downstream portion of the exposed footing of Pier 1 with penetrations of up to 5 inches. Numerous 1/16 inch to 1/2 inch wide cracks and areas of section loss were observed on the top of the footing between the pier shaft and the edge of the footing.
- (D) The grouted riprap was deteriorated/missing from the west side of the upstream Pier 1 shaft to the slope protection mat for the western embankment.

Photograph 1. View of Pier 1, Looking West.

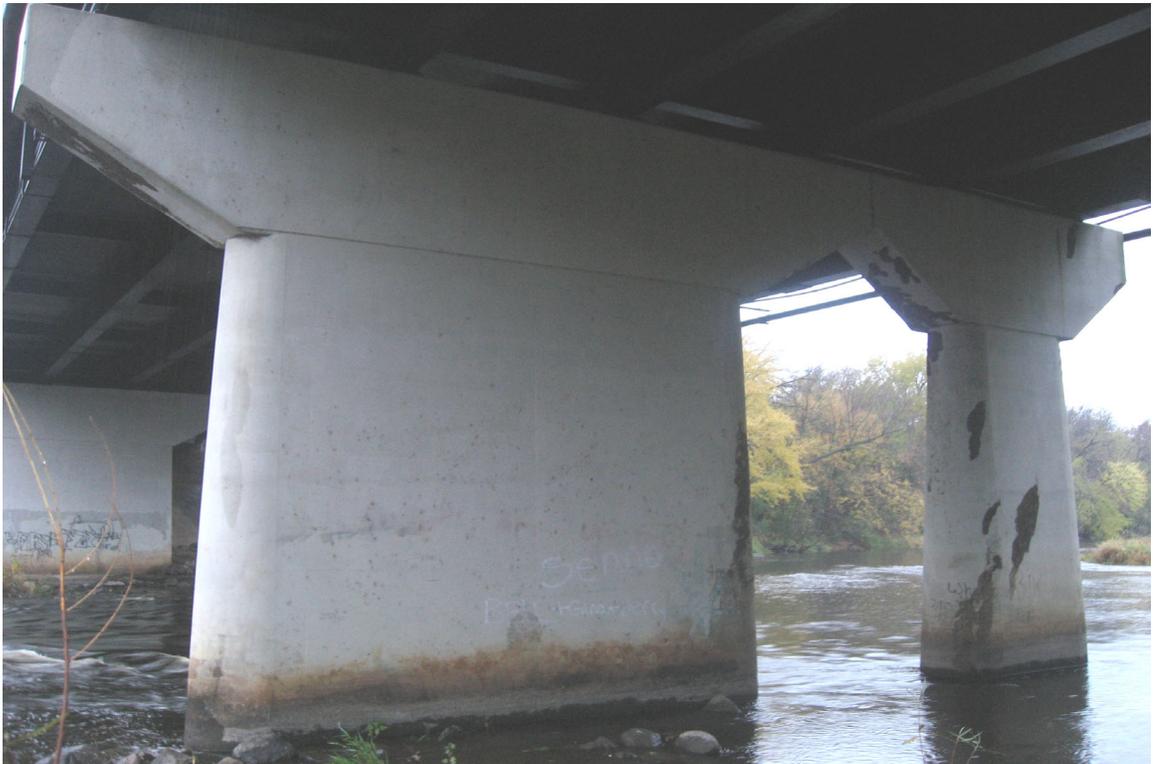
Photograph 2. View of the Pier 2, Looking Northwest.

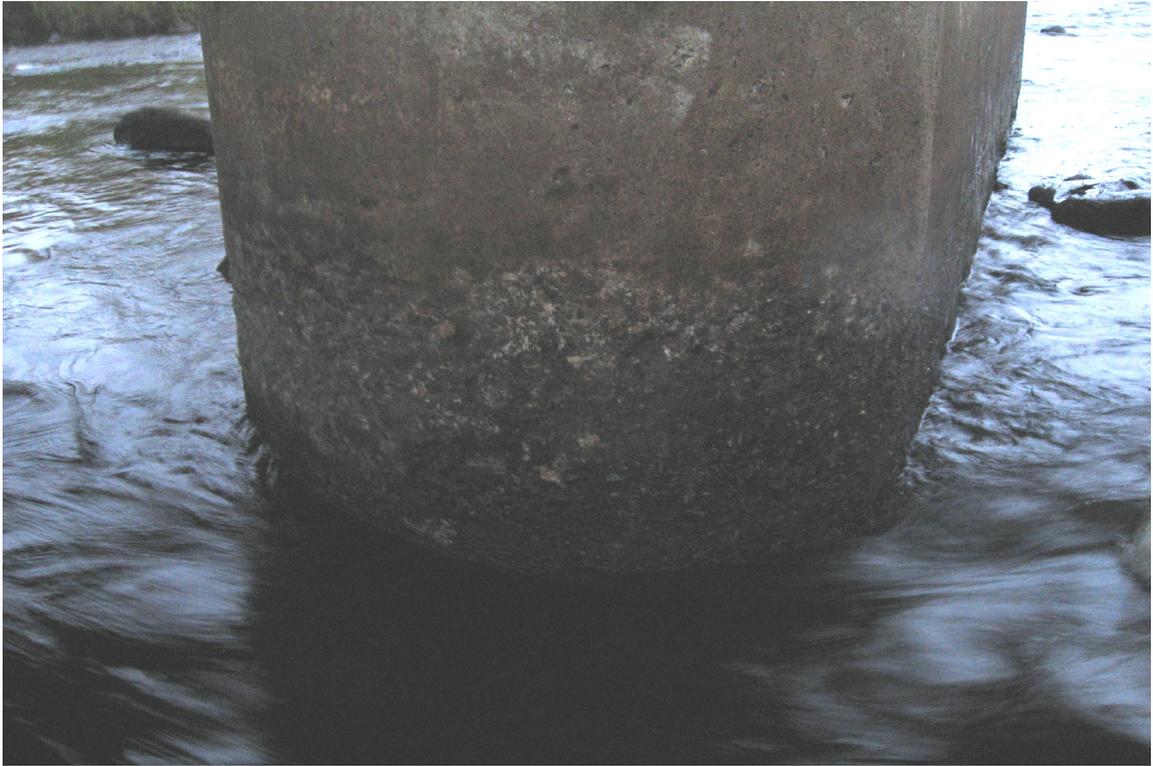
Photograph 3. Scaling at Pier 2 at the Upstream Nose of the Downstream Shaft, Looking Southeast.

- 3 Moderate scaling was observed around the entire perimeter of the downstream shaft of Pier 2 from the channel bottom to 2 feet above the waterline with a maximum penetration of 2 inches. The heaviest scaling was along the west face and the upstream nose.

- (B) Reinspect the submerged substructure units at the normal maximum recommended (NBIS) interval of five (5) years.

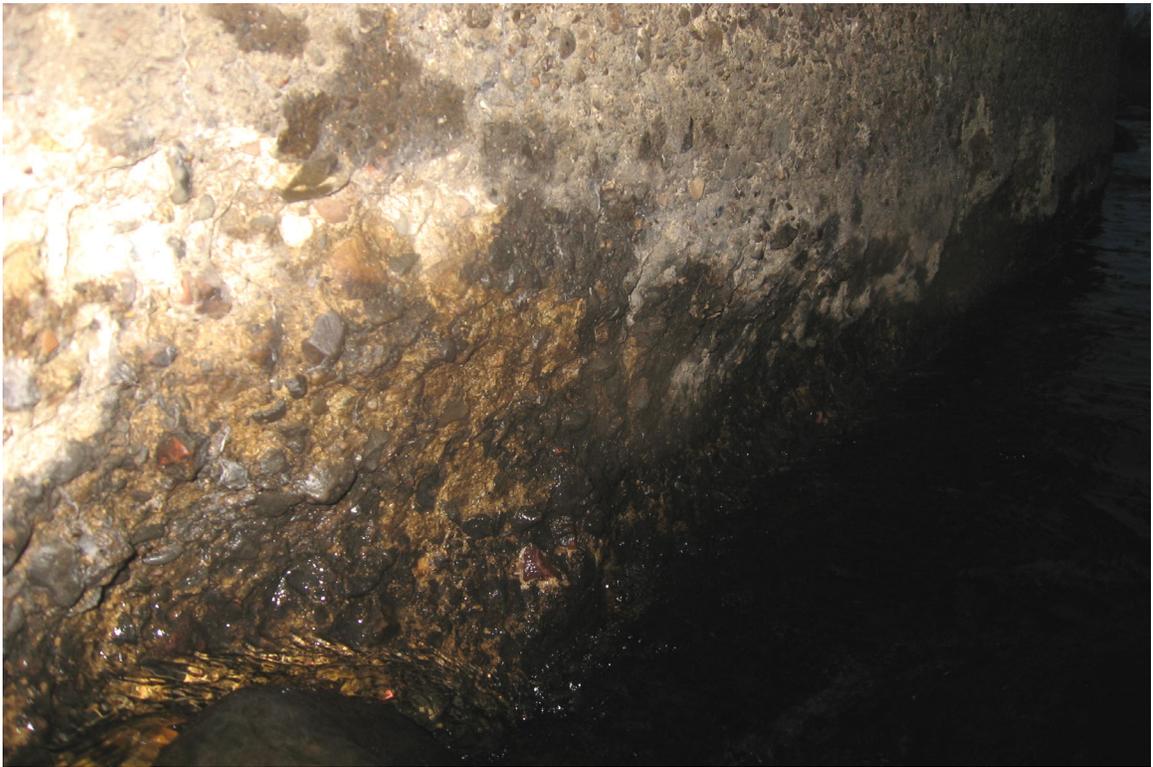
Photograph 4. Scaling on the West Face on the Downstream Shaft of Pier 2, Looking Southeast.

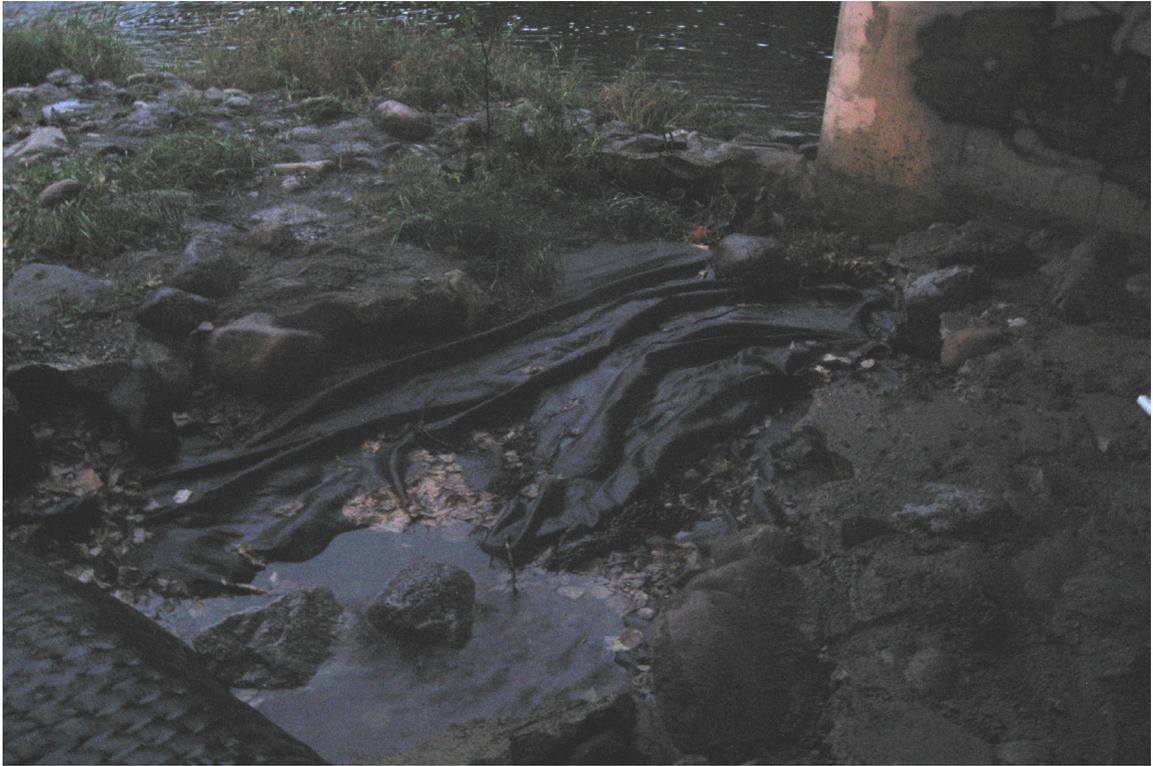
Photograph 5. Washed out area (West Face of Pier 1), Looking Northeast.

- 7 The grouted riprap was deteriorated with missing riprap extending from the west side of the upstream shaft of Pier 1 to the slope protection mat along the western embankment.

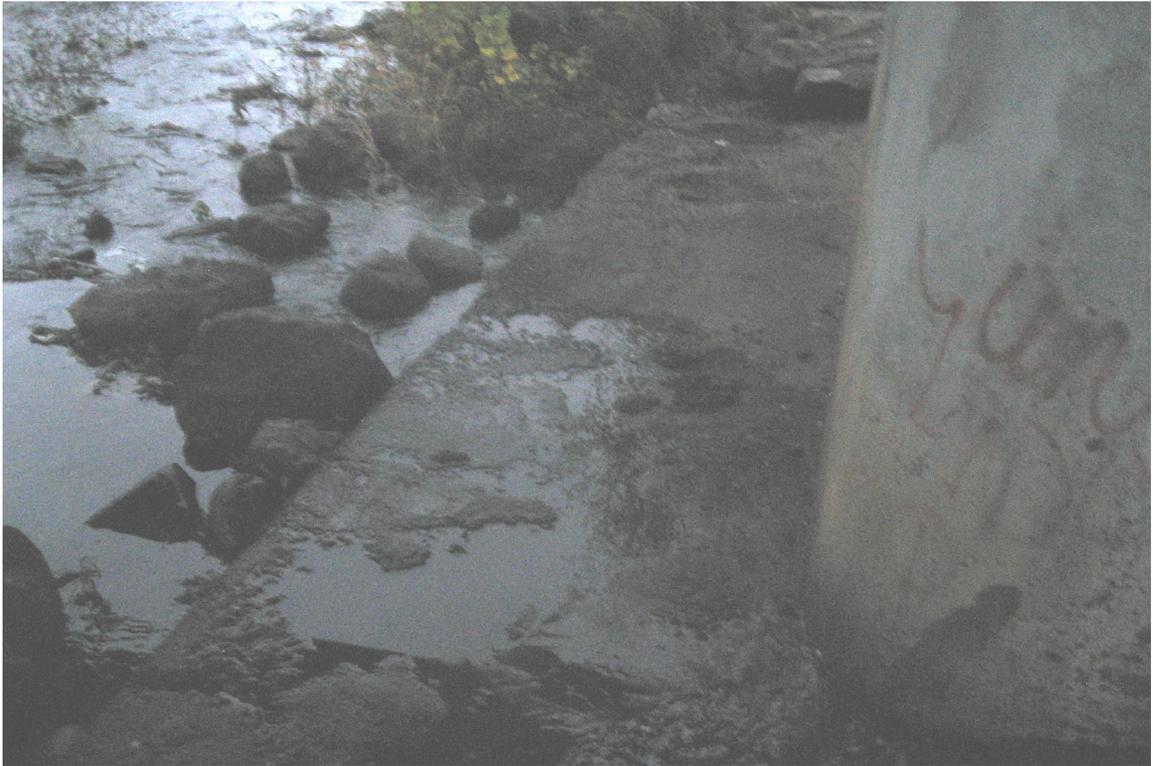
Photograph 6. View of top of the footing at the Downstream Pier Shaft of Pier 1, Looking South.

- 4 Heavy scaling and cracking was observed on the top of the footing from the shaft to the footing edge with a maximum penetration of 5 inches. Numerous 1/16-inch- to 1/2-inch-wide cracks and areas of section loss were also observed on the top of footing from the pier shaft to the edge of the footing with the cracks extending into the channel bottom along the vertical face of the footing.

- (A) Monitor the concrete deterioration of the footing at Pier 1. If found to be progressing in the future, consideration could be given to repair by removing the unsound concrete and reforming with a concrete mix designed to promote high durability and low permeability.

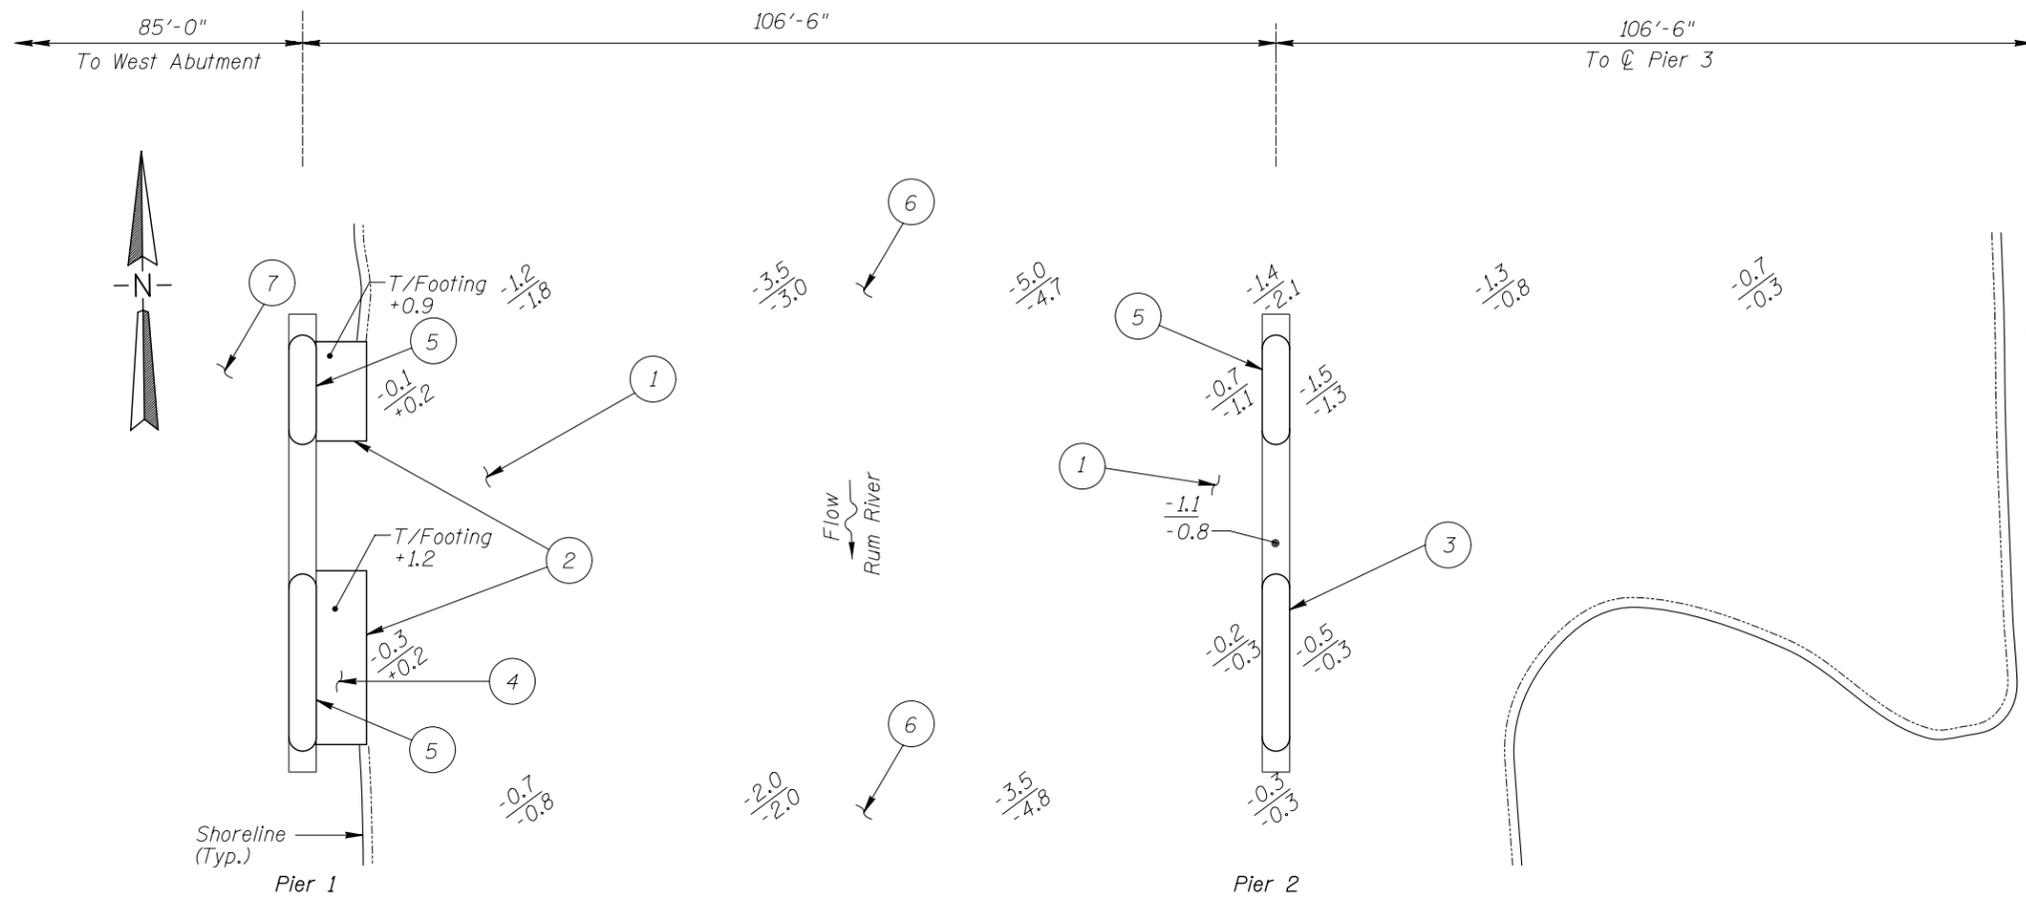
**SOUNDING PLAN**

- 1 The channel bottom material consisted of 2-foot-diameter and smaller riprap.
- 2 The footing was exposed along the east side of Pier 1 with up to 1.5 feet of the vertical face exposed.

- 5 The concrete shaft was in smooth and sound condition with no noted deficiencies.
- 6 The waterline elevation was approximately 6 inches lower along the downstream fascia compared to the upstream fascia.
